1. Name of Property

Historic name Maplecroft Farmstead
Other names/site number Frisbie Farm; KHRI #087-0000-00006 (House); KHRI #087-444 (Barn)
Name of related Multiple Property Listing Historic Agriculture-Related Resources of Kansas

Narrative Description

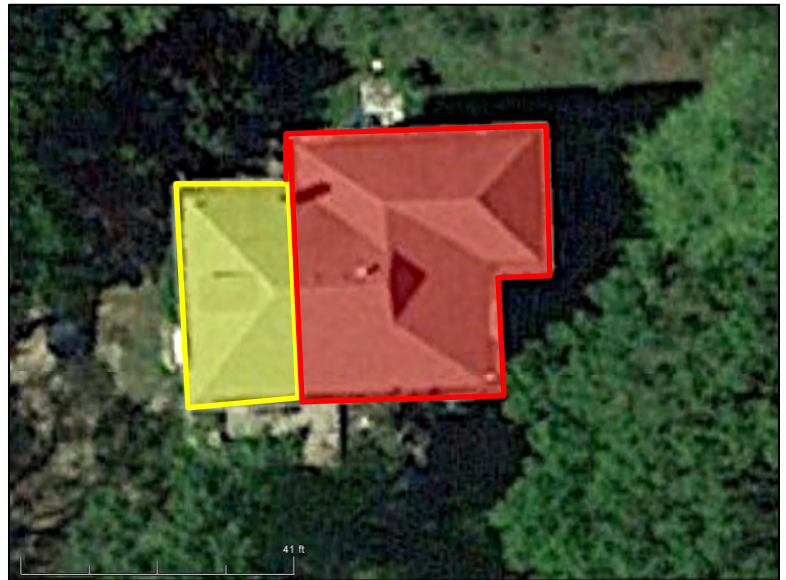
Figure 2: 2014 Aerial image of house, showing original block of house (left) and 1870s block (right). A second story was added to the left portion in 1922. North is up.

The 3,149 sq.ft. Italianate house faces east and is built on a hill with a gently sloping grade in every direction. The stone dwelling was built in three main phases that produced its current irregular plan, measuring approximately 36' wide (north to south) and 52' long (east to west) (*Figure 2*).¹⁴ The original one-story rectangular block dates to ca.1862 and is currently the ground level of the west portion.¹⁵ An L-shaped, two-story block was built to the east of the original portion in the 1870s, and the second level of the west portion was added in ca.1920.¹⁶ The construction of the east portion of the house is attributed to M. R. Dutton, who began construction of the stone house and a limestone barn in the 1870s. Frisbie family history states that the house was under construction when Hanson Z. Frisbie bought the property in 1873 and moved here in 1874.¹⁷ Architecturally, the house is one of the largest residential vernacular stone structures with Italianate details in the county.

Excepting the roof, the entire structure is composed of hand-cut native limestone blocks that were quarried on private property just north of the house in Section 7. The foundation sits on a natural limestone outcropping and supports 18" thick stone walls. It is significant to note that these walls not only comprise the outside of the structure but also include two, two-story interior walls.¹⁸ The masonry is laid with lime mortar, though patching is evident on the north elevation (*Photos 8 & 9*). Repairs to the mortar voids on the west end of the home were completed with type N masonry compound in November of 2015. Additional repairs were made to the west basement stairs, walls, and doorway at this time. The junction between the walls and roof are ornamented by a heavy top cornice molding supported by decorative bracket corbels, primarily in pairs, along the wide overhanging horizontal cornice eaves. The roof is mostly low-pitched cross-hipped with composition shingles; it was repaired and shingles replaced around 2006. Only one of the original five brick chimneys pierce the roof today, the others having been taken down to attic level (one in c1922 and three in 1968) (*Figures 3 & 4*). The extant chimney is located in the north wall of the west block; it is in the northeast corner of the kitchen on the first floor and the laundry room on the second level (*Photos 10 & 11*).¹⁹

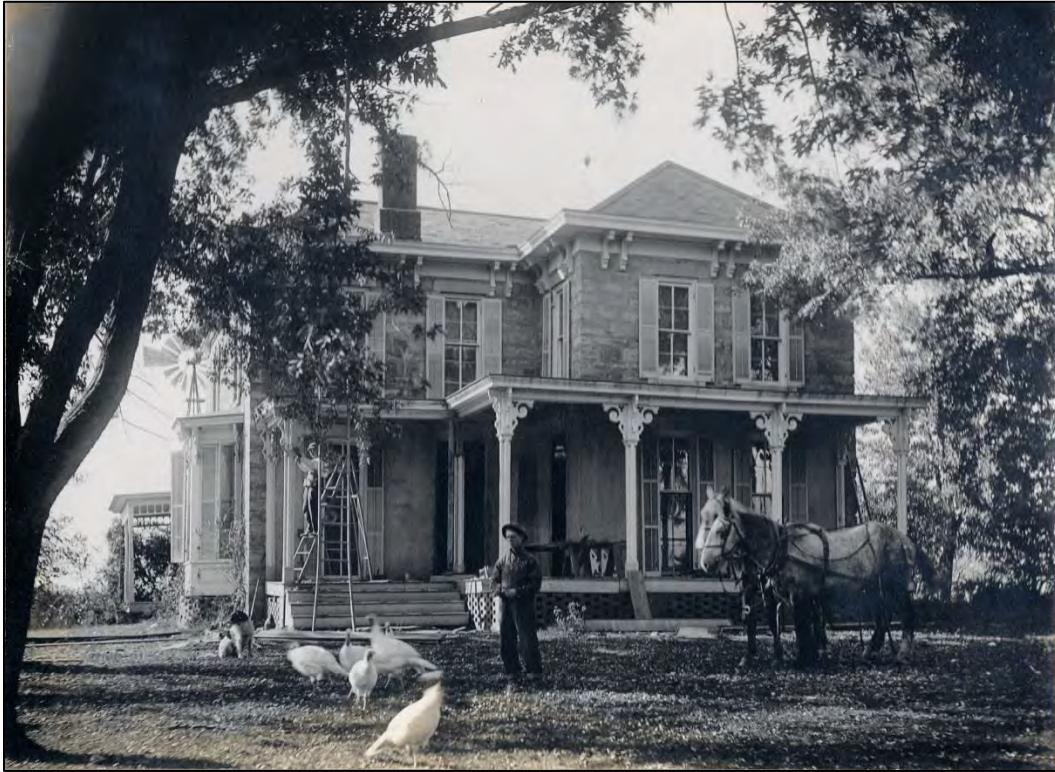
Figure 3: East side of house, showing chimney above roofline. Notice the absence of the gable-on-hip in the roof. 1917. Unknown photographer.

The original porch on the east side of the house was decorated with ornately carved, F-shape brackets on square porch posts with beveled edges and no railing or balustrade (*Figure 3*). This porch was removed around 2010 due to severe deterioration to an unsafe state; it had included a wood porch swing which was removed sometime in the early 1980s due to deterioration.²⁵ The porch's roof line is evident along the width of the façade, indicated by post holes in the masonry and remnants of lime parging added under the porch at an unknown time; however, photographic evidence suggests it was prior to 1917 (*Figure 3*). Recent consultation with a stone mason indicates the parging was intended to serve as a sort of stucco in the original design of the homes' covered porch, with scoring to resemble stone shaped blocks, over the top of the existing smaller stones that make up the east wall.²⁶

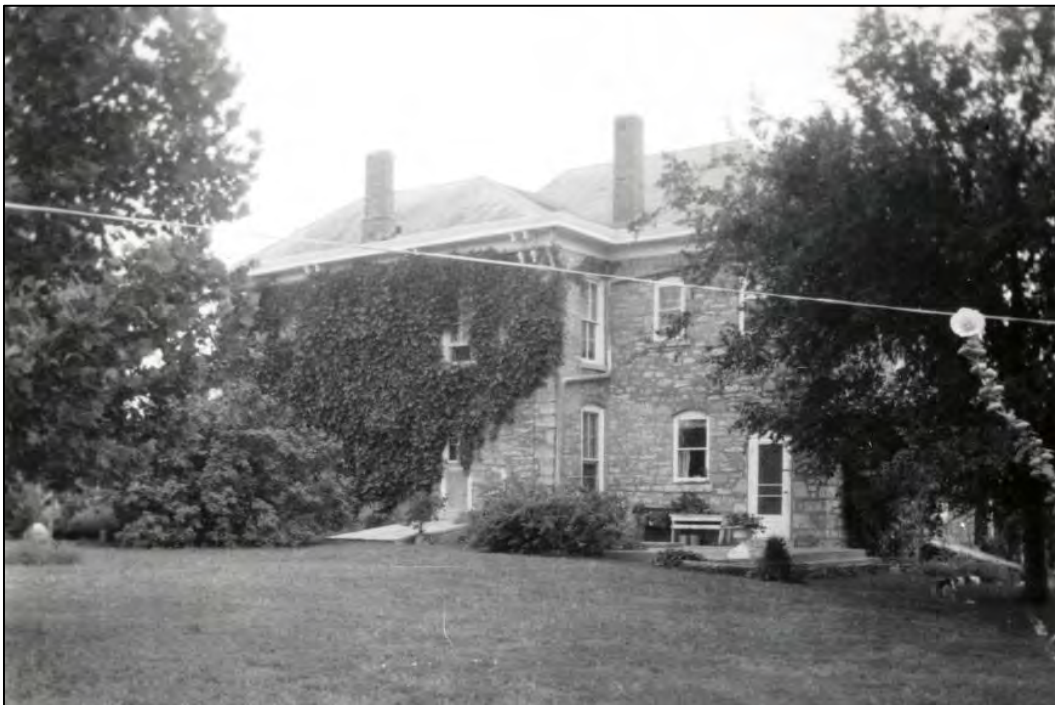
Figure 4: Detail of two chimneys on north side of house. Pre-1968²⁰. Unknown photographer.

There was a woodstove, or possibly a coal stove, in the parlor on the north wall west of the window. Two of the house's wood stoves are stored on the farm property.

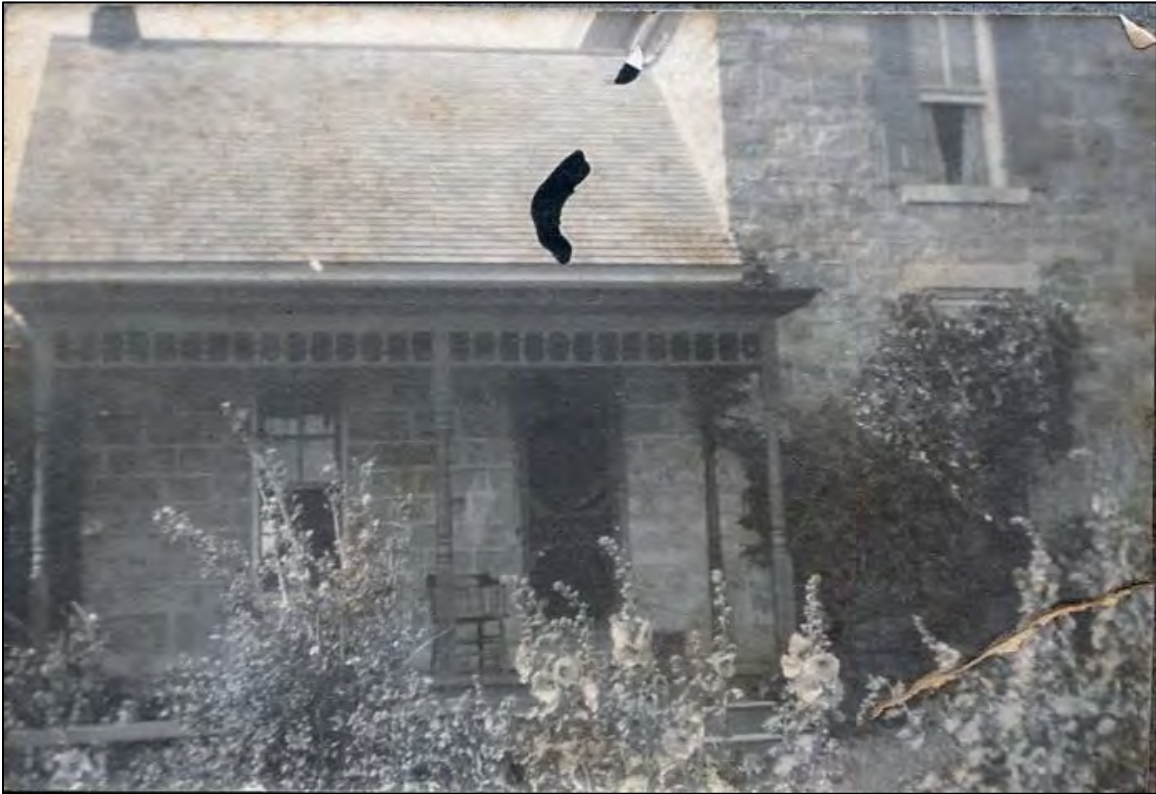
Figure 5: South elevation of rear block prior to 1922.

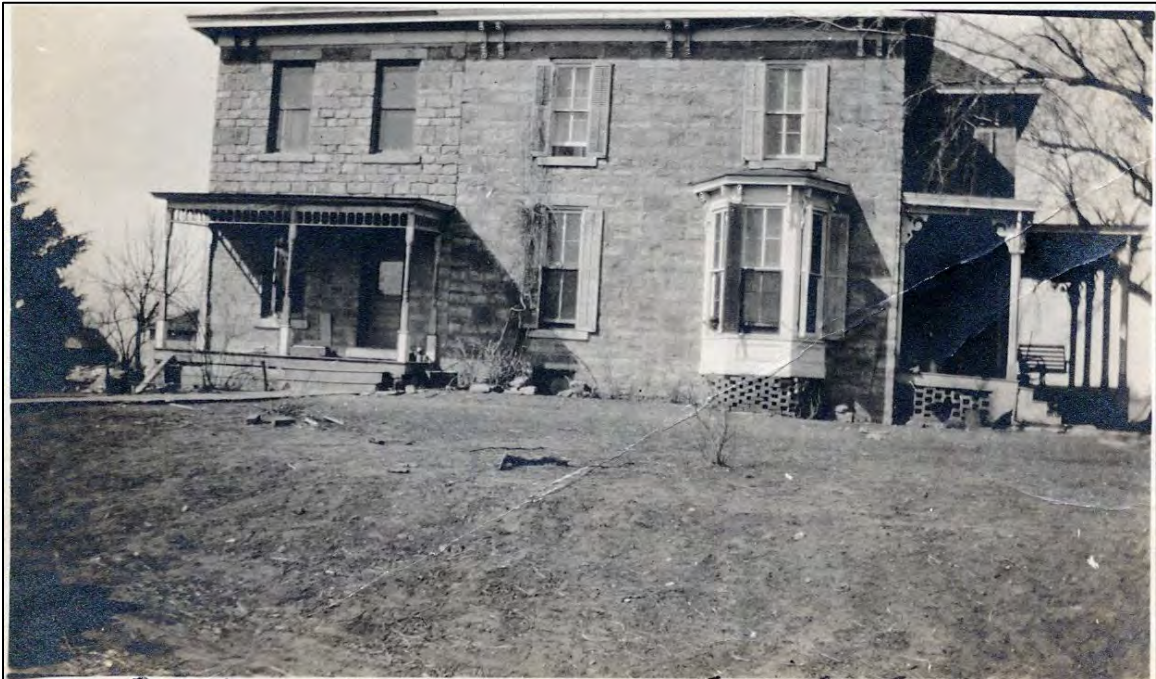
Figure 6: South elevation after second level added to rear block. Post-1922.

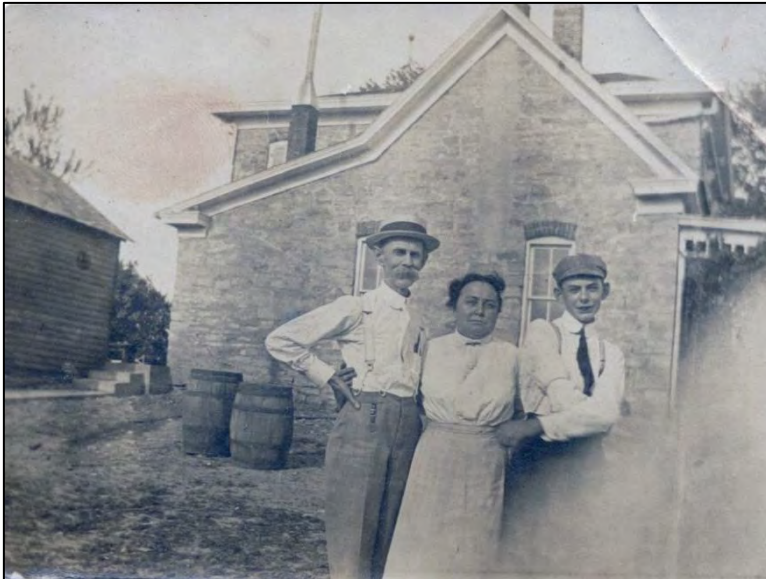
Figure 7: West elevation, ca. 1905, with Clarence, Kate, and Ross Frisbie.

limestone sill and double soldier brick segmental arch lintel.³⁰ Bay 4 has a wide one-over-one double-hung sash with cut limestone sill and double soldier brick segmental arch lintel on the main level with an upper window identical to the one in Bay 3. Below the lower level window is a covered set of concrete over stone steps leading down to the basement. Centered in the hip of the roof above Bays 2 through 4 is a shed-roof dormer with a non-historic double-pane window. The eave brackets and window arrangement on this elevation (excepting in Bay 1) date to 1922, according to photographic evidence from circa 1905 (*Figure 7*).

⁴² A wood structure of unknown age, visible in Figures 7, 9 and 10, is adjacent to the cistern and pump room. Stones from the foundation of this building are still visible next to the cement sidewalk and stairs of the back porch. Ann Frisbie Brunton recalled that when she was young they tore down a building on the farm but she did not remember if it was this structure or a different one.

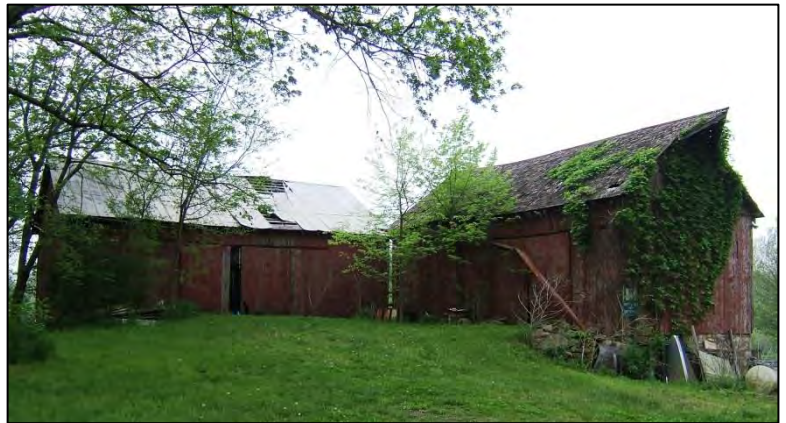
Figure 8: Looking south-southwest and south barn (left) and west barn (right). May 2007. Leisa Gale.

The south bank barn replaced an earlier limestone barn that burned in 1946, being built atop the limestone foundation of this older barn, which was encapsulated between concrete walls. The stone foundation extends from the ground on the lower basement level to the ground level on the bank side. It has a limestone floor. Vertical wood planks enclose the sides above the foundation. The bank barn measures 30' (N/S) x 40' (E/W). The structure is balloon/timber-frame hybrid. Walnut timbers from a demolished bridge at Muddy Creek just south of the property were incorporated into the structure as lower-level support beams (*Photo 17*).⁴⁶ The structure has a full basement, with limestone floor, and a full upper story (no loft) (*Photo 16*). The side gable roof is covered with metal, installed sometime prior to 1976.⁴⁷ A concrete block bearing the date 1947 is located next to the foundation of this barn⁴⁸.

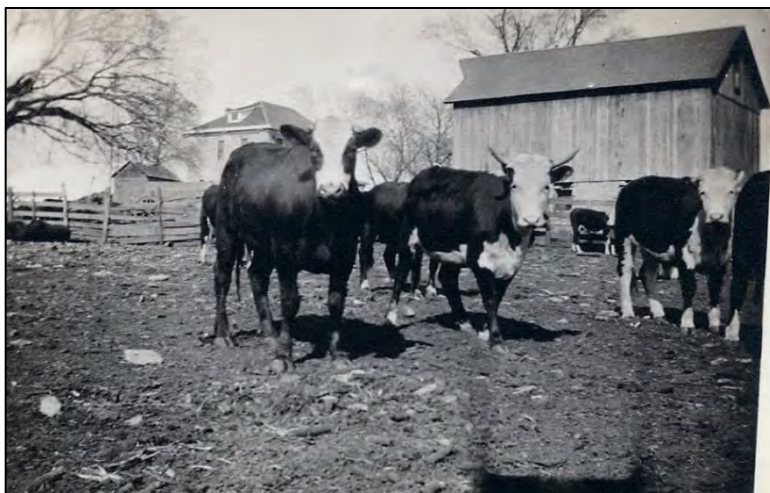
Figure 9: Looking NE at west and south elevations of West Barn (right); house is in background. c.1937.

The west bank barn replaced an earlier wood barn that also burned in 1946. It was rebuilt as a balloon/timber-frame hybrid barn on the previously existing limestone foundation (exposed). The stone foundation extends from the ground on the lower basement level to the ground level on the bank side. Vertical wood planks enclose the sides above the foundation. This barn was built to the west of the original limestone south barn location and sits at a right angle to it (*Figure 8; Photo 18*). The west barn measures 20' (E/W) x 36' (N/S).⁵⁰ This barn retains a shake shingle side gable roof with hay hood on the north elevation (*Photos 19 & 20*). It has a full basement, main level, accessed by the bank on the east, and a hay loft. There is a large sliding door on the main level at the east side of the barn and a single pedestrian door on the west side on the basement level (*Photos 19 & 21*). The interior of the basement is divided into three stalls and a feeding trough (*Photo 22*). The floor is limestone. There is a large doorway with a wooden gate on the south end of the barn at the basement level (*Photo 22*). The interior of the main level has stairs leading to the basement located along the west wall to the south of the large sliding door. To the north of the sliding door are the stairs leading to the upstairs loft. Located on the main level at the north end of the barn are two grain storage bins with a loft above (*Photo 23*). There is a pulley system on a rail mounted to the center roofline that allows hay to be moved from the ground level into the loft at the north end of the barn.

In July of 2016, the roof, south, and west walls of this barn collapsed. The north and east walls are still standing.

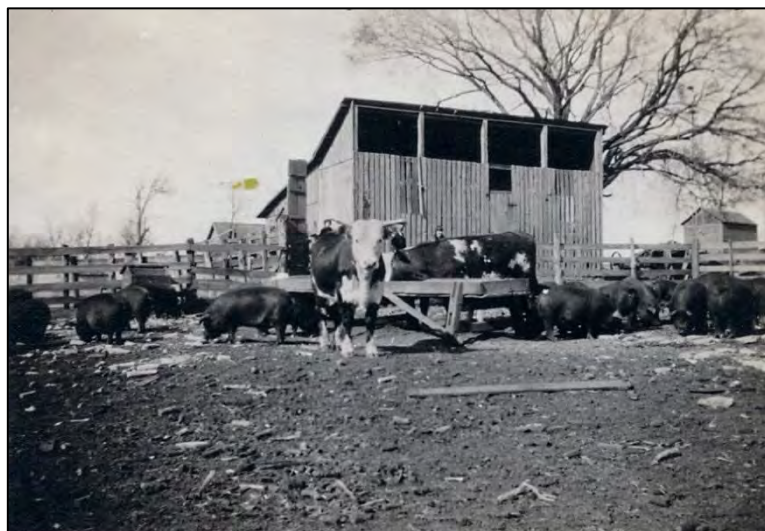
Figure 10: Looking NE at corn crib and shop. ca. 1937.

The corn crib and shop is located southwest of the house and northwest of the barns. The shed-roof structure measures approximately 28' (N/S) x 32' (E/W). The corn crib is located in the south portion of the building. The south elevation is partially open at the top 1/4 with loosely-spaced vertical wood planks on the bottom 3/4. The entrance to the corn crib is located in the center of the south side. The shop is located in an enclosed room on the north portion of the building. It is accessed by a sliding barn door on the east side. The entire structure is built of hand-hewn timber. The north, east, and west sides are

covered in vertical wood planks. The roof has metal sheeting, installed at an unknown date, which is partially missing and damaged.

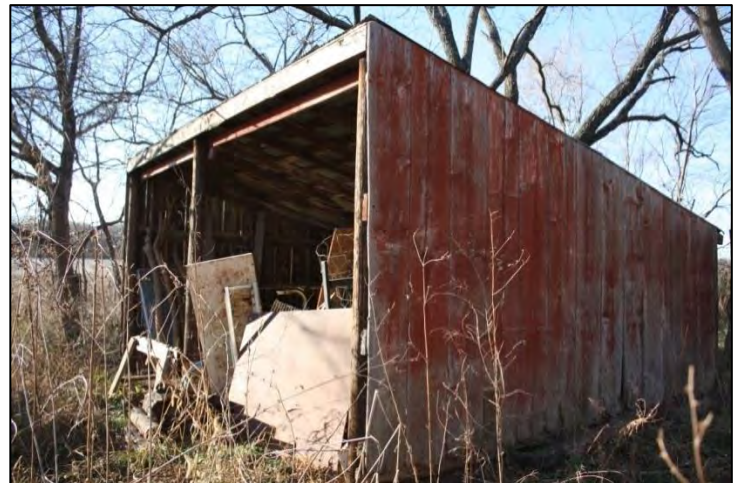
Figure 11: Cattle Shed, looking northwest. November 2013. Leisa Gale.

Located southwest of the house in the cattle feed lot west of the corn crib and shop, this 12'x20' cattle shed has a pole frame with vertical planks on the west, north, and east sides. It is open to the south and has a north sloping roof covered with metal sheeting. This barn, though currently used for storage, is in good condition. A second cattle shed, which measured 20'x40' and was located to the south of this structure, collapsed in ca. 1995. Only the foundation of that structure remains today (see 11 on map).

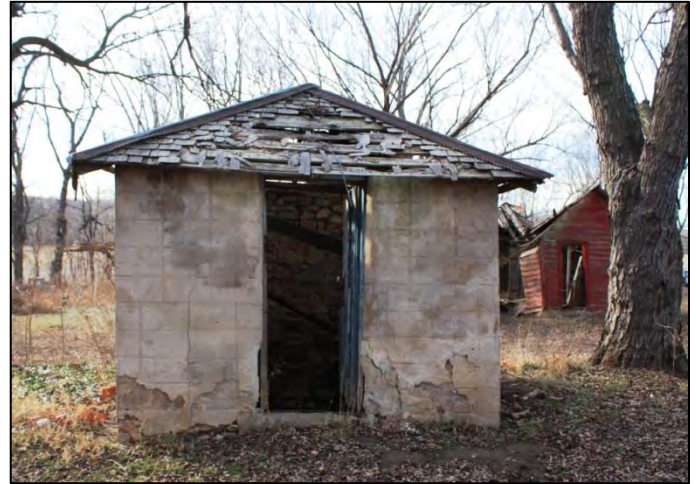
Figure 12: Smoke House, looking west. January 2015. Leisa Gale.

A square (9'-0" x 10'-0") one-story stone smoke house is situated to the northwest of the house's west block. The below-grade portion is about six feet deep. The exterior walls are parged and scored to look like cut stone blocks. The pyramidal roof retains its original shake shingle roof but is in poor condition. A single pedestrian door is centered on the east elevation. Herbert L. Frisbie related the following story in *The History of Grantville, Kansas*:

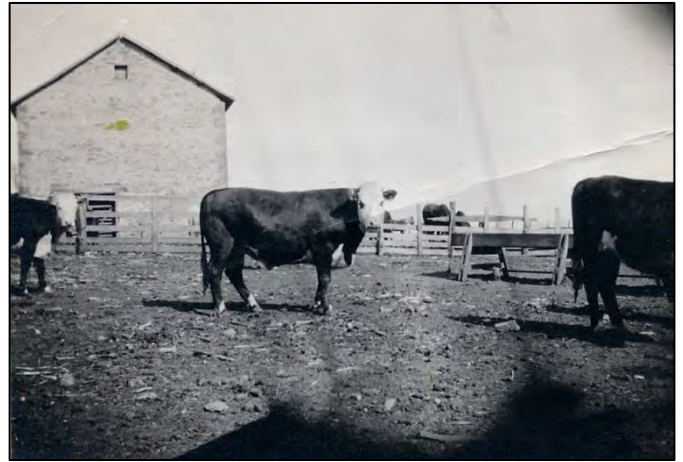
Figure 14: Looking east at west end of original limestone barn. ca 1937. Photographer Unknown.

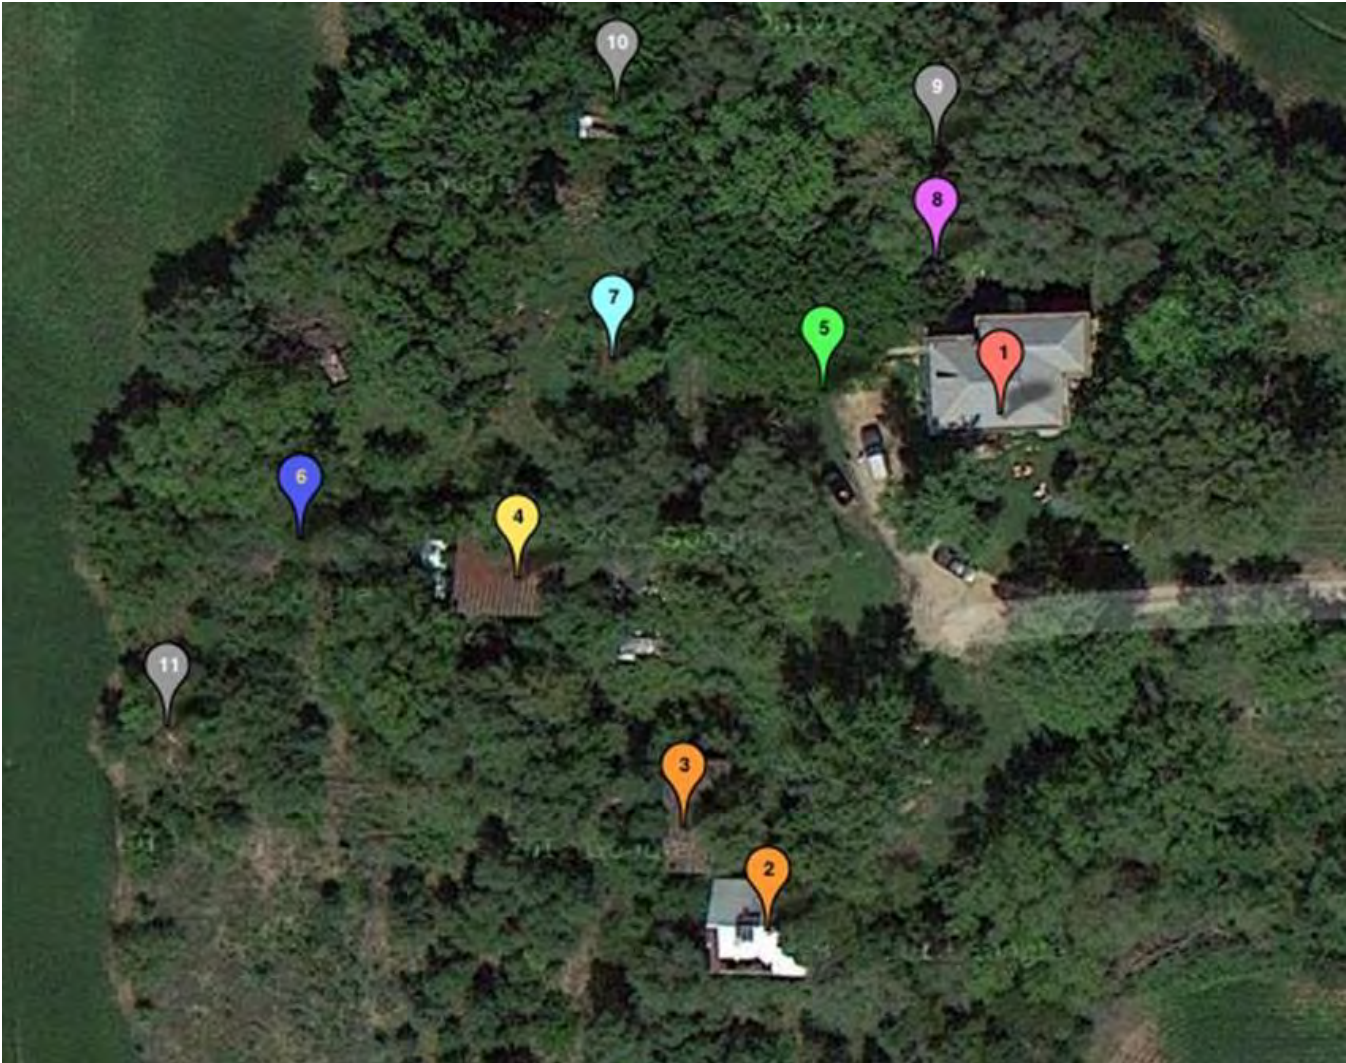
Map 1. Maplecroft Farm, showing locations of built resources – adapted by Leisa Gale from Google maps.

- 1) Frisbie House 36 x 52
- 2) South Barn 30 x 40
- 3) West Barn 20 x 36
- 4) Corn Crib and Shop 28 x 32
- 5) Hand Dug Well and Windmill
- 6) Cattle Shed 12 x 20
- 7) Chicken House 10 x 12
- 8) Smoke House
- 9) Outhouse Ruin
- 10) Brooder Shed Ruins 12 x 30
- 11) Cattle Shed Ruins 20 x 40

The nominated farmstead is arranged with the hand dug well and windmill practically at its center (*Map 1*, at end of document). About 16 yards to the east sits the limestone house. About 15 yards to the west is the chicken house. The driveway from KOA Road is about 130 yards from the road to the house. It curves around the southwest corner of the house between it and the well site allowing for a gravel parking area. It continues to curve around west toward the brooder house where the drive continues north toward tilled farmland and south toward the corn crib / shop. It circles in front of the two barns and reconnects with the driveway back to KOA Road. The brooder house is about 35 yards northwest of the house. The outhouse is located to the east of the brooder house, and north of the house. The smoke house is 10 yards northwest of the house. The south barn is 54 yards southwest of the house with the west barn at a right angle to it. The west barn is 48 yards southwest of the house. To the northwest of the barns is the corn crib / shop; they are 48 yards from the stone house.

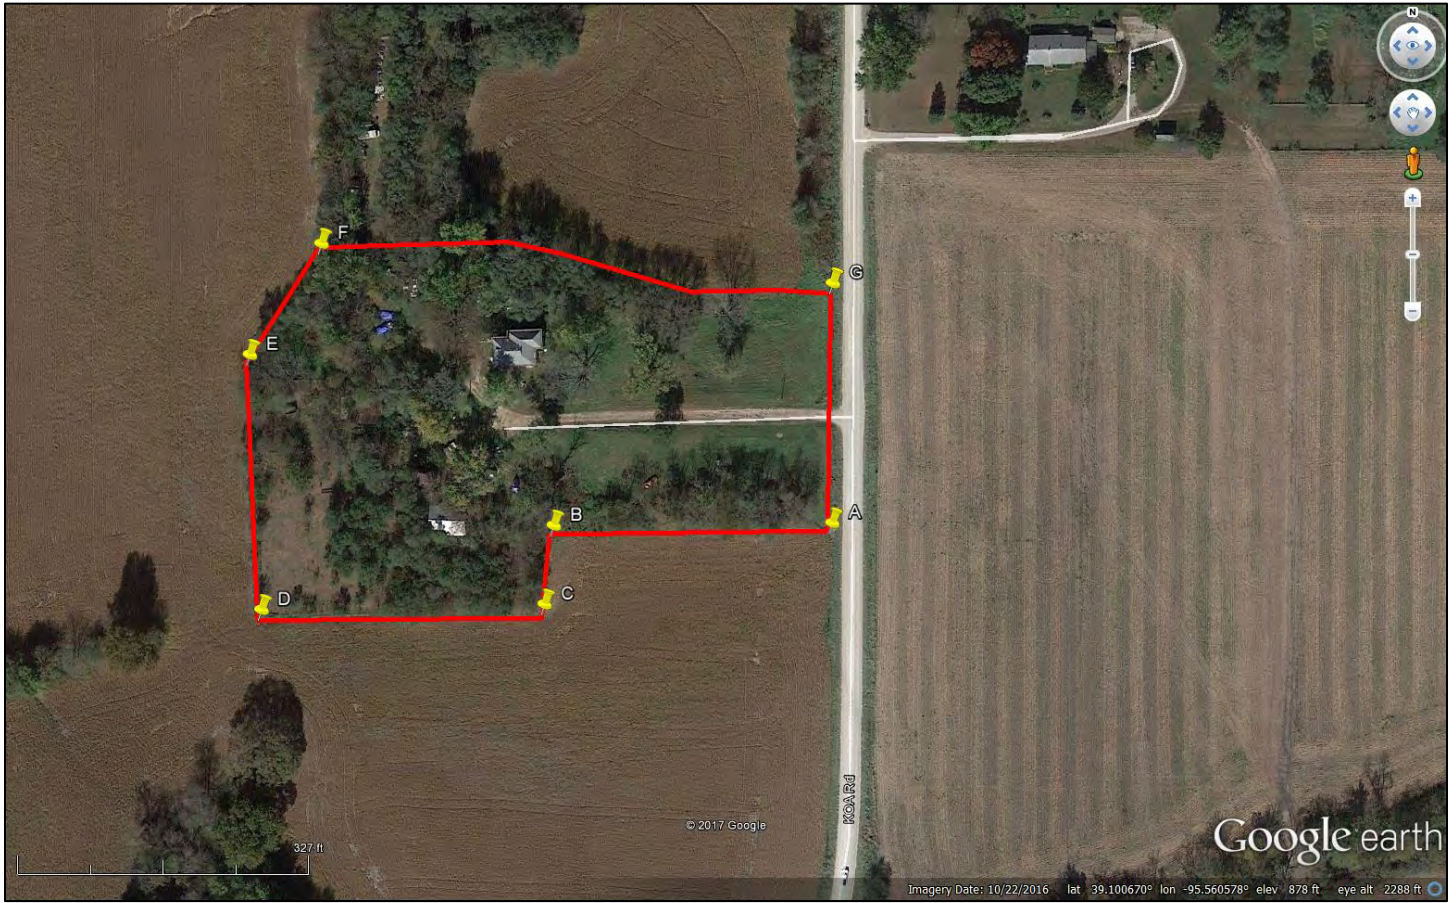
Boundary Map.

- A) 39.099132, -95.557681
- B) 39.099127, -95.558776
- C) 39.098885, -95.558816
- D) 39.098865, -95.559943
- E) 39.099648, -95.559982
- F) 39.099983, -95.559687
- G) 39.099865, -95.557680
