National Register of Historic Places Registration Form

Historic name: Union Meeting House
Other names/site number: Whiting Village Church
Name of related multiple property listing: N/A
(Enter "N/A" if property is not part of a multiple property listing)

Street & number: 153 US Route 1
City or town: Whiting State: Maine County: Washington
Not For Publication: n/a Vicinity: n/a

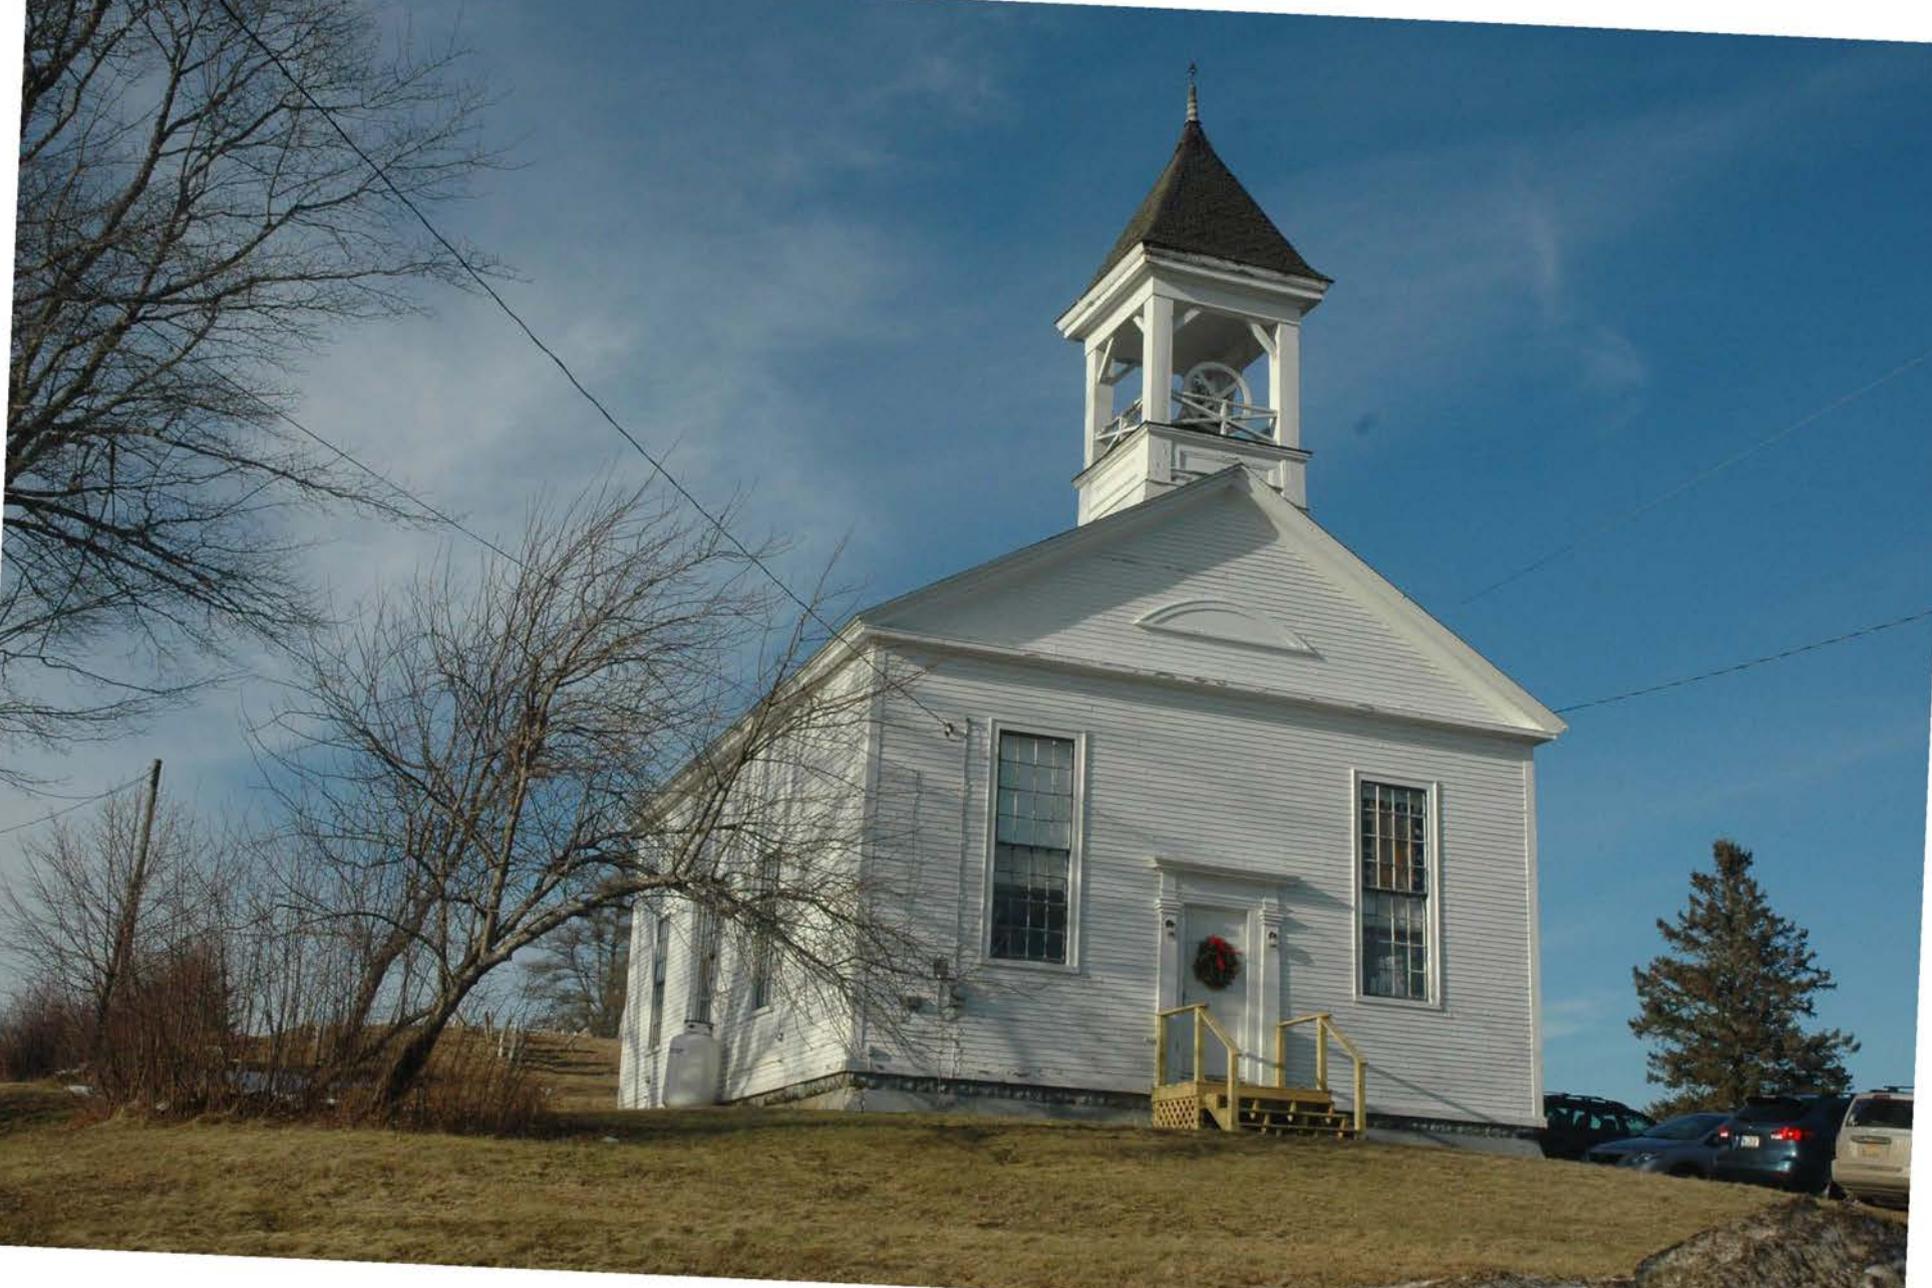
1 of 12 ME_Washington County_Union Meeting House_0001.tif
Exterior, primary façade; facing northeast.

The façade of the high-posted Union Meeting House is three bays wide and contains a central door flanked by two sixteen-over-sixteen windows. Relatively narrow boards, with a moulded bead on the corner, mark the edges of the building and a full Greek Revival-style cornice return creates a gable pediment. Centered within the pediment is a wooden, fan-like, arched panel. The wood front door has six raised panels, in a "double cross" style, and it is set in a surround with engaged Doric pilasters and a full entablature. The windows are trimmed with a simple band moulding and the slightly over hanging roof features moulded rake trim, a boxed cornice and crown moulding, except on the rear elevation, where the rake is held tight to the wall. A water-table board marks the transition to the foundation. A new wooden stoop with side rails is positioned in front of the main entry.

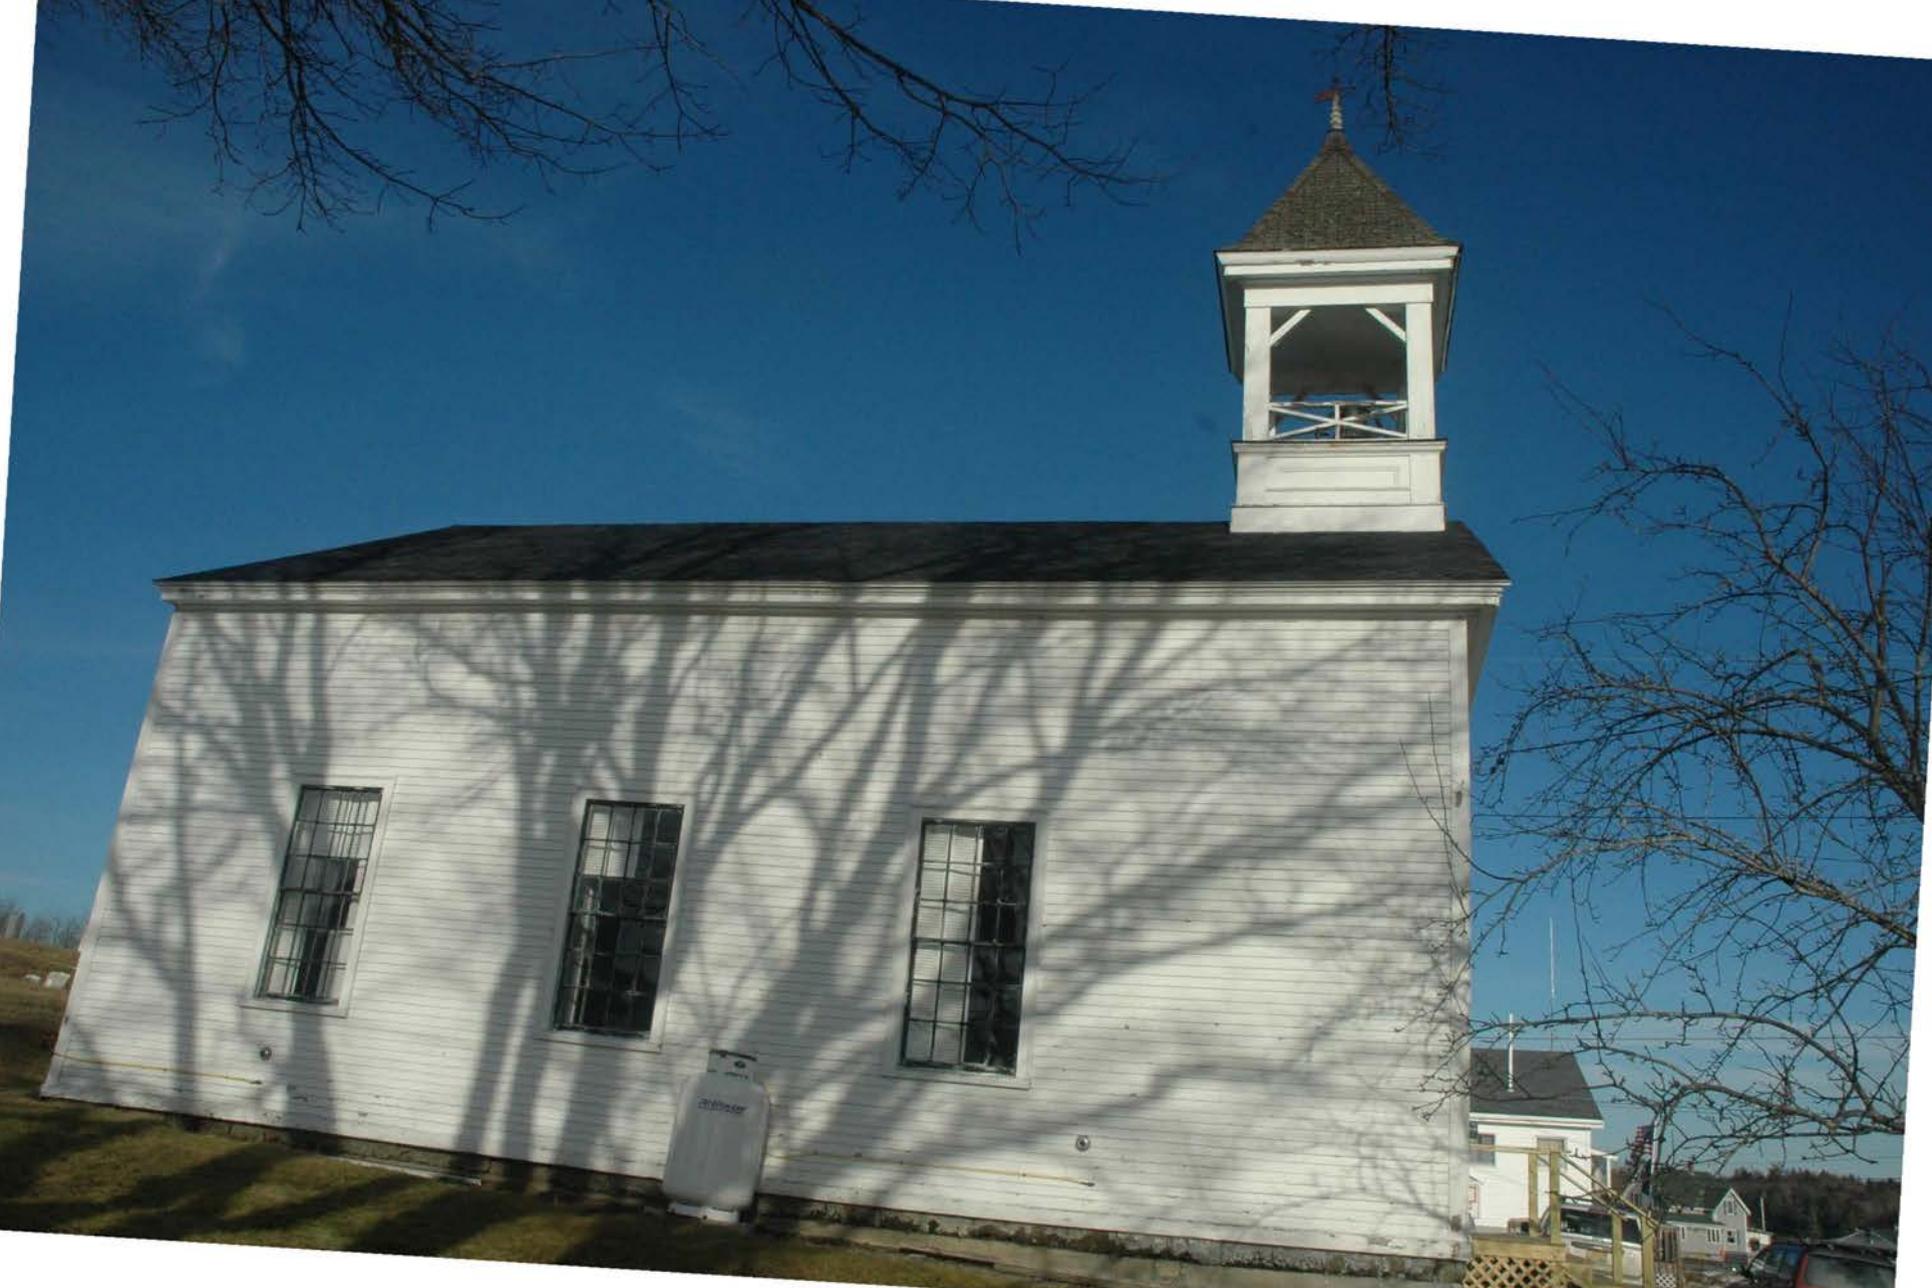
2 of 12 ME_Washington County_Union Meeting House_0002.tif
Exterior, west elevation; facing east.

Both of the side elevations contain three bays, all but one filled with twelve-over-twelve-sash windows. All the windows in the building are double-hung, small-paned and original. They are the most prominent character-defining feature of the building's exterior. On the east elevation there are only two evenly-spaced twelve-over-twelve windows. The third bay contains a two-leaf side door, added in 1969. Roughly-made, this luan door is not of exterior quality and the leaves are warped. Above the door are the top two tiers of lights from the sash window which was removed when the door was installed. The north elevation contains a single nine-over-six single-hung sash window in the gable peak.

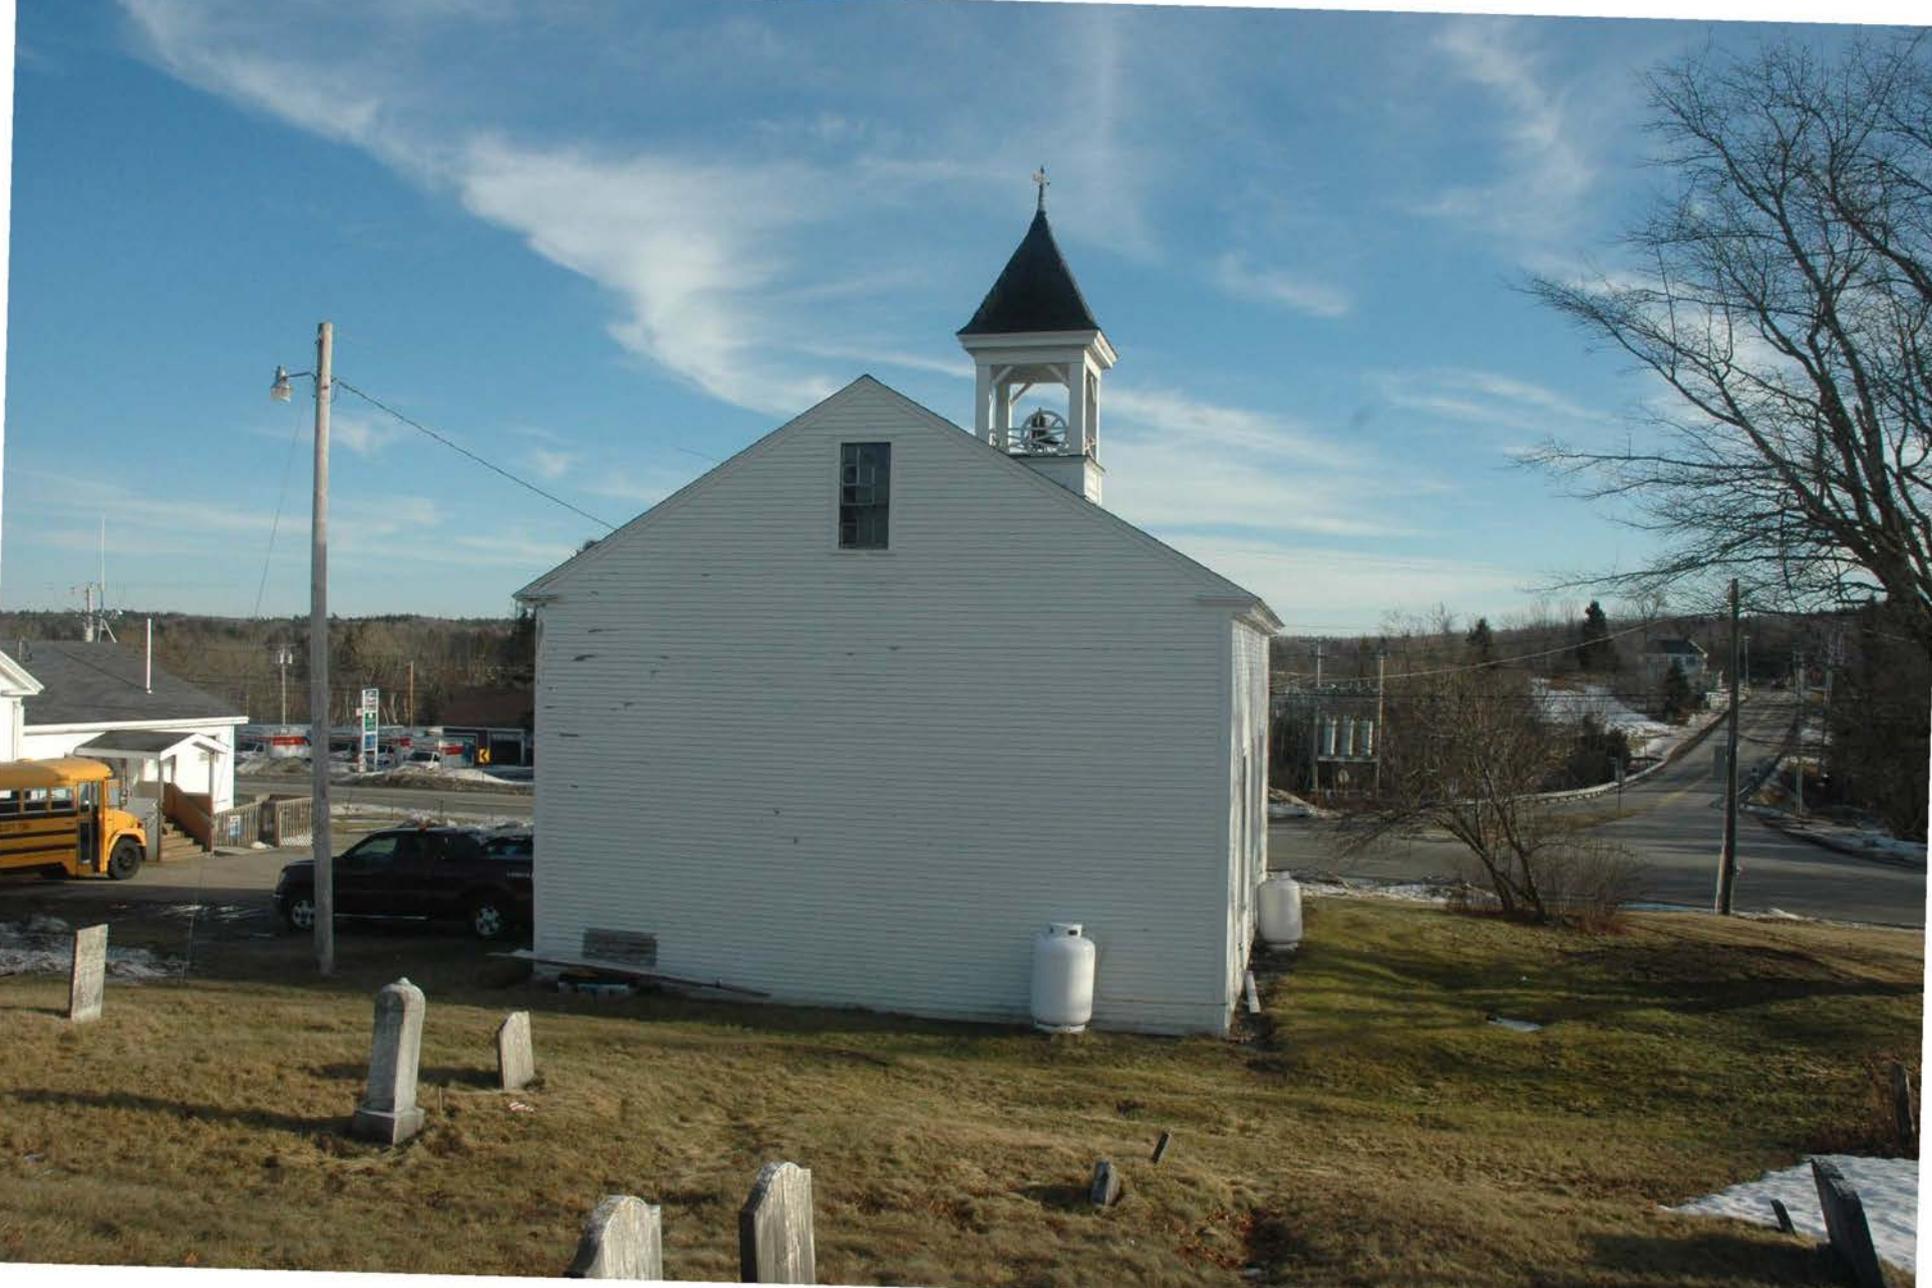
- 3 of 12 ME_Washington County_Union Meeting House_0003.tif
Exterior, north elevation; facing south.
- 4 of 12 ME_Washington County_Union Meeting House_0004.tif
Exterior, pediment and closed cornice; facing north.

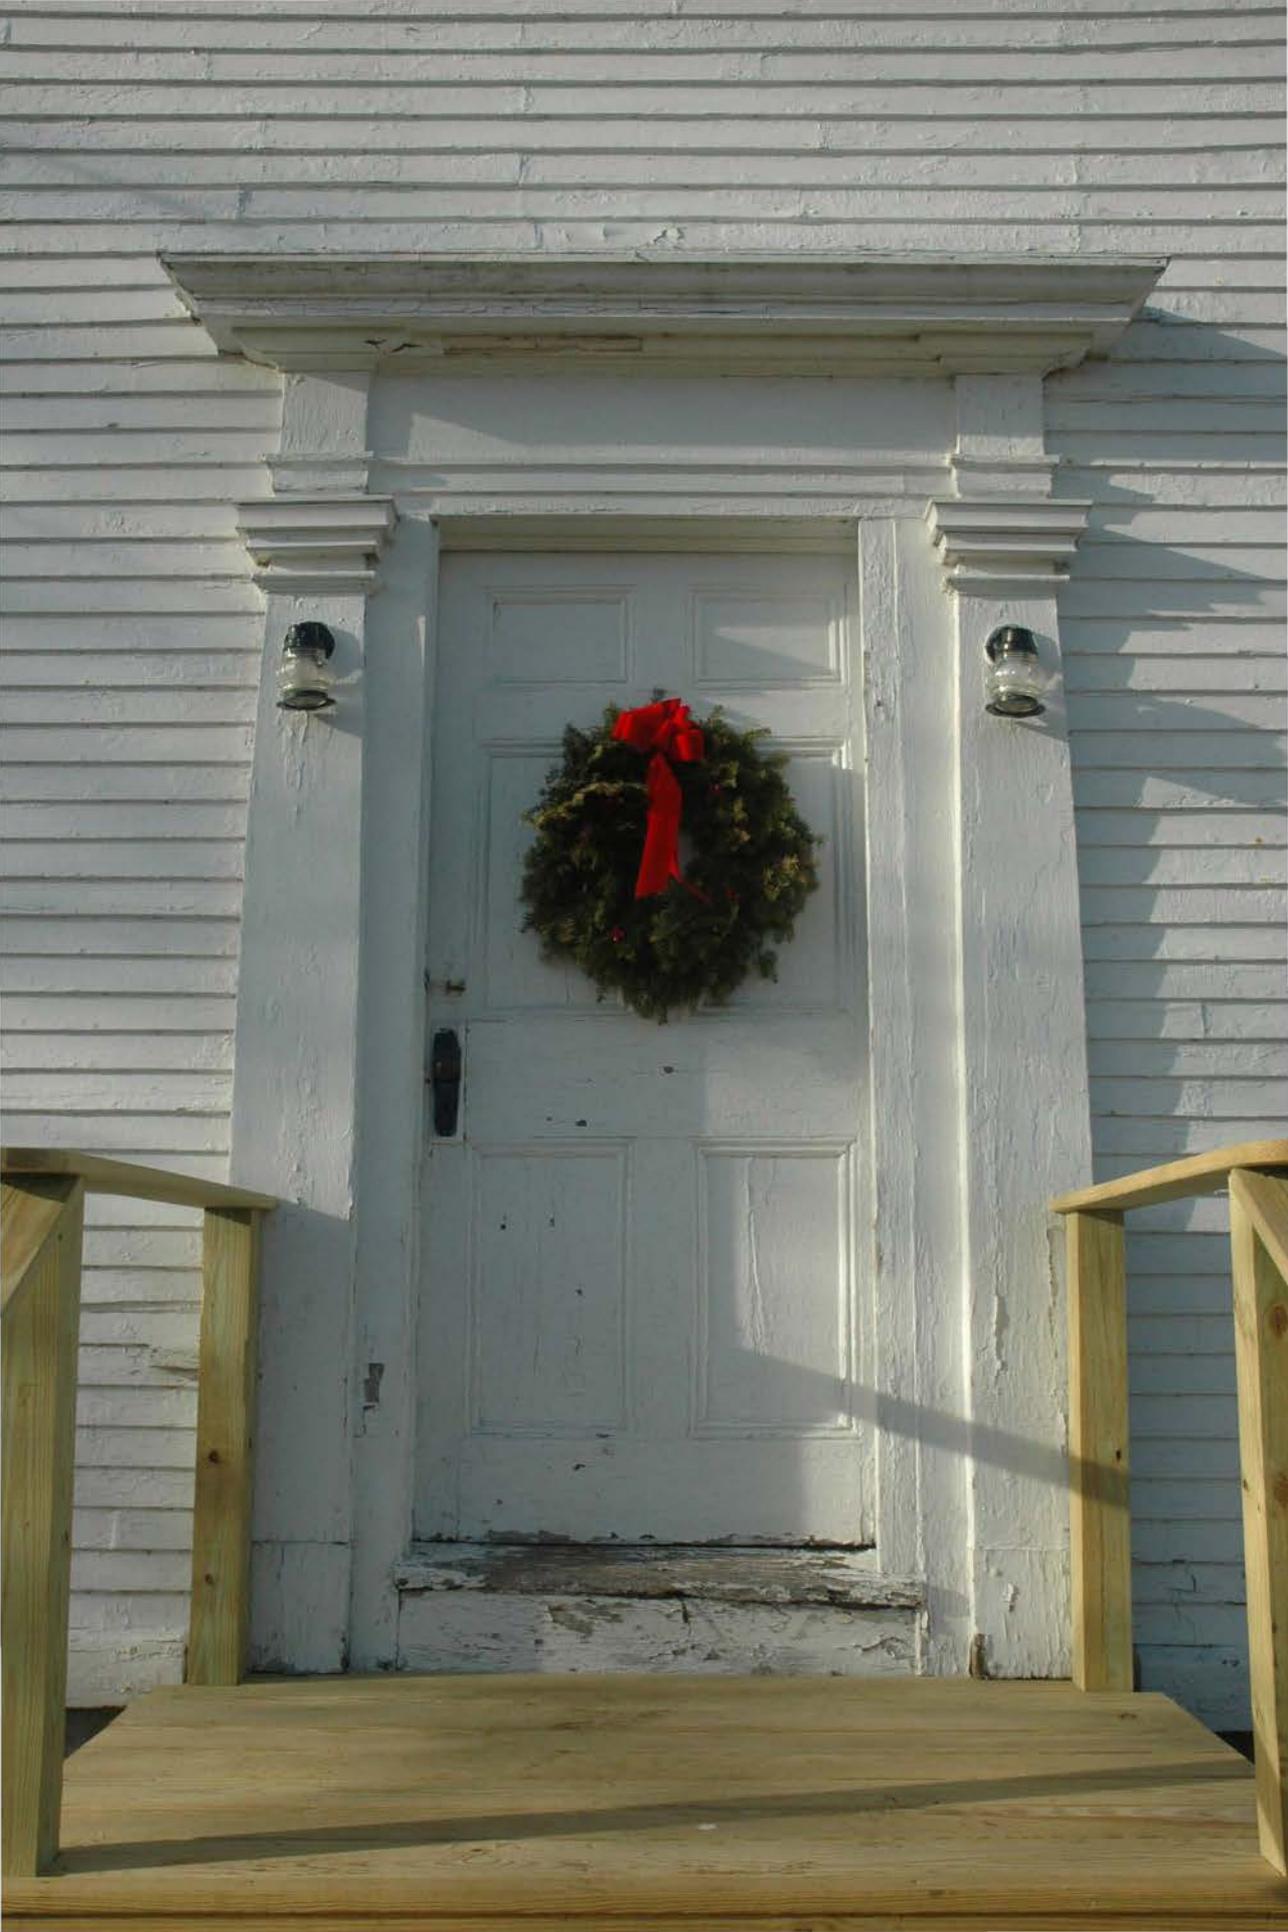
- 5 of 12 ME_Washington County_Union Meeting House_0005.tif
Front door; facing north.
- 6 of 12 ME_Washington County_Union Meeting House_0006.tif
Front windows; facing north.

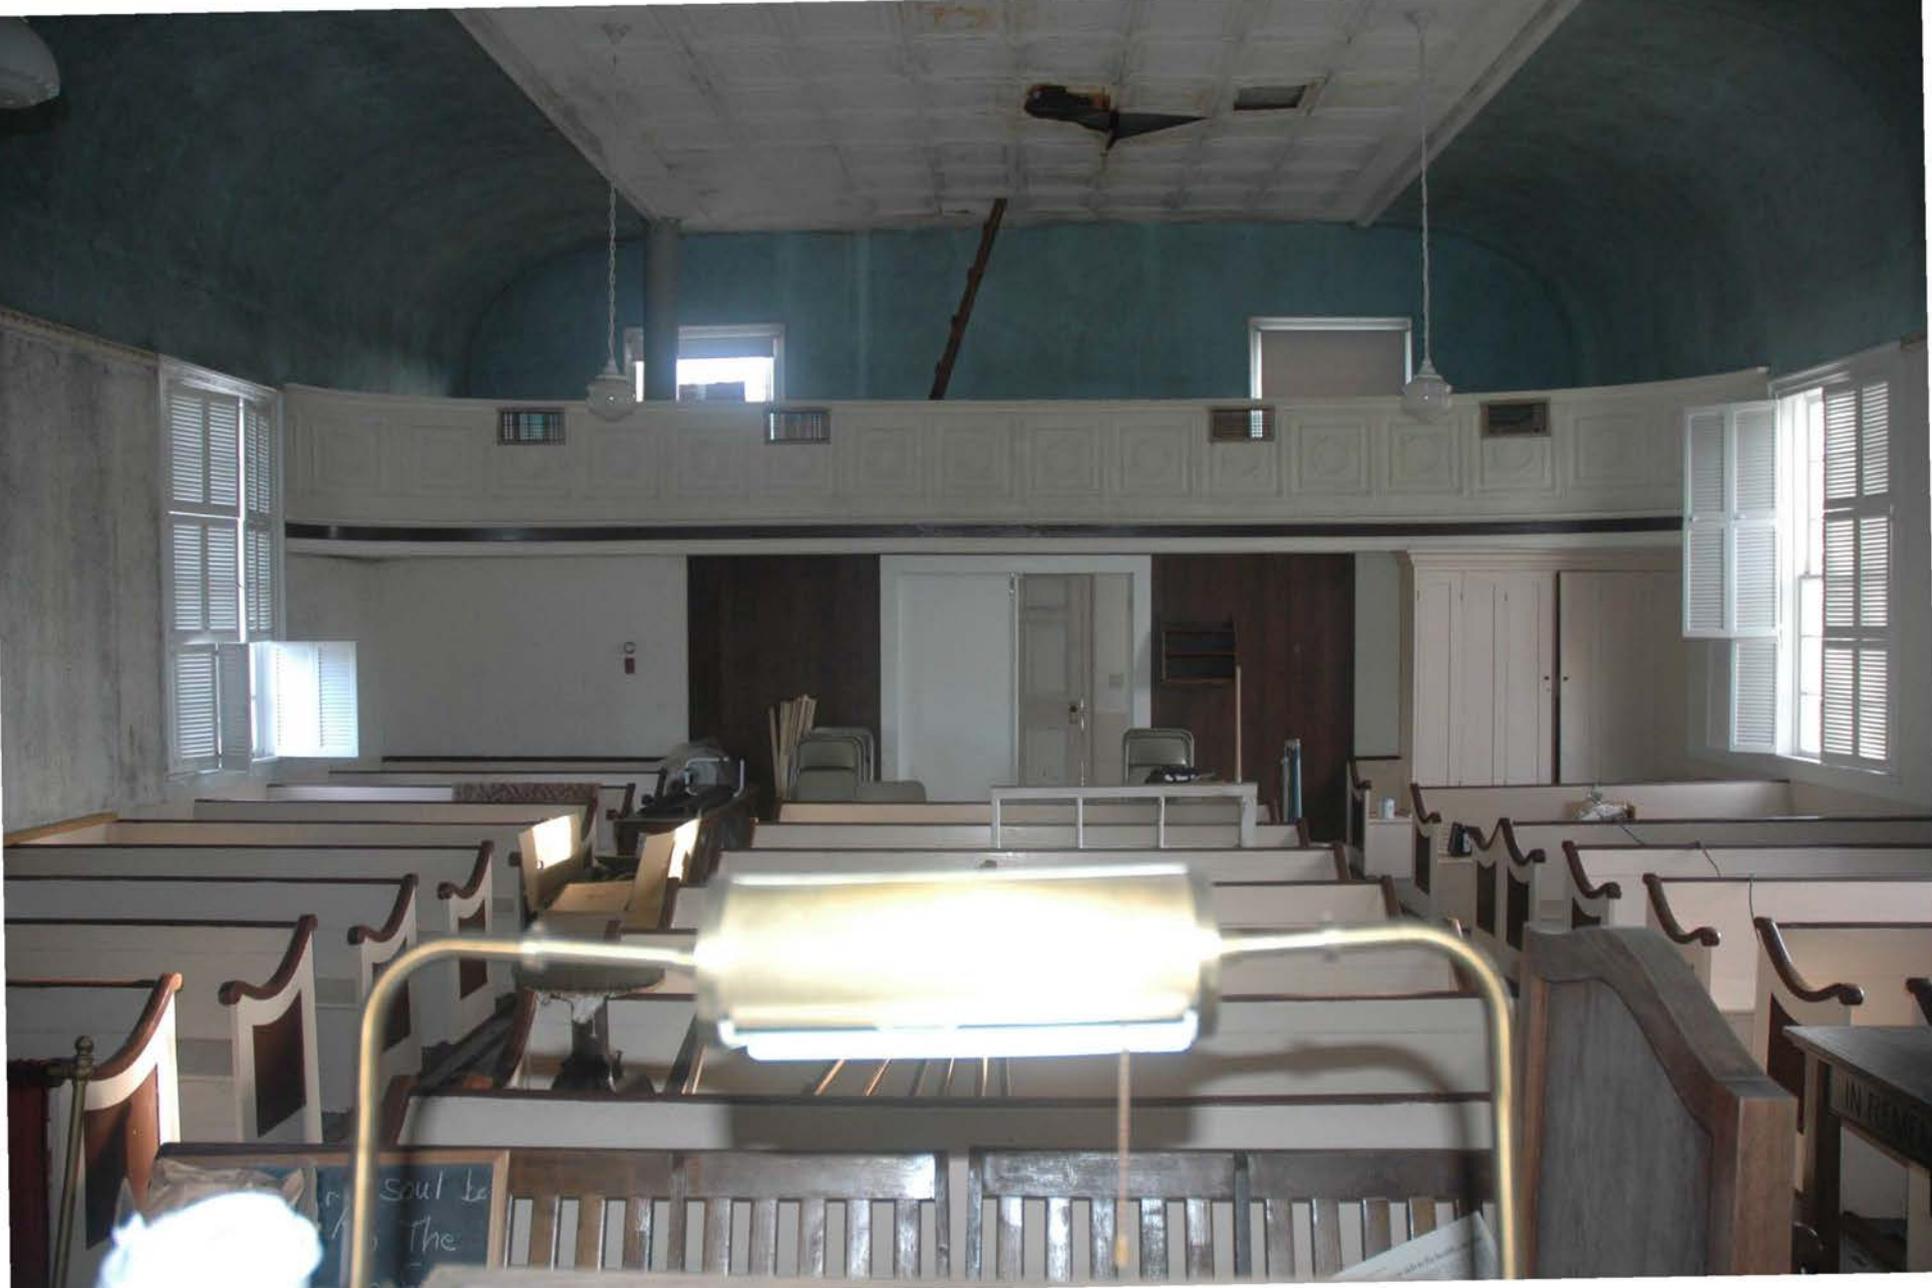
- 7 of 12 ME_Washington County_Union Meeting House_0007.tif
Interior, back of sanctuary and gallery; facing south.
- 8 of 12 ME_Washington County_Union Meeting House_0008.tif
Interior, front of sanctuary from gallery; facing northeast.

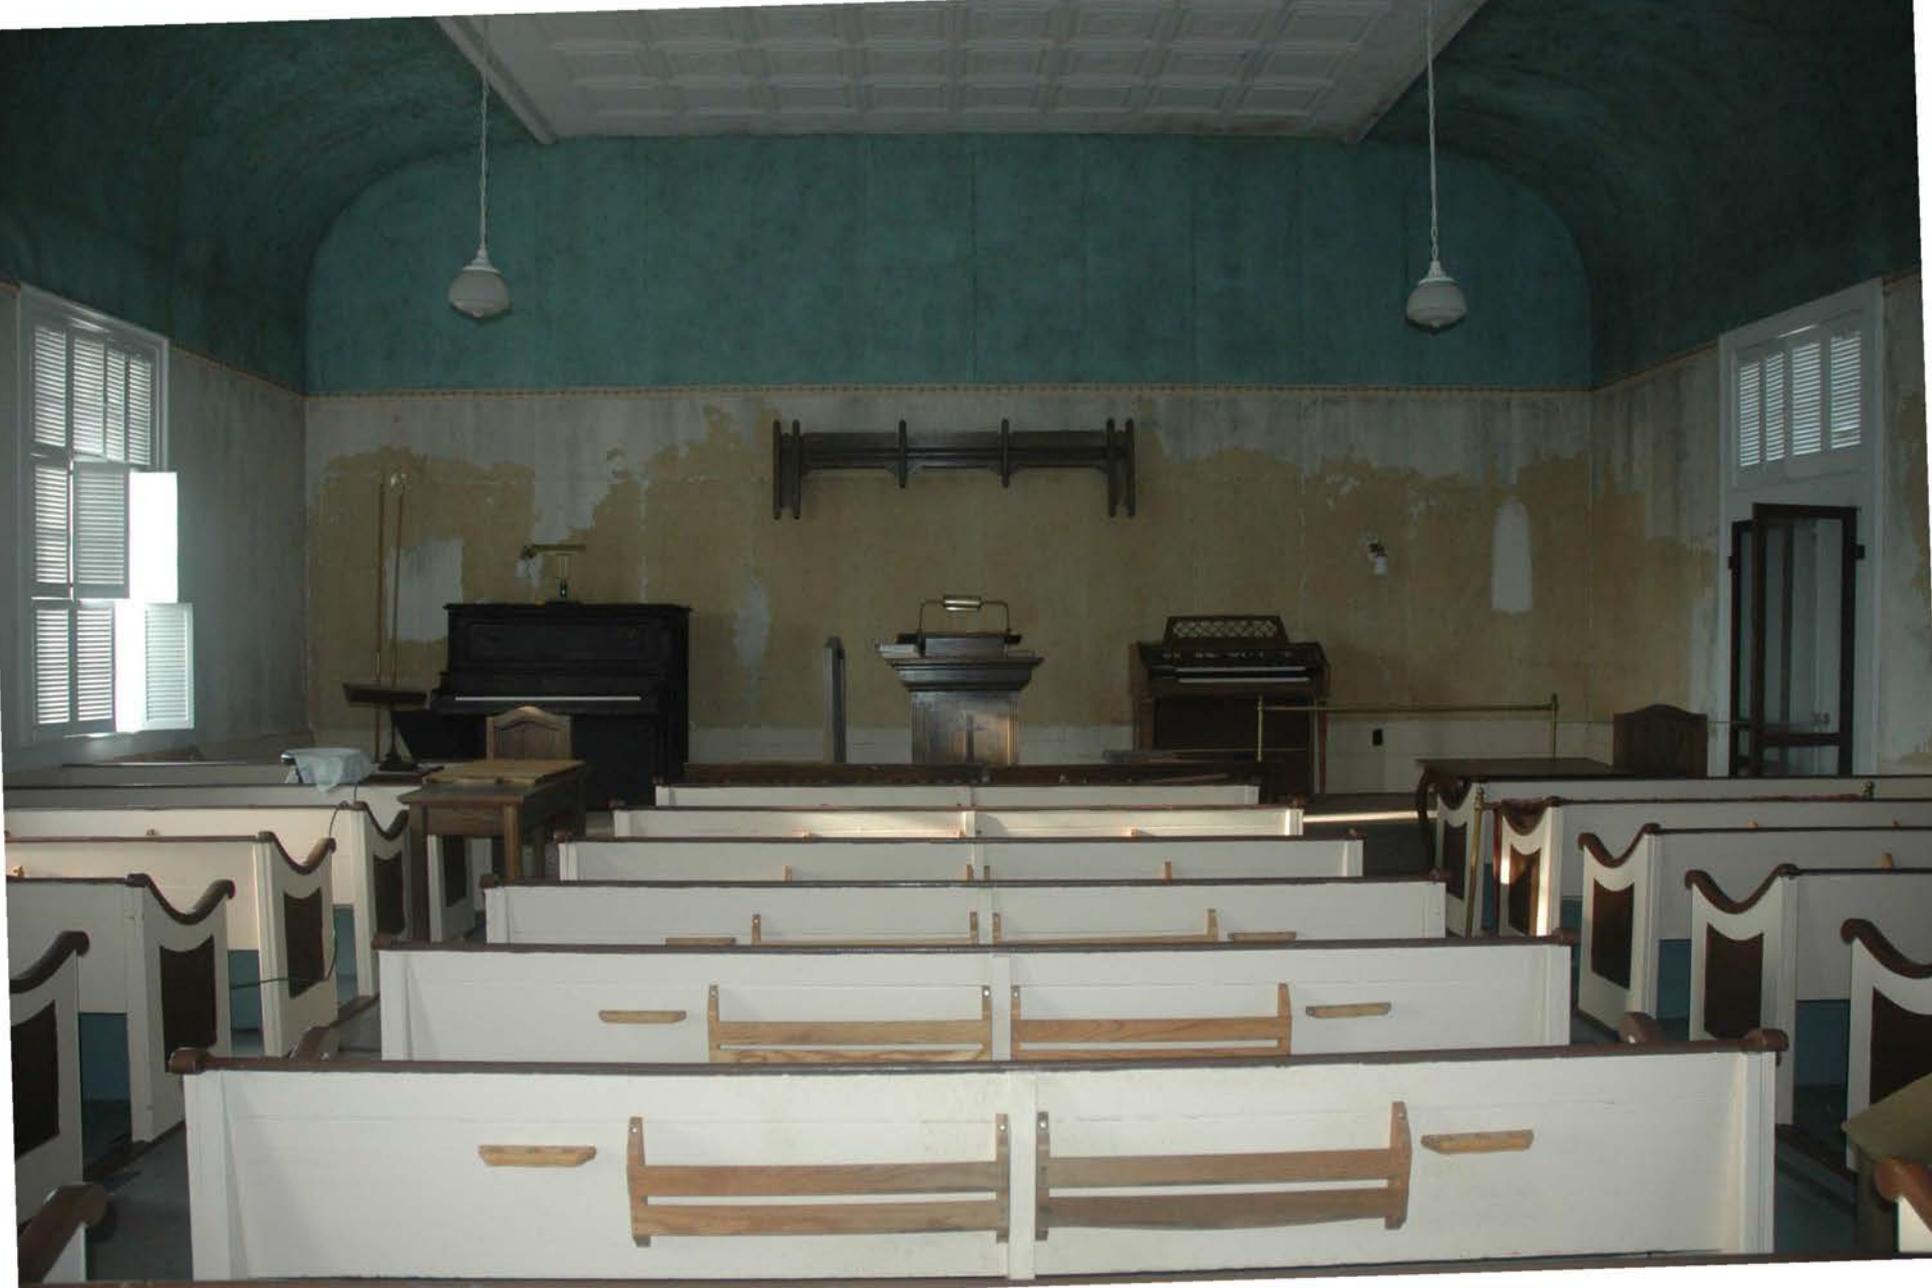
- 9 of 12 ME_Washington County_Union Meeting House_0009.tif
Interior, front of sanctuary; facing north.
- 10 of 12 ME_Washington County_Union Meeting House_0010.tif
Interior, east wall and front of sanctuary from gallery; facing northwest.

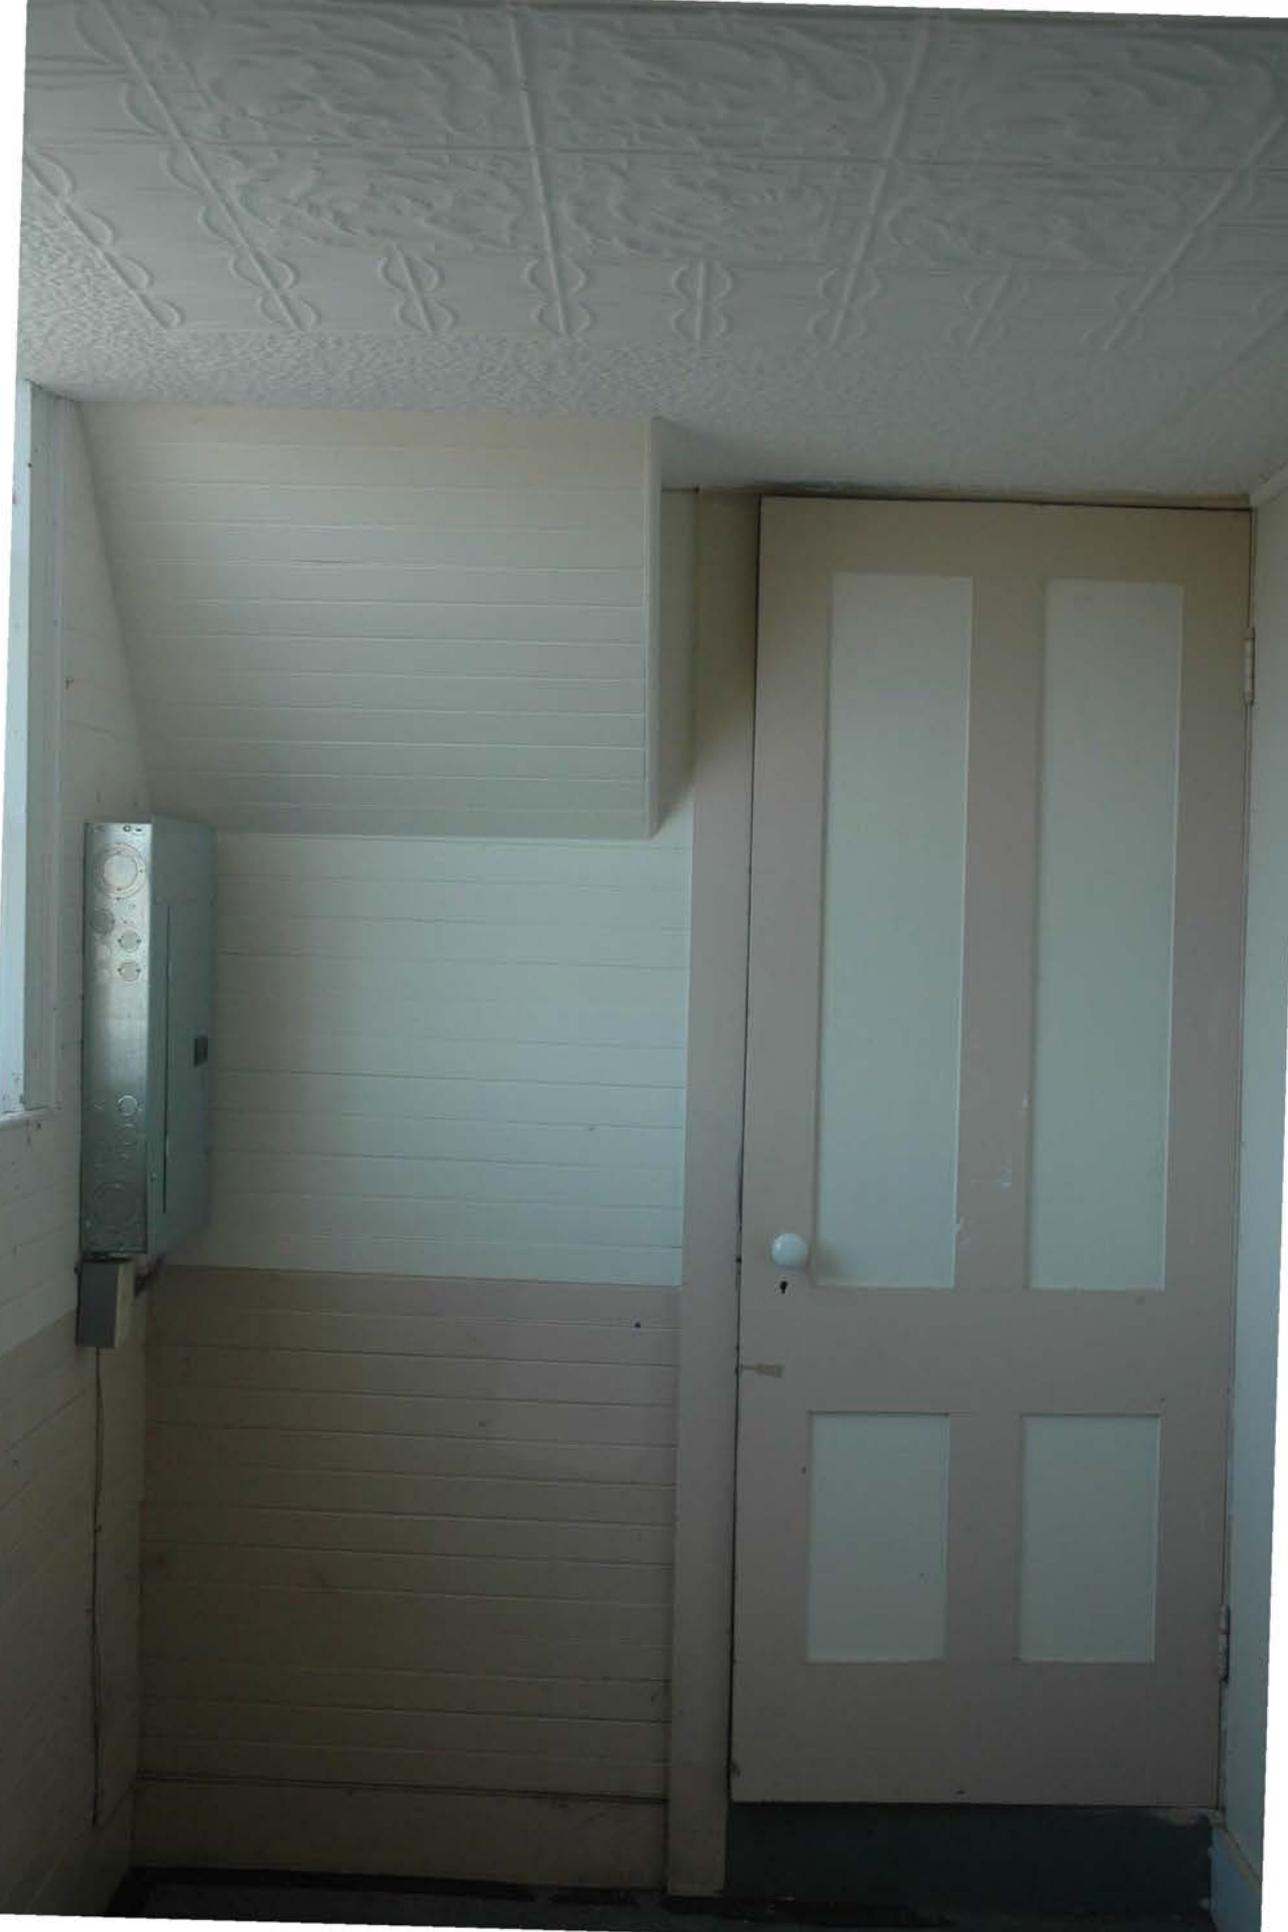
- 11 of 12 ME_Washington County_Union Meeting House_0011.tif
Interior, door to winder stairs in vestibule; facing west.
- 12 of 12 ME_Washington County_Union Meeting House_0012.tif
Interior, front of gallery and cupboard; facing west.
