National Register of Historic Places Registration Form

1. Name of Property	
Historic name Reid, Lyman, House	
Other names/site number KHRI #059-4270-00292; Mudrick Mansion; Koch House; Dudersta	dt House
Name of related Multiple Property Listing N/A

2. Location	
Street & number 306 S Elm Street	not for publication
City or town Ottawa	vicinity
State Kansas Code KS County Franklin Code 059	Zip code 66067

Narrative Description Summary

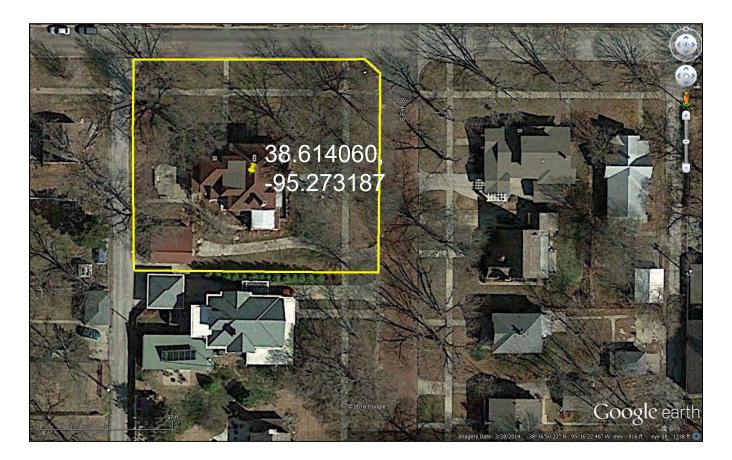
Boundary Map. The nominated one-acre site is depicted by the outlined shape. Contextual map shown below with X marking location of house.
