National Register of Historic Places Registration Form

Historic name: St. Andre's Parish
Other names/site number: _____
Name of related multiple property listing: N/A
(Enter "N/A" if property is not part of a multiple property listing)

Street & number: 73 Bacon Street, 75 Bacon Street, 39 Sullivan Street, & 41 Sullivan Street
City or town: Biddeford State: Maine County: York
Not For Publication: N/A Vicinity: N/A

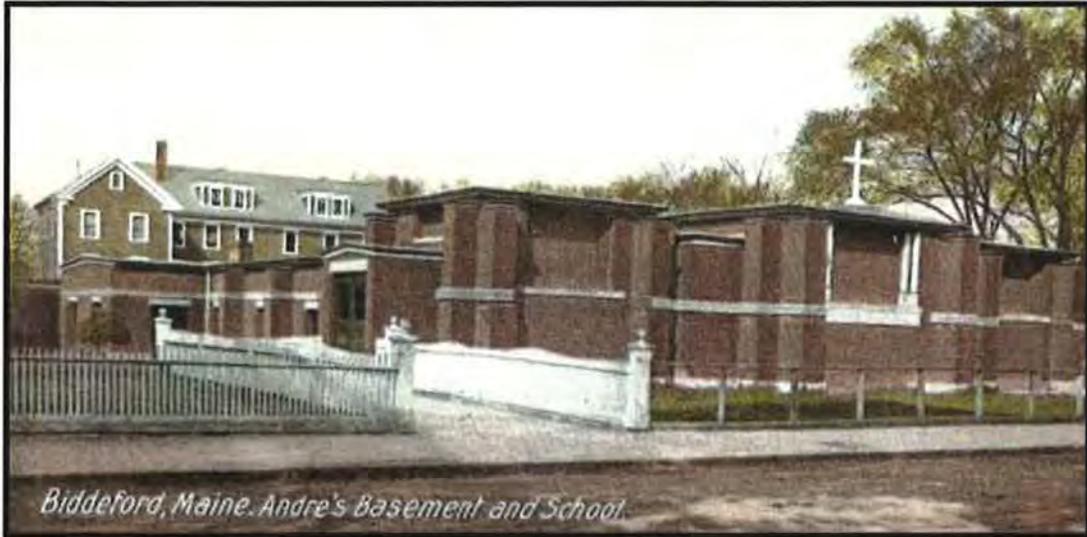
FIGURE 1

St. Andre's Church and School
(c. 1900)

St. Andre's Church was constructed in two phases, the first being the lower raised basement level that was built in 1900 to serve as the temporary worship space until the upper main sanctuary was completed in 1909/1910 (see Figure 1). The Romanesque Revival style church is constructed of red brick trimmed with what appear to be painted cast stone elements, in the form of belt courses, window sills, hood molds, caps, arched hood molds at the windows, and brackets at the cornice. Rising from a very low rough-cut granite foundation, the church follows a traditional cruciform plan. The transept and apse are located at the north end of the nave. A central tower at the facade (south elevation) rises above the narthex. The church is enclosed by a steeply pitched slate-covered gable roof with small triangular dormers running along the sides. The rooflines at the side and rear elevations are defined by corbeled brick in the form of stylized arcading.

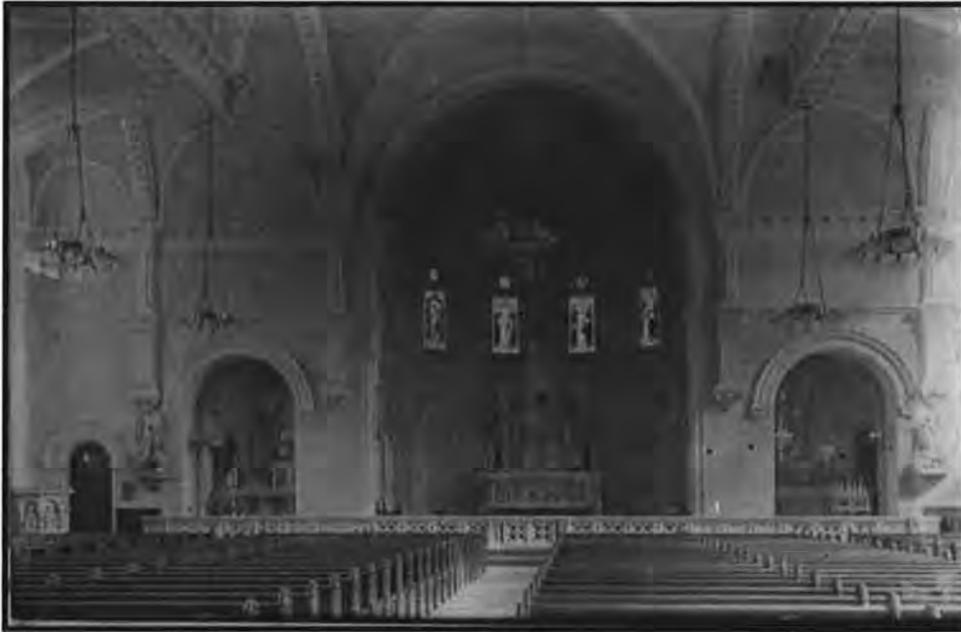
**FIGURE 3**

St. Andre's Church(c. 1910)

The interior of the church remains very much intact, although the altar railing was removed and the original altar itself was replaced (see figure 3 and photograph 4). The main worship space, vestibules, and galleries retain the historic layout and finishes, including wood pews, light fixtures, decorative plasterwork, wood staircases, and wood balustrades. The most notable modifications to the main floor are the modern aluminum doors in the three vestibule entrances. The lower level, which was originally used as the main worship space and then a community hall, remains a large open space with a raised stage and pressed tin ceiling.

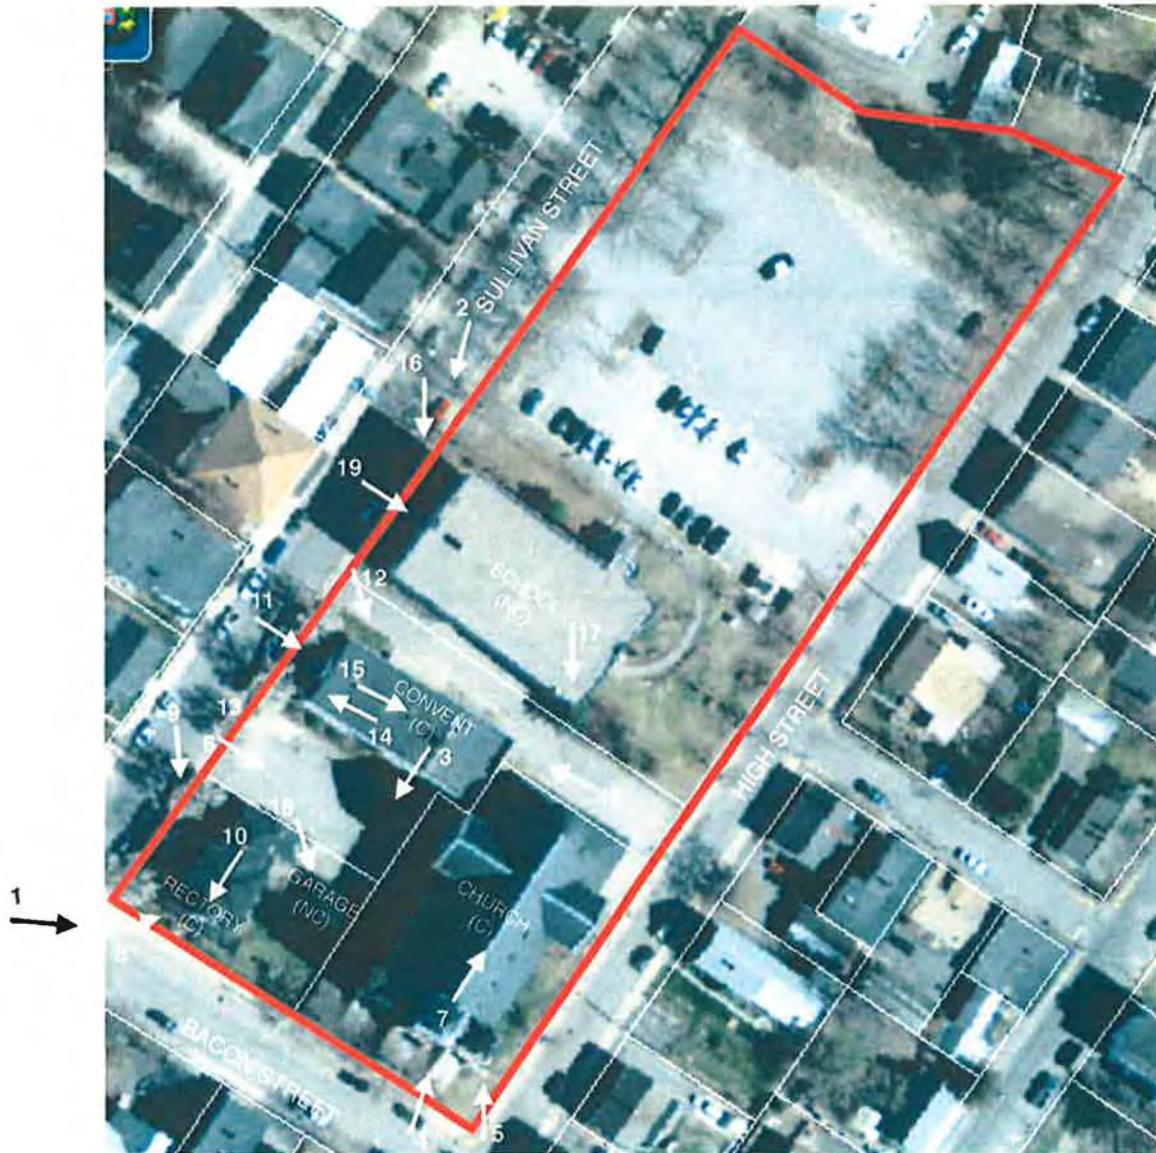
**ST. ANDRE'S PARISH COMPLEX
SKETCH MAP**

→ = Photo Numbers
 C = Contributing Resource
 NC = Noncontributing Resource
 — = District Boundary
