National Register of Historic Places  
Registration Form

historic name Jonathan and Simon Hosmer House

Jonathan & Simon Hosmer House  
Acton (Middlesex), MA

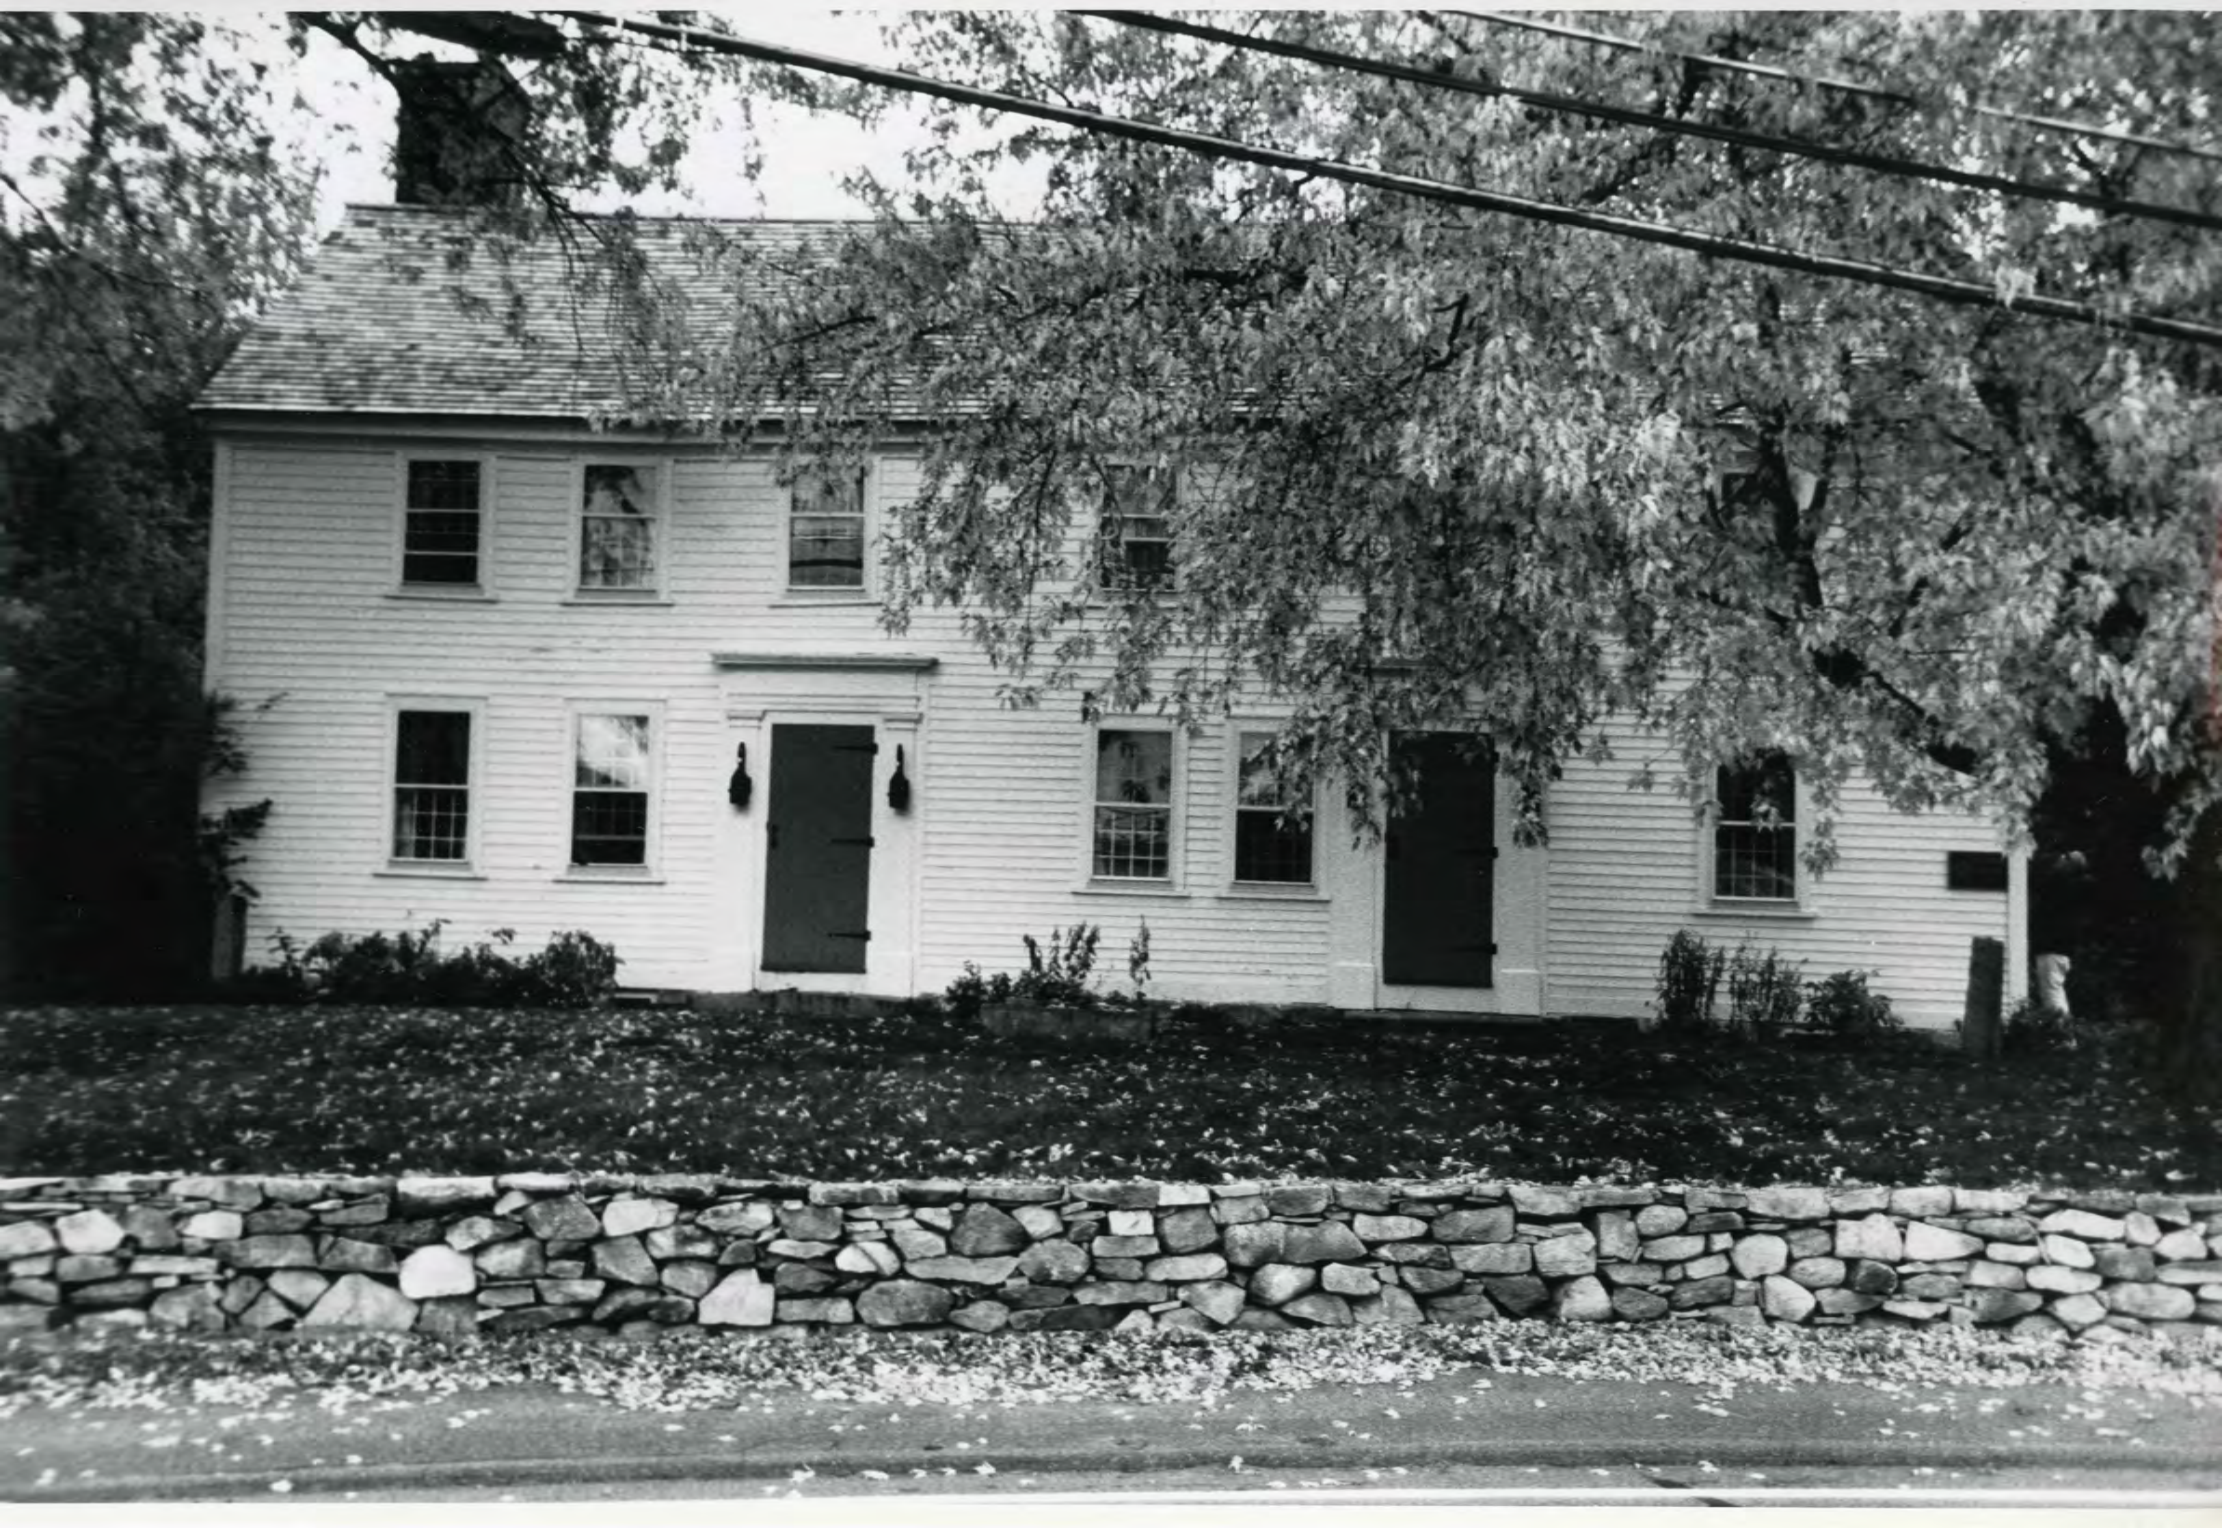
① Hosmer House, 300 Main St. Acton, MA, Middlesex County  
Photographer, October, 1958 David Harris  
Neg. in AHC Files, Town Hall, Acton #1

Front of Hosmer House from across Main St. looking North

The house built for Simon Hosmer abuts the west end of his father's residence (photo #1). Its layout is a more conventional two-room-plan, 2 1/2-story, three-bay half-house. Like the 1760 house, however, its main doorway opens directly into the first-story room. The diagonal fireplace in this room has a rectangular opening, with a molded surround that was recreated according to paint evidence found during the 1970s restoration. Fitted beside the chimney stack to the west of the fireplace is a fine example of a two-door wall cupboard, each door with a single raised-field panel. The H-hinges of the cupboard doors retain their leather washers, still visible under many layers of paint (photo #14).

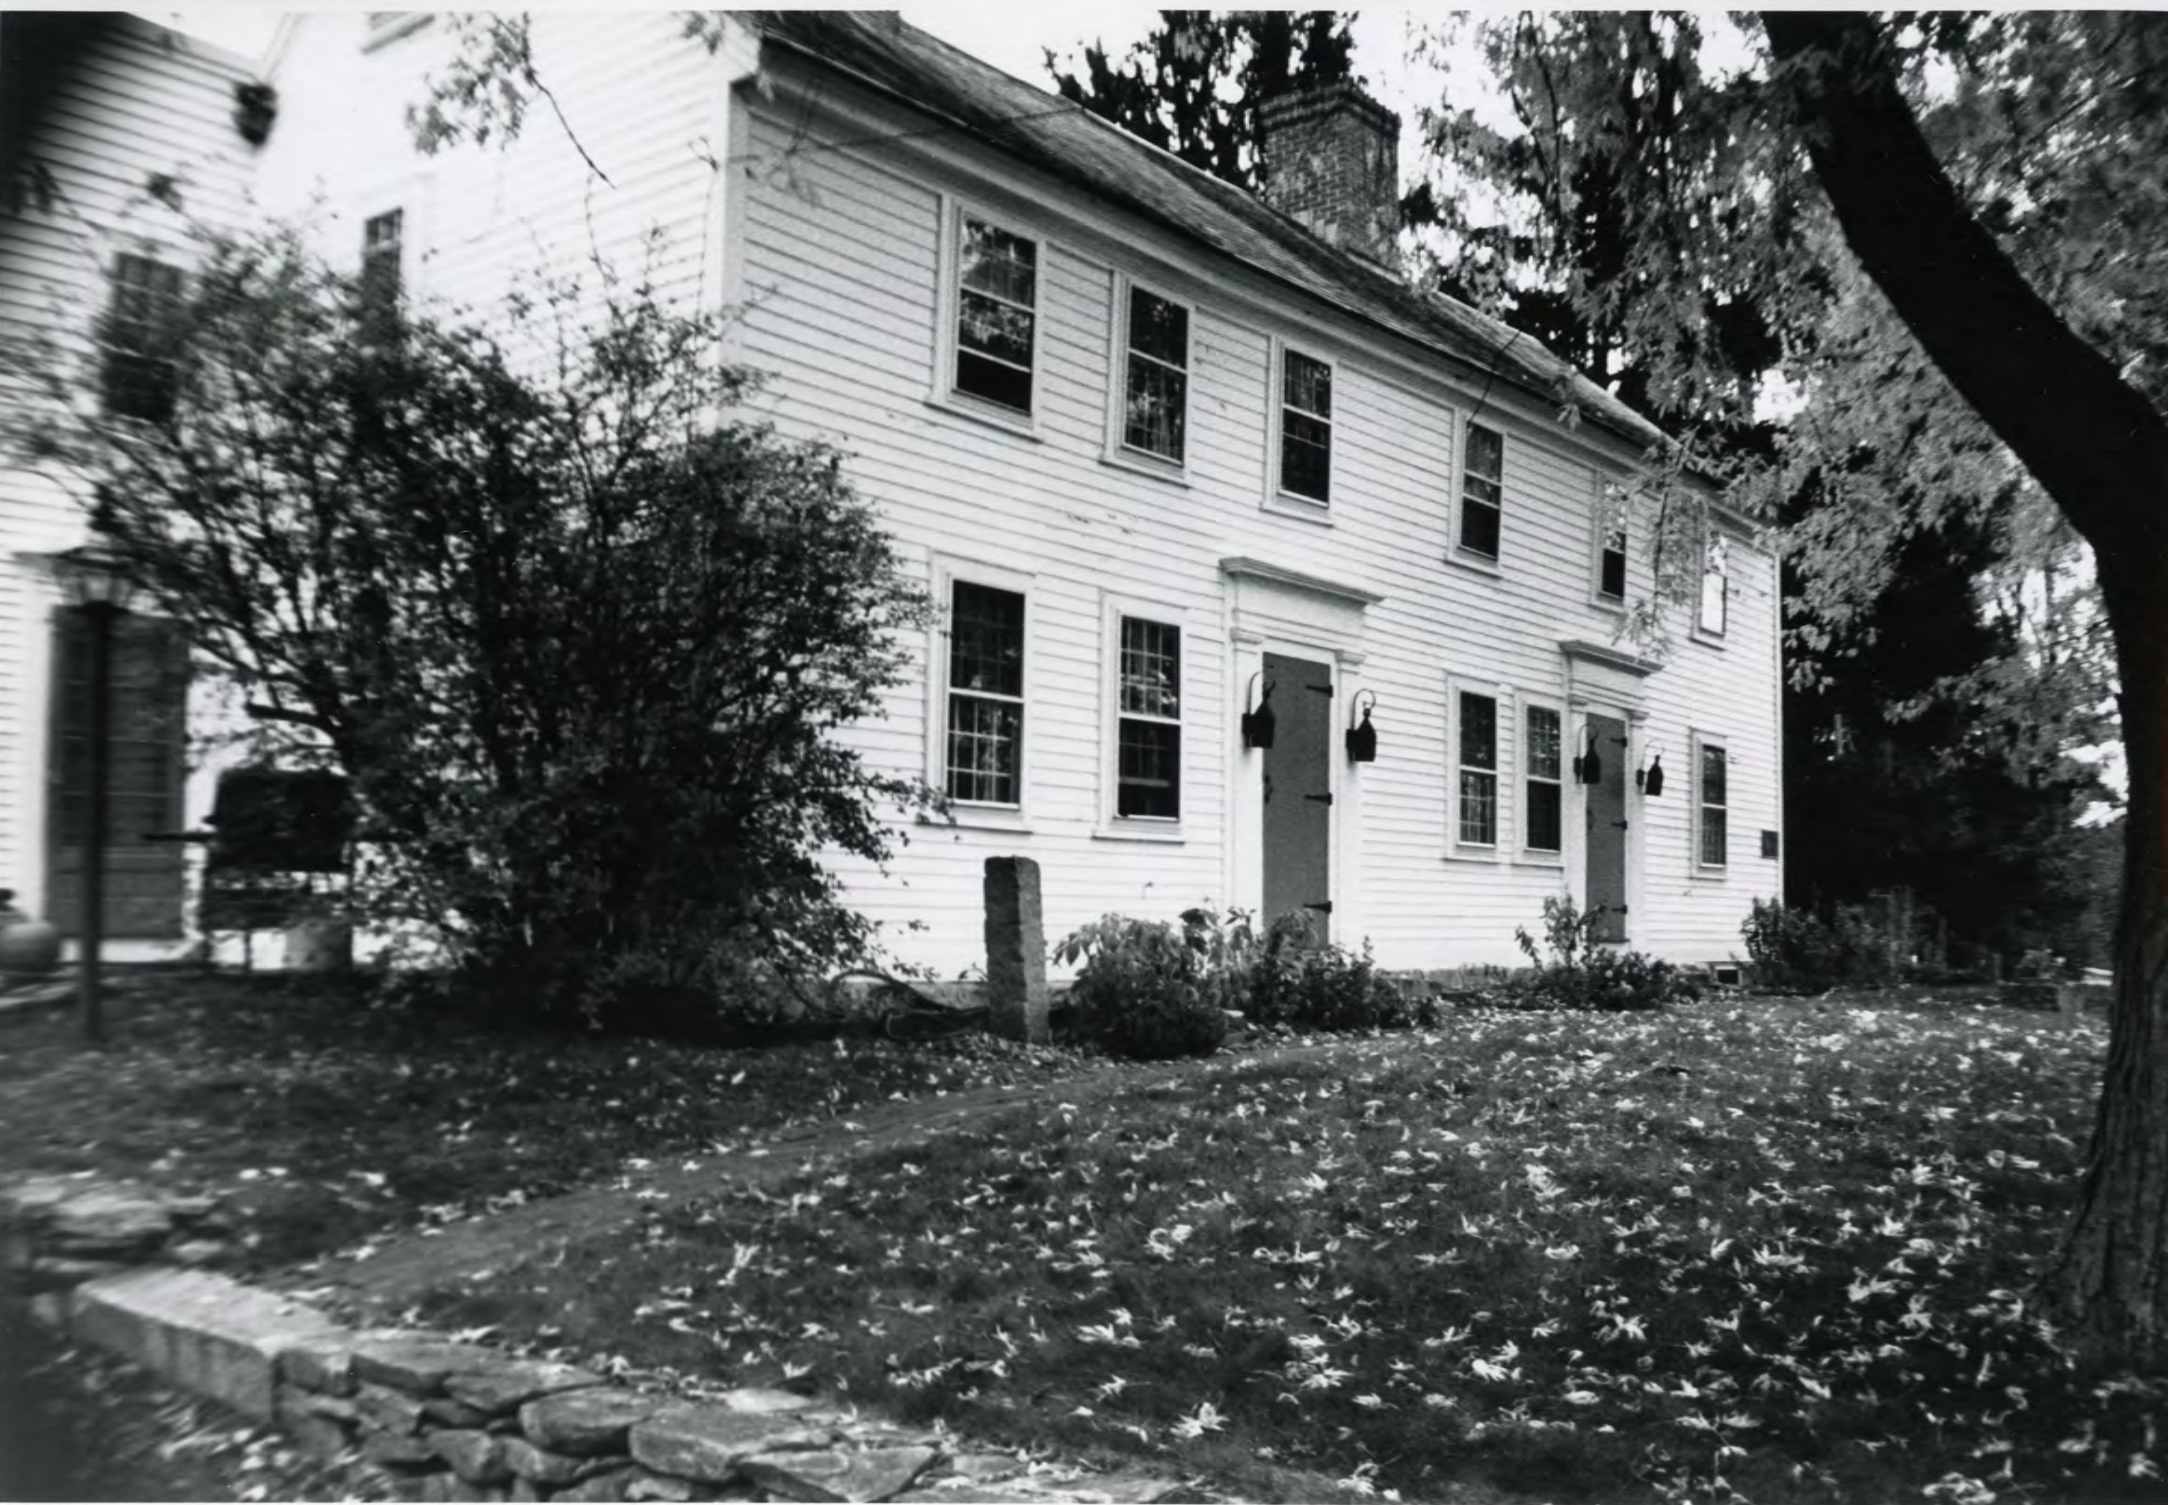
Neg. in AHC Files, Town Hall, Acton #24

Front and South side of Hosmer House, showing parter "Beverly jog"  
taken from South lawn

house of Jonathan Hosmer, Jr. (photo #2) The awkwardly-placed window just west of the main entry may have been inserted at a later date; if so, this building would originally have had a nearly symmetrical, three-bay facade. Its plan is not a conventional three-room/lobby-entrance arrangement, however. (See sketch plan) Both its square dimensions and lack of the usual front lobby entrance are more characteristic of a direct-entry square plan, an alternative Colonial-era floor plan that is rare in the Acton area. The facade door opens directly into the southwest first-story room, which is divided from the southeast room only by a partition wall of vertical feather-edged sheathing (largely hidden from view by a closet), and a four-panel door. Both of these front rooms are dominated by the slightly off-center mass of the chimney, which contains a diagonally-positioned corner fireplace in each room. The simple arched-board front of the fireplace in the southwest room was restored in the 1970s renovations. The fireplace opening in the southeast room is also segmentally-arched. The treatment here is much more elaborate, however, with a heavy Victorian molding above the opening, and a pair of slender ceiling-height fluted pilasters(photo #6). The pilasters may have been a direct imitation of another pair, which flank a china cupboard fitted into the northeast corner of the room, and topped with a dentiled and molded cornice (photo #7). (It is believed that this cabinet, of a style which predates 1760, may have been moved here from another location.) Both front rooms are plastered, with corner posts that are simply cased in flat boards.

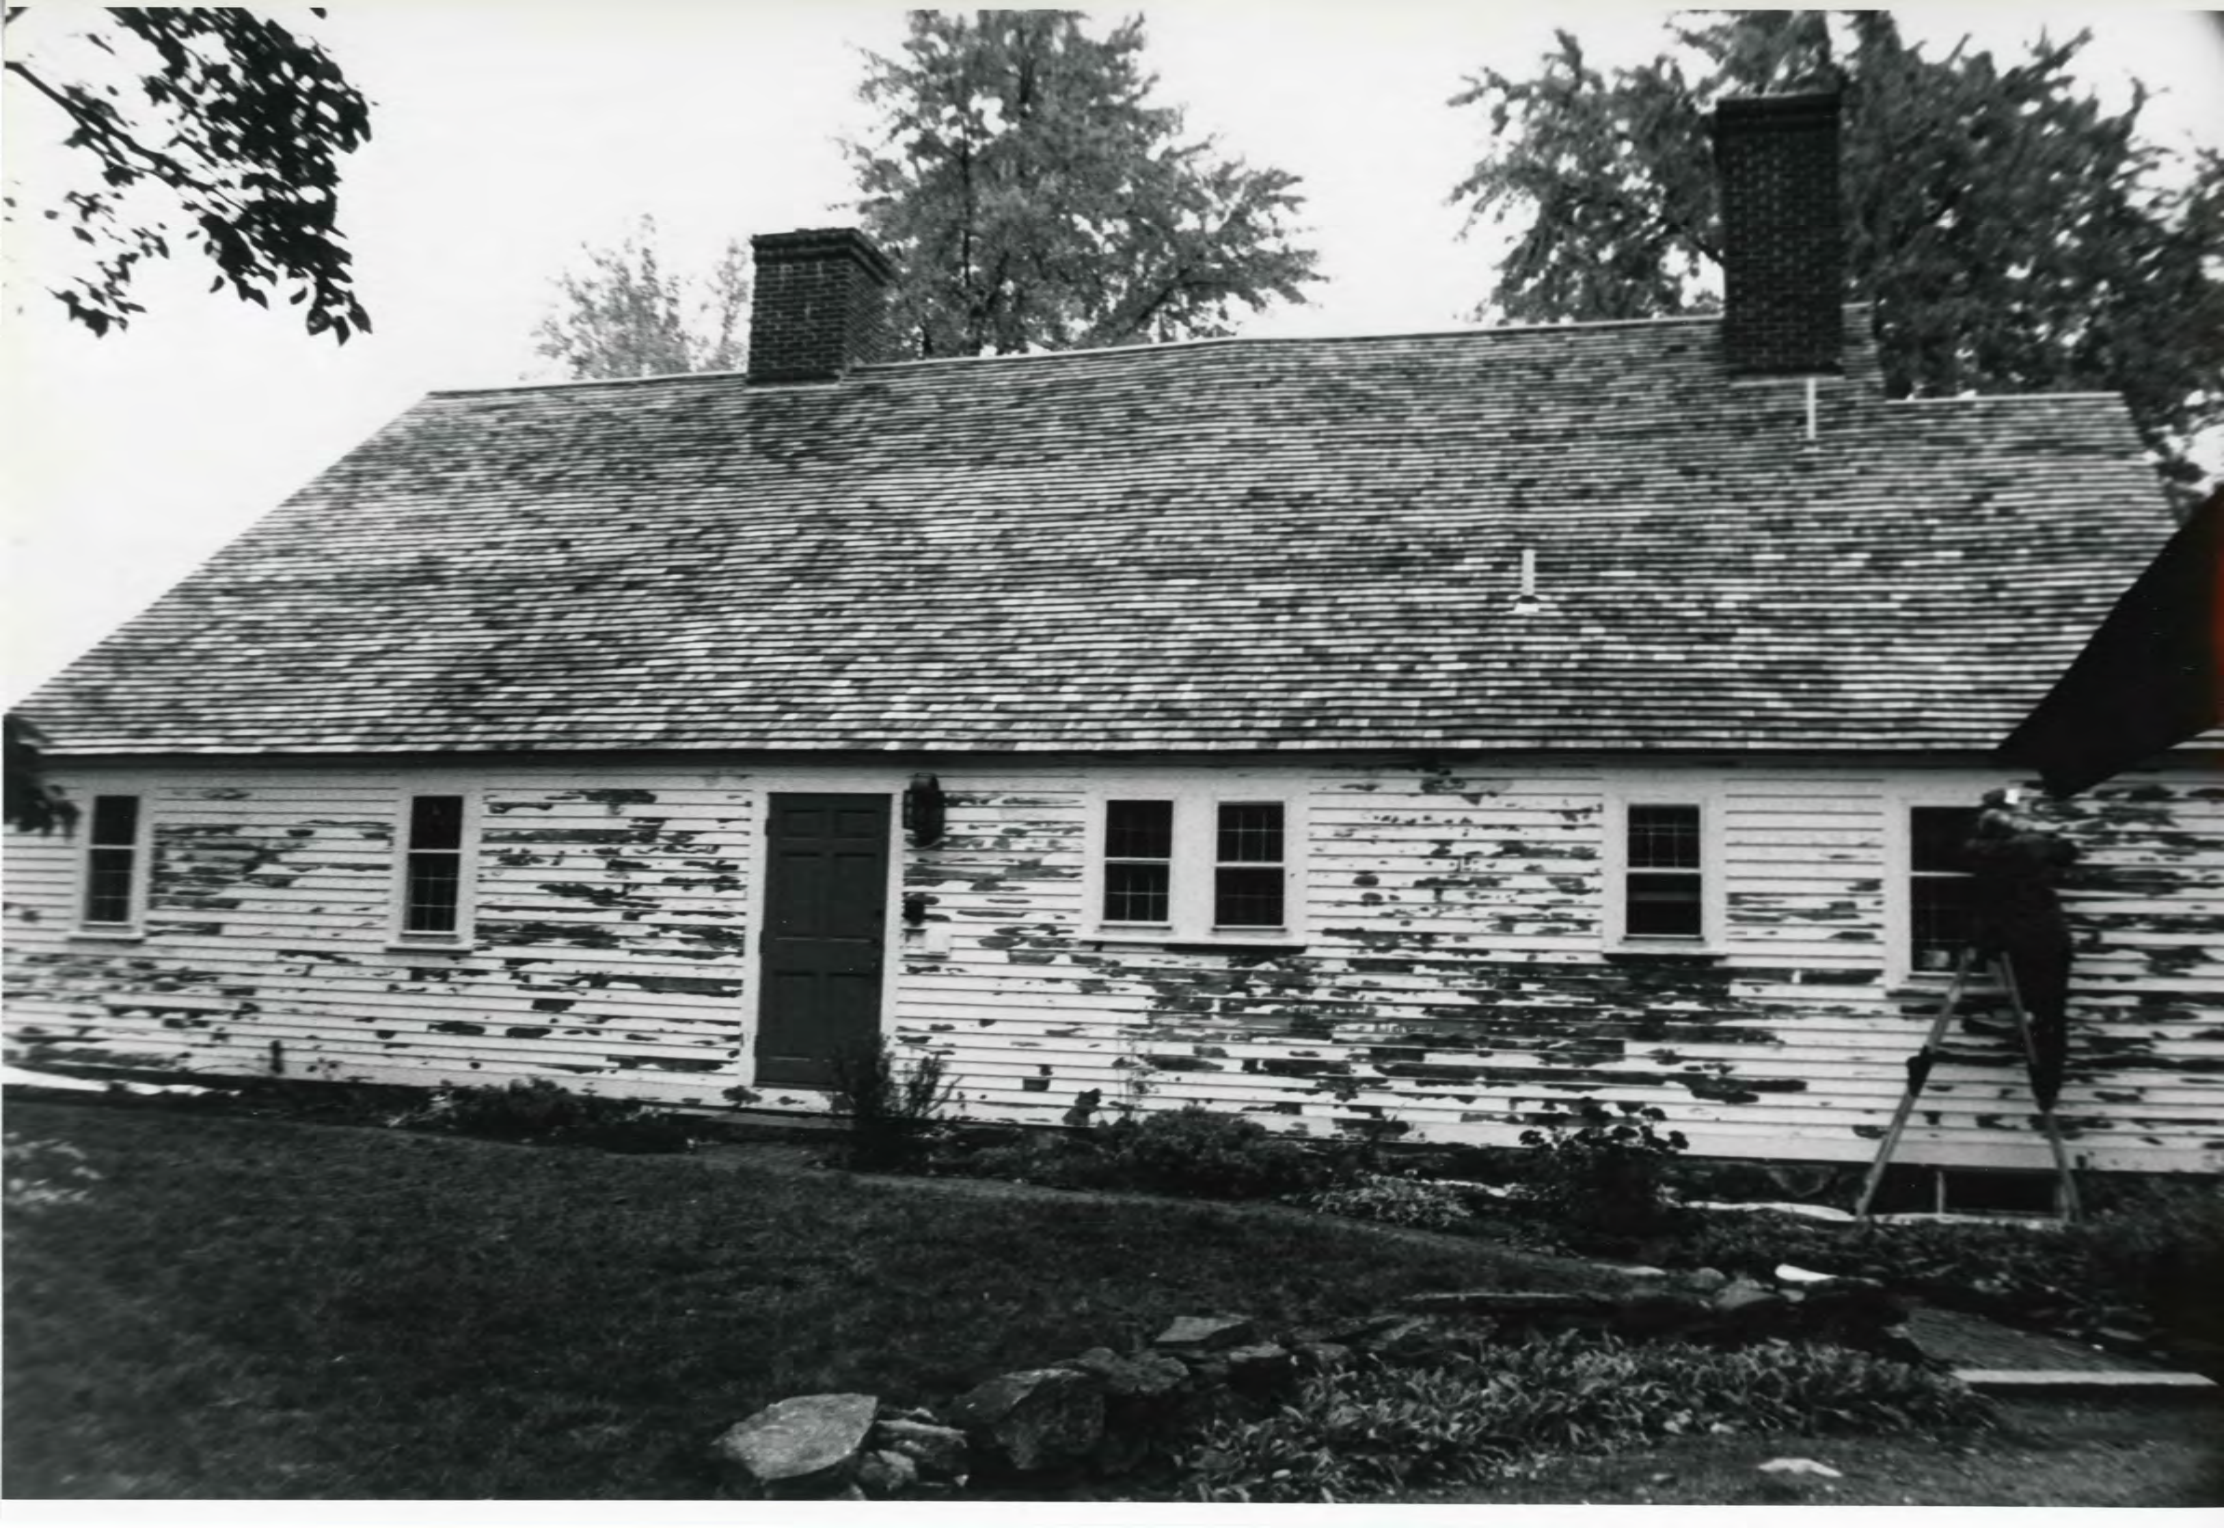
③

Rear view of Hosmer House showing saltbox roof  
taken from yard looking south

replacement (photo #5). The rear (north) elevation below the sweep of the leanto roof is one story high, with an asymmetrical arrangement of three 6-over-9 windows, three 6-over-6's, and a 6-panel wood door, all of which are replacements. (Most of the rear wall was reconstructed in the mid-1970s, after a 1972 fire badly damaged the rear wall, the adjacent interior ceilings, and a makeshift back porch (photo #3).)

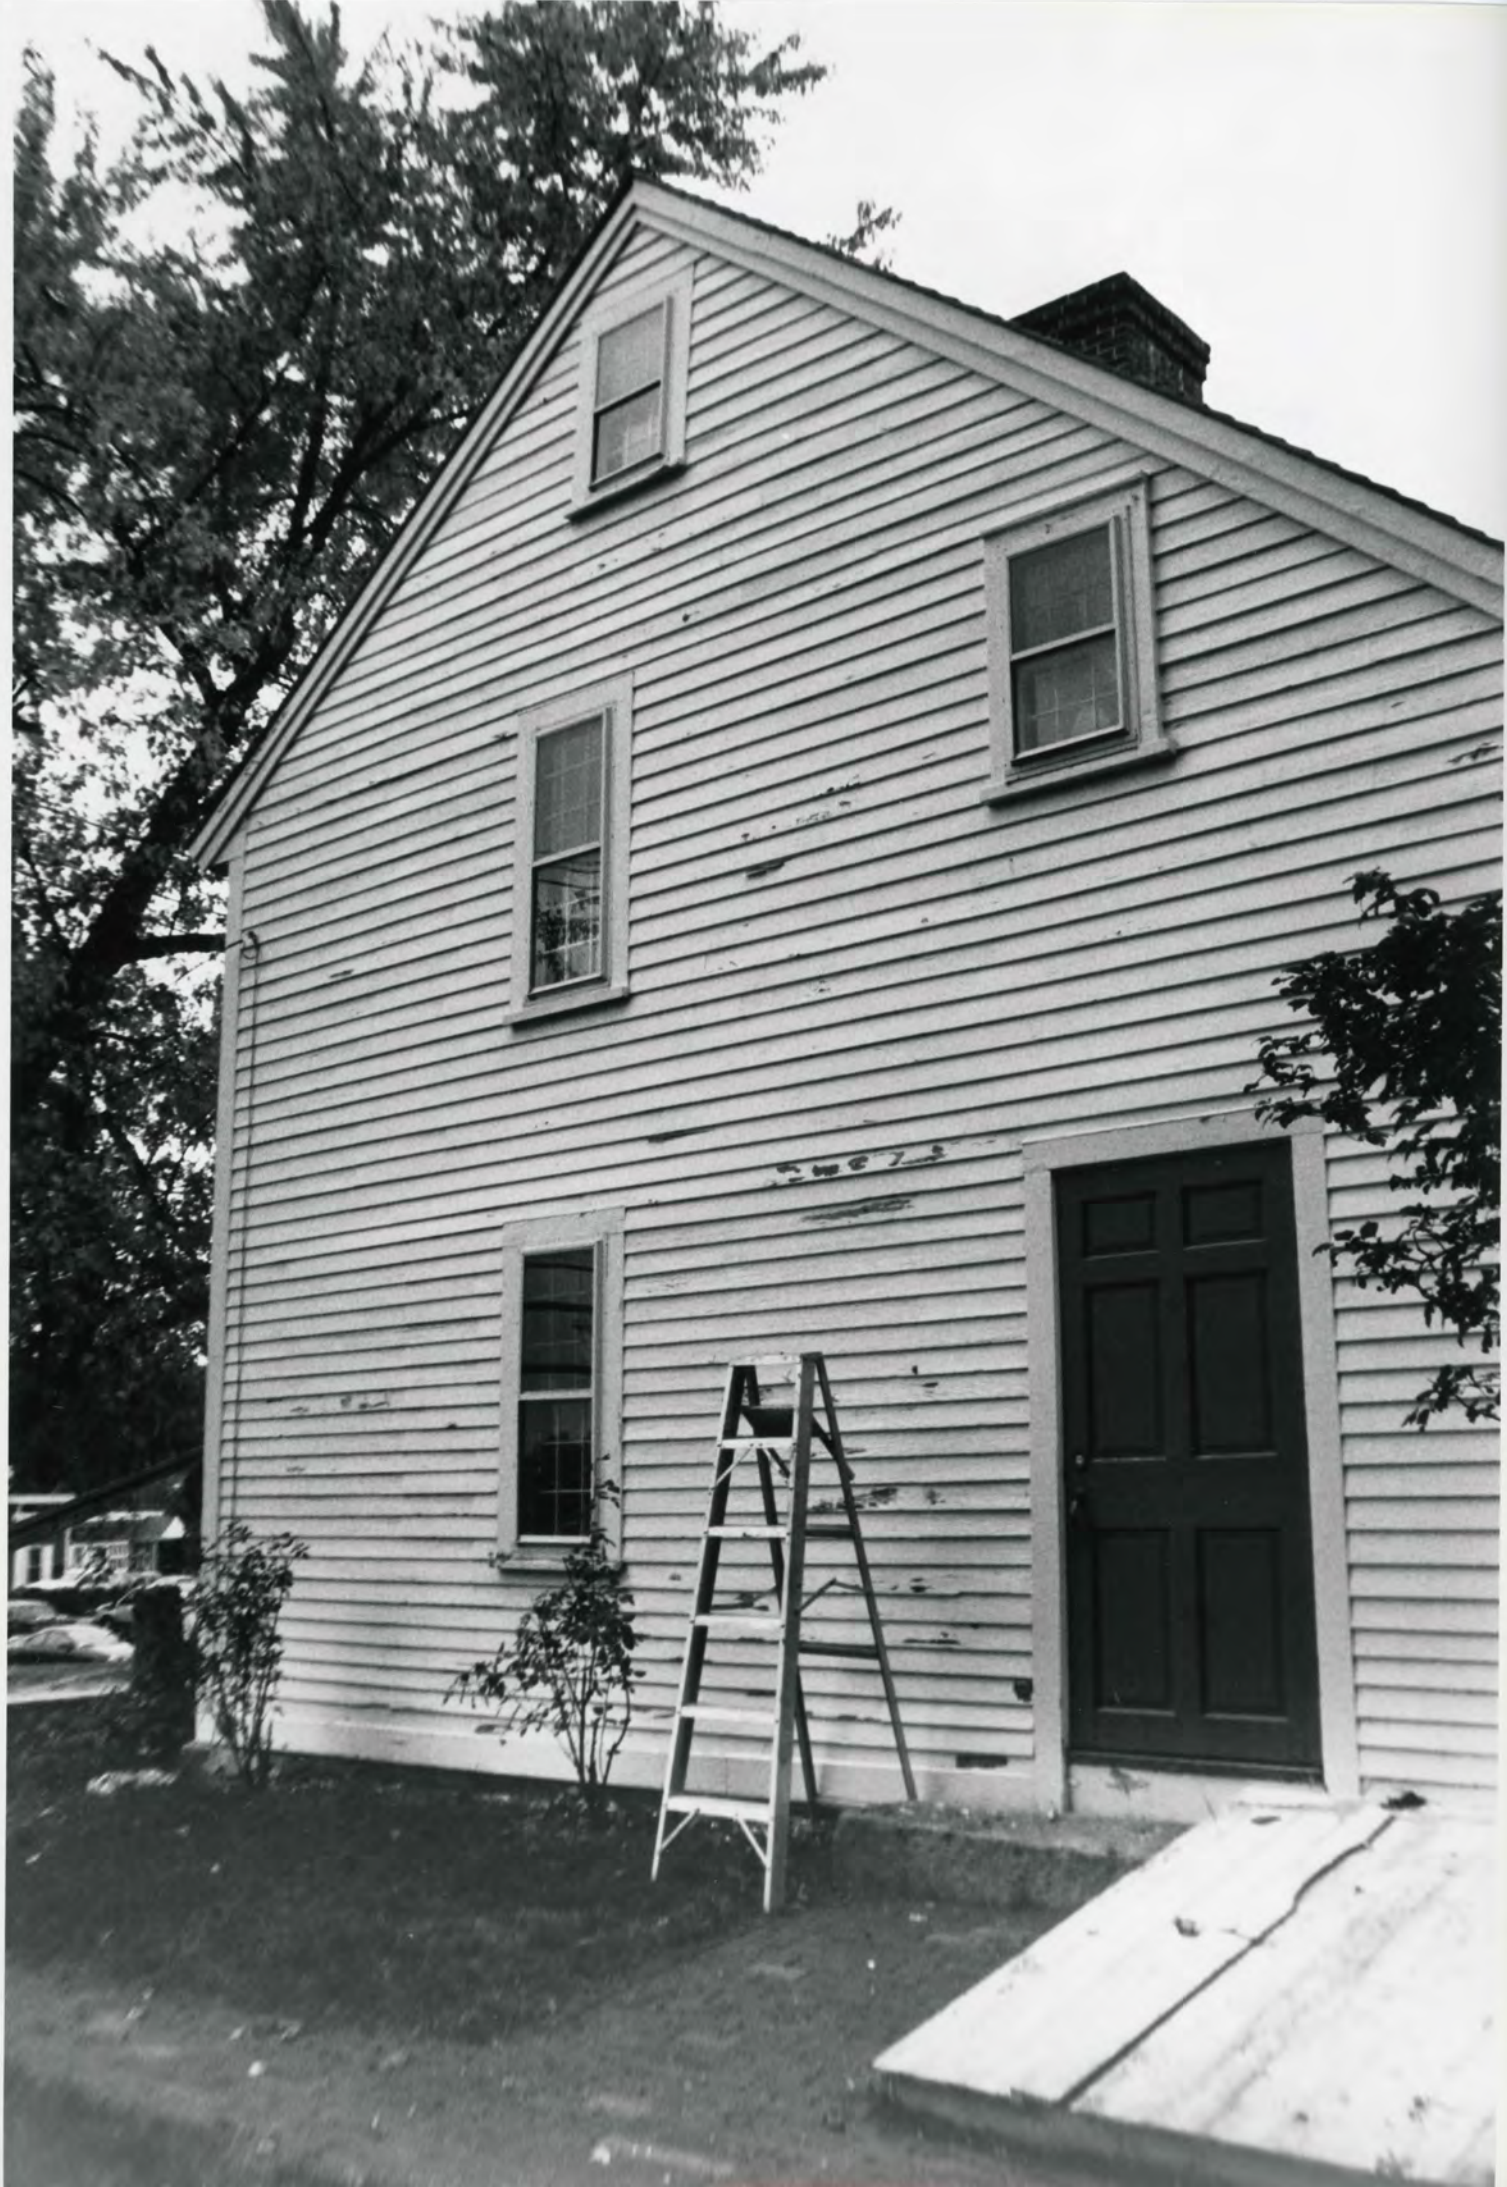
④ Hosmer House, 300 Main St, Acton, MA, Middlesex  
County

East end of Hosmer House, looking Southwest

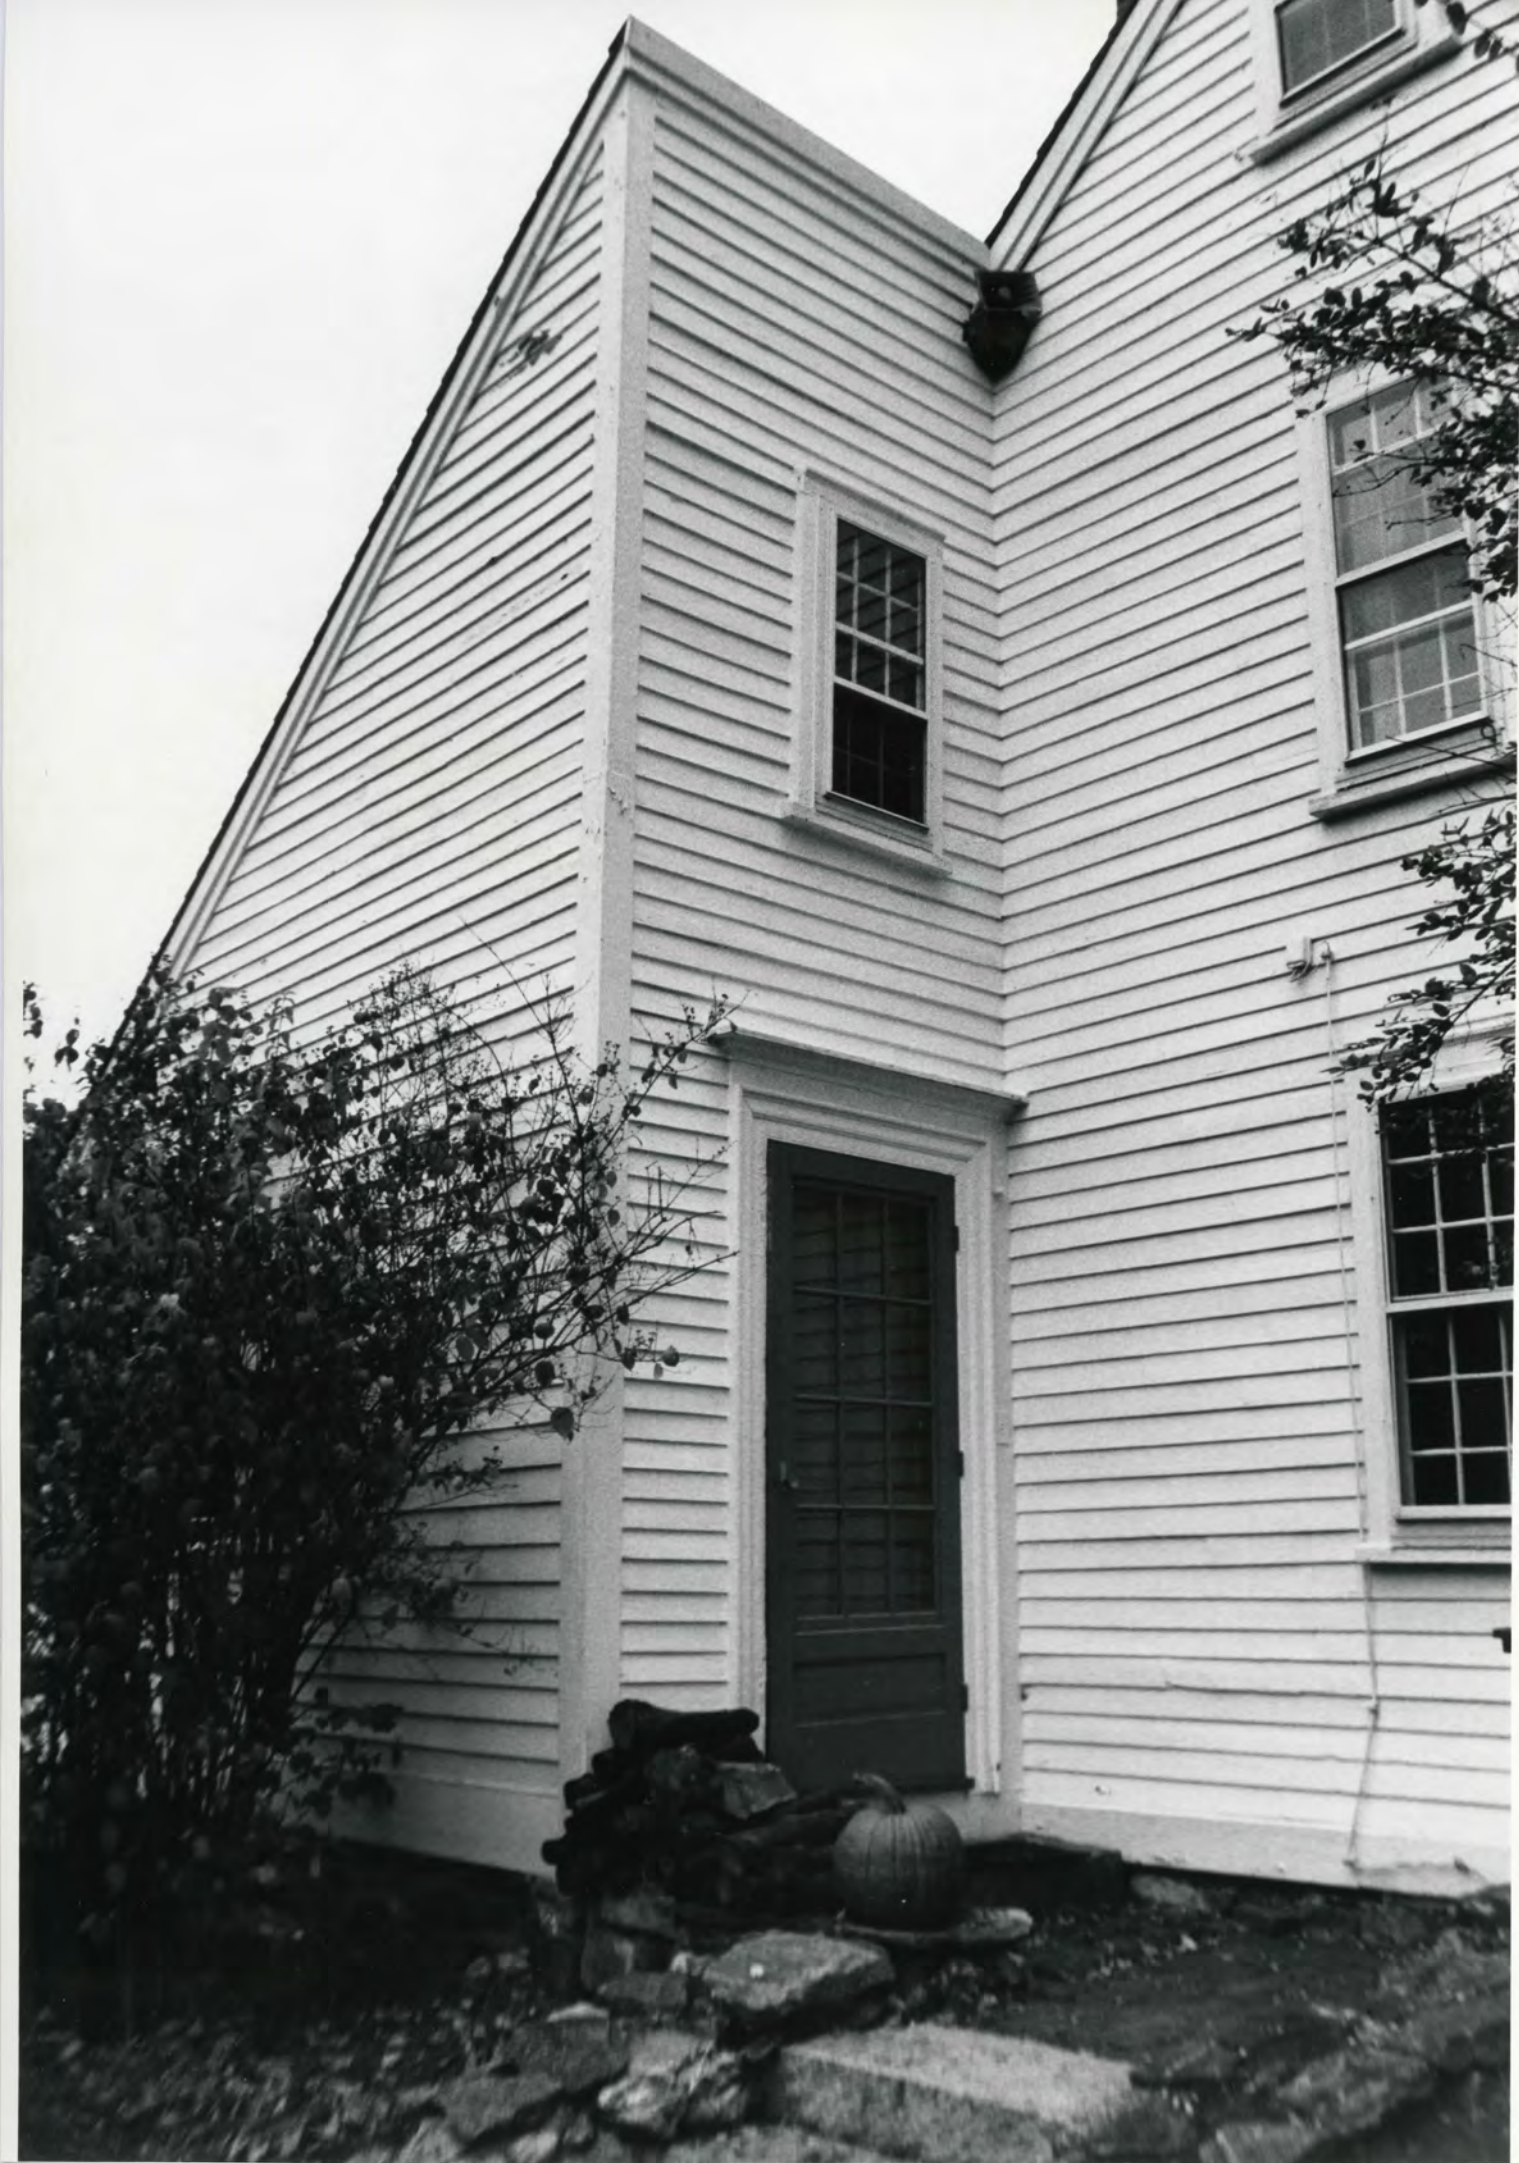
5

"Beverly jog": west end of Hosmer House

The Hosmer House is a long 2 1/2-story, side-gabled double house with a full-width rear leanto extending five feet beyond the northwest corner of the main house to form a tall "Beverly jog." The building stands on a fieldstone foundation topped with rough-cut granite blocks, has a wood-shingle roof, and is clad in wood clapboards. As viewed from the exterior, the asymmetrical main facade is seven bays wide at the first story, and six at the second (photo #1). There are three principal southern entries--one in the jog, and two on the main section, one for each part of the double-house, occupying the second and the fifth bays from the north end. Two large brick chimneys, both rebuilt above the attic floor in the 1970s, rise from the roof. One is a ridge chimney positioned nearly in line with the easternmost entry; the other is an interior chimney in the rear slope of the roof at the west end of the main house. The east gable end of the building displays a center window at each story and one in the attic, aligned vertically; in the east end of the leanto to their rear is a modern door and a 6-over-9-sash window at the first story (both are 1970s replacements, occupying the locations of a former door and window), and a small 6-over-6 window in the upper wall above the door (photo #4). The west gable end of the main house is also aligned with one window at each story; the west end of the leanto in the jog area has a paired modern kitchen window at the first story, and is windowless in the upper section, although the lines of a former small window there are evident in the pattern of clapboard

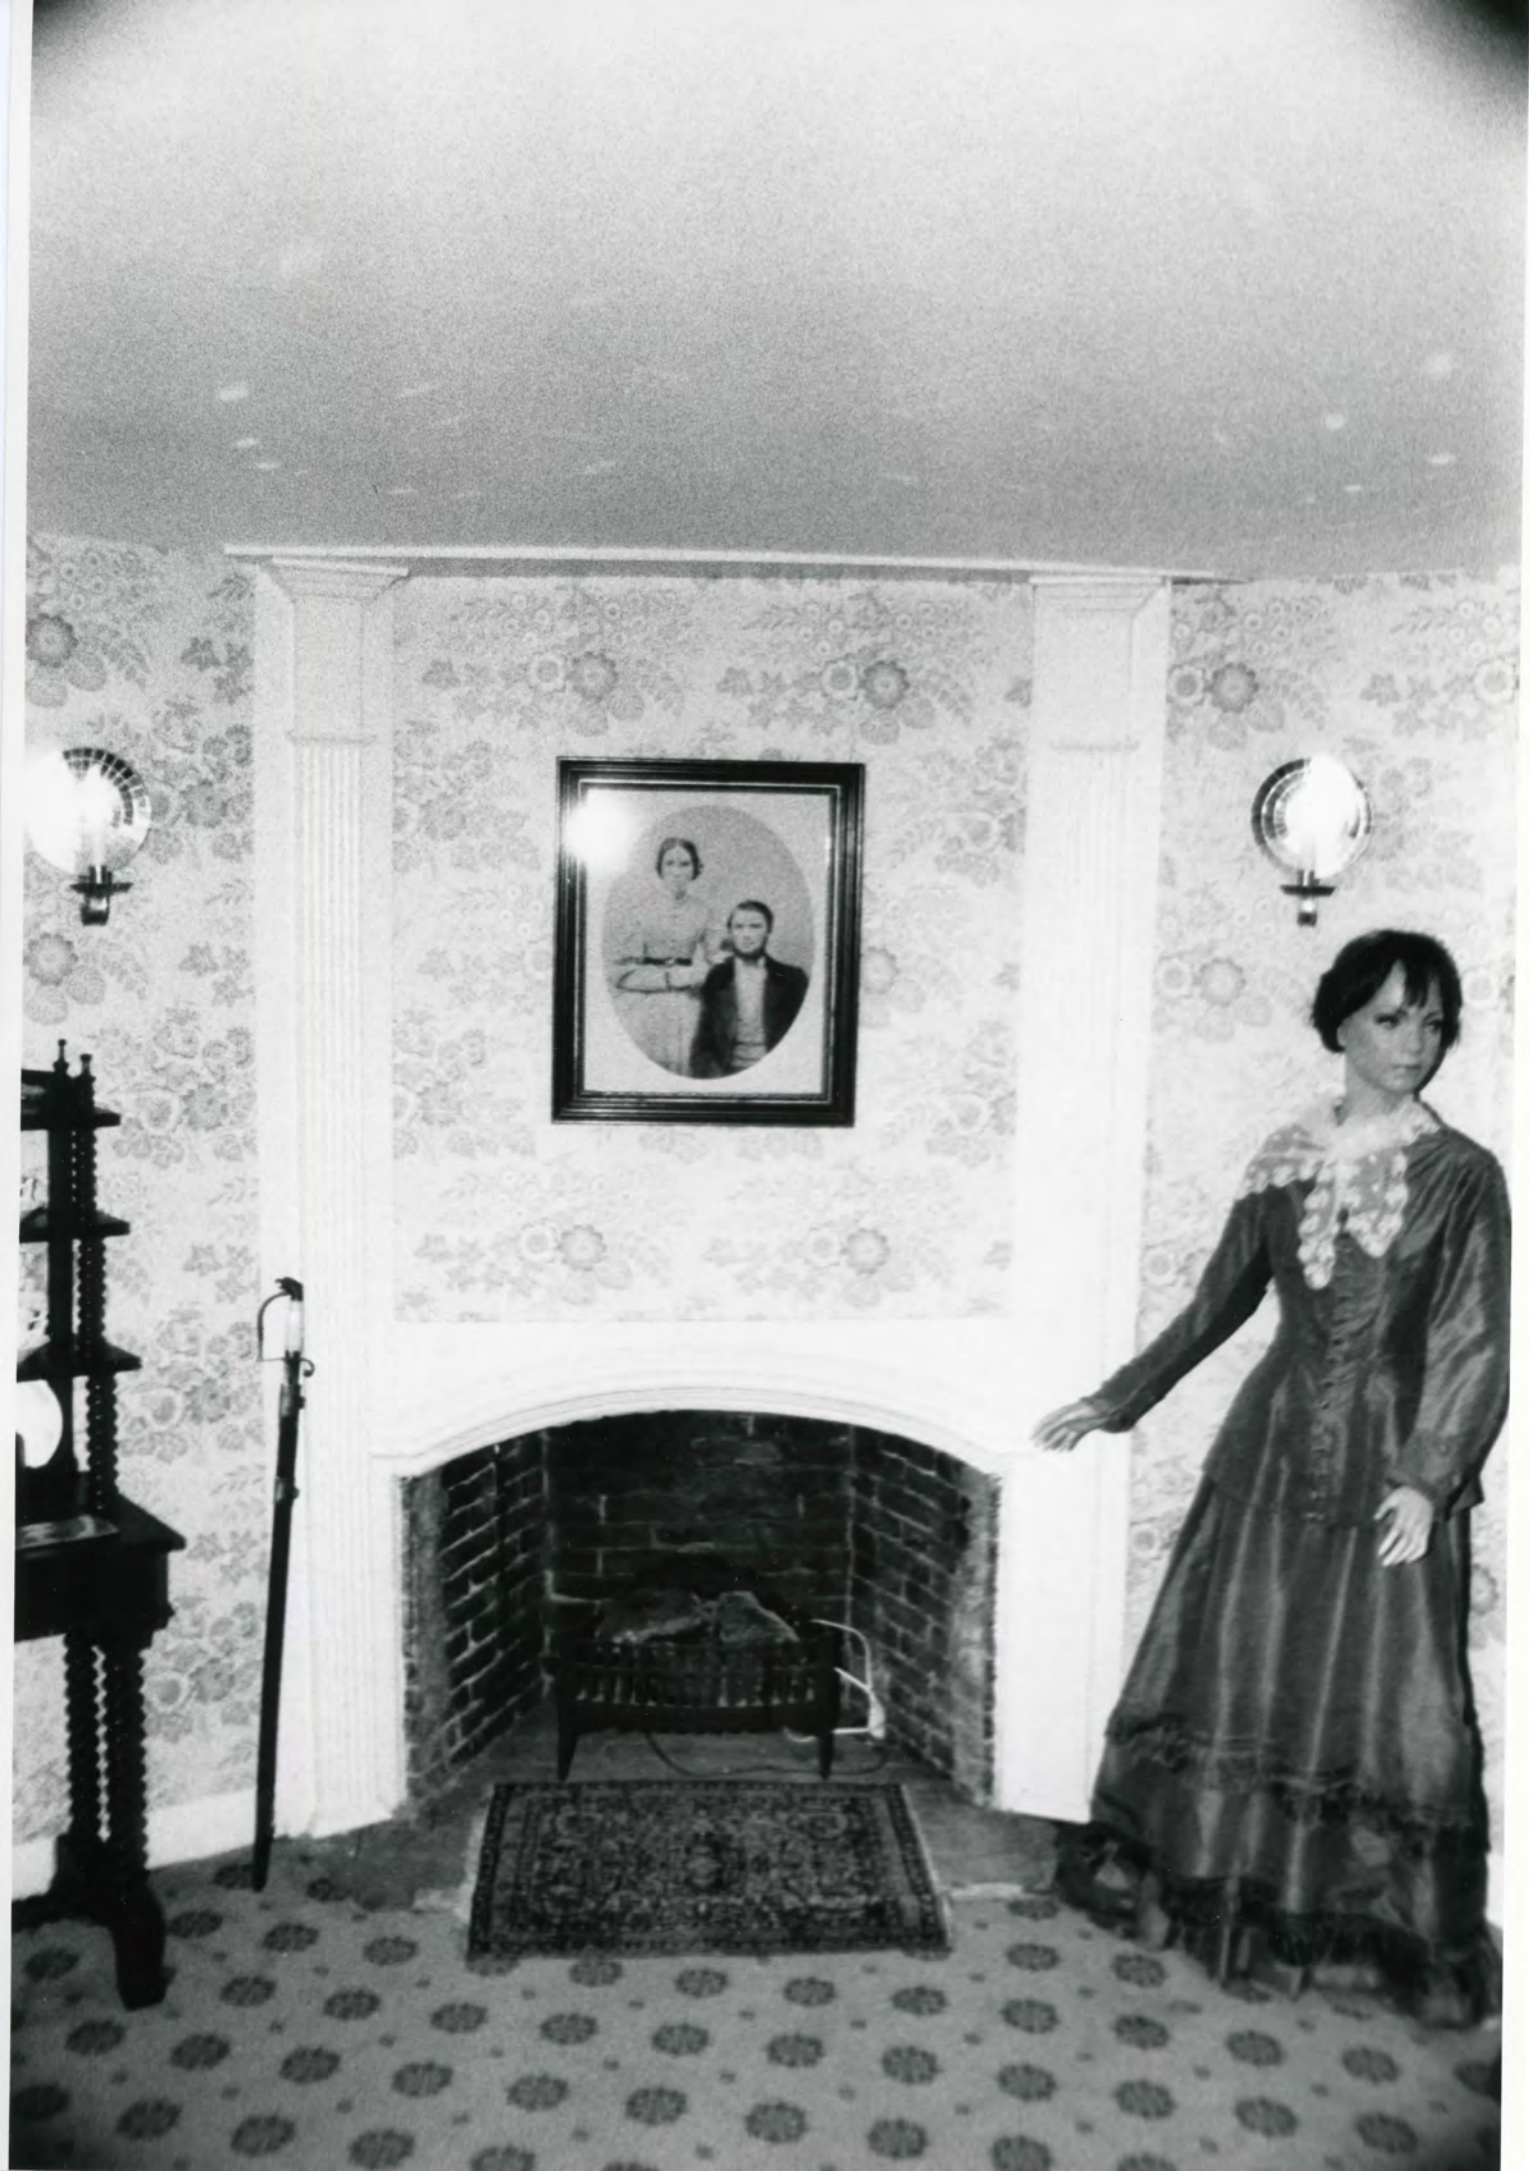
⑥ Hosmer House, 320 Main St. Acton, MA  
Middlesex County

Living Room fireplace, Southeast 1st story room
