National Register of Historic Places  
Registration Form

historic name Jonathan and Simon Hosmer House

Jonathan & Simon Hosmer House  
Acton (Middlesex), MA

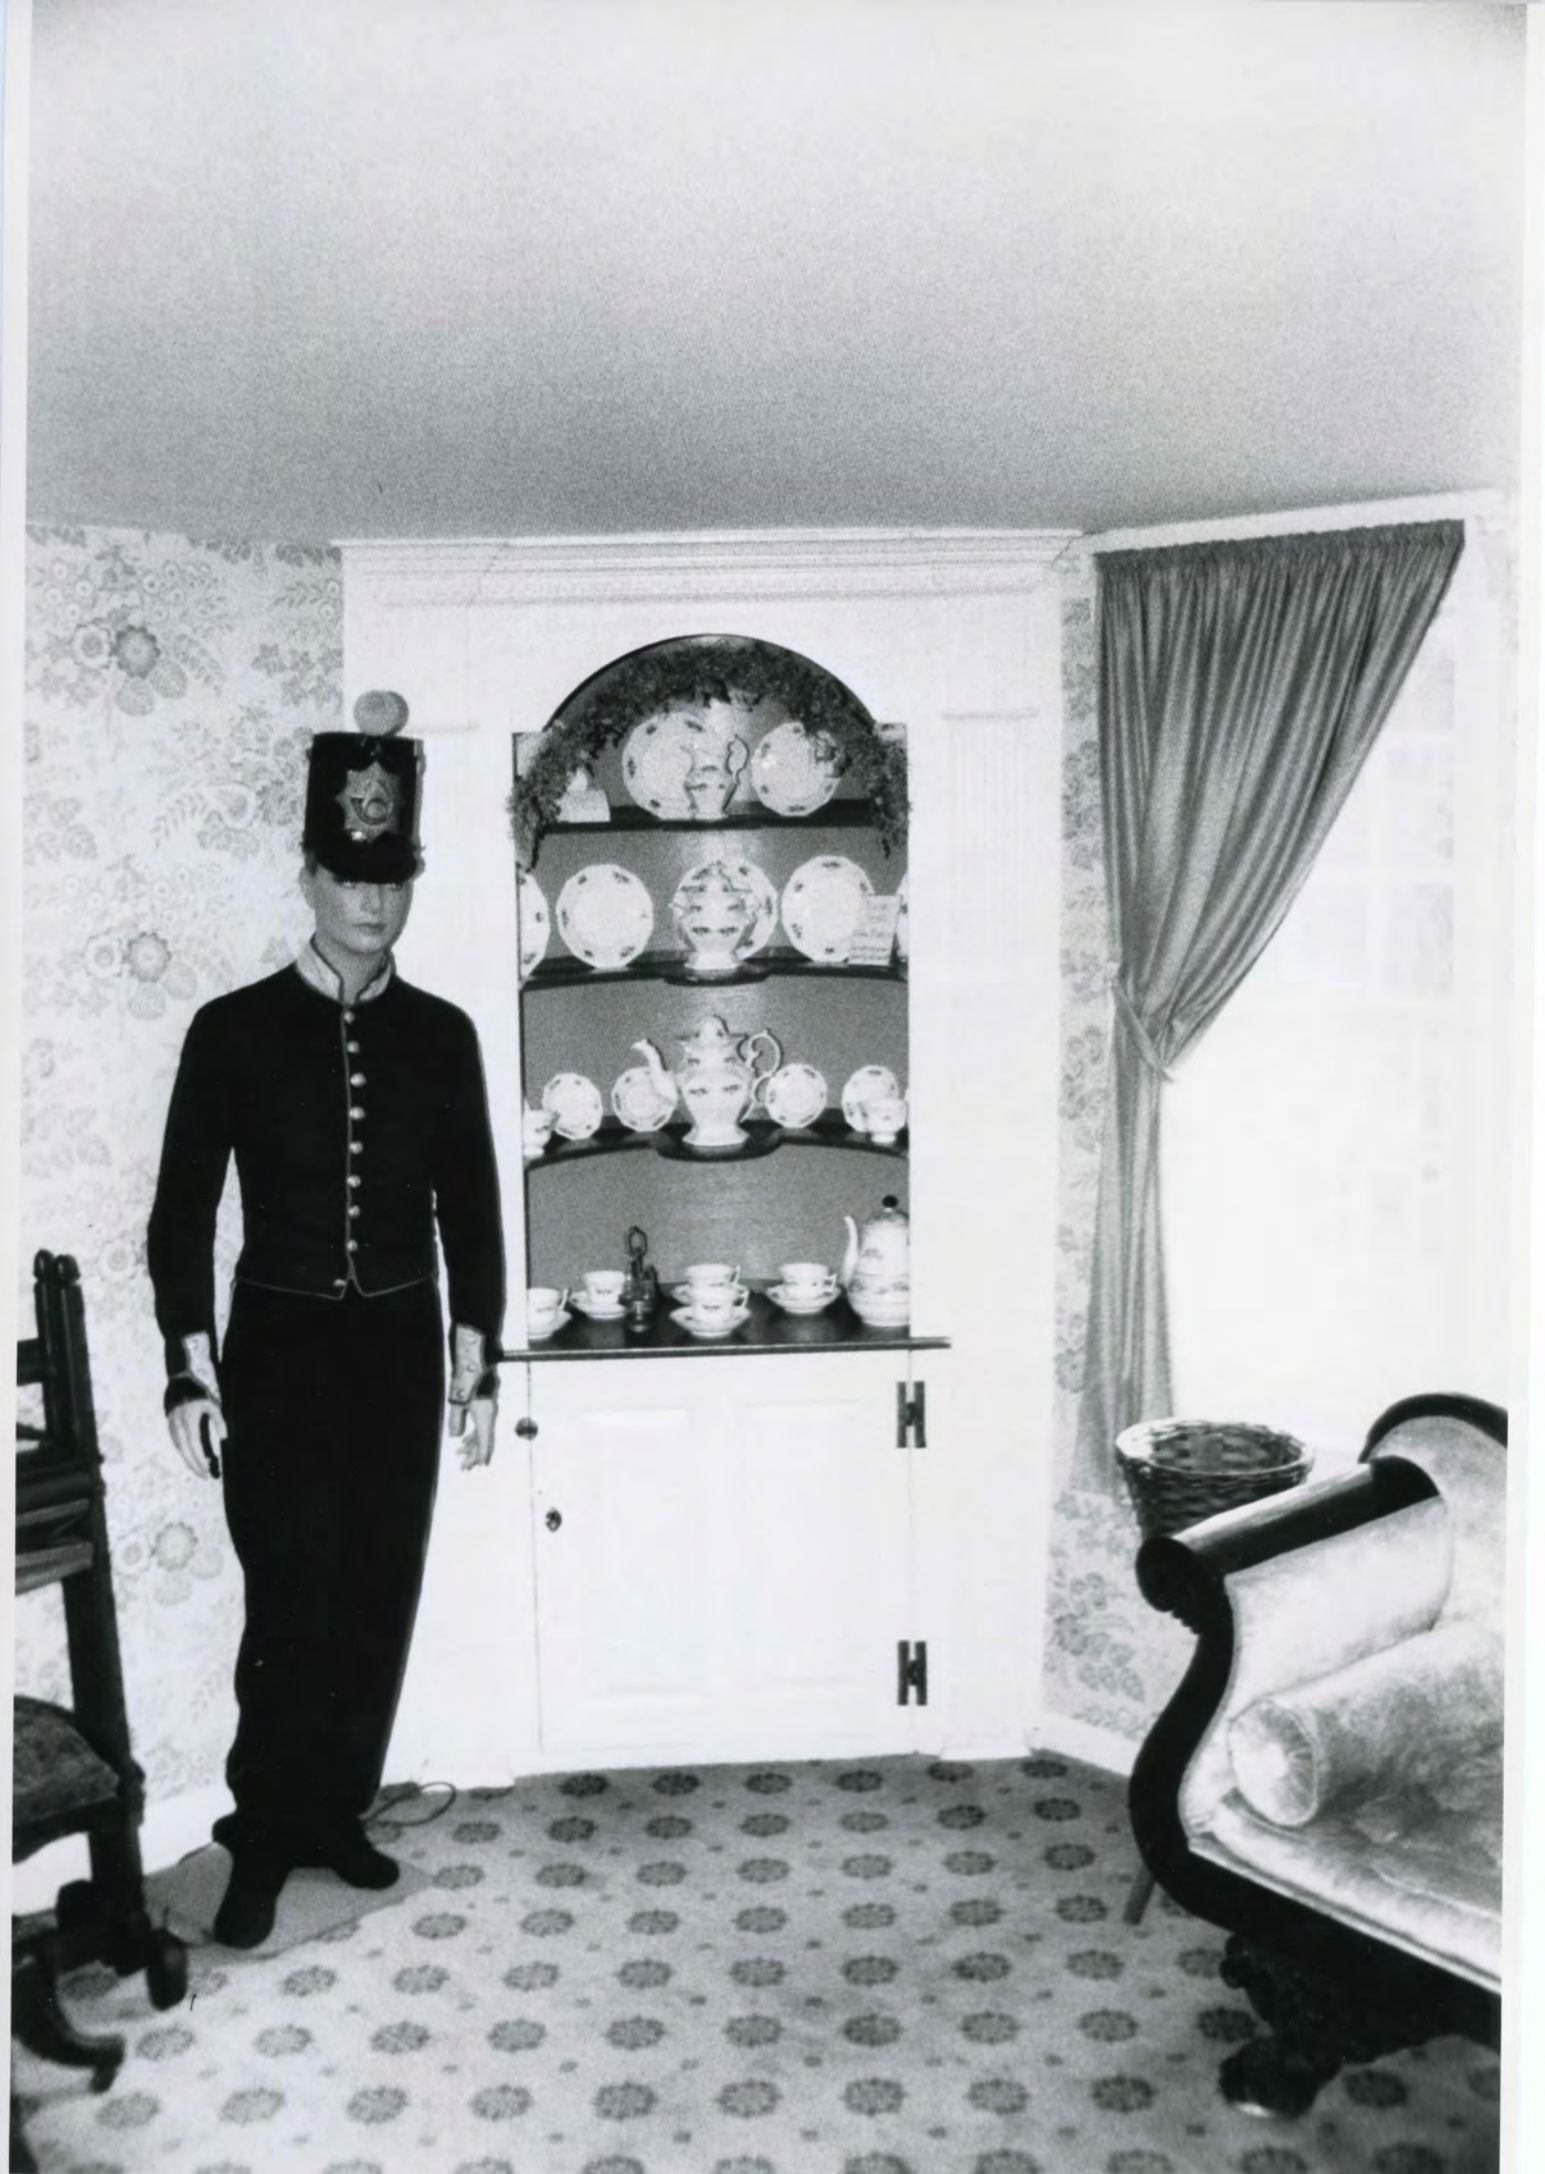
① Hosmer House, 300 Main St. Acton, MA,  
Middlesex County

Corner Cupboard in Hosmer House Living Room  
(Southeast 1<sup>st</sup> story room)

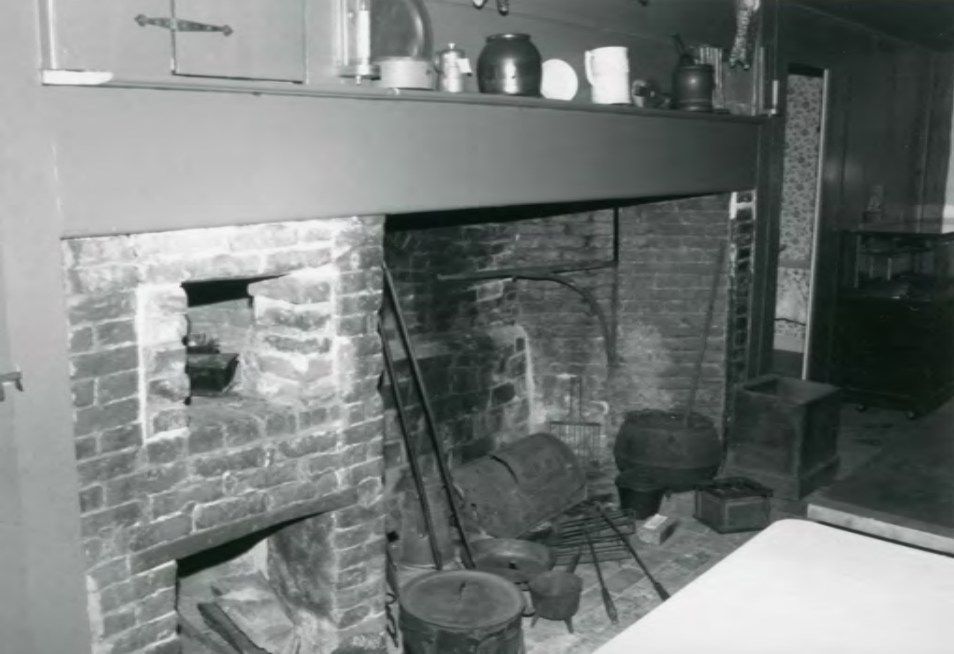
Neg - AHC files, Town Hall #13  
⑧

Fireplace, Keeping Room  
(kitchen)

In the leanto across the rear of the 1760 house is one large room, used originally as a kitchen, and today referred to as the "keeping room." Its focal point is the large, deep fireplace in the front wall, which has two bake ovens--one in the back wall of the firebox, the other, apparently a later addition, abutting the east end of the fireplace(photos #8-9). The long board above the openings is a 1970s covering for the heavy, charred fireplace lintel; the chimney face above it is covered with horizontal feather-edge sheathing. North of the fireplace are the enclosed stairs to the second floor. Much of both the structure and fabric of this room had to be replaced after the 1972 fire. The flared, exposed, rear corner posts survived the blaze, however, as did the chimney girts and a few ceiling joists, a portion of vertical feather-edge sheathing on the south wall, and the plaster and plain dado on the west end wall. Feather-edge sheathing was recreated for the rest of the fireplace

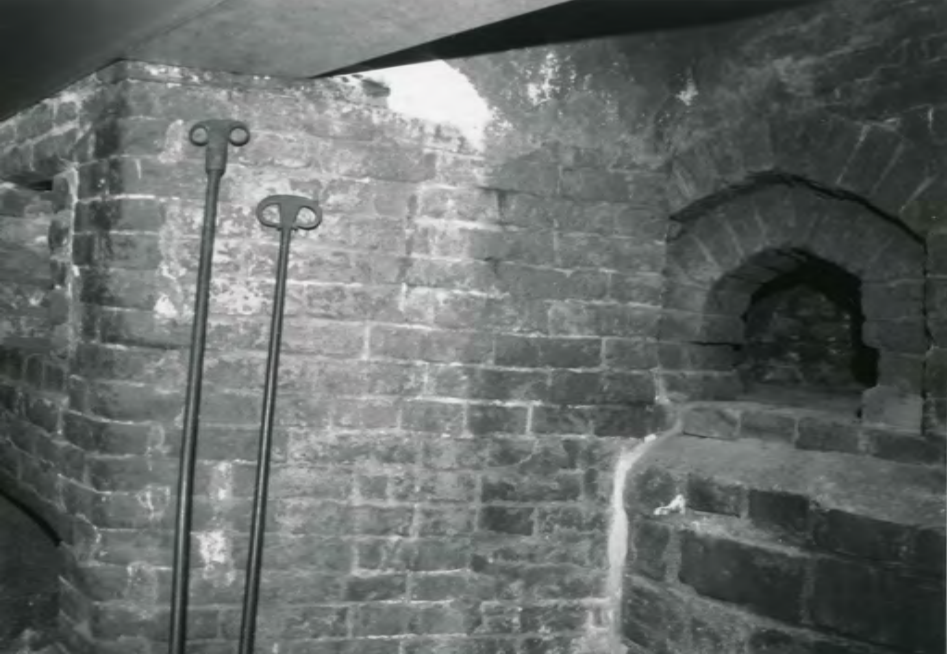
Neg. AHC Files, Town Hall #14  
⑨

Beehive oven, Keeping Room fireplace  
(interior bake oven)

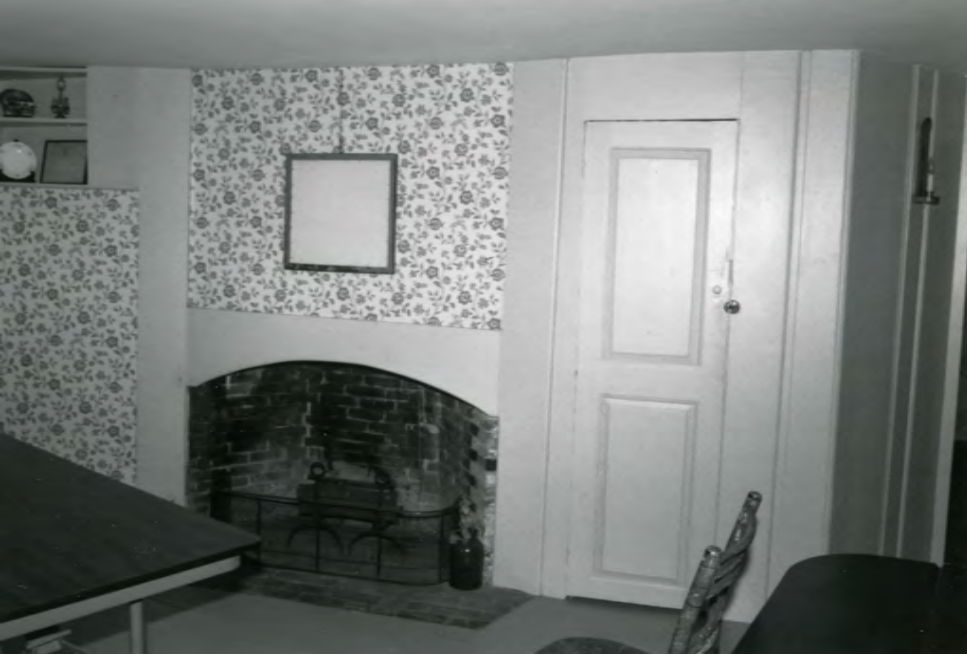
⑩ Dining Room Fireplace =  
SE 1st story room Jonathan Hoxer  
House

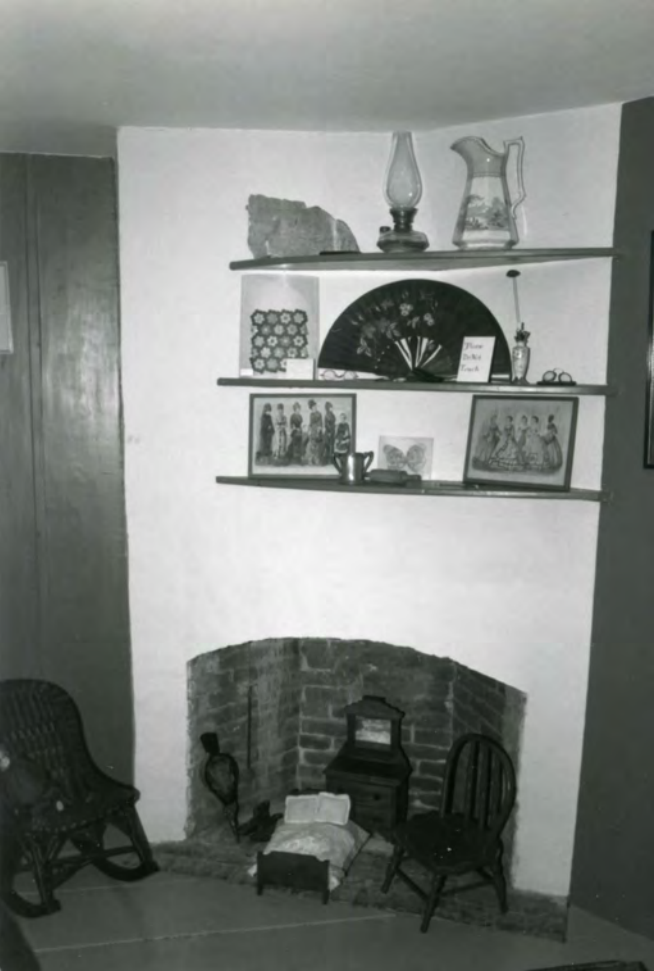
⑫ Southwest Chamber Fireplace,  
Jonathan Hornett House

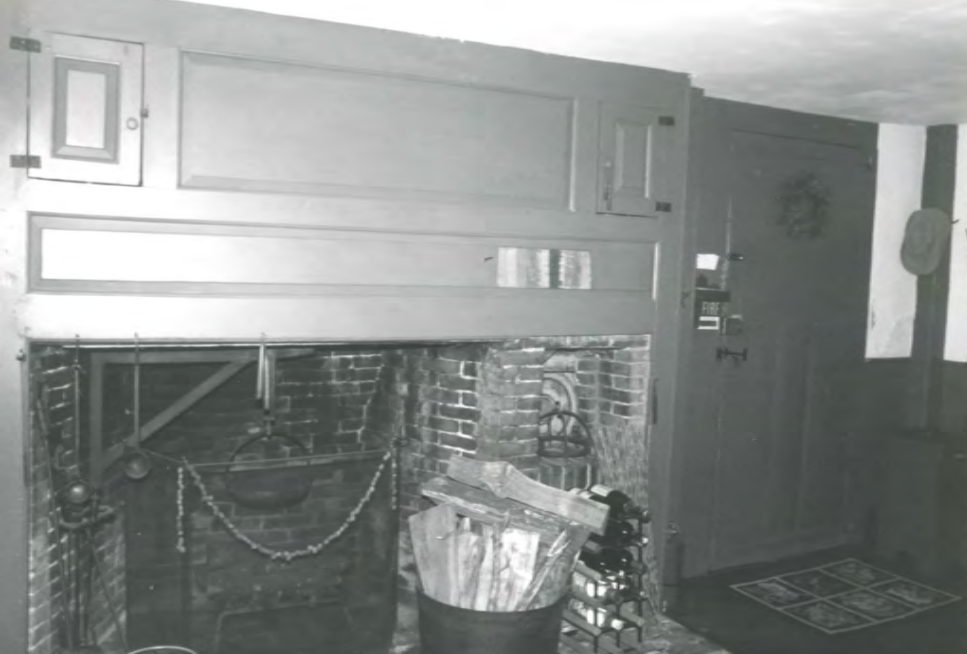
⑬ Kitchen Living 1999 Addition

(Simon Hasmer House)

In the leanto to the rear is the original 1790s kitchen, with an enclosed interior stair at its east end, and a modern double lavatory in its northeast portion. The face of the chimney above its large cooking fireplace is covered with long raised-field panels. The exterior bake oven is positioned just west of the firebox. This room extends west into the jog, where the interior face of the door in the front wall is covered with vertical board and hung on long strap hinges with pointed cusps (photo #13).

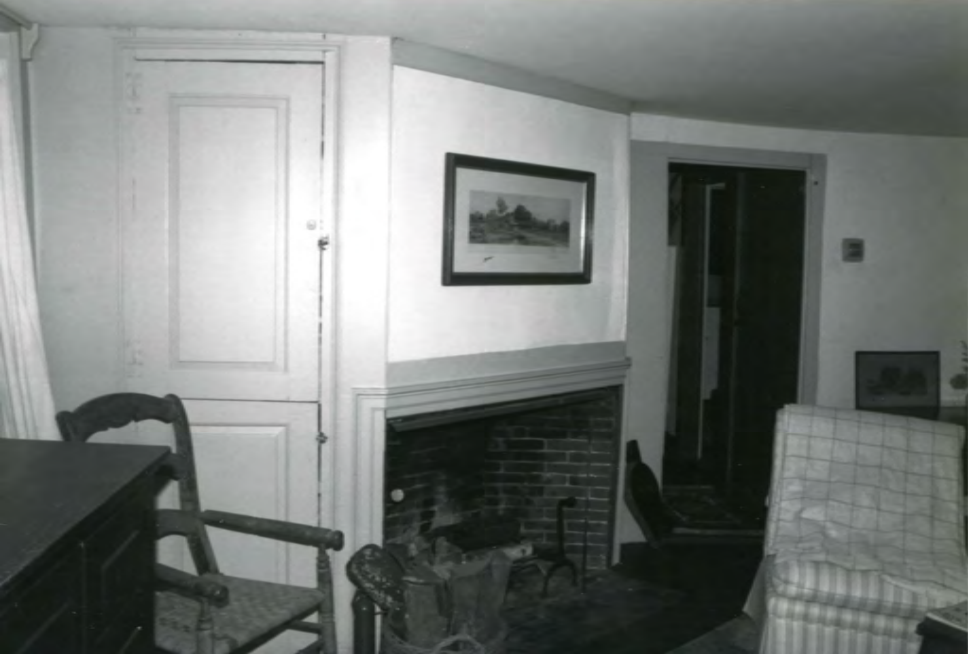
(14)

Living Room Fireplace - 1740 Addition  
+ wall cabinet (Simon Hosmer House)

The house built for Simon Hosmer abuts the west end of his father's residence (photo #1). Its layout is a more conventional two-room-plan, 2 1/2-story, three-bay half-house. Like the 1760 house, however, its main doorway opens directly into the first-story room. The diagonal fireplace in this room has a rectangular opening, with a molded surround that was recreated according to paint evidence found during the 1970s restoration. Fitted beside the chimney stack to the west of the fireplace is a fine example of a two-door wall cupboard, each door with a single raised-field panel. The H-hinges of the cupboard doors retain their leather washers, still visible under many layers of paint (photo #14).

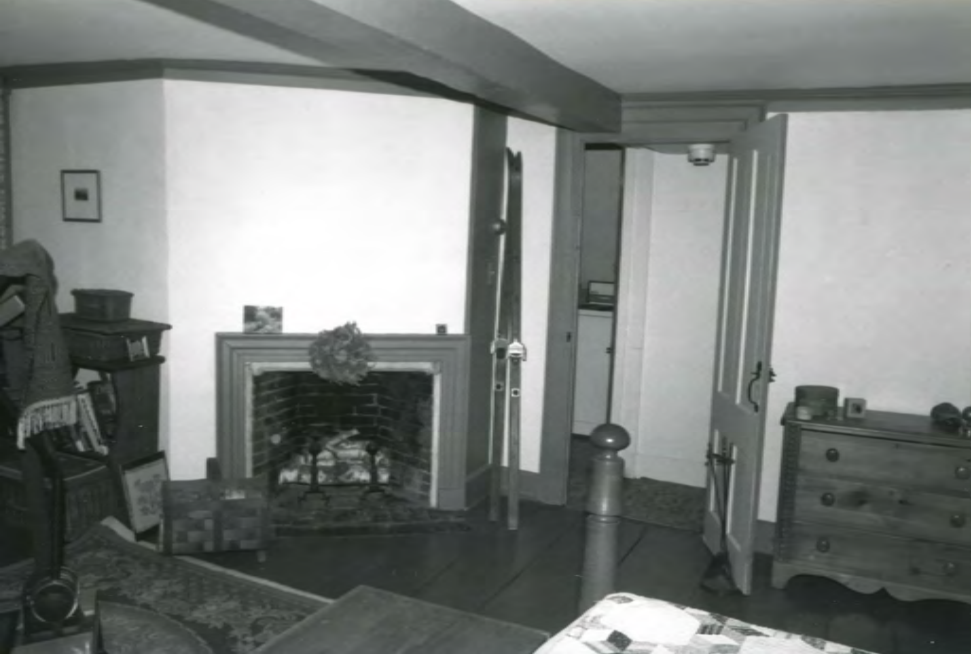
(13)

Fireplace - 1790 Addition Chamber  
(Simon Hosmer House)  
- looking northwest

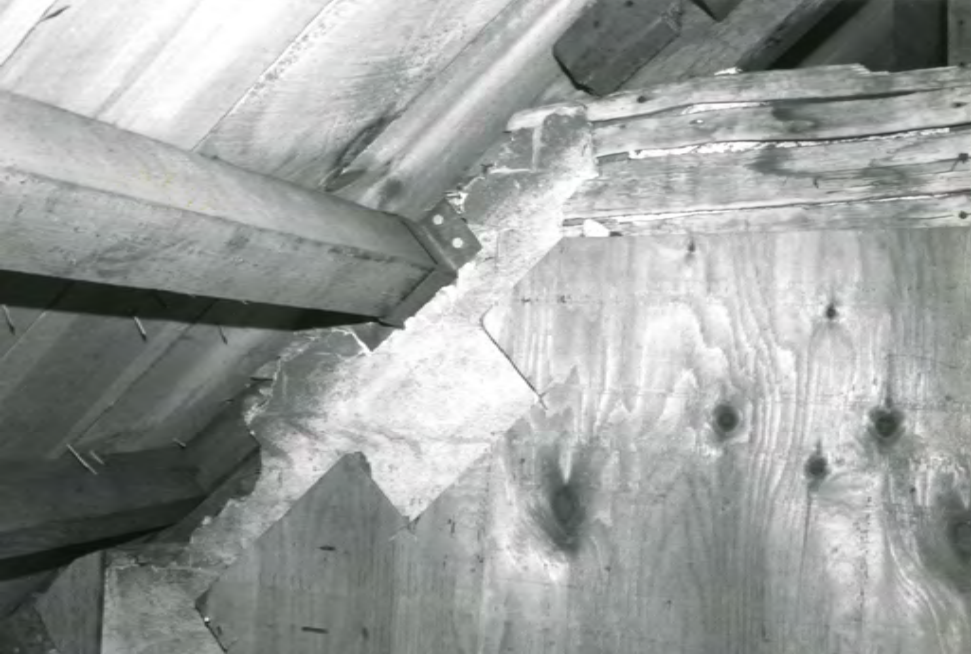
(16) Attic - showing piece of stucco scored  
to resemble brick - original exterior  
treatment of sides. (former west  
gable, Jonathan Hosmer House)

**Attic.** The two houses share a common attic space, with a principal-rafter and purlin roof structure. The rafters are joined at a four-sided ridge beam; the roof boards are laid vertically, and many have been replaced. An extremely rare feature preserved inside the attic is visible on the original west gable-end wall of the 1760 house, which was left in place when the building was extended in 1796-97. While the east gable is sheathed and clapboarded in the expected manner, this wall has riven lath, rather than sheathing, nailed to the west face of the studs. The lath is plastered between the studs on the east (interior) side, and stuccoed or plastered on the west (former exterior) side. Areas of red paint in an imitation brick design are well preserved on the stucco, suggesting that Jonathan Hosmer may have used his own house to advertise his masonry skills (photo #16).
