STATE OF CONNECTICUT
CONNECTICUT HISTORICAL COMMISSION
59 SOUTH PROSPECT STREET, HARTFORD, CONNECTICUT 06106
(203) 566-3005

IDENTIFICATION	1. BUILDING NAME (Common) (Historic)		Private Residence		Zaccheus Baldwin House	
	2. TOWN/CITY		VILLAGE		COUNTY	
	Branford				New Haven	
	3. STREET AND NUMBER (and/or location)					
	154 Damascus Rd.		Map G6, Block 7, Lot 18; 1.1 acres			
DESCRIPTION	4. OWNER(S)					
	Pearl Blackstone Milne <input type="checkbox"/> Public <input checked="" type="checkbox"/> Private

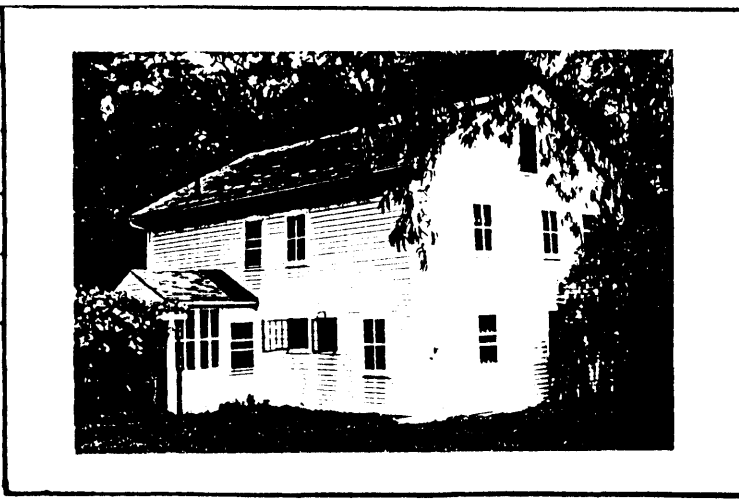
PHOTO

Constructed on a rectangular plan with its ridge parallel to the street, this structure has a shallow-pitched roof (less than 6:12) with cornice returns. It has a brick chimney, set behind the entry, which straddles the ridge. It has an asymmetrical four-bay seven window facade, featuring a classical entry with fluted pilasters and a three-part entablature. It has five-window gables. Its windows have eight-over-twelve sash and feature pedimented wood trim.

VIEW: South & West Elevs.
