NEW JERSEY TRANSIT RAILROAD STATION SURVEY

- ✓ A. Name: Common Orange Station Historic Line: Hoboken Division--Morristown (DL&W)
- B. Address or location:
 - ✓ 73 Lincoln Avenue Orange, NJ 07050
 - ✓ County: Essex Municipality: Orange City Block & lot: part of 82/19
- C. Owner's name: NJ Transit Address: Trenton, NJ
- D. Location of legal description: Recorder of Deeds, Essex County Courthouse, Raymond Boulevard, Newark, Newark, N.J.
- E. Representation in existing surveys: (give number, category, etc., as appropriate)

FACILITY NAME: Orange

Field Survey Conducted September, 1978

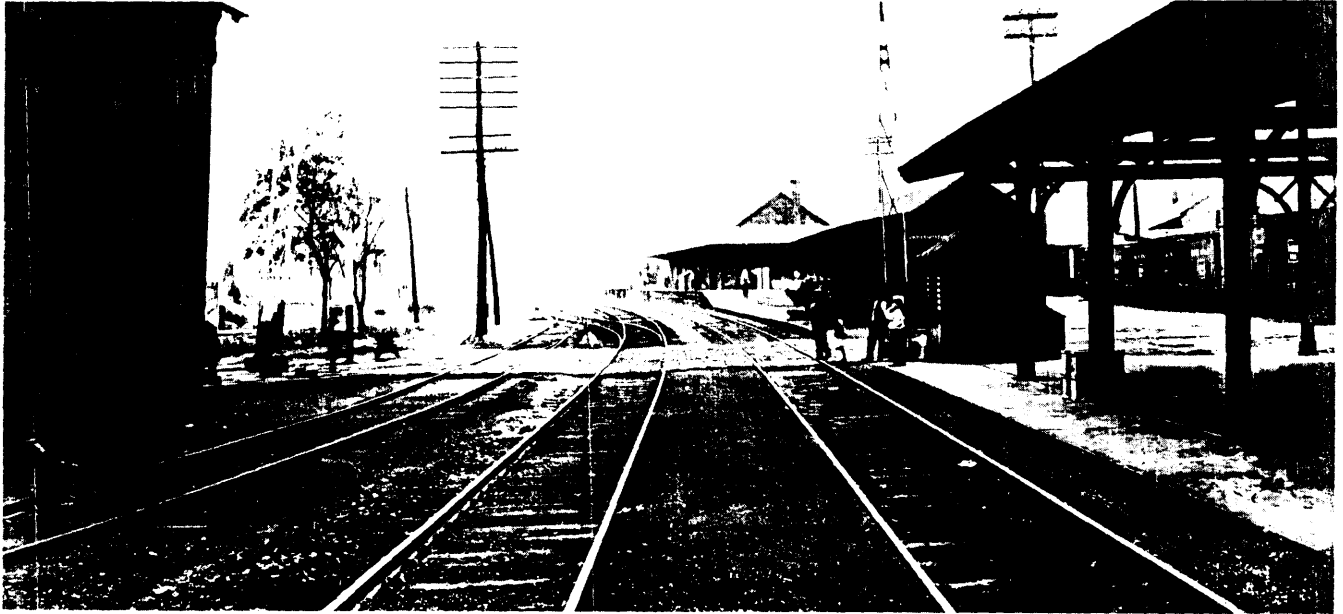
84 2-7 Orange Railroad Station (Taber, 20th, p. 84)

Just west of the Orange station was the freight station with its team tracks to the north of the main line. On the south side were some additional tracks. Between 1916 and 1918 the tracks were elevated a few feet at Orange and west through Highland Avenue and past Mountain Station toward South Orange, which had had its elevation work completed in 1915. The new route between Orange and Highland Avenue was somewhat west of the old so as to reduce Orange curve and take the tracks off Scotland Street.

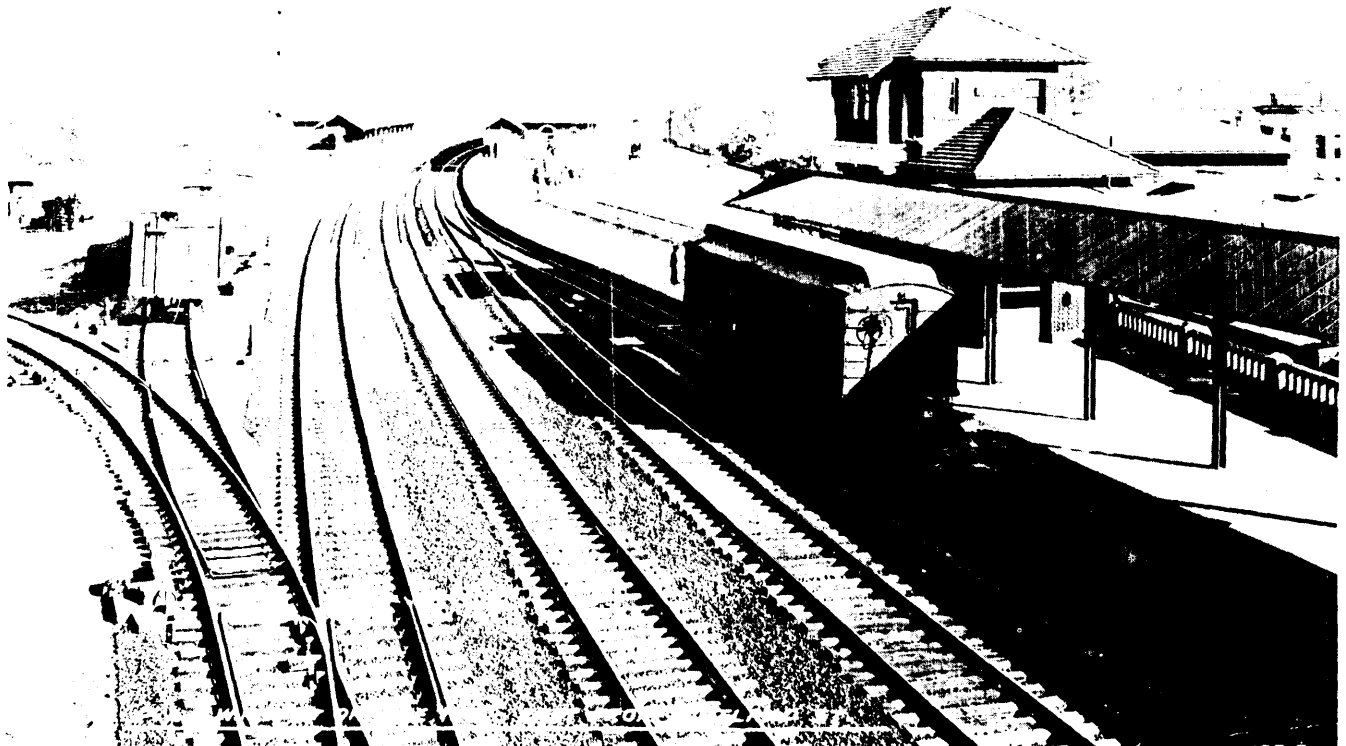
Orange station looking east. The interlocking tower sits on top of the Railway Express building. A milk car is being used for express. Behind the tower is the freight station and new team tracks. This yard also served East Orange. Several coal companies and meat distributing plants had sidings in East Orange along the main line which were elevated when the track elevation work was done. To the left of the main line, where the old freight yard had been, is a single track to serve a customer. The remaining yard area is now part of a road underpass. Although the curve does not appear to be sharp, its speed limit of fifty restricts east bound trains, and should there ever be higher powered trains in the future, westbound trains also. It is the only curve between Milburn and Roseville having a restriction.

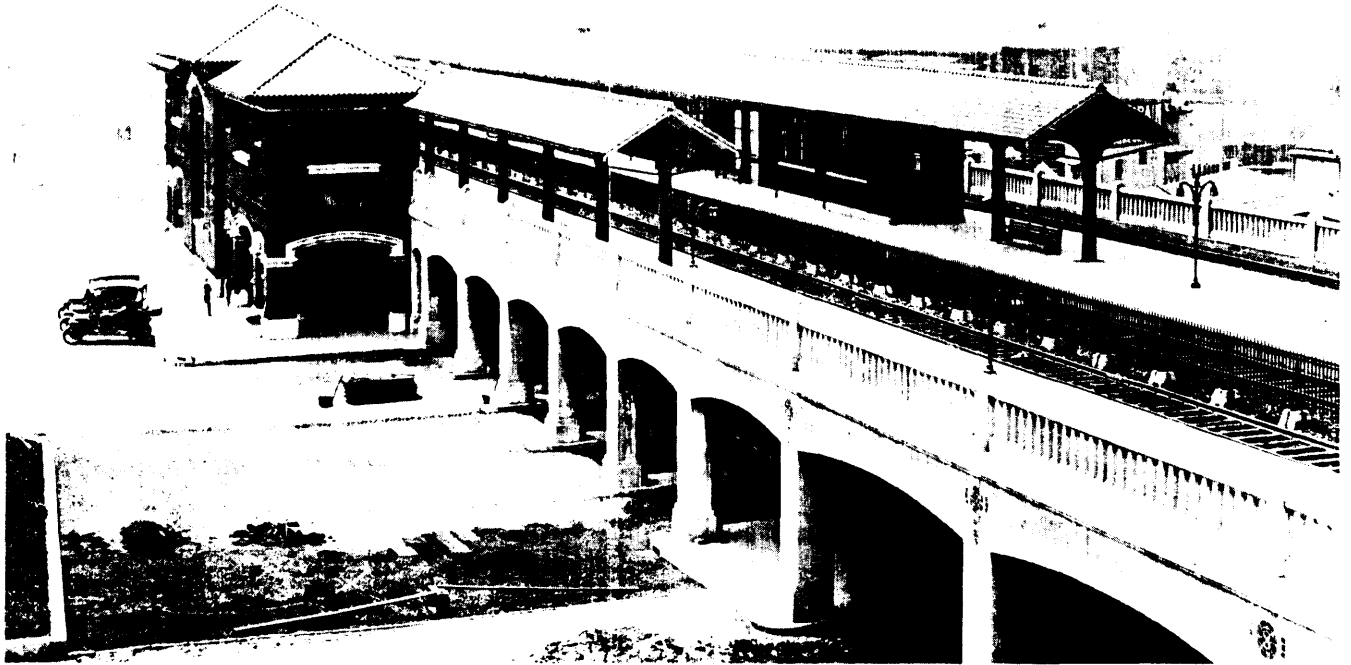
2-10 South Orange Railroad Station (Taber, 20th, p. 88)

The first trains passed through the new South Orange station on February 1, 1916. Due to lack of space Chief Engineer George Ray took the advice of the railroad's architect, F. J. Nies, to build the thousand foot station up on pillars for part of its length using the design originated by the Soo Line Railroad freight terminal in Chicago and in later years — following the South Orange success — used by the Lackawanna at Buffalo, East Orange, and Brick Church. The flat slab concrete design, upon which the tracks and station platforms were placed, was constructed under the direction of A. B. Cohen, the railroad's competent concrete engineer who was responsible for all the concrete work on the railroad — and there was plenty of that. To enhance the appearance of the plain concrete exterior, ornamental tiles were inlaid over each column. The station was completed in February 1916. To celebrate the opening, a formal dinner was given in the waiting room which was attended by Lackawanna officials and the town fathers.
