PHOTOGRAPH #1  
 Croton Aqueduct  
 Westchester, Bronx & New York Counties, New York  
 Hydrographic map showing the route of the Aqueduct and  
 an elevation profile of the Manhattan portion.  
 From: Theoph Schramke, Description of the New York  
 Croton Aqueduct, New York, 1843.

Croton Aqueduct

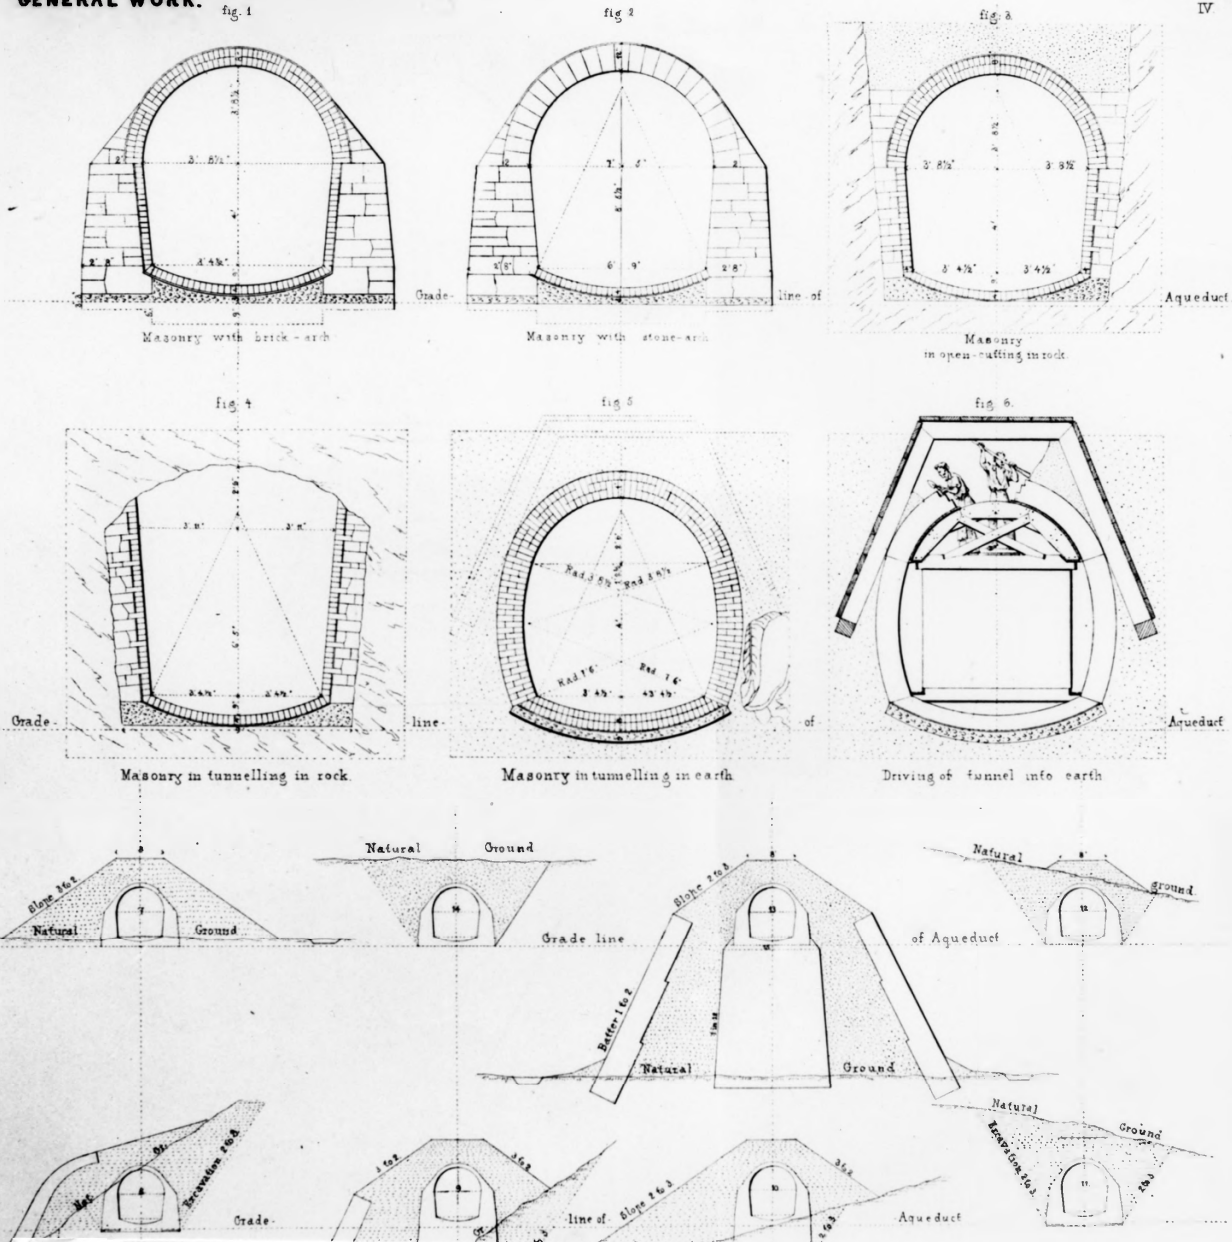
PHOTOGRAPH #2  
 Croton Aqueduct  
 Westchester, Bronx & New York Counties, New York  
 Sections showing construction methods used through  
 different ground materials and grade elevations.  
 From: Theoph Schramke, Description of the New York  
 Croton Aqueduct, New York, 1843.

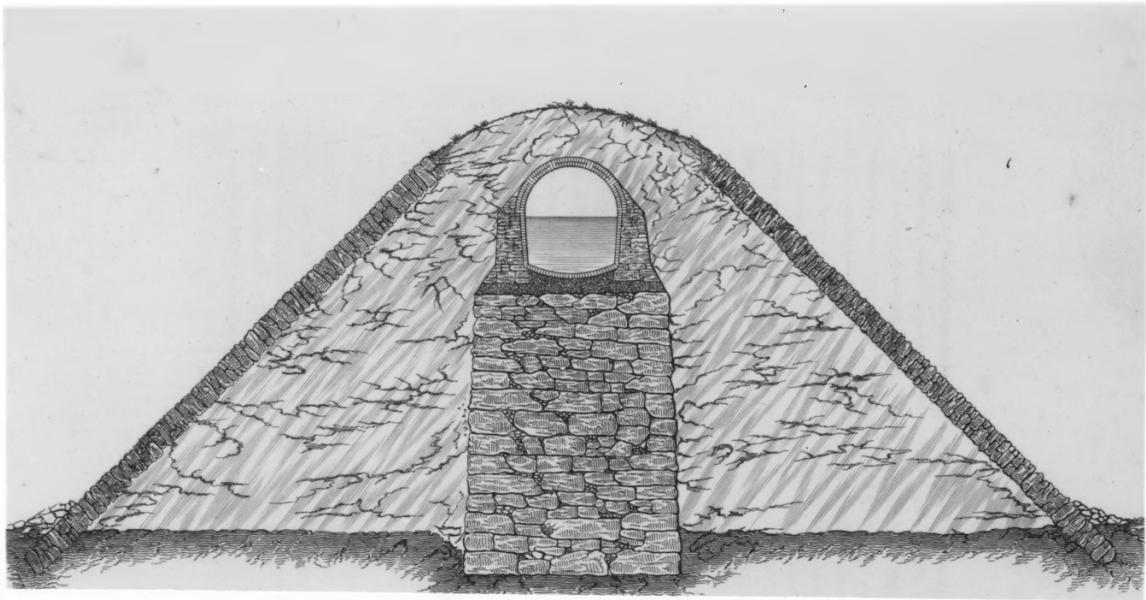
PHOTOGRAPH #3

Westchester, Bronx & New York Counties, New York  
Section showing typical bermed construction of Aqueduct  
foundation and conduit.

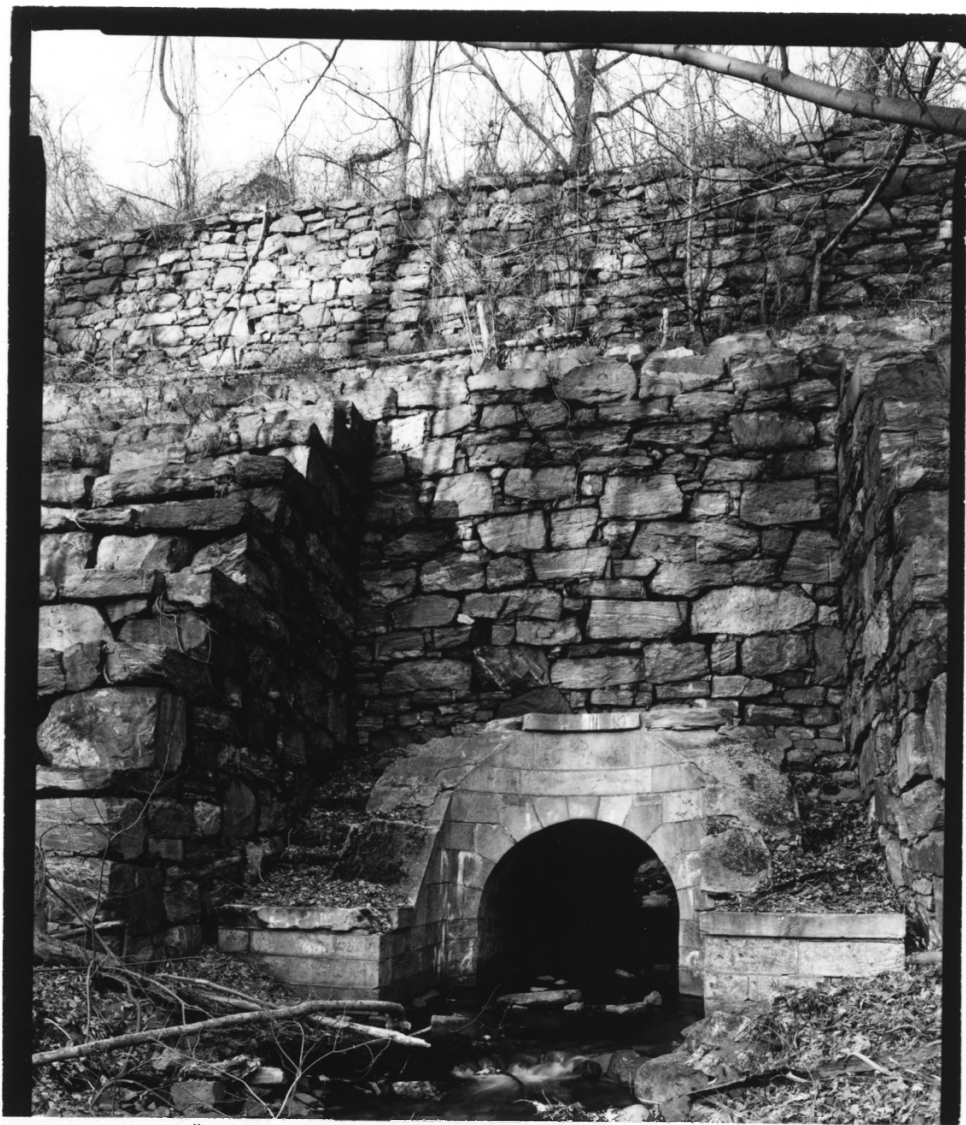
PHOTOGRAPH #4

Indian Creek culvert passing beneath the Aqueduct near  
Reservoir and Quaker Bridge Roads.

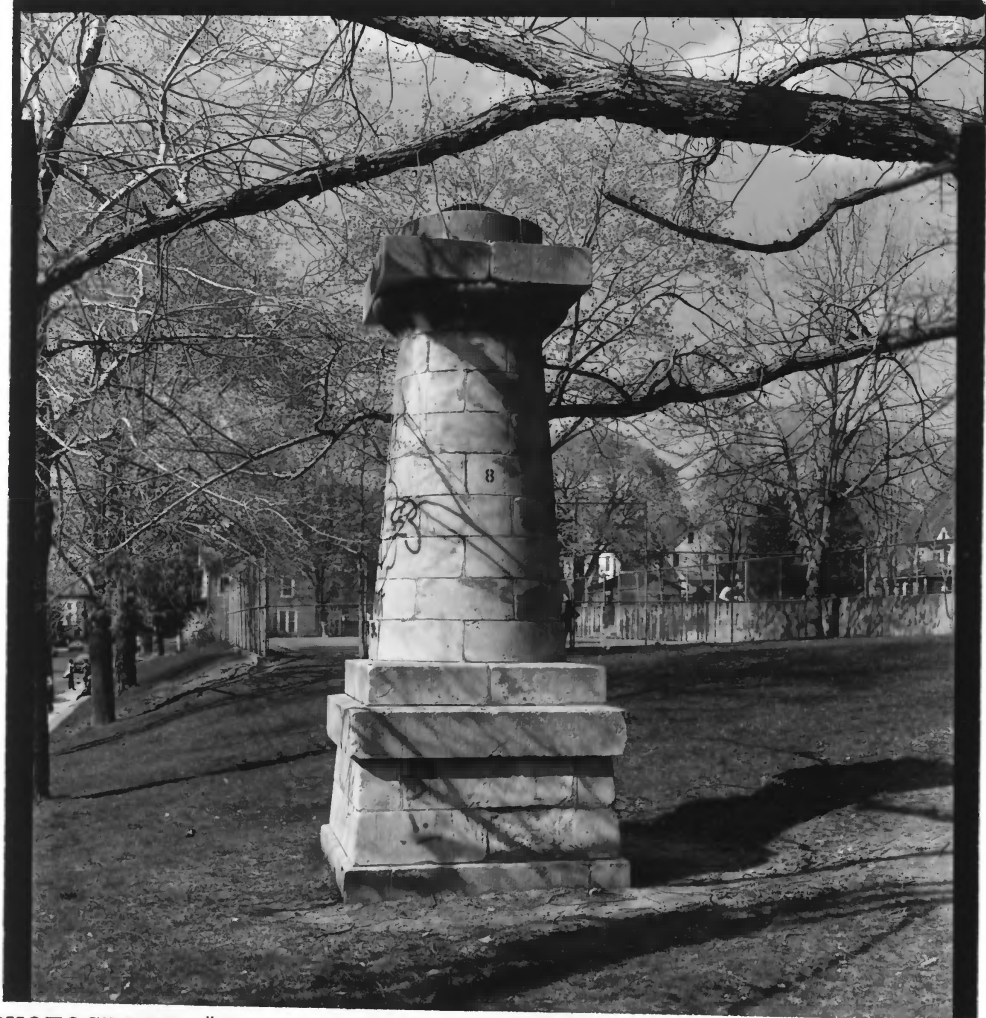
PHOTOGRAPH #5  
Croton Aqueduct  
Ossining, New York  
Ventilator Shaft No. 9 at Spring Street and Everett  
Avenue.  
Jack Boucher, 1978, HAER Photo No. NY-111-1.

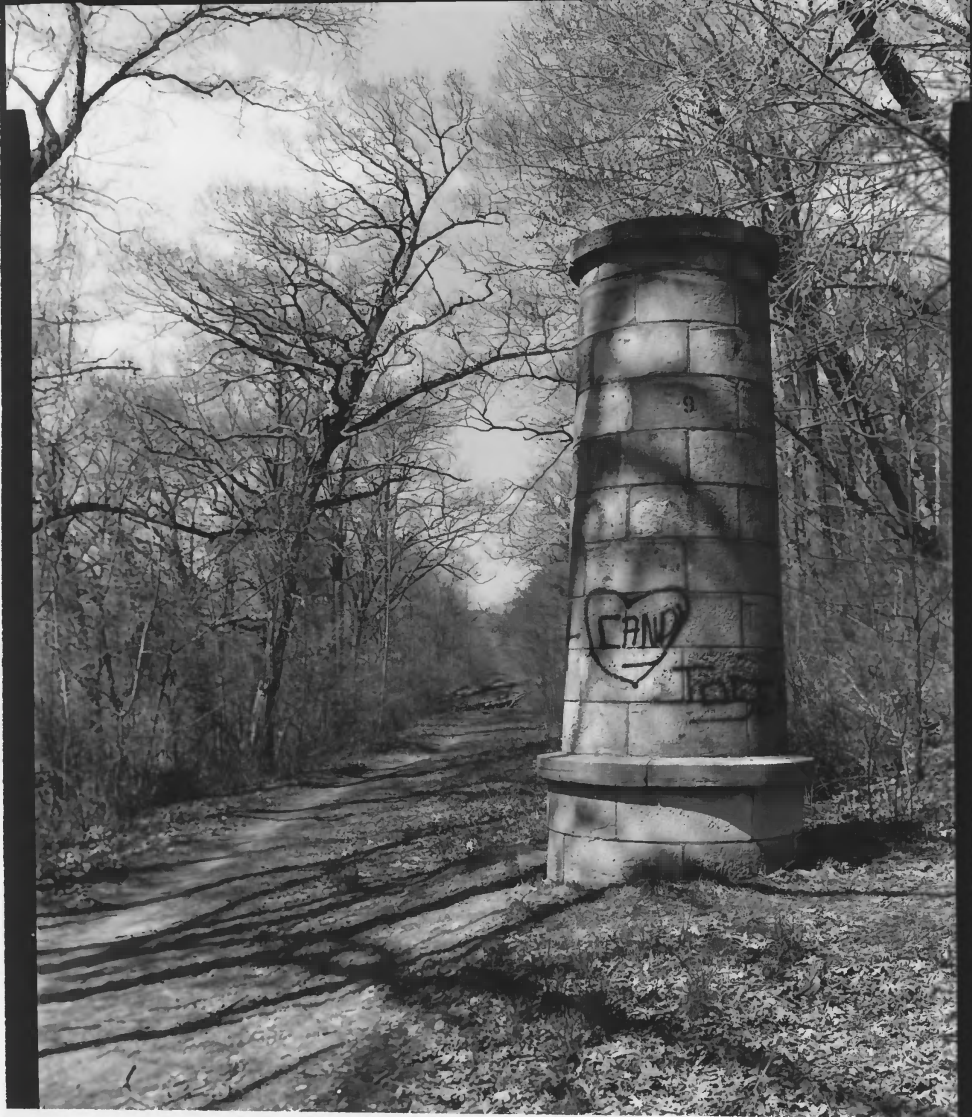
PHOTOGRAPH #6

Ventilator Shaft No. 10, north of Scarborough Road.

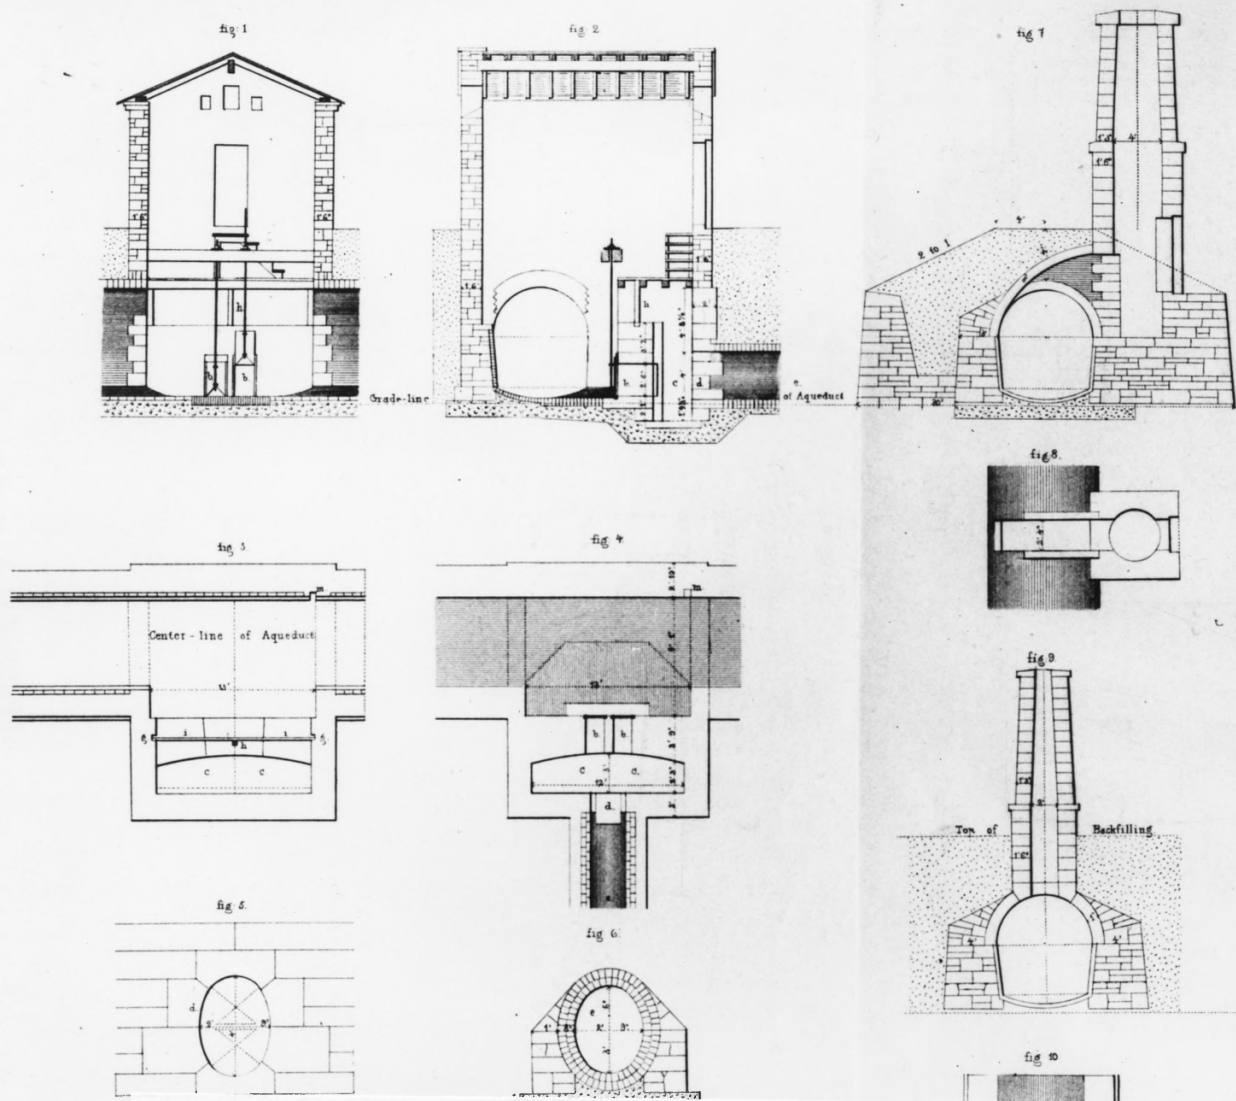
PHOTOGRAPH #7

Westchester, Bronx & New York Counties, New York  
 Sections showing typical construction of the Aqueduct's  
 waste weirs and ventilator shafts.

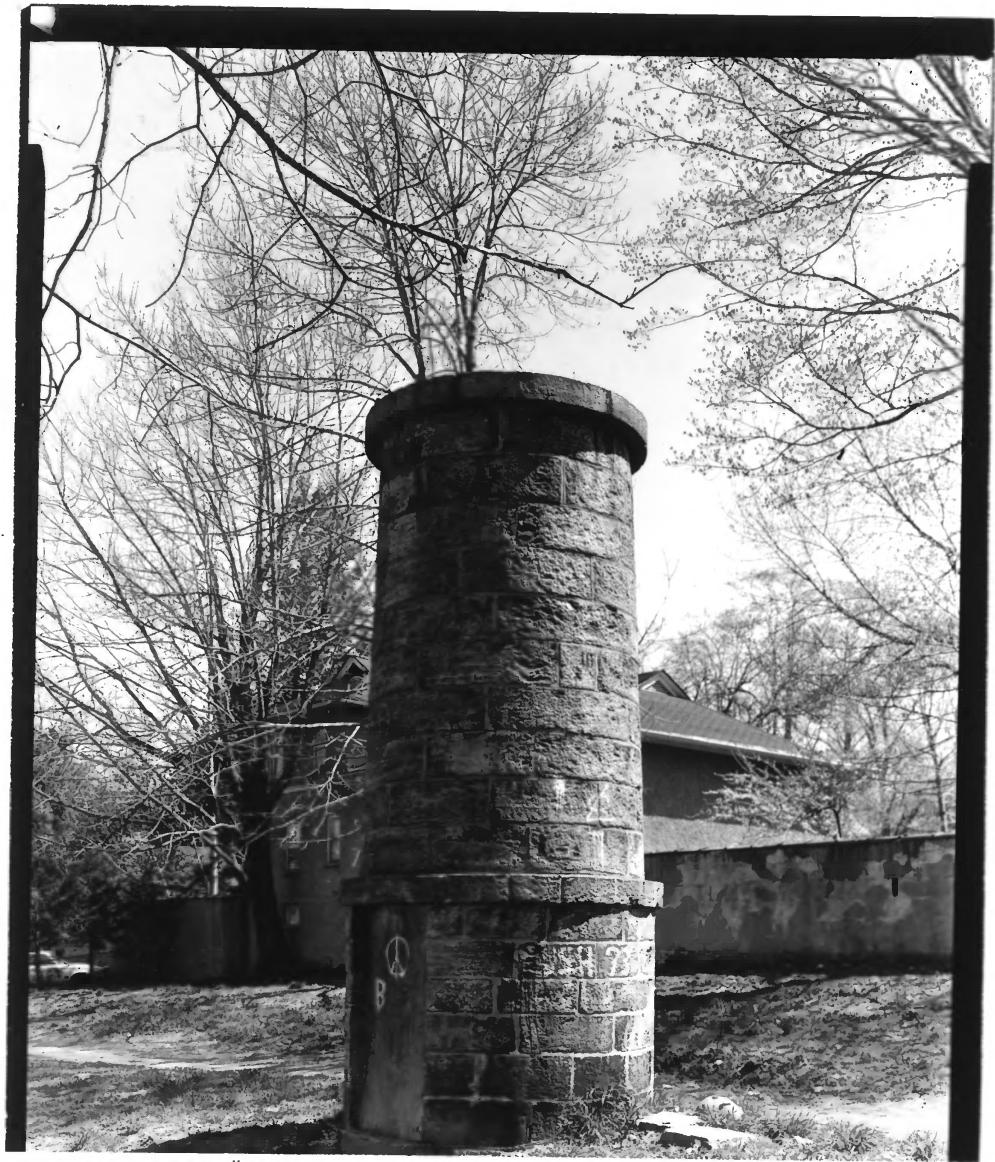
PHOTOGRAPH #8  
Croton Aqueduct  
Irvington, New York  
Ventilator Shaft No. 18 (with access door), south of  
Main Street.  
Jack Boucher, 1978, HAER Photo No. NY-208-1.

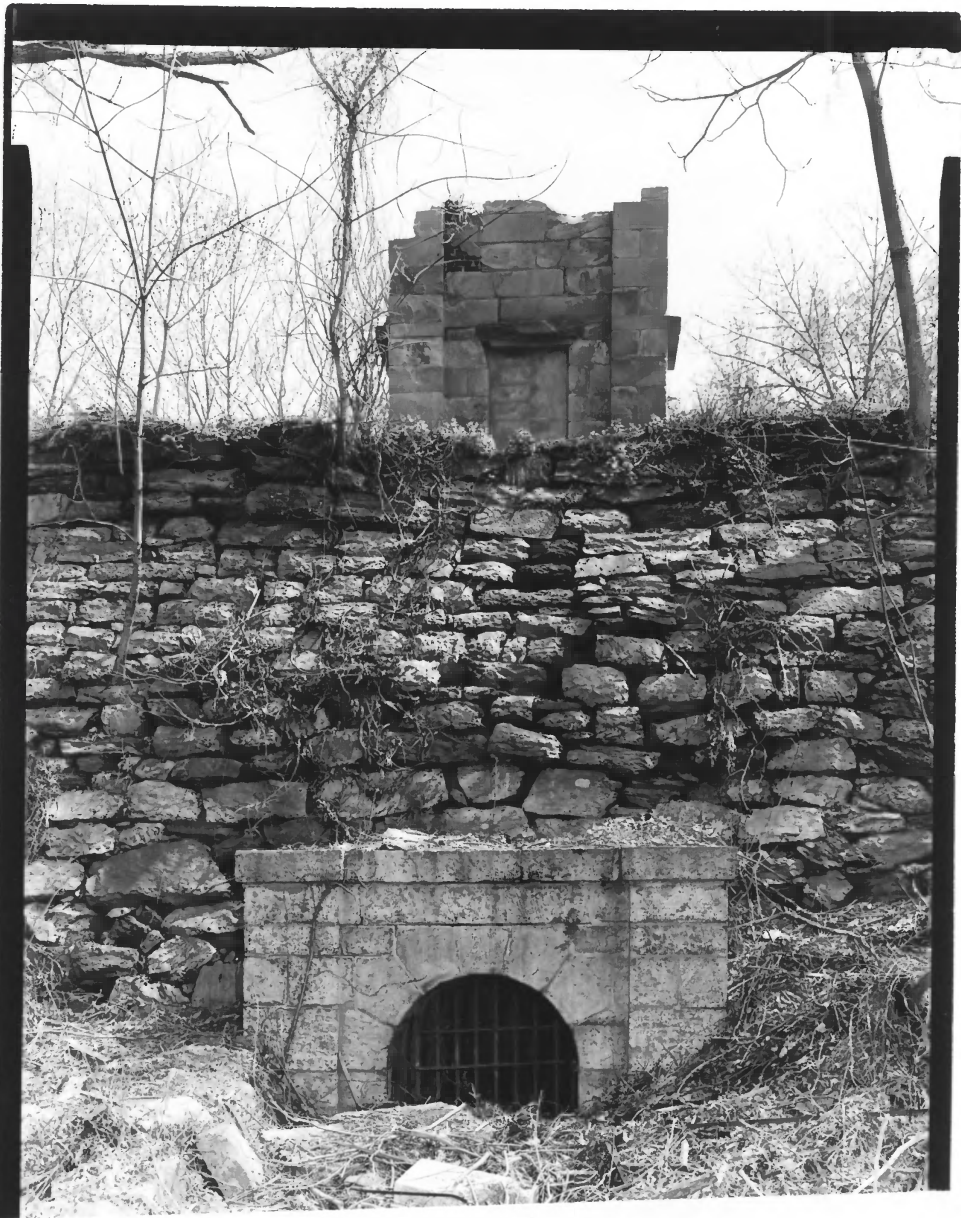
PHOTOGRAPH #9  
Croton Aqueduct  
Ossining, New York  
Western elevation of the waste weir atop the Aqueduct  
and its discharge conduit at Snowden Avenue and Van  
Wyck Street in Ossining.  
Jack Boucher, 1978, HAER Photo No. NY-109-4.

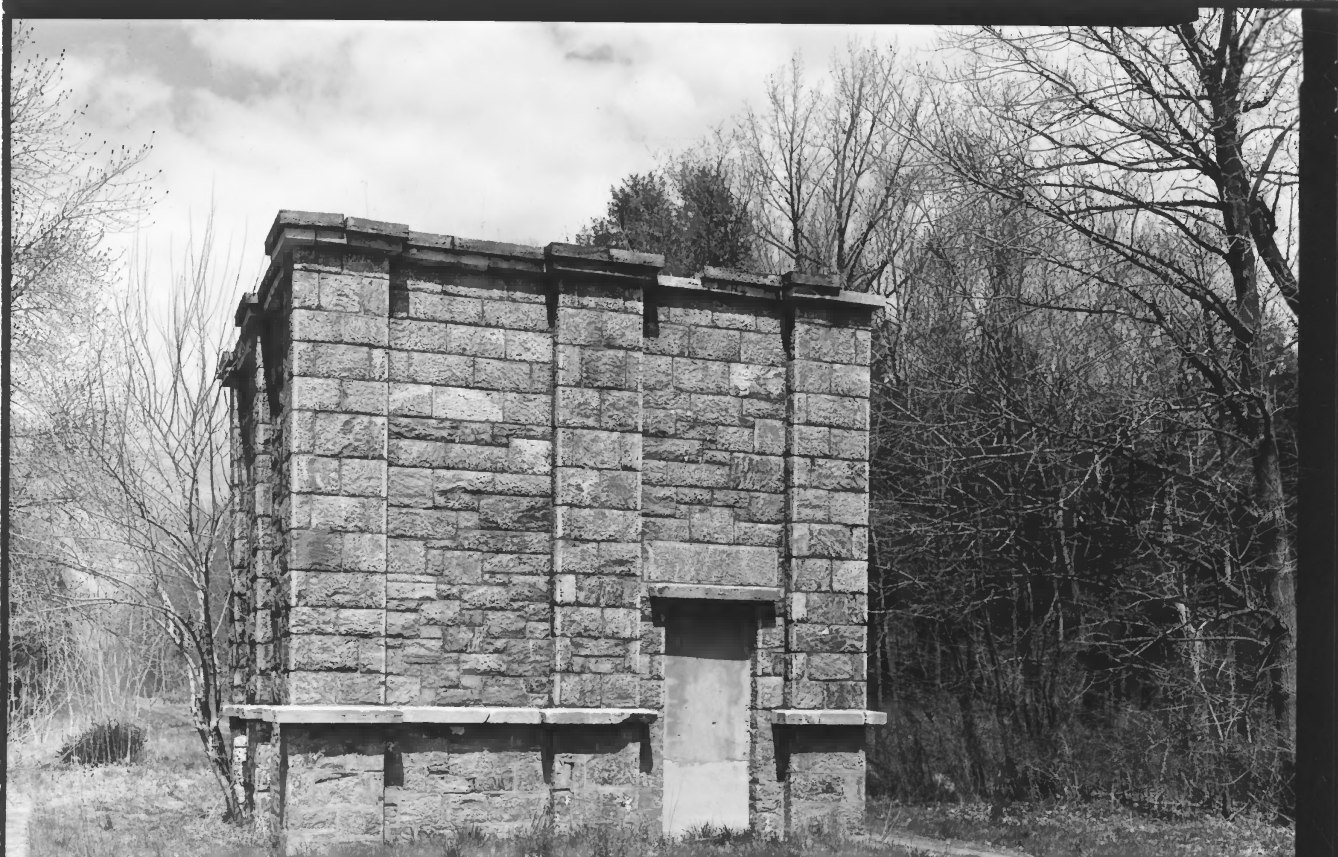
PHOTOGRAPH #10

Mill River waste weir atop Aqueduct near US Route 9 at  
Sleepy Hollow Cemetery.

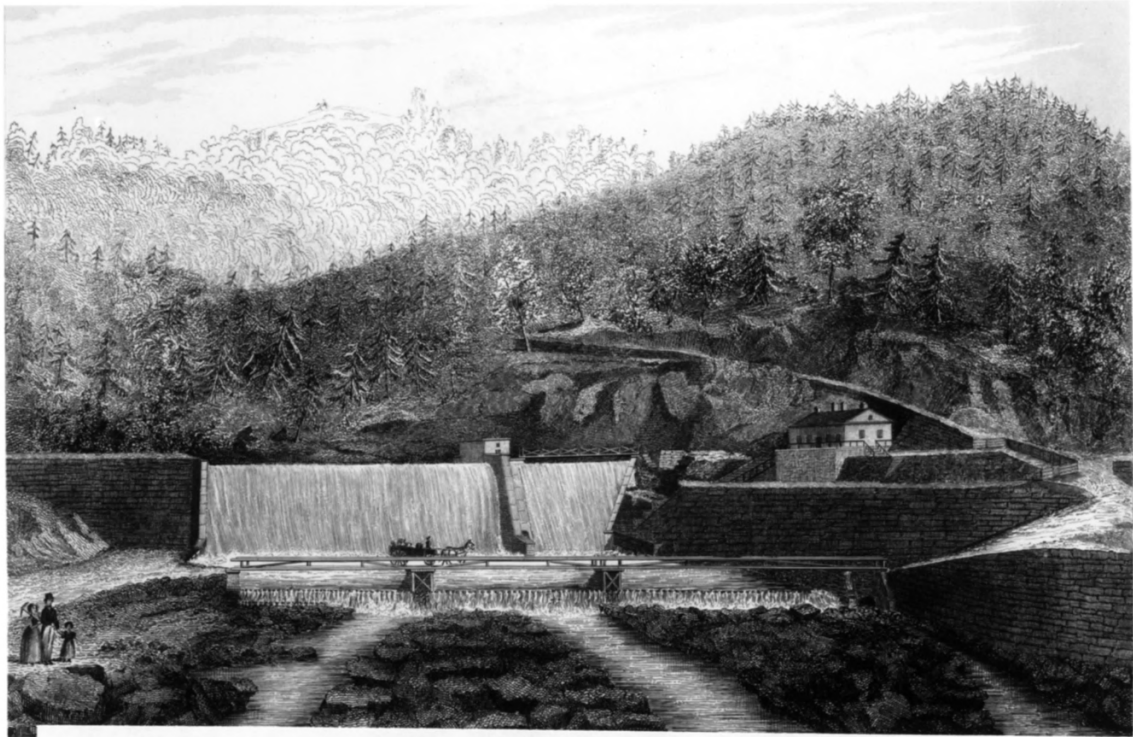
PHOTOGRAPH #11

Engraving of the (now submerged) Croton dam and gatehouse.

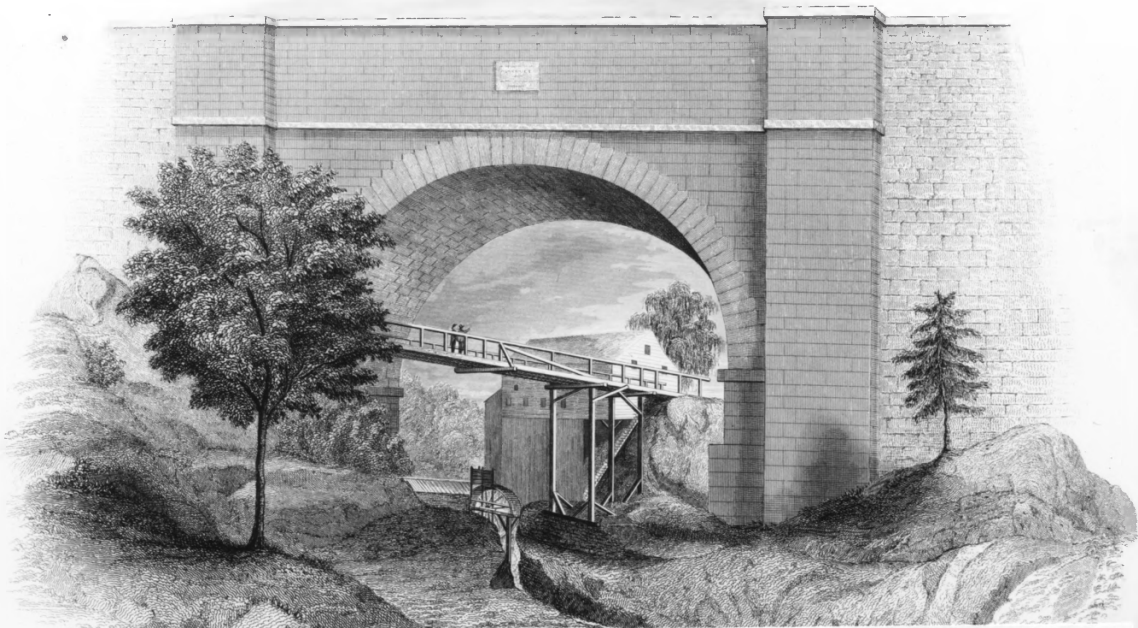
PHOTOGRAPH #14

Engraving of Sing-Sing Kill Bridge, showing the existing bridges the Aqueduct was required to cross.

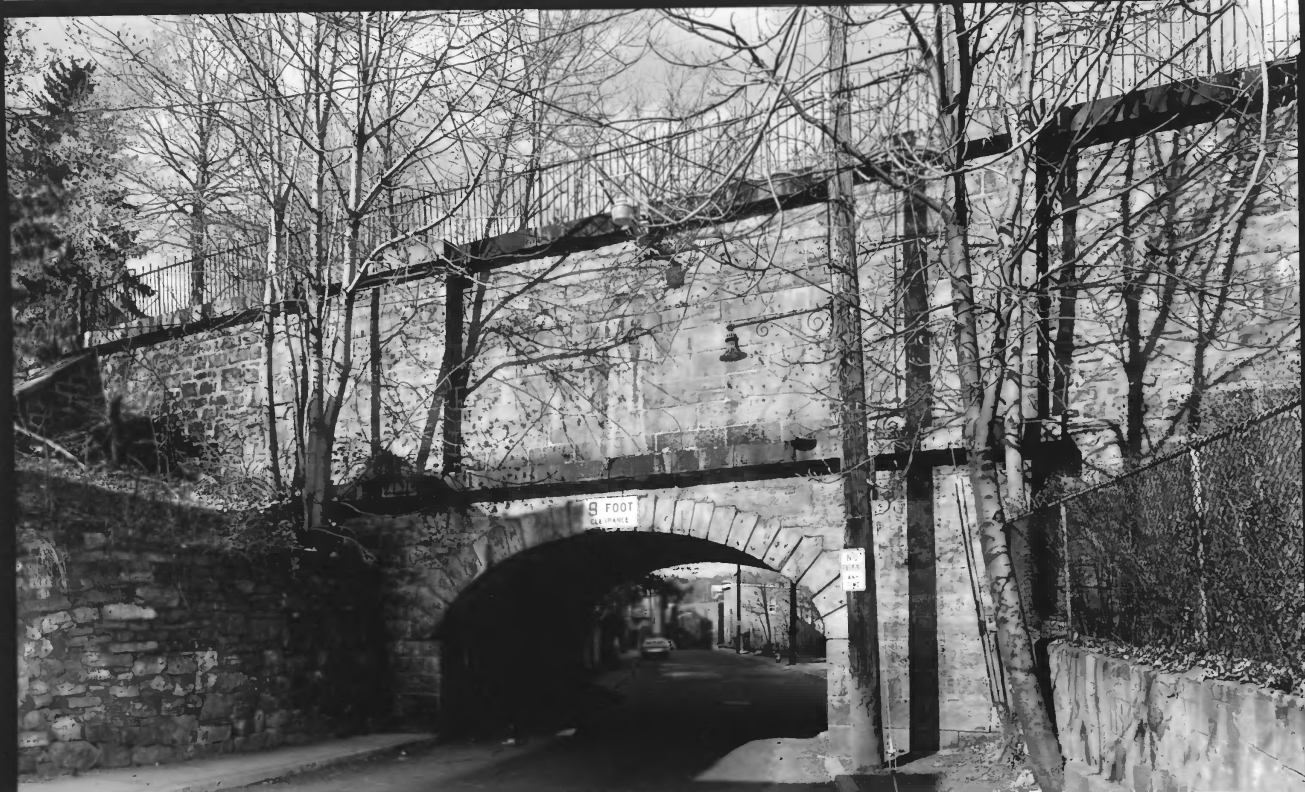
PHOTOGRAPH #15  
Croton Aqueduct

Sing-Sing Kill Bridge, showing the roadway arch located  
at the northeastern end of the structure.

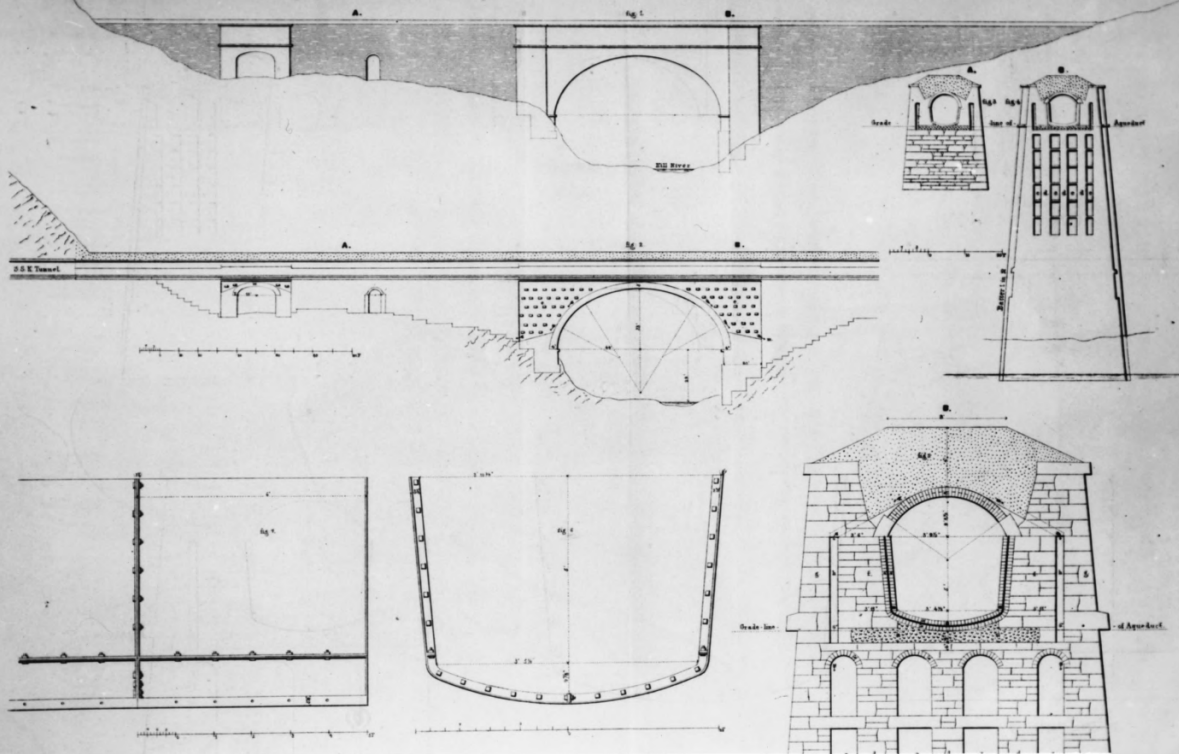
PHOTOGRAPH #16

Sections of Sing-Sing Kill Bridge showing iron lining and hollow space internal construction.

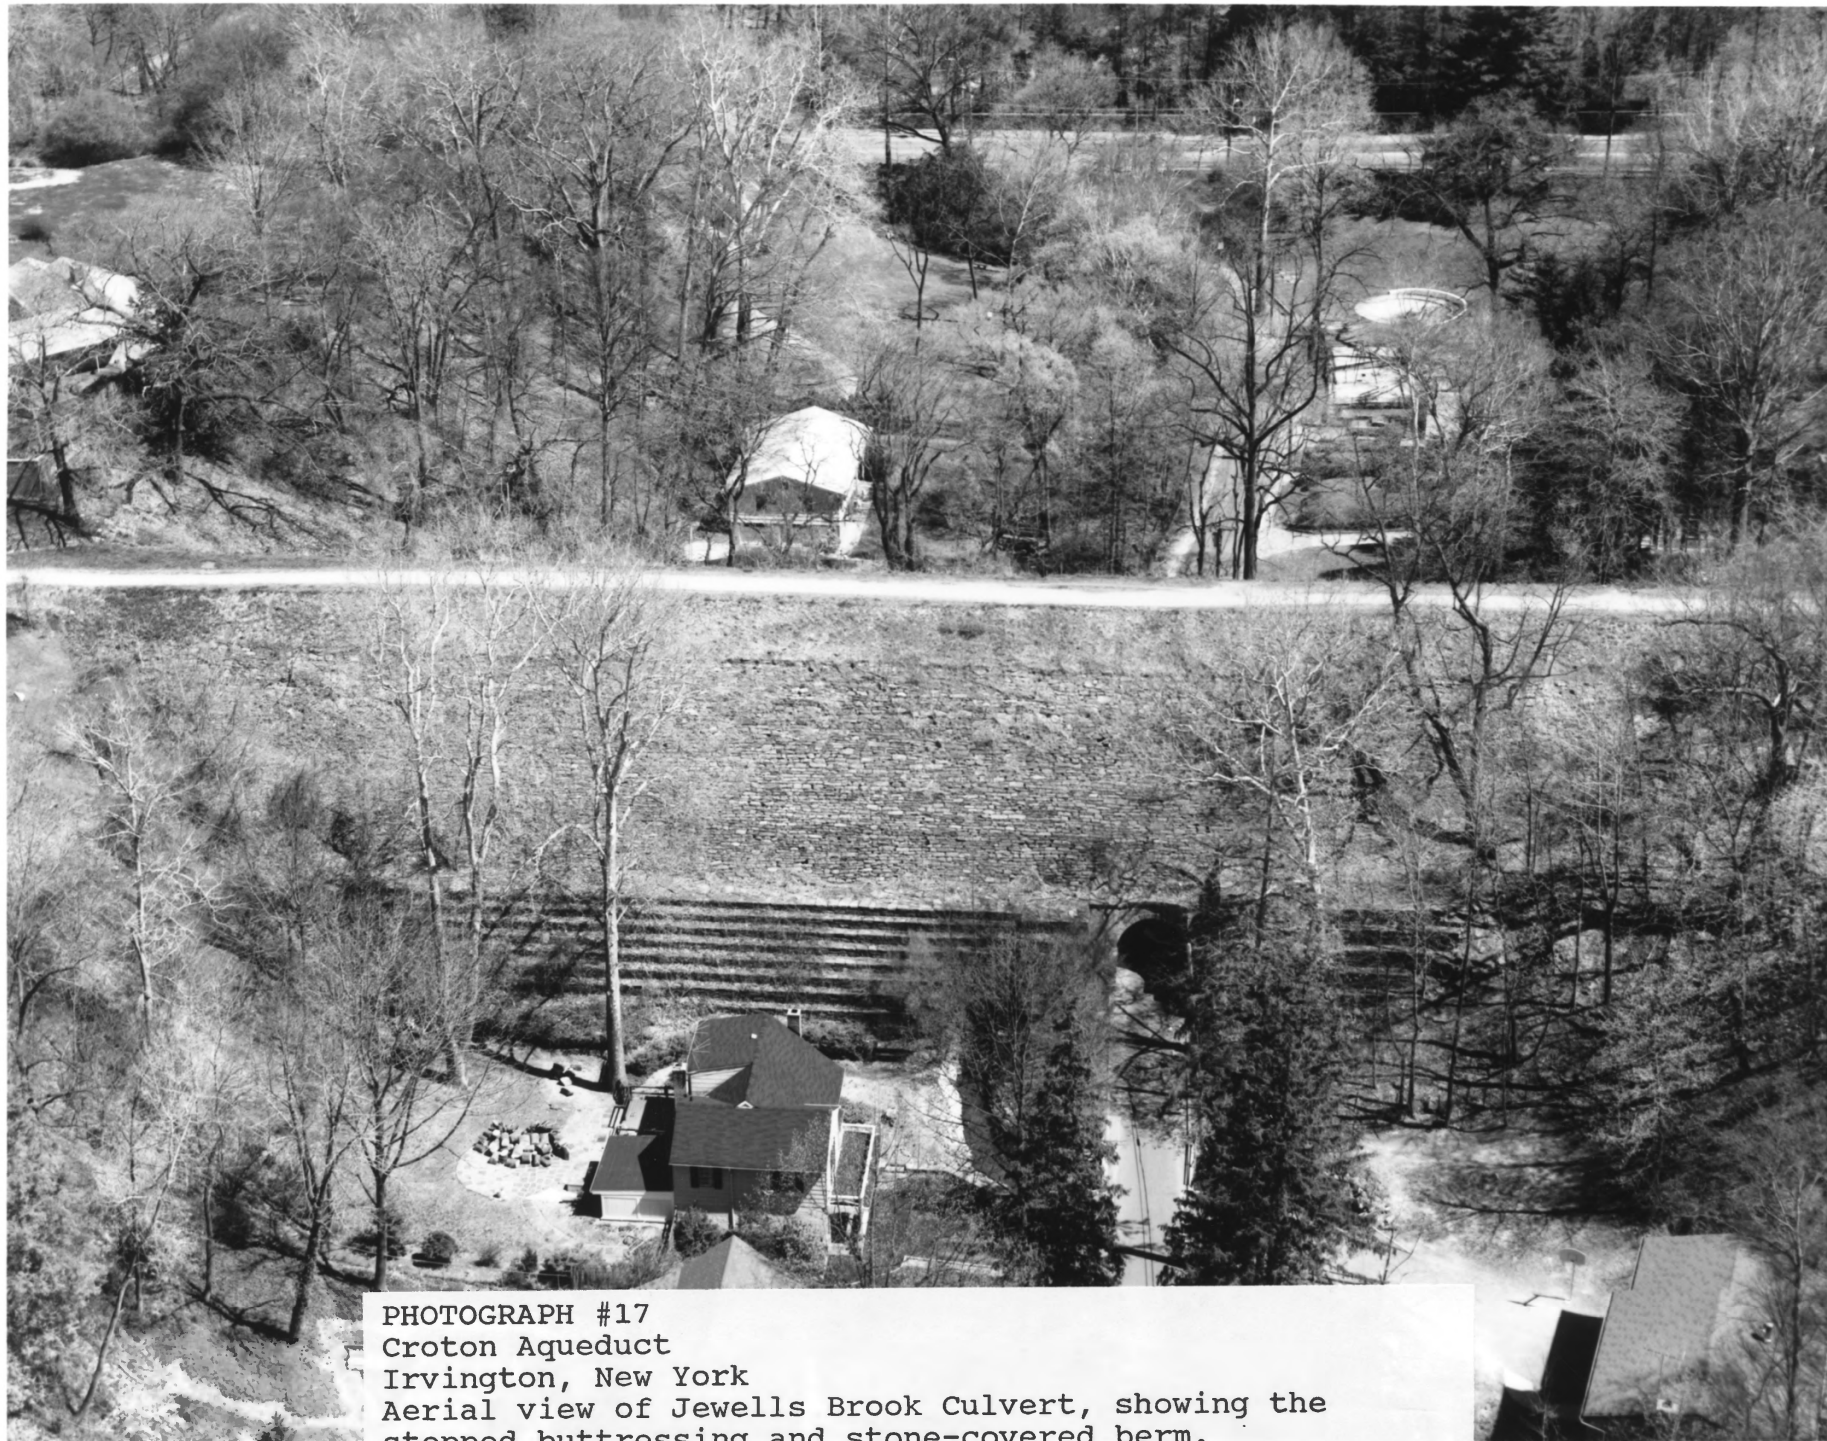
PHOTOGRAPH #17  
Croton Aqueduct  
Irvington, New York  
Aerial view of Jewells Brook Culvert, showing the  
stepped buttressing and stone-covered berm.  
Jack Boucher, 1978.

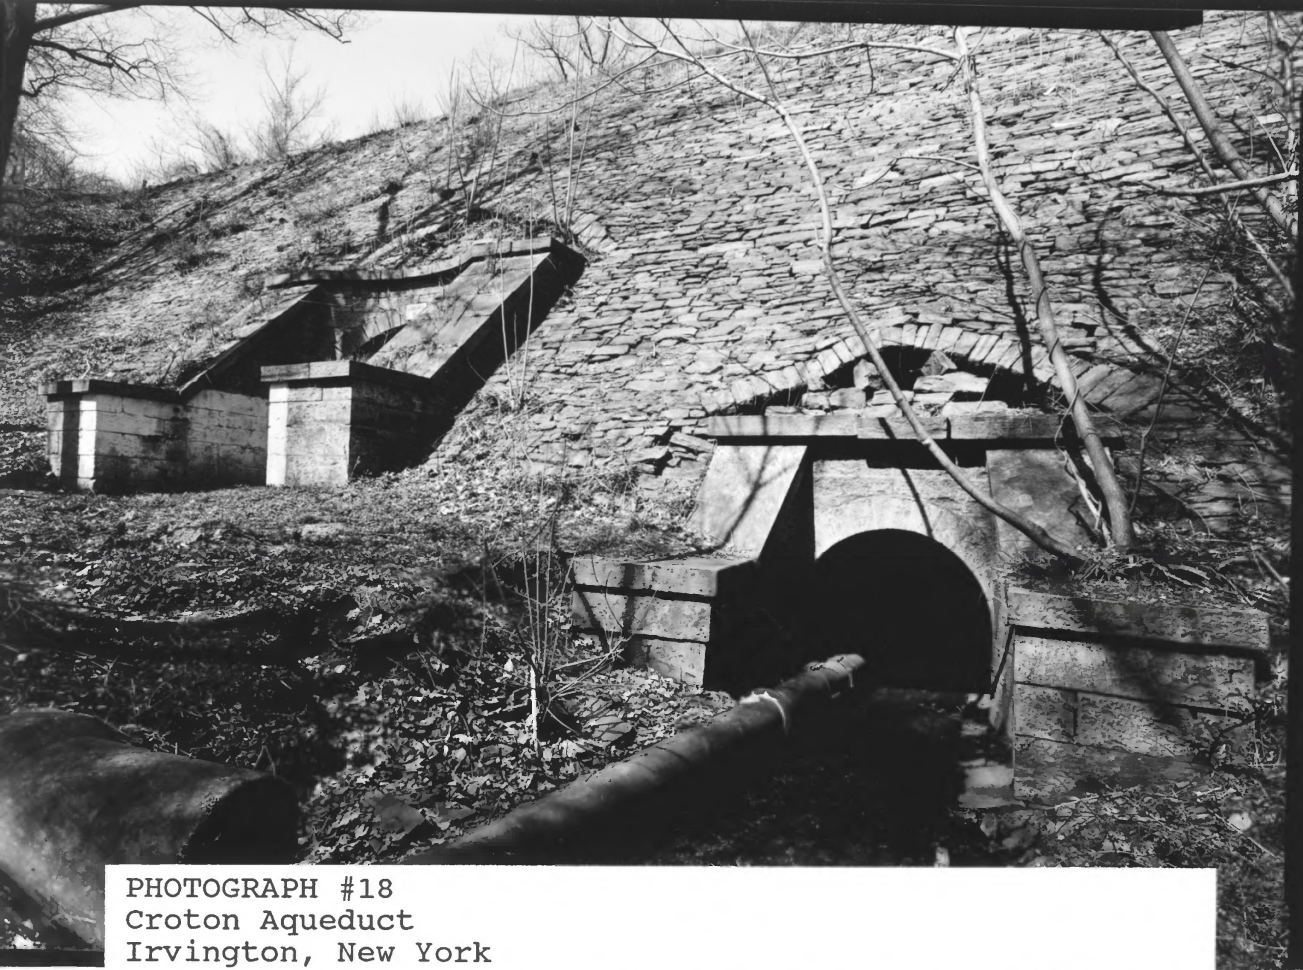
PHOTOGRAPH #18  
Croton Aqueduct

Jewells Brook Culvert, showing the stone-covered berm  
and the Station Road and Jewells Brook culvert arches.  
Jack Boucher, 1978, HAER Photo No. NY-114-6.

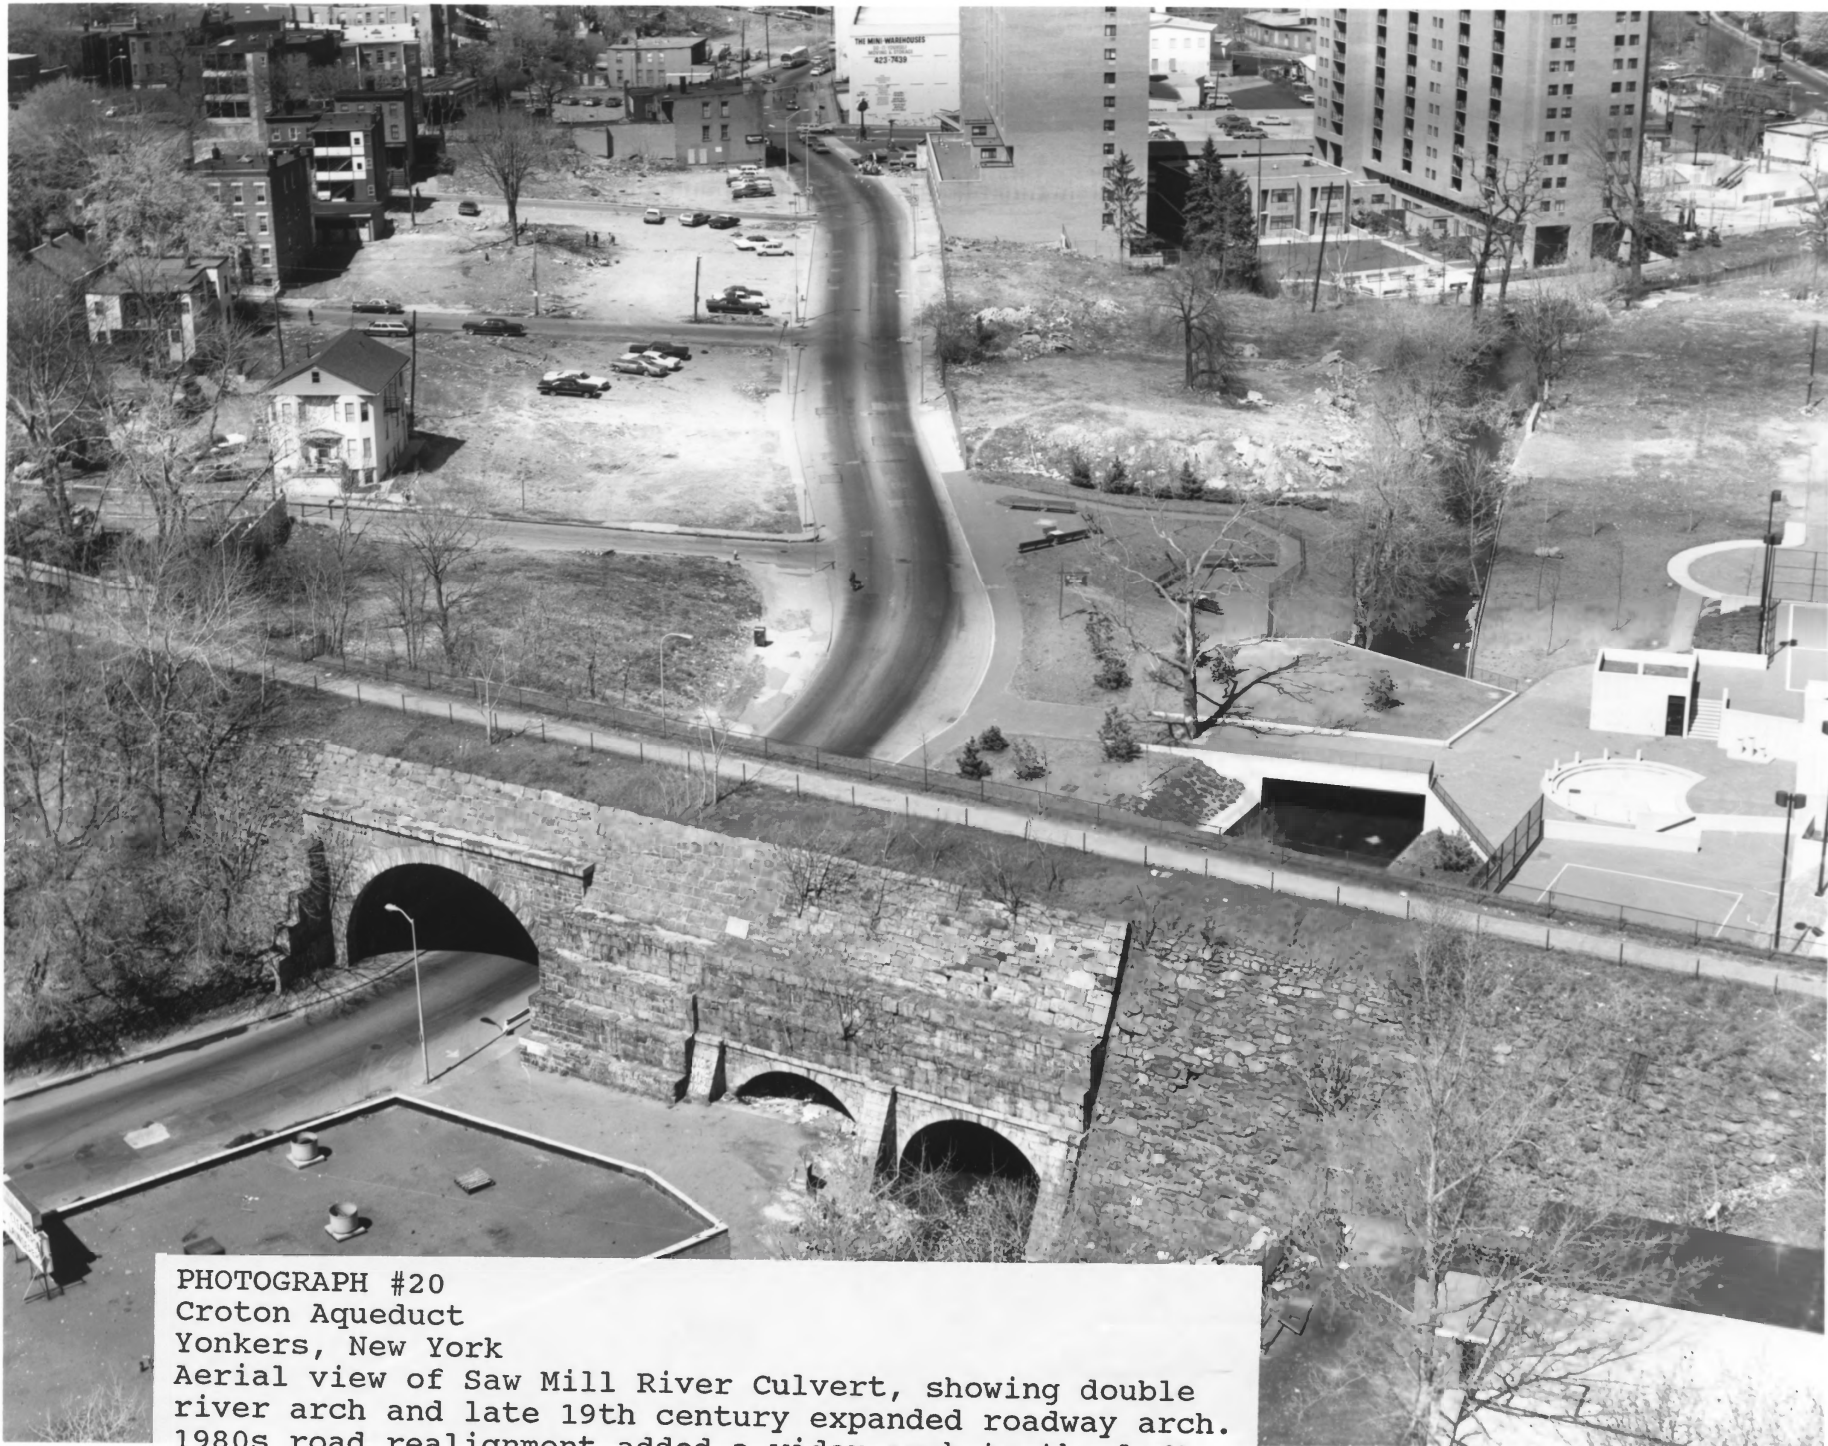
PHOTOGRAPH #20  
Croton Aqueduct  
Yonkers, New York  
Aerial view of Saw Mill River Culvert, showing double  
river arch and late 19th century expanded roadway arch.  
1980s road realignment added a wider arch to the left.  
Jack Boucher, 1978.

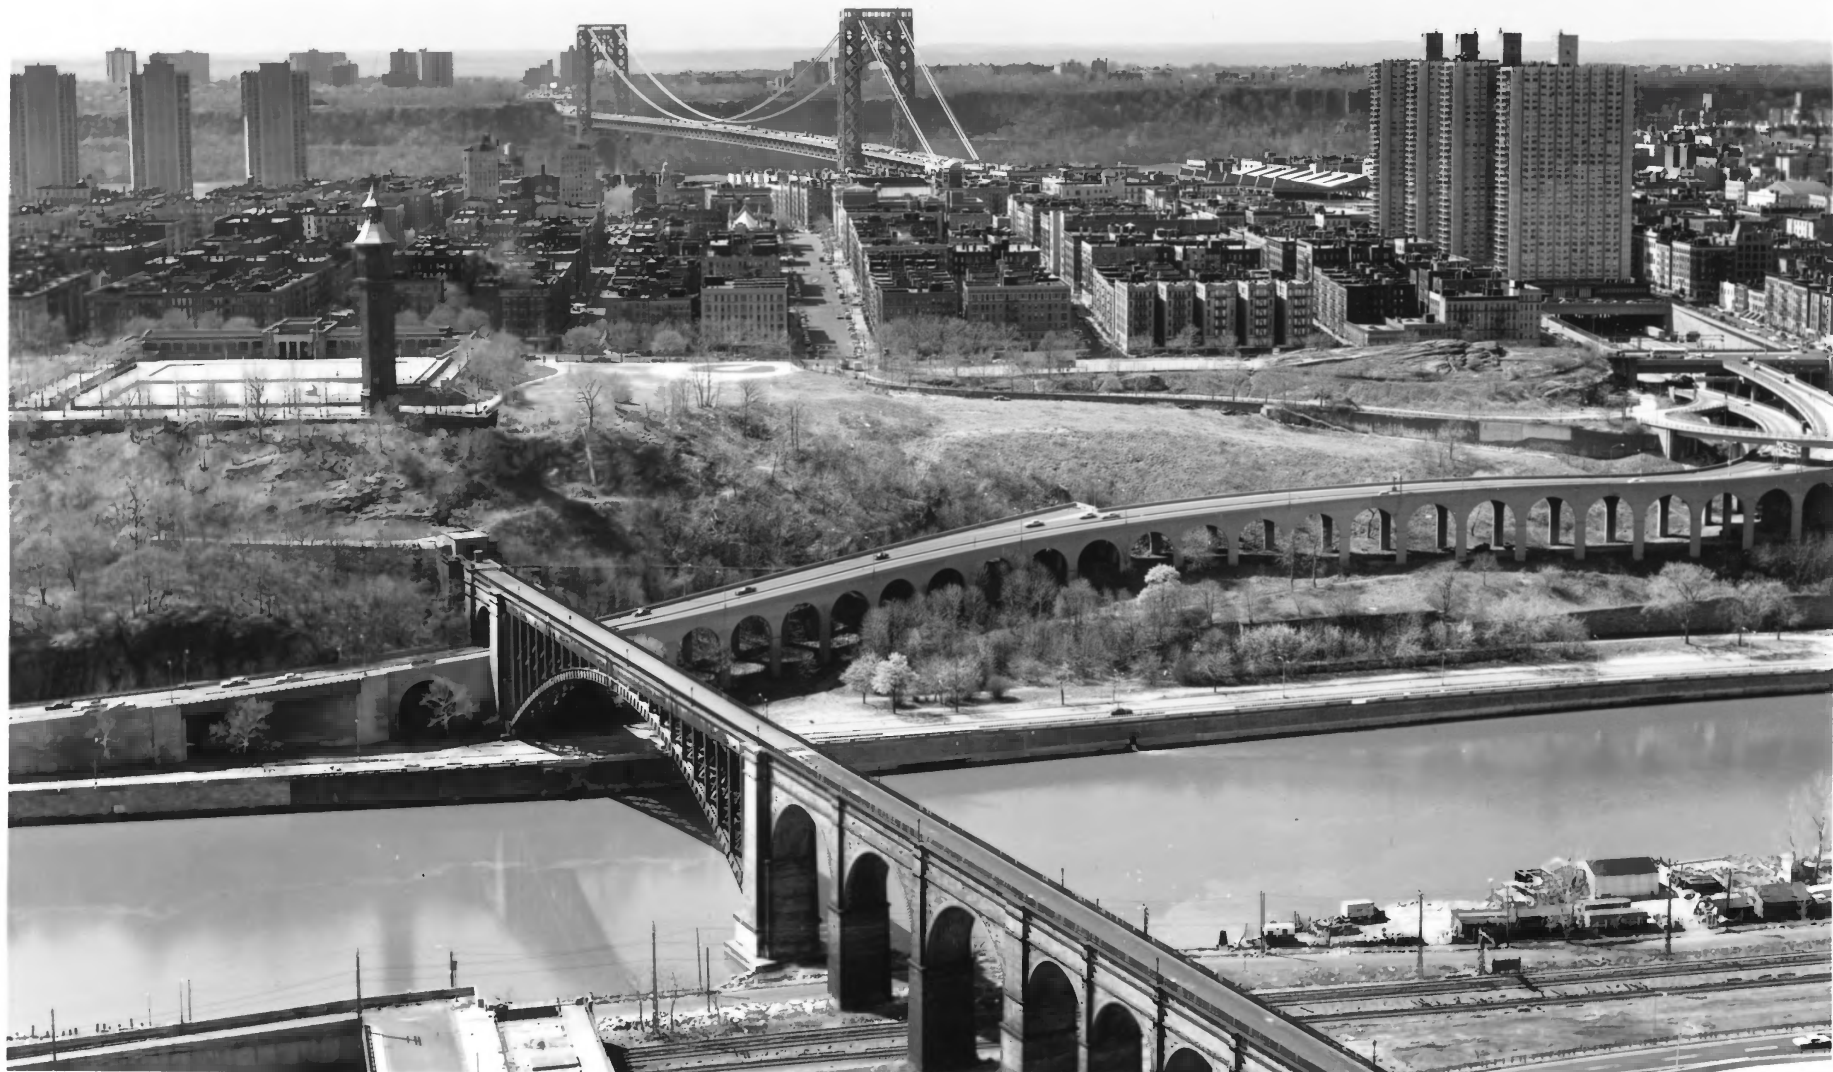
PHOTOGRAPH #21

Aerial view of the Aqueduct's High Bridge crossing the Harlem River from the Bronx (foreground) to Manhattan.

Note High Bridge Water Tower left of center.
