Name: The Richards Mansion  
*Sussex Co.*  
Location: Georgetown, Delaware  
Dick Carter  
Photographer:  
Date: September, 1978  
Location of Negative: Hall of Records, Dover, DE  
Description: Front of house facing The Circle

Photograph Number: One of 13

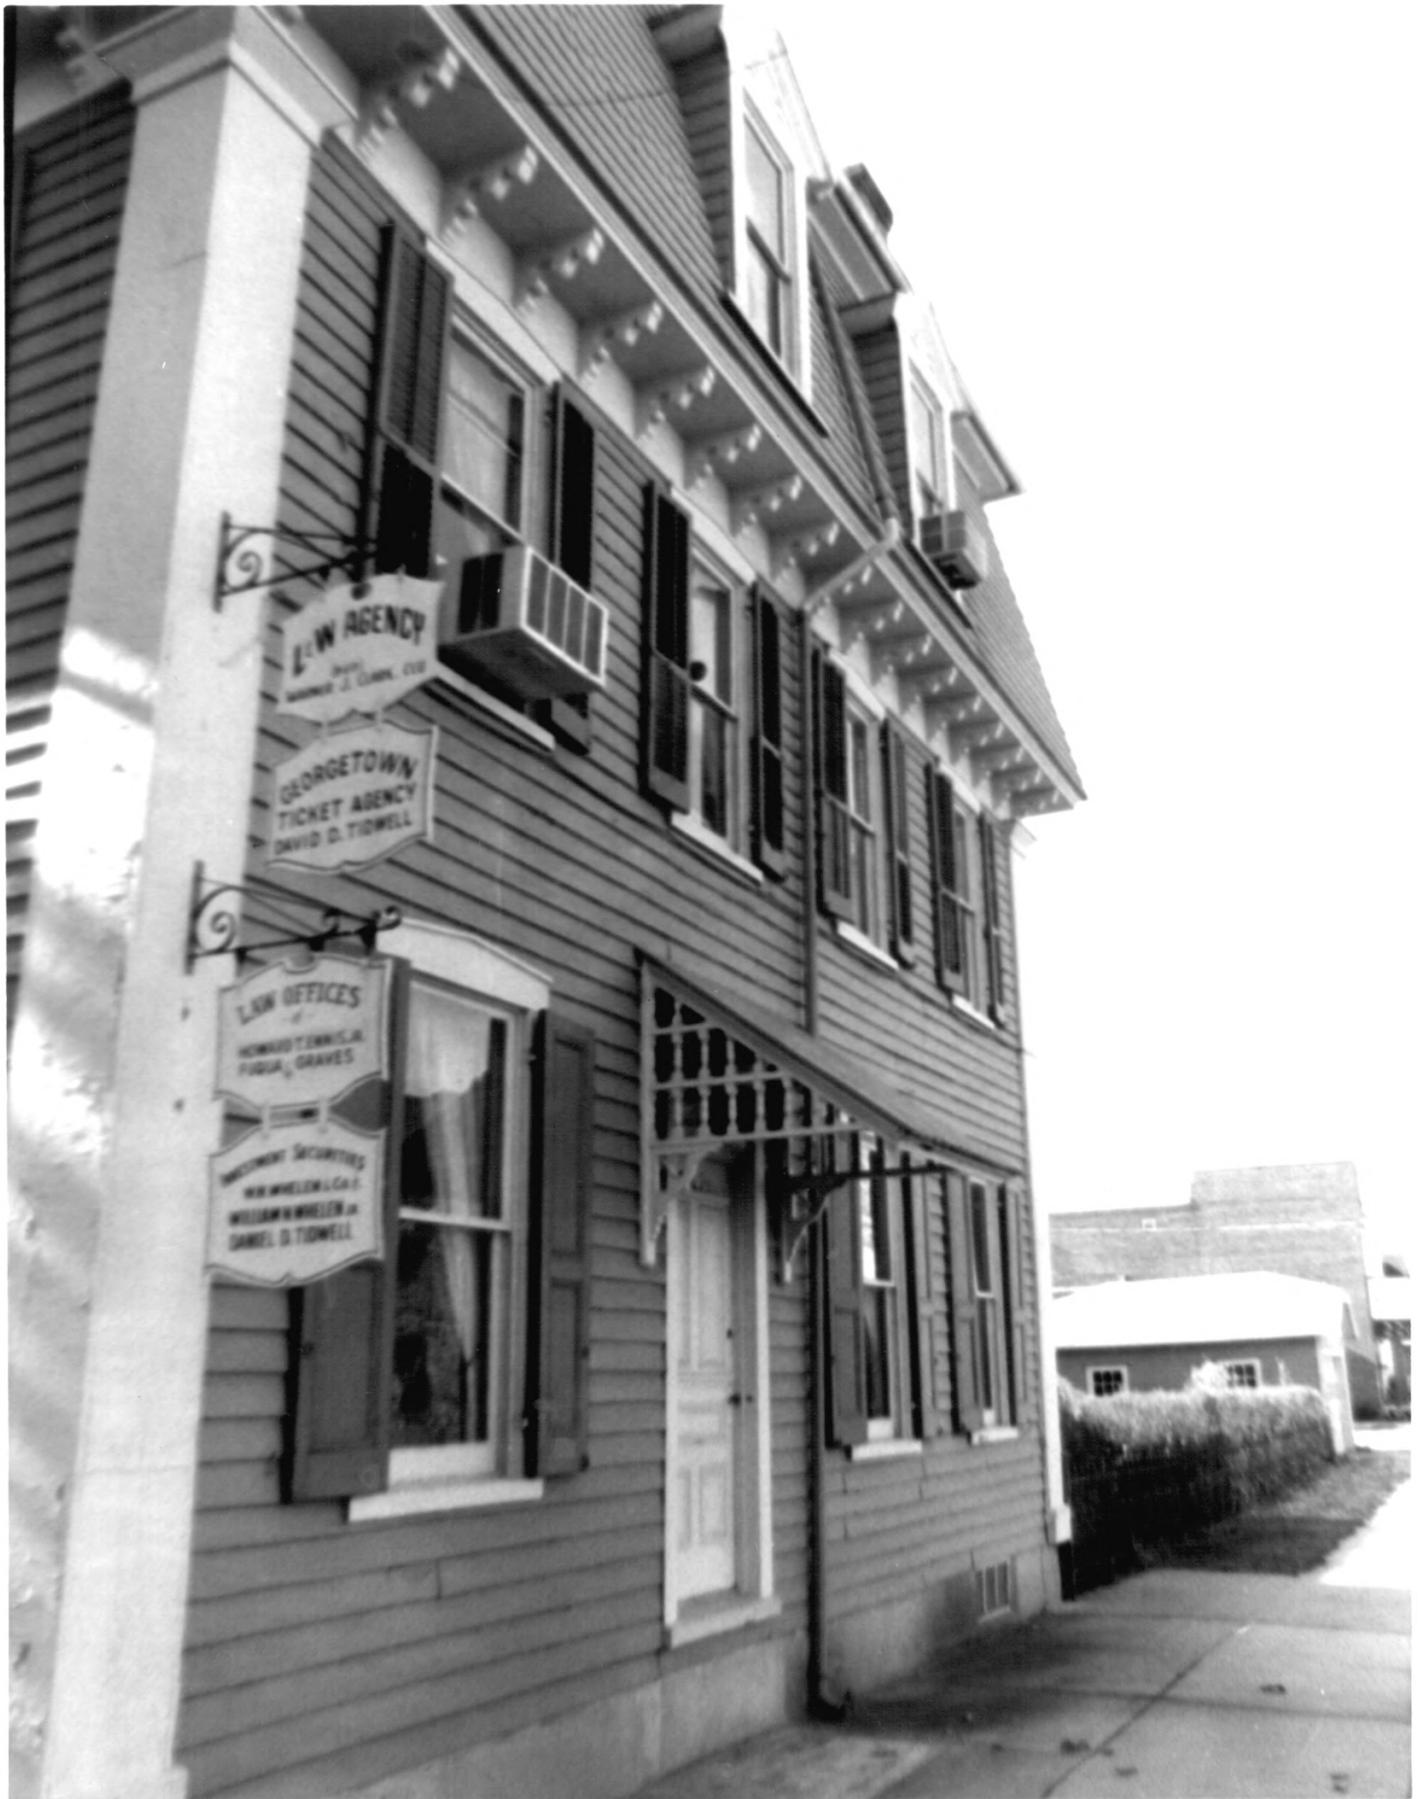
Photograph Number: Two of 13

Name: The Richards Mansion (S-132)  
*Sussex Co.*  
Location: The Circle and N. Bedford St.; Georgetown,  
Del.  
Photographer: Dick Carter  
Date: Sept, 1978  
Location of Negative: Hall of Records, Dover, DE  
Description: Side of front section of house facing  
North Bedford Street

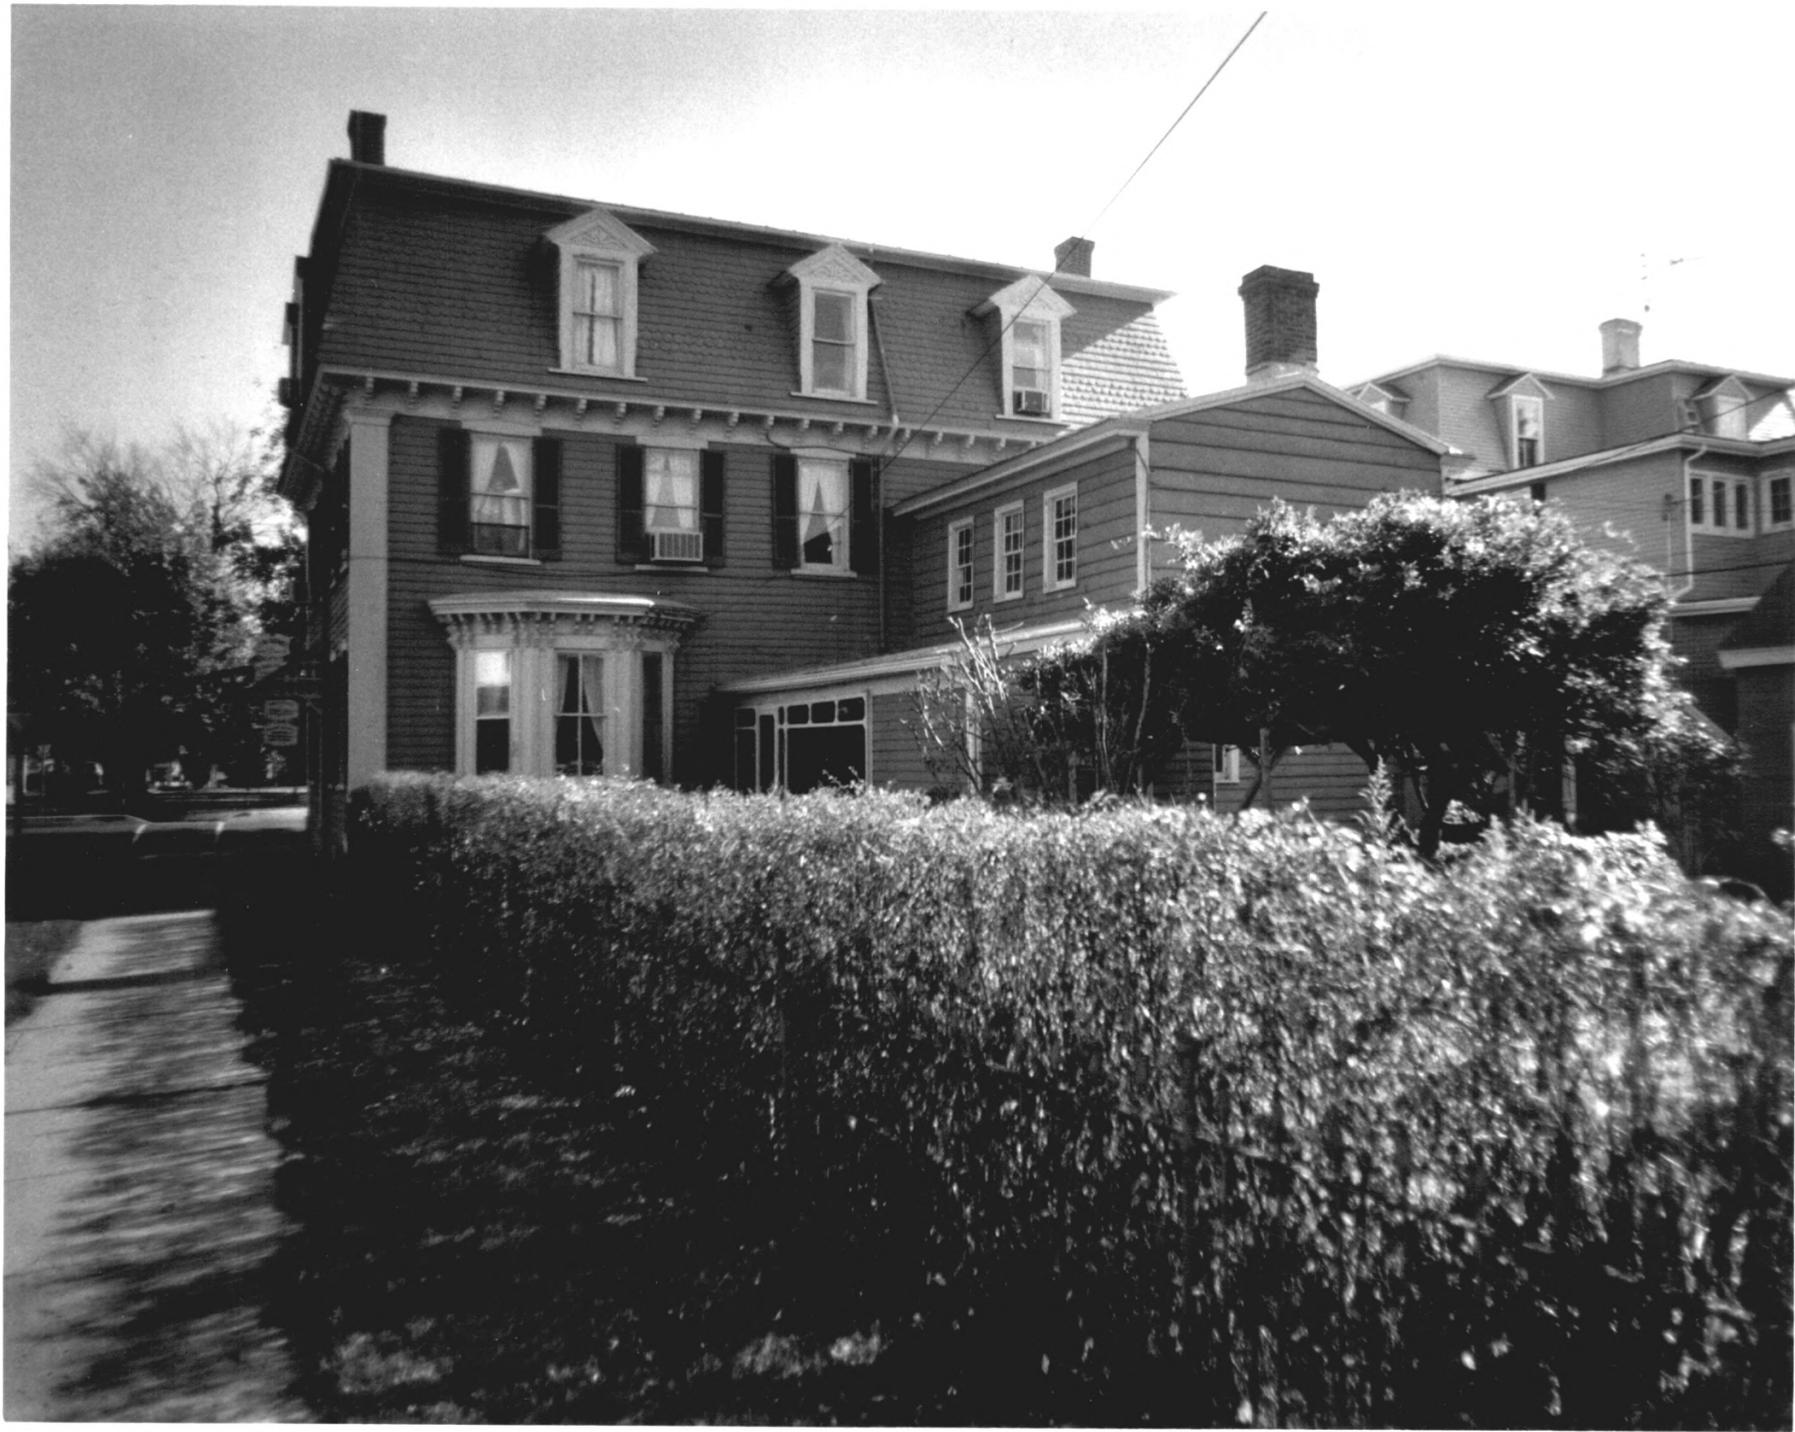
Three of 13

Description: Rear of house on N. Bedford St. side showing  
Greek Revival front section with later Victorian add-  
itions, and remaining portion of 1790's house at rear  
with lowered roof and 19th century porch addition.

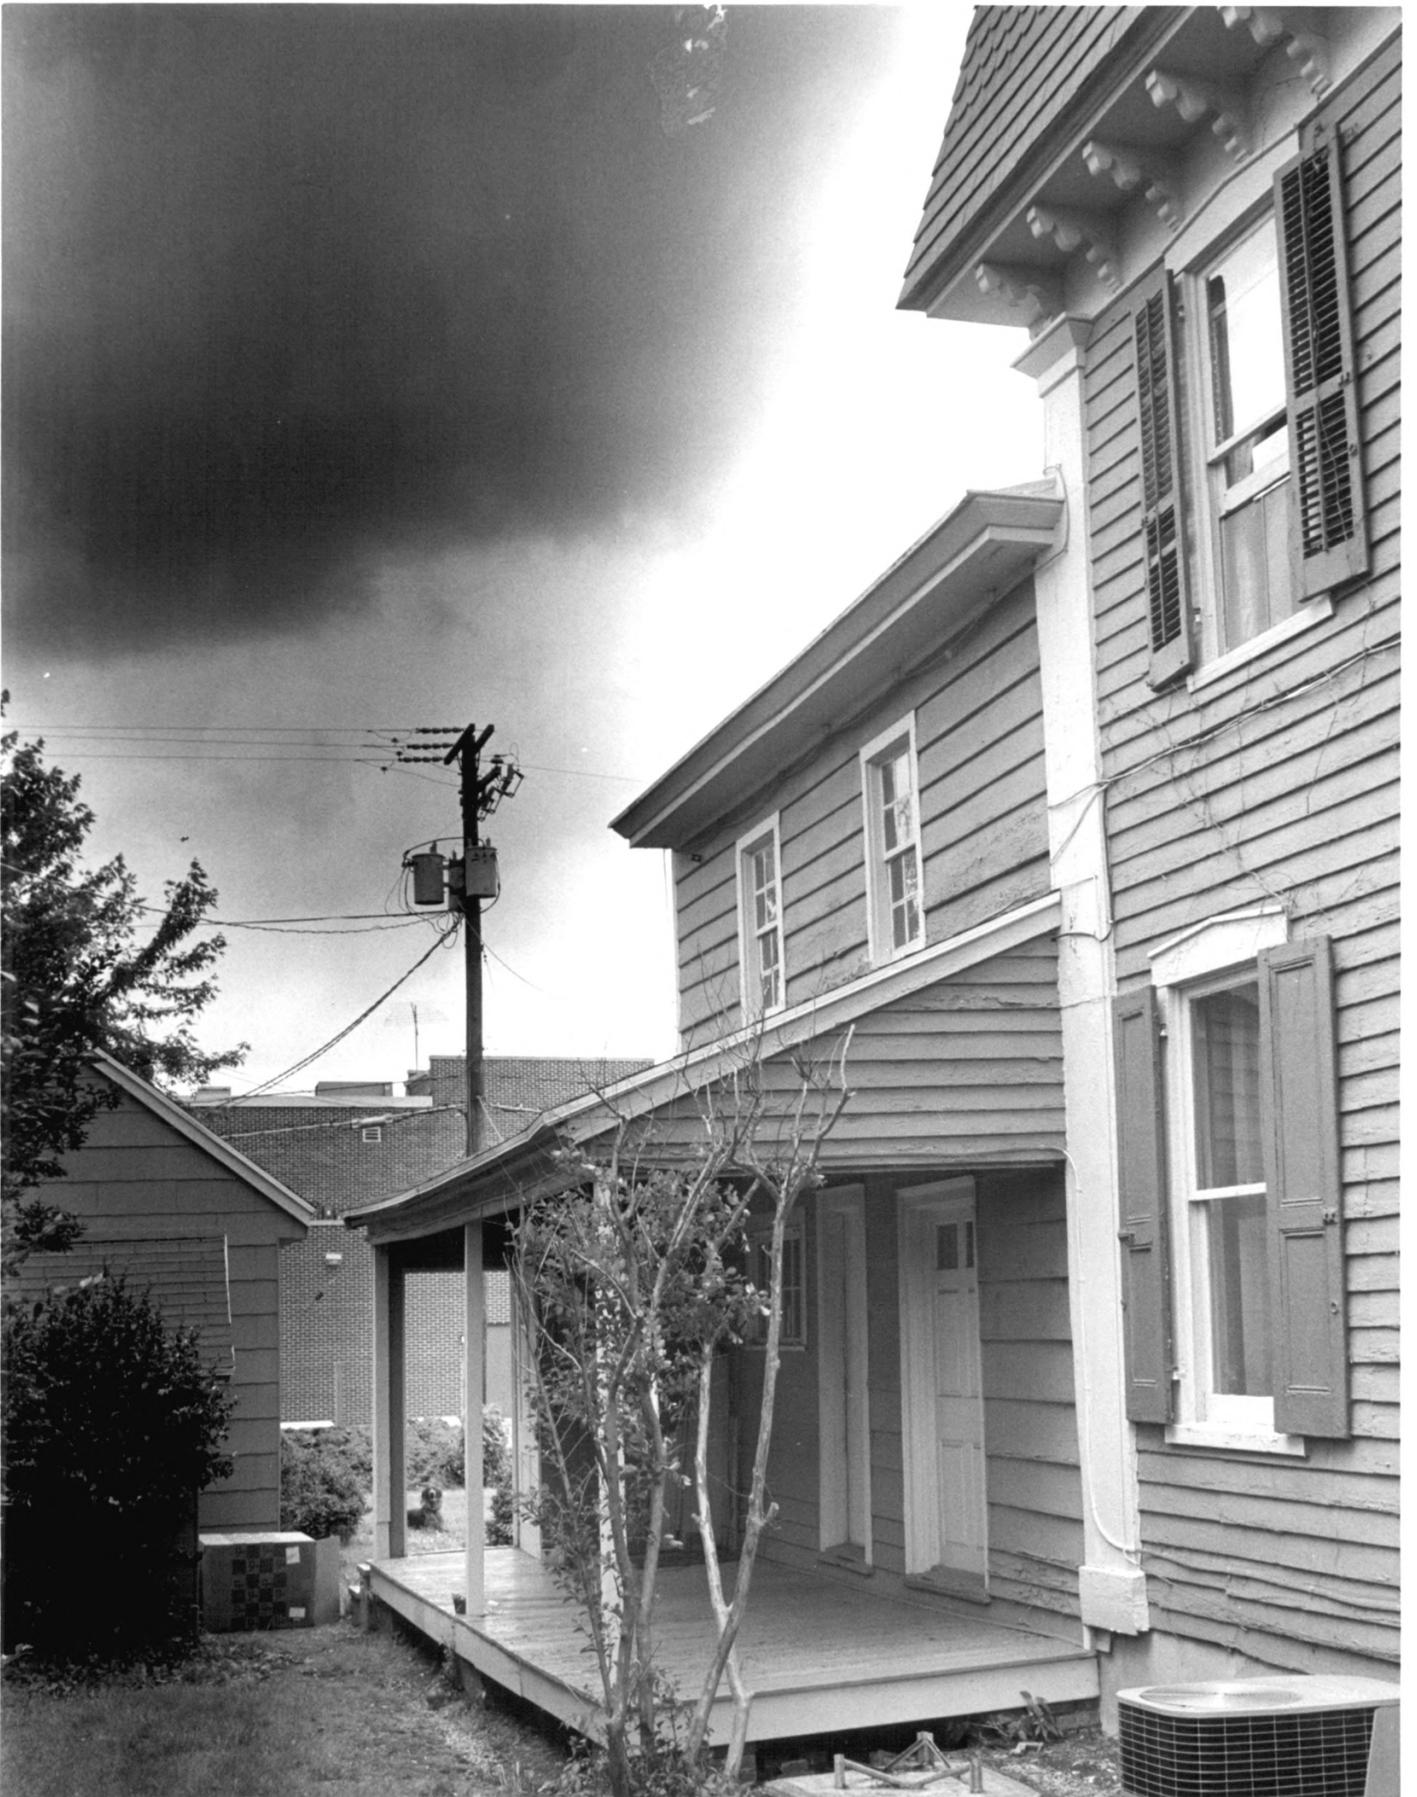
Photograph Number: Four of 13

Name: The Richards Mansion (S-132)  
Location: The Circle and N. Bedford St., Georgetown, DE  
Photographer: Dick Carter *Sussex Co.*  
Date: Sept., 1978  
Location of Negative: Hall of Records, Dover, DE  
Description: Southwest side of rear section of the house.  
Portion of Greek Revival section is visible  
at right. Small Milk House and larger shed  
are visible at left.

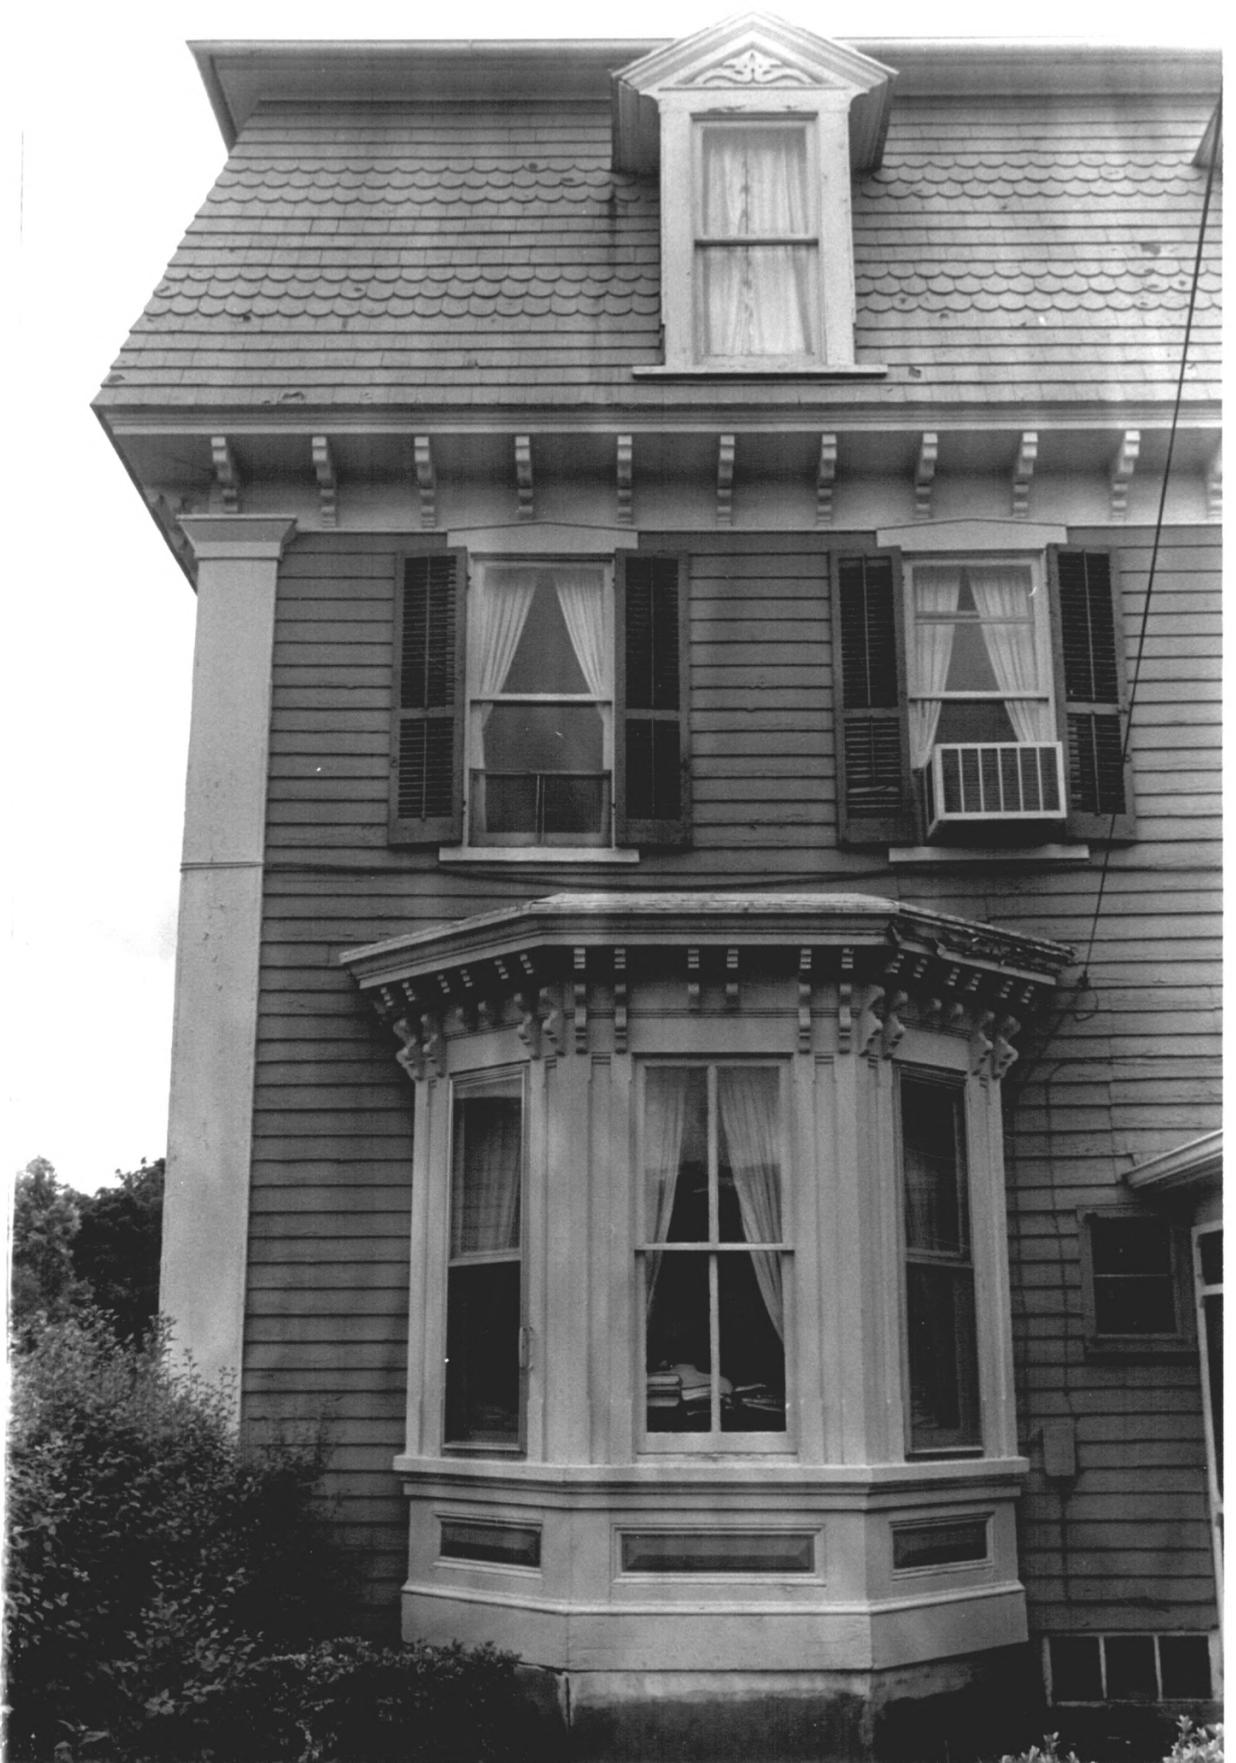
Photograph Number: Five of 13

Description: Detail of northeast corner of main section showing blending of Greek Revival and Victorian details, including modified mansard roof and bay window.

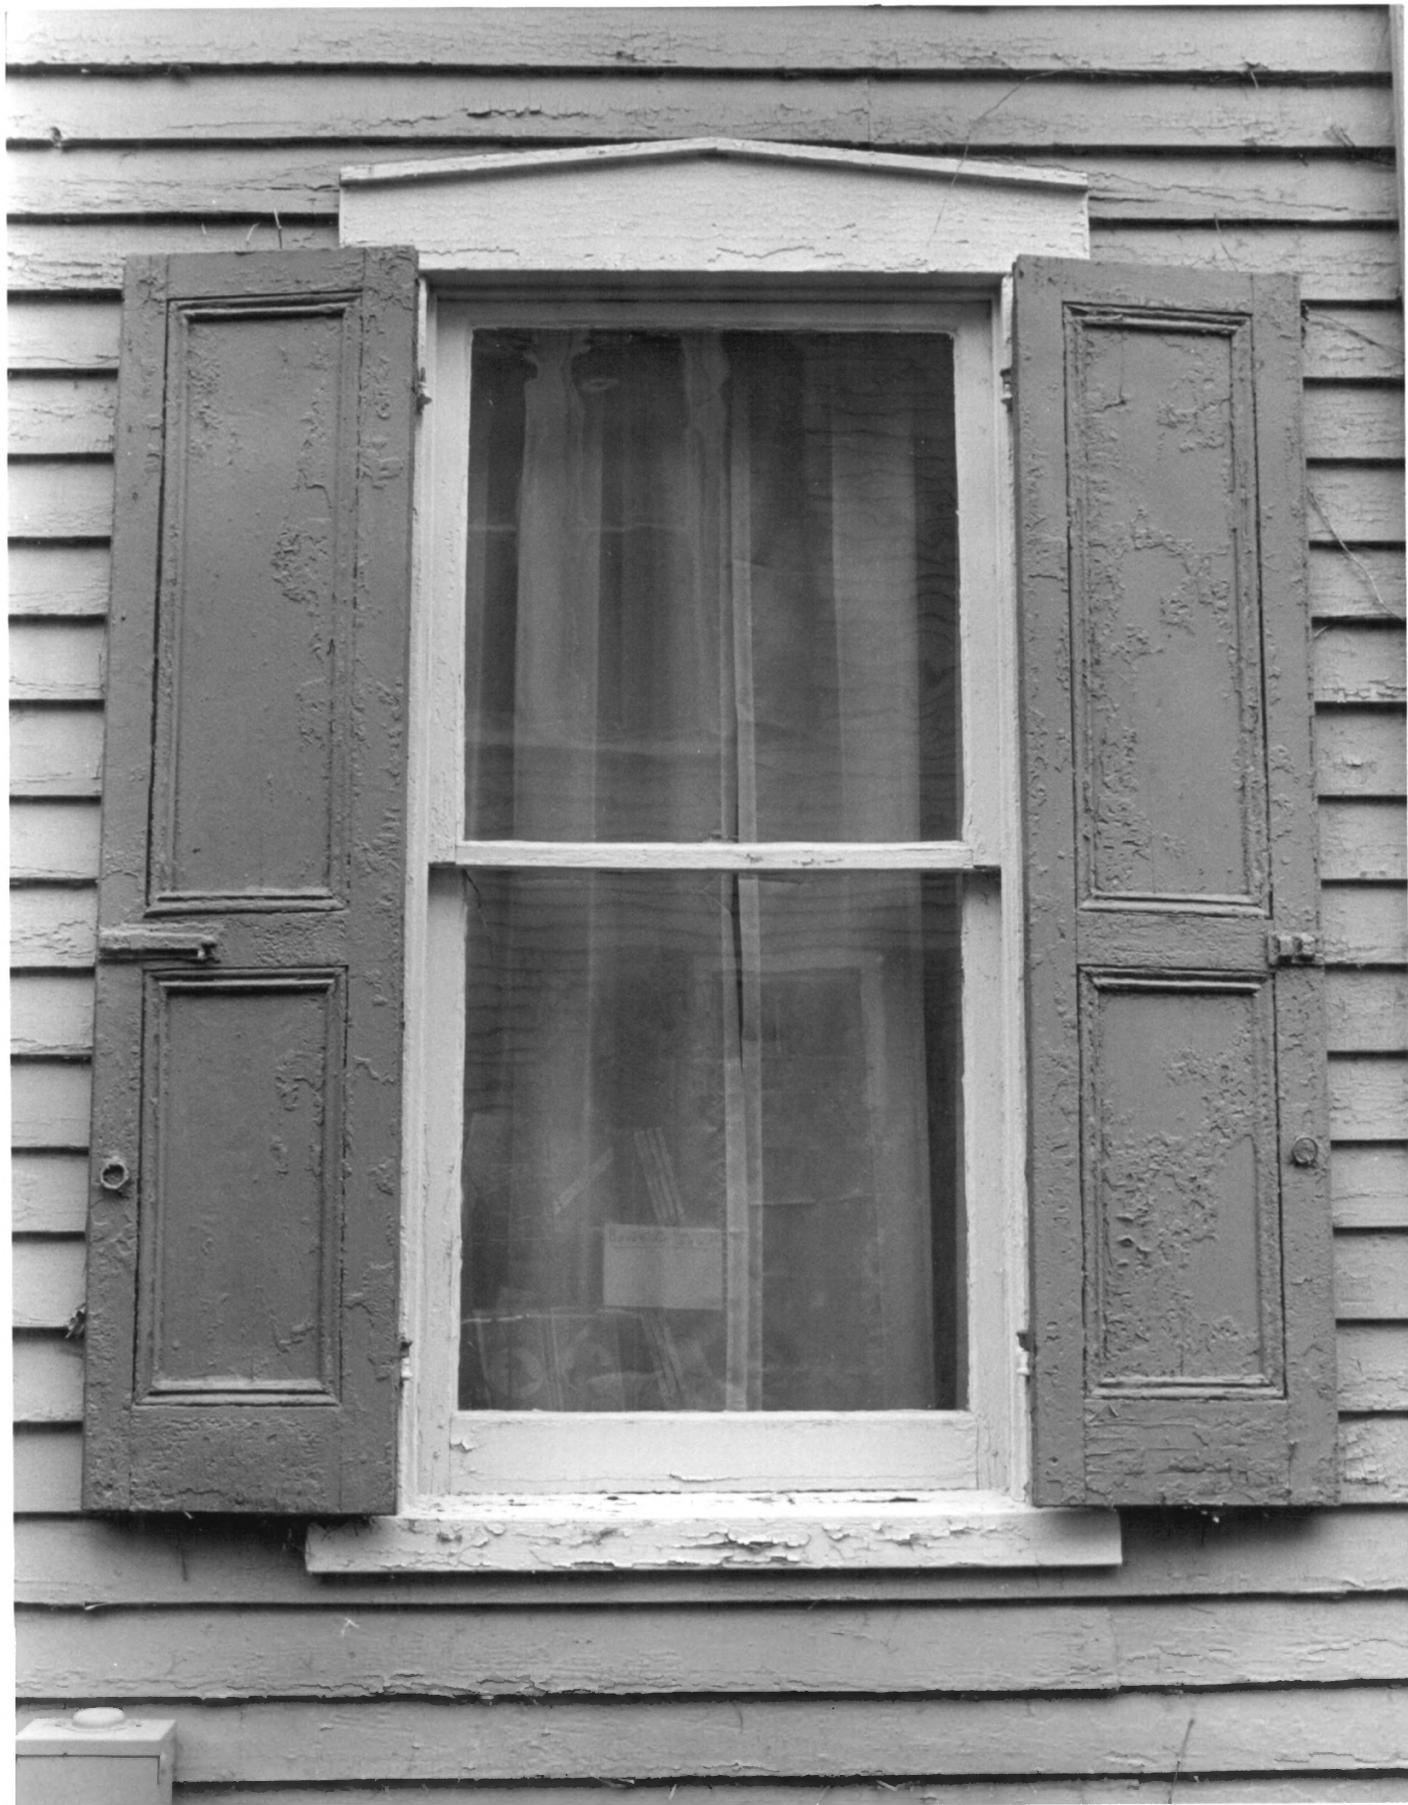
Photograph Number: Six of 13

Description: Detail showing typical window of main section  
of house (this one on the southwest side,  
first floor)

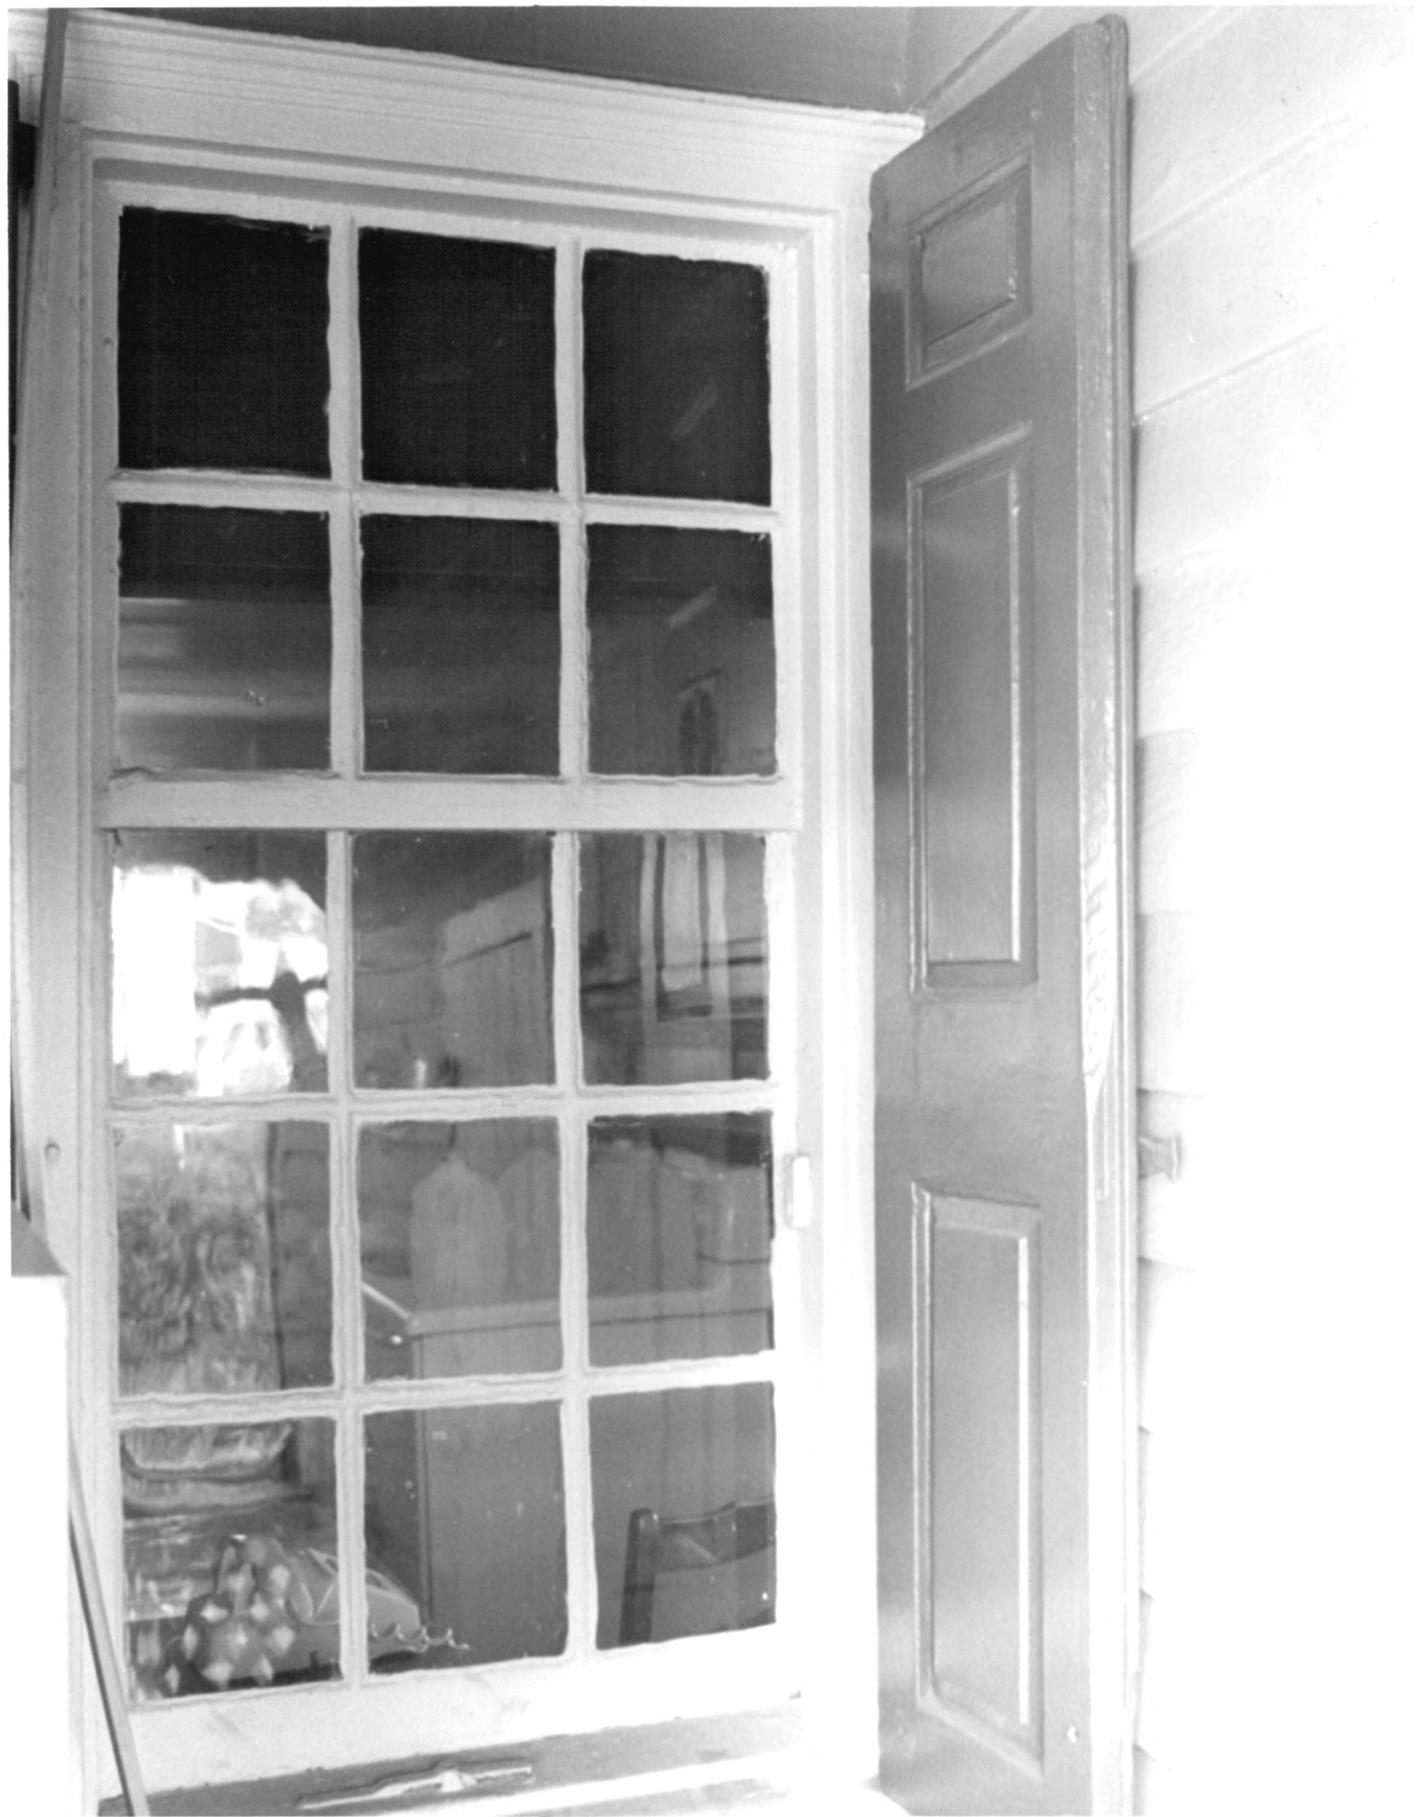
Seven of 13

Description: Detail showing one of original windows in rear (1790's) wing of house. Note: paneled shutters have board and batten exteriors. Shutter rests against wall of pantry added

Photograph Number: in 19th century.

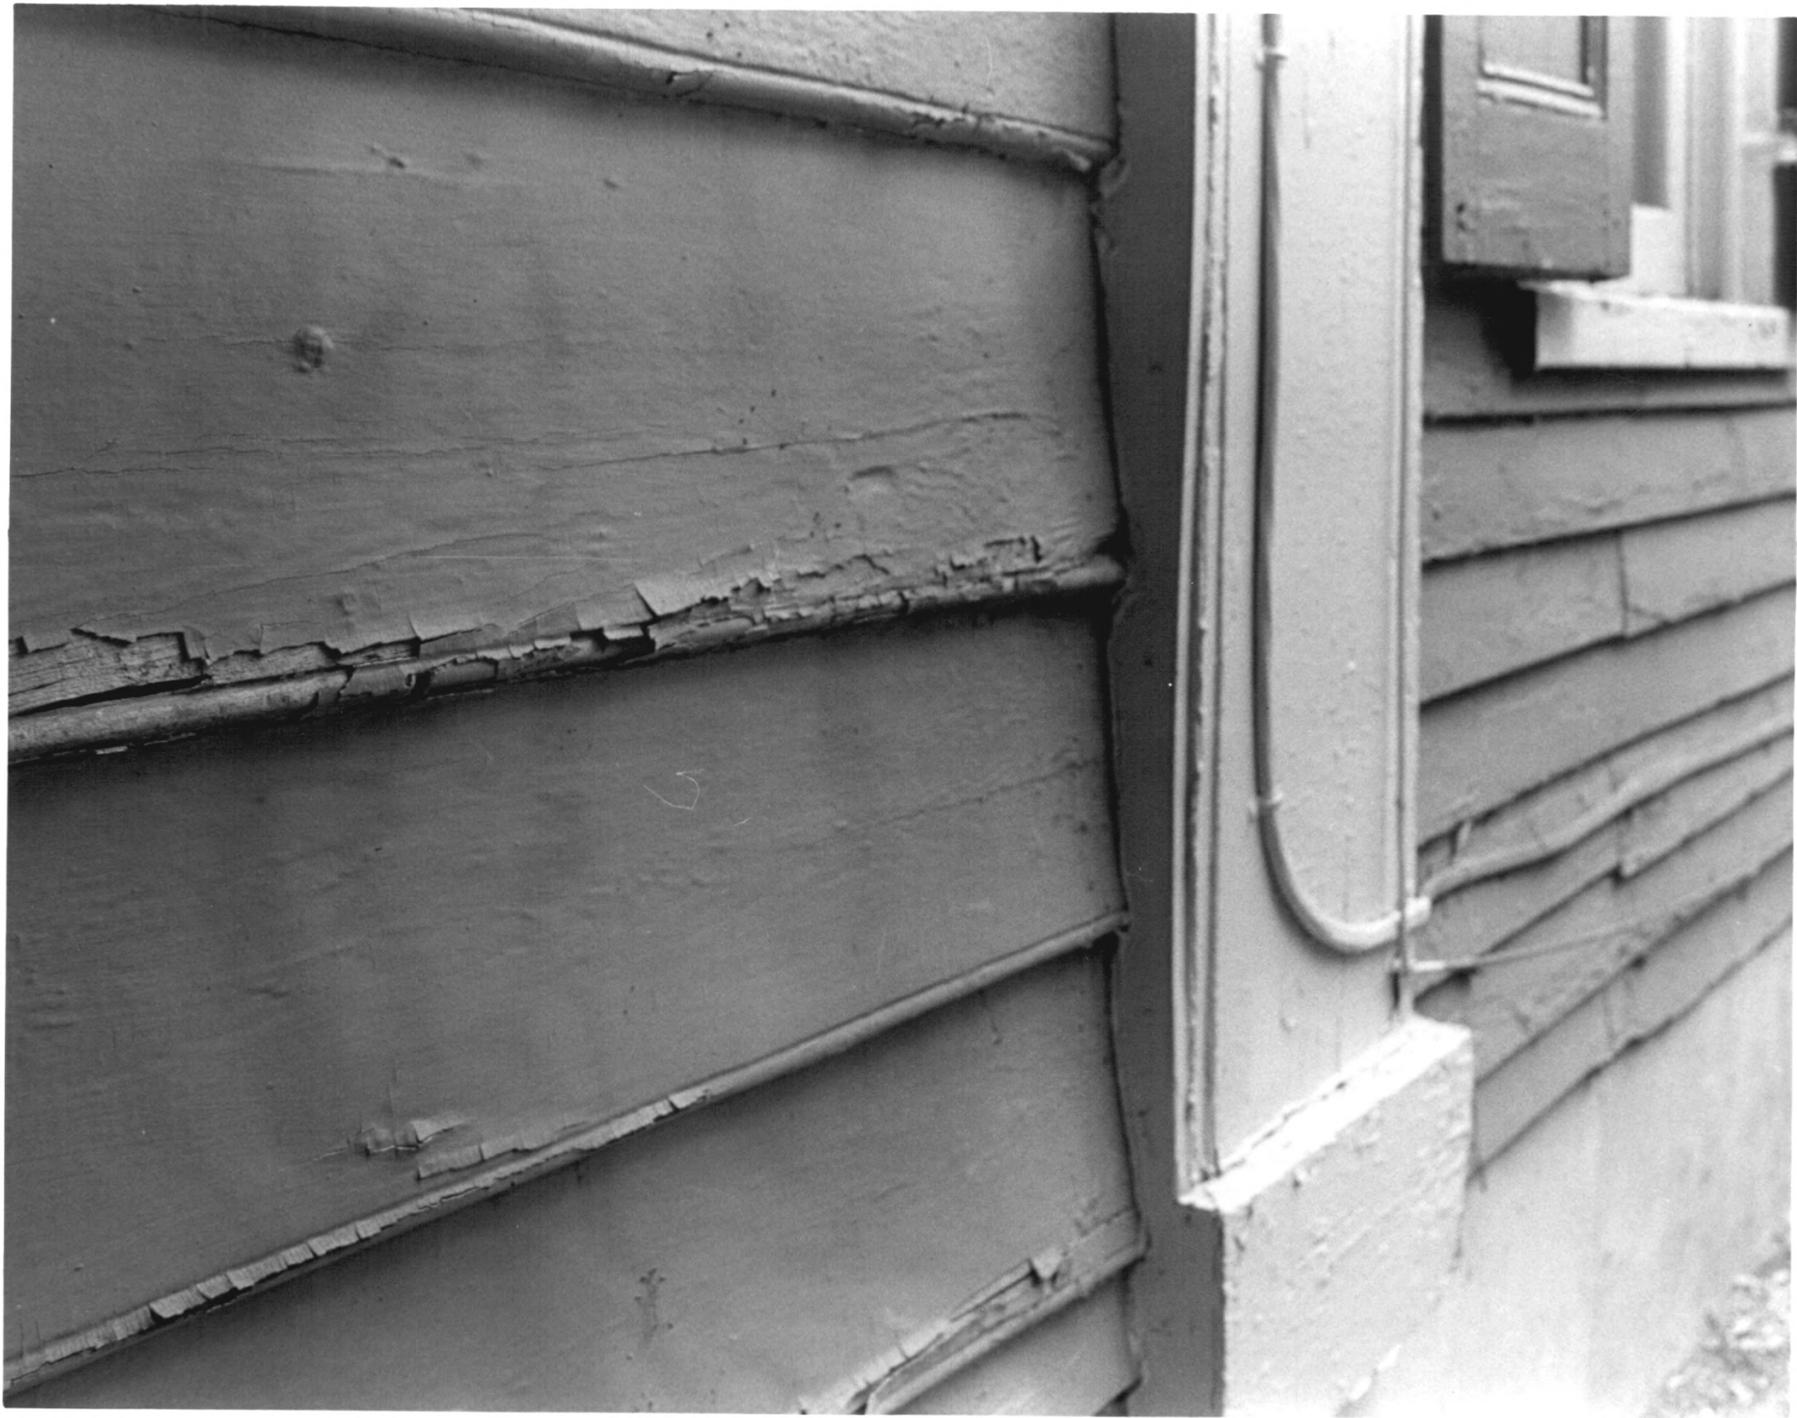
Name: The Richards Mansion (S-132)  
Location: The Circle and N. Bedford St., Georgetown, DE  
*Sussex Co.*  
Photographer: Dick Carter  
Date: Sept., 1978  
Location of Negative: Hall of Records, Dover, DE  
Description: Detail of southwest side of house showing original wide horizontal beaded weatherboards of old section at left and narrower weatherboard siding of 19th century section at right. Note base of corner pilaster in center.  
Photograph Number: Eight of 13

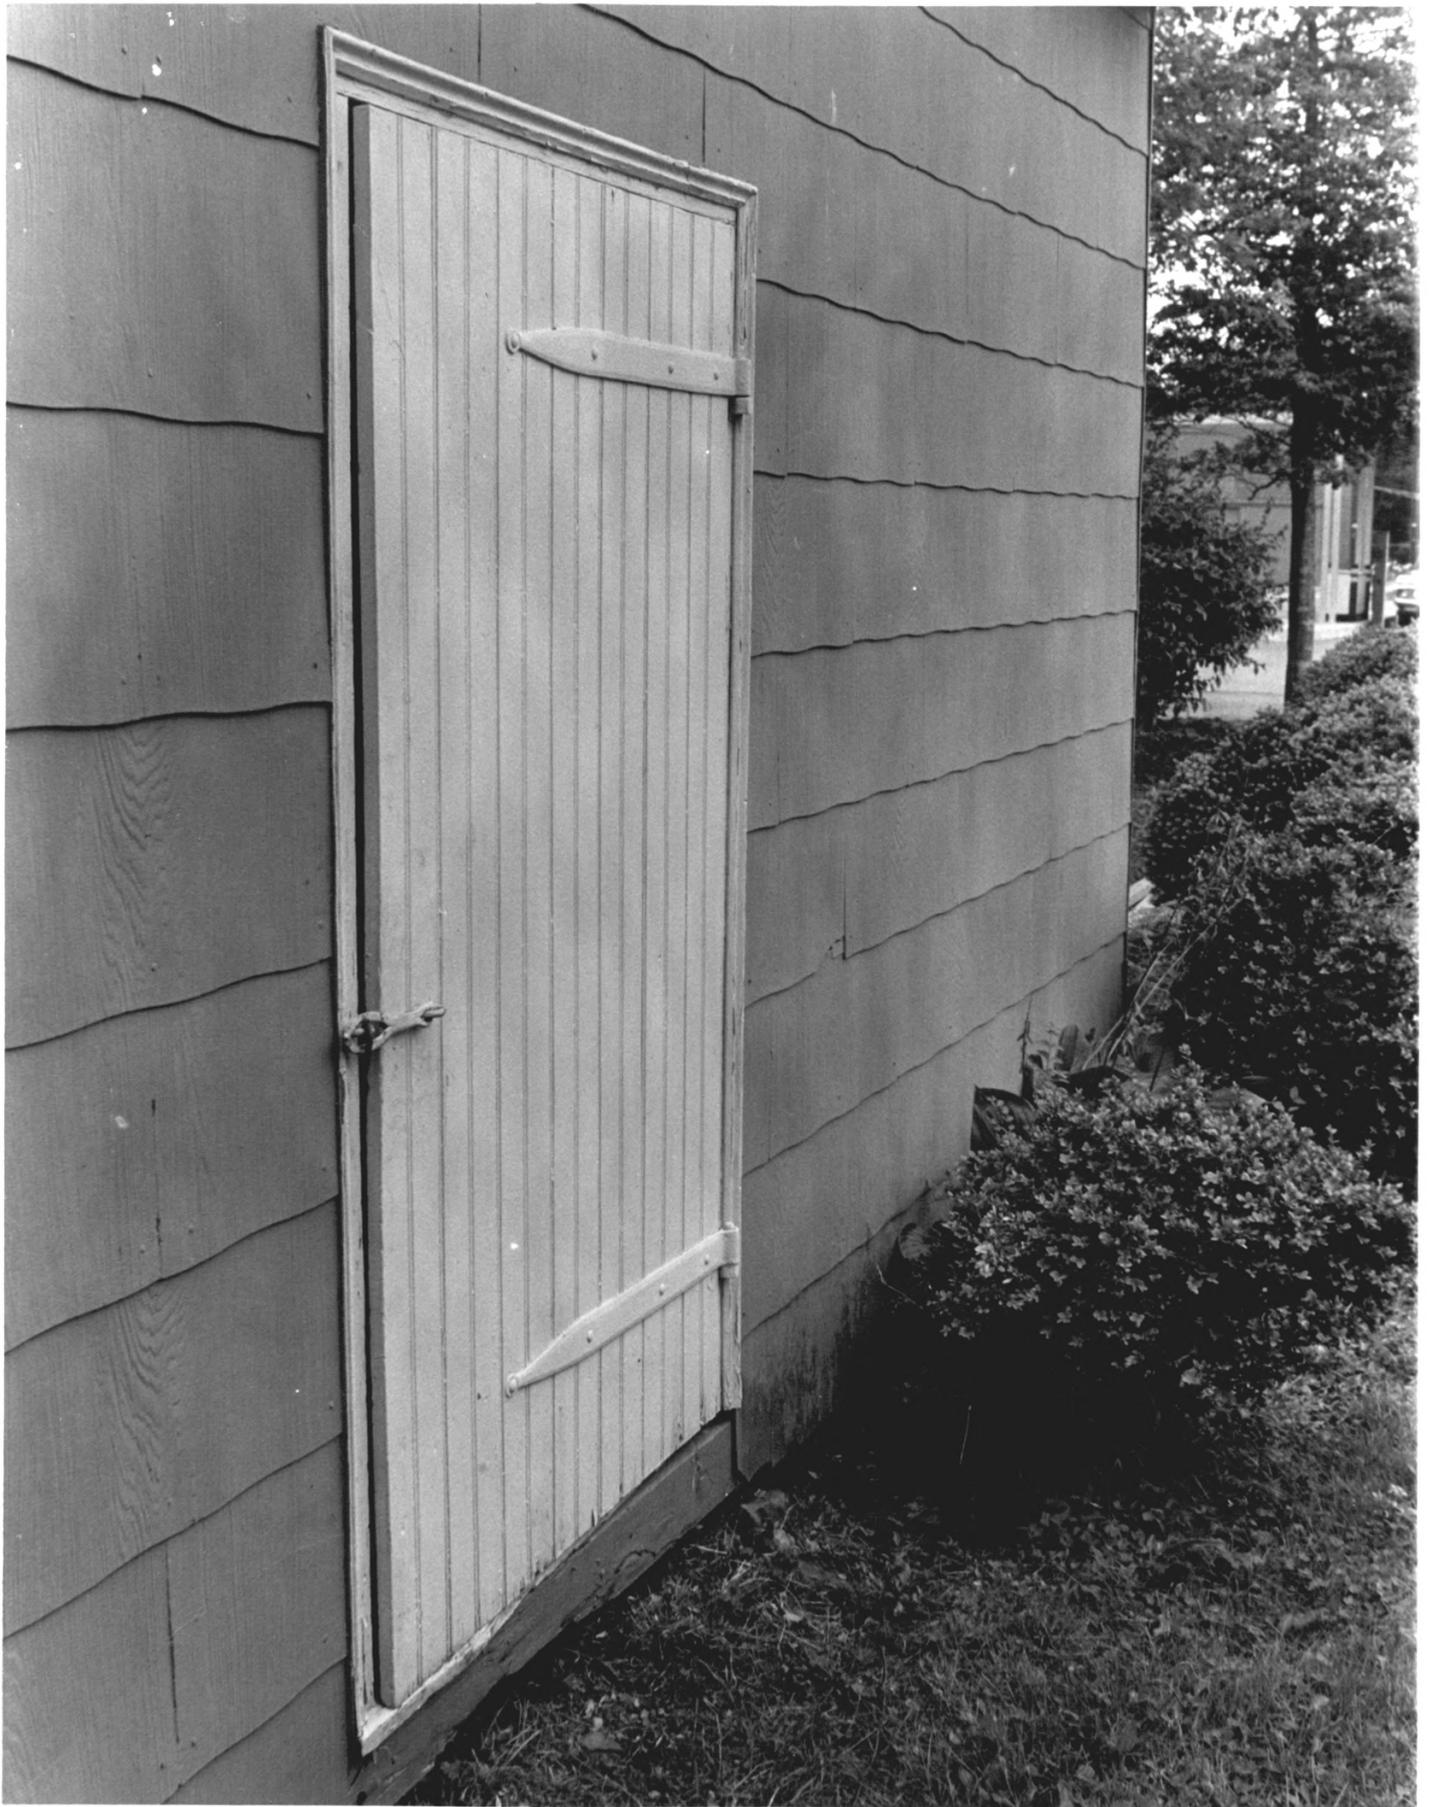
Photograph Number: Nine of 13

Description: Detail of shed at southwest side of property  
showing door strap hinges and modern asbestos  
shingle siding (over original weatherboards)

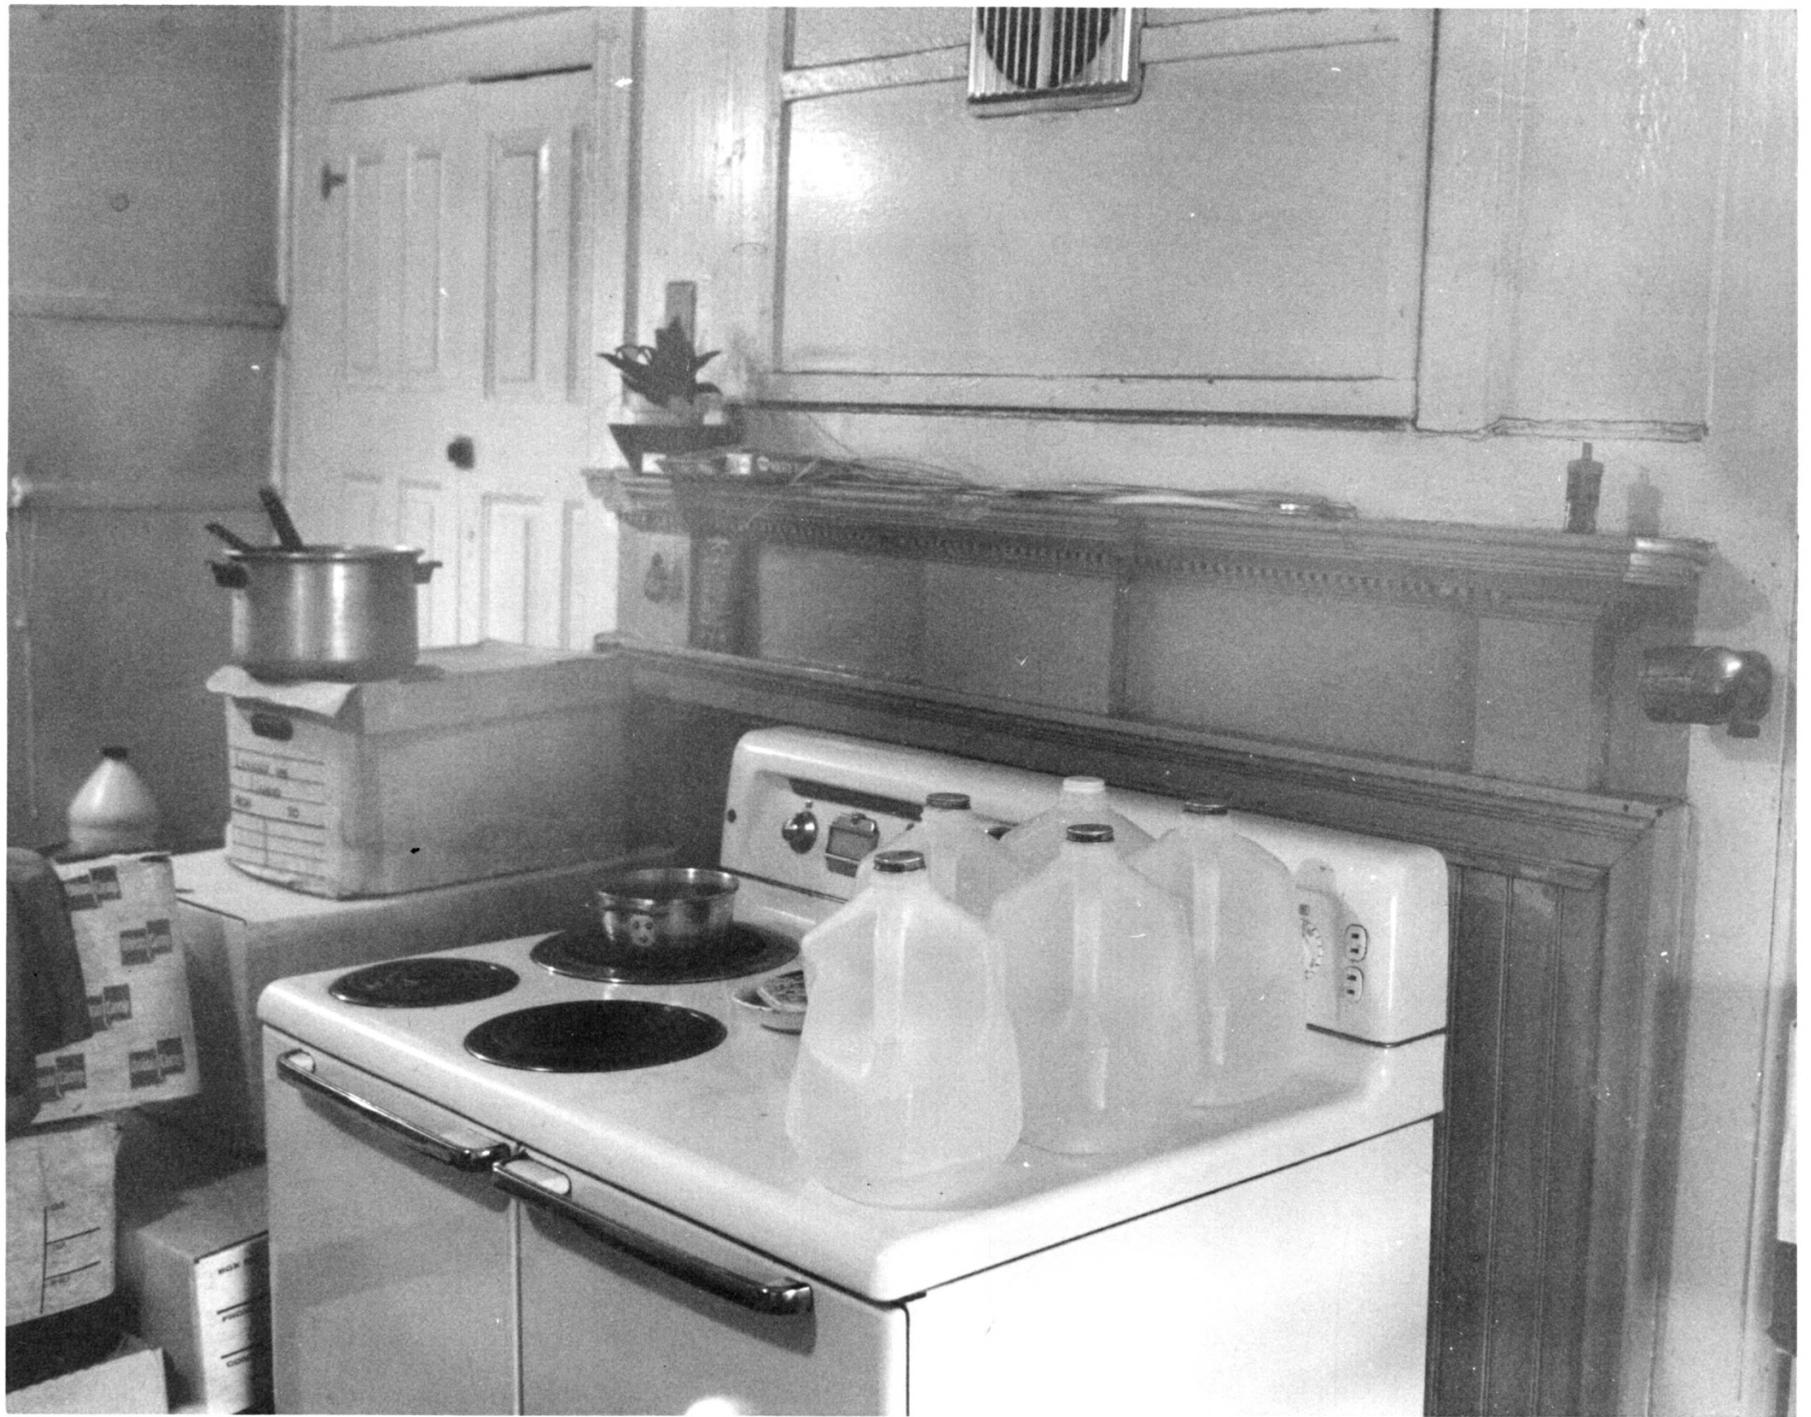
Photograph Number: Ten of 13

Description: View of original Federal mantelpiece and  
cupboard in what is now the kitchen of the house  
in 18th century section.
