Name: The Richards Mansion  
*Sussex Co.*  
Location: Georgetown, Delaware  
Dick Carter  
Photographer:  
Date: September, 1978  
Location of Negative: Hall of Records, Dover, DE  
Description: Front of house facing The Circle

Photograph Number: One of 13

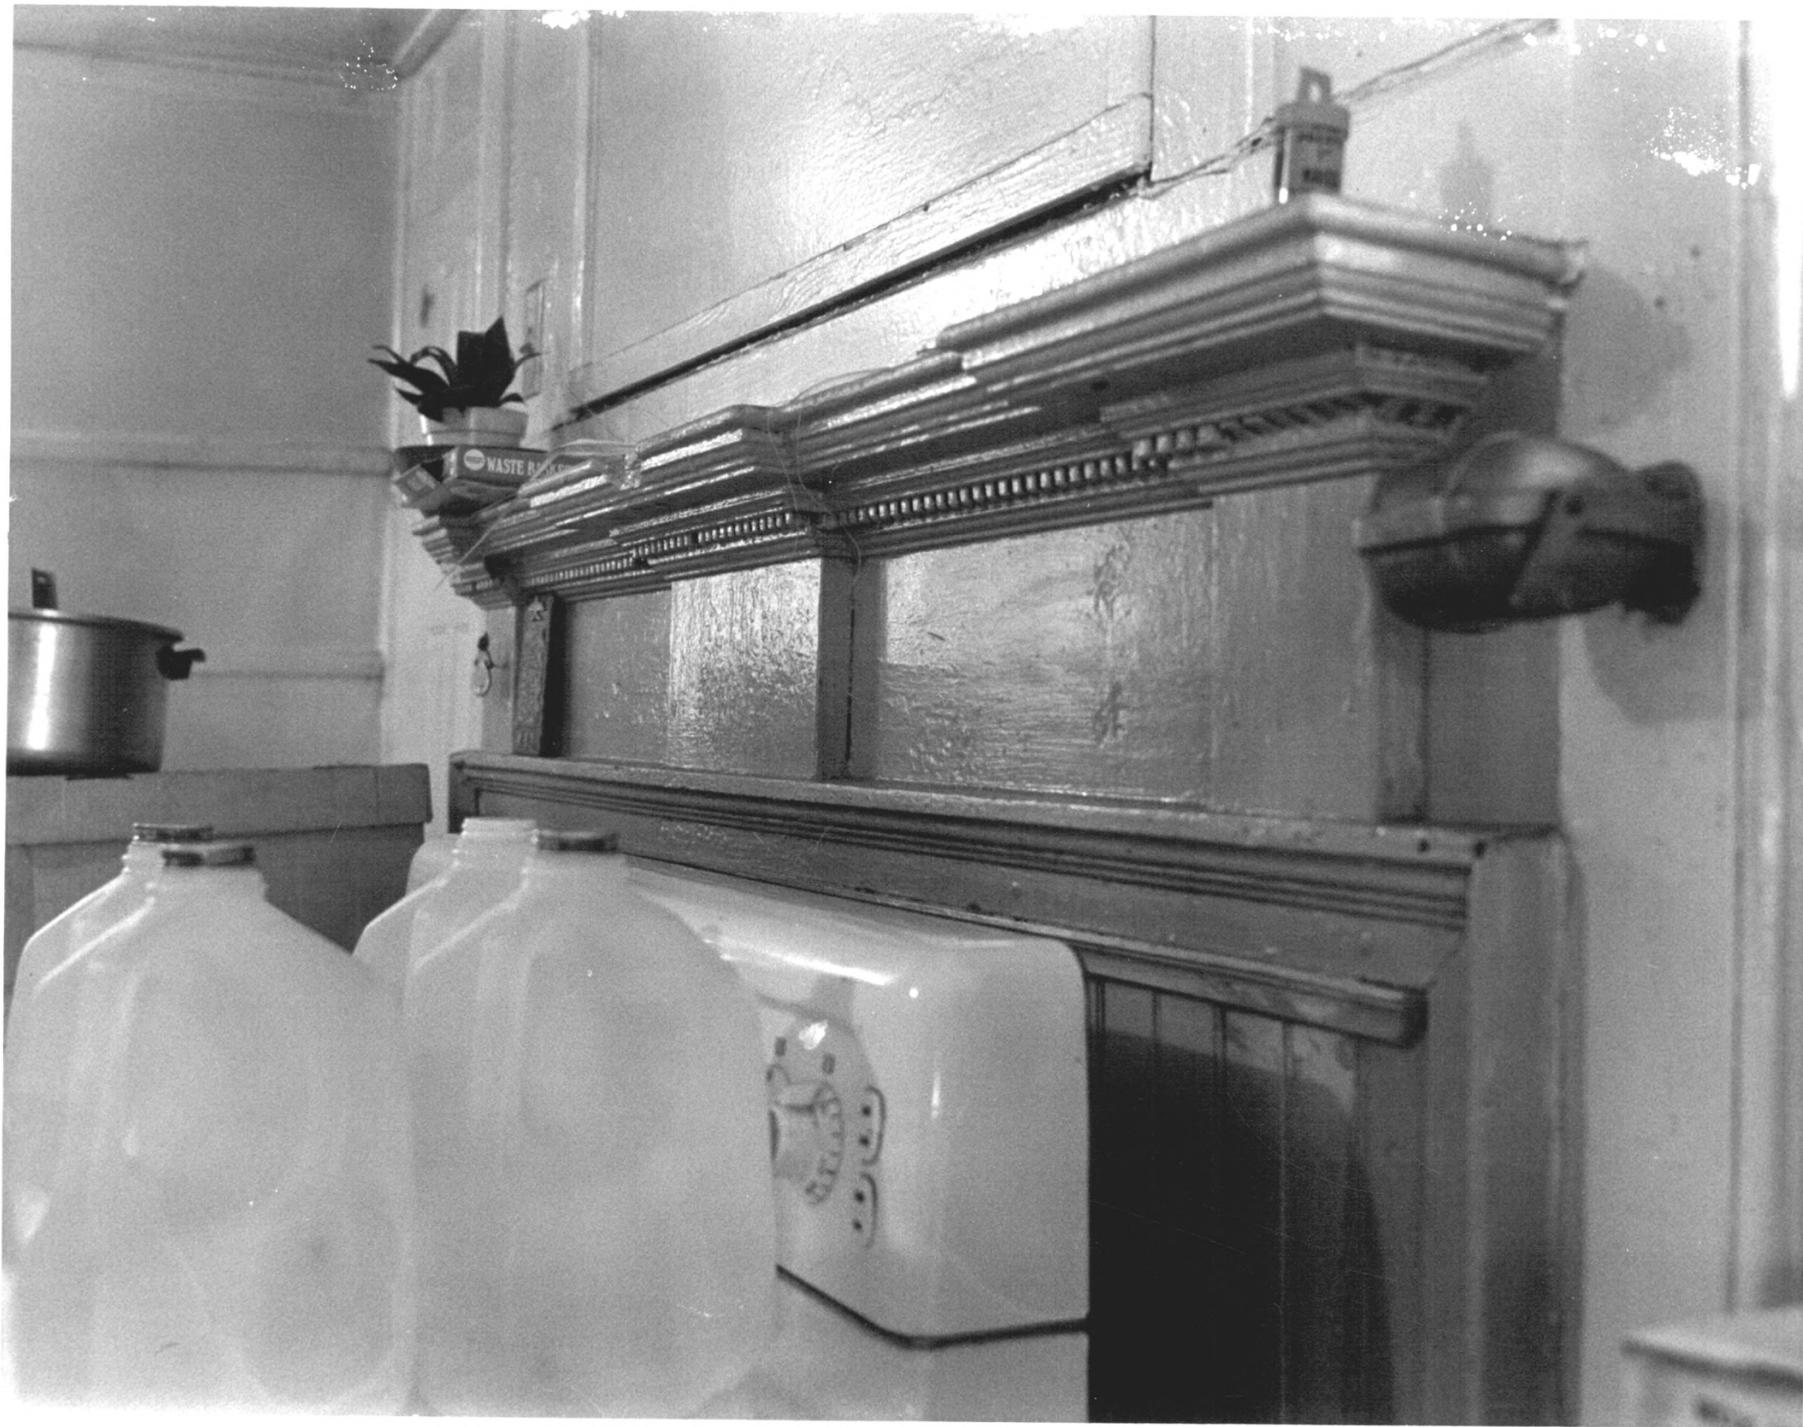
Photograph Number: Eleven of 13

Name: The Richards Mansion (S-132)  
*Sussex Co.*  
Location: The Circle and N. Bedford St., Georgetown, DE  
Dick Carter  
Photographer:  
Date: Sept., 1978  
Location of Negative: Hall of Records, Dover, DE  
Description: Detail of Federal mantle in original  
section of house.

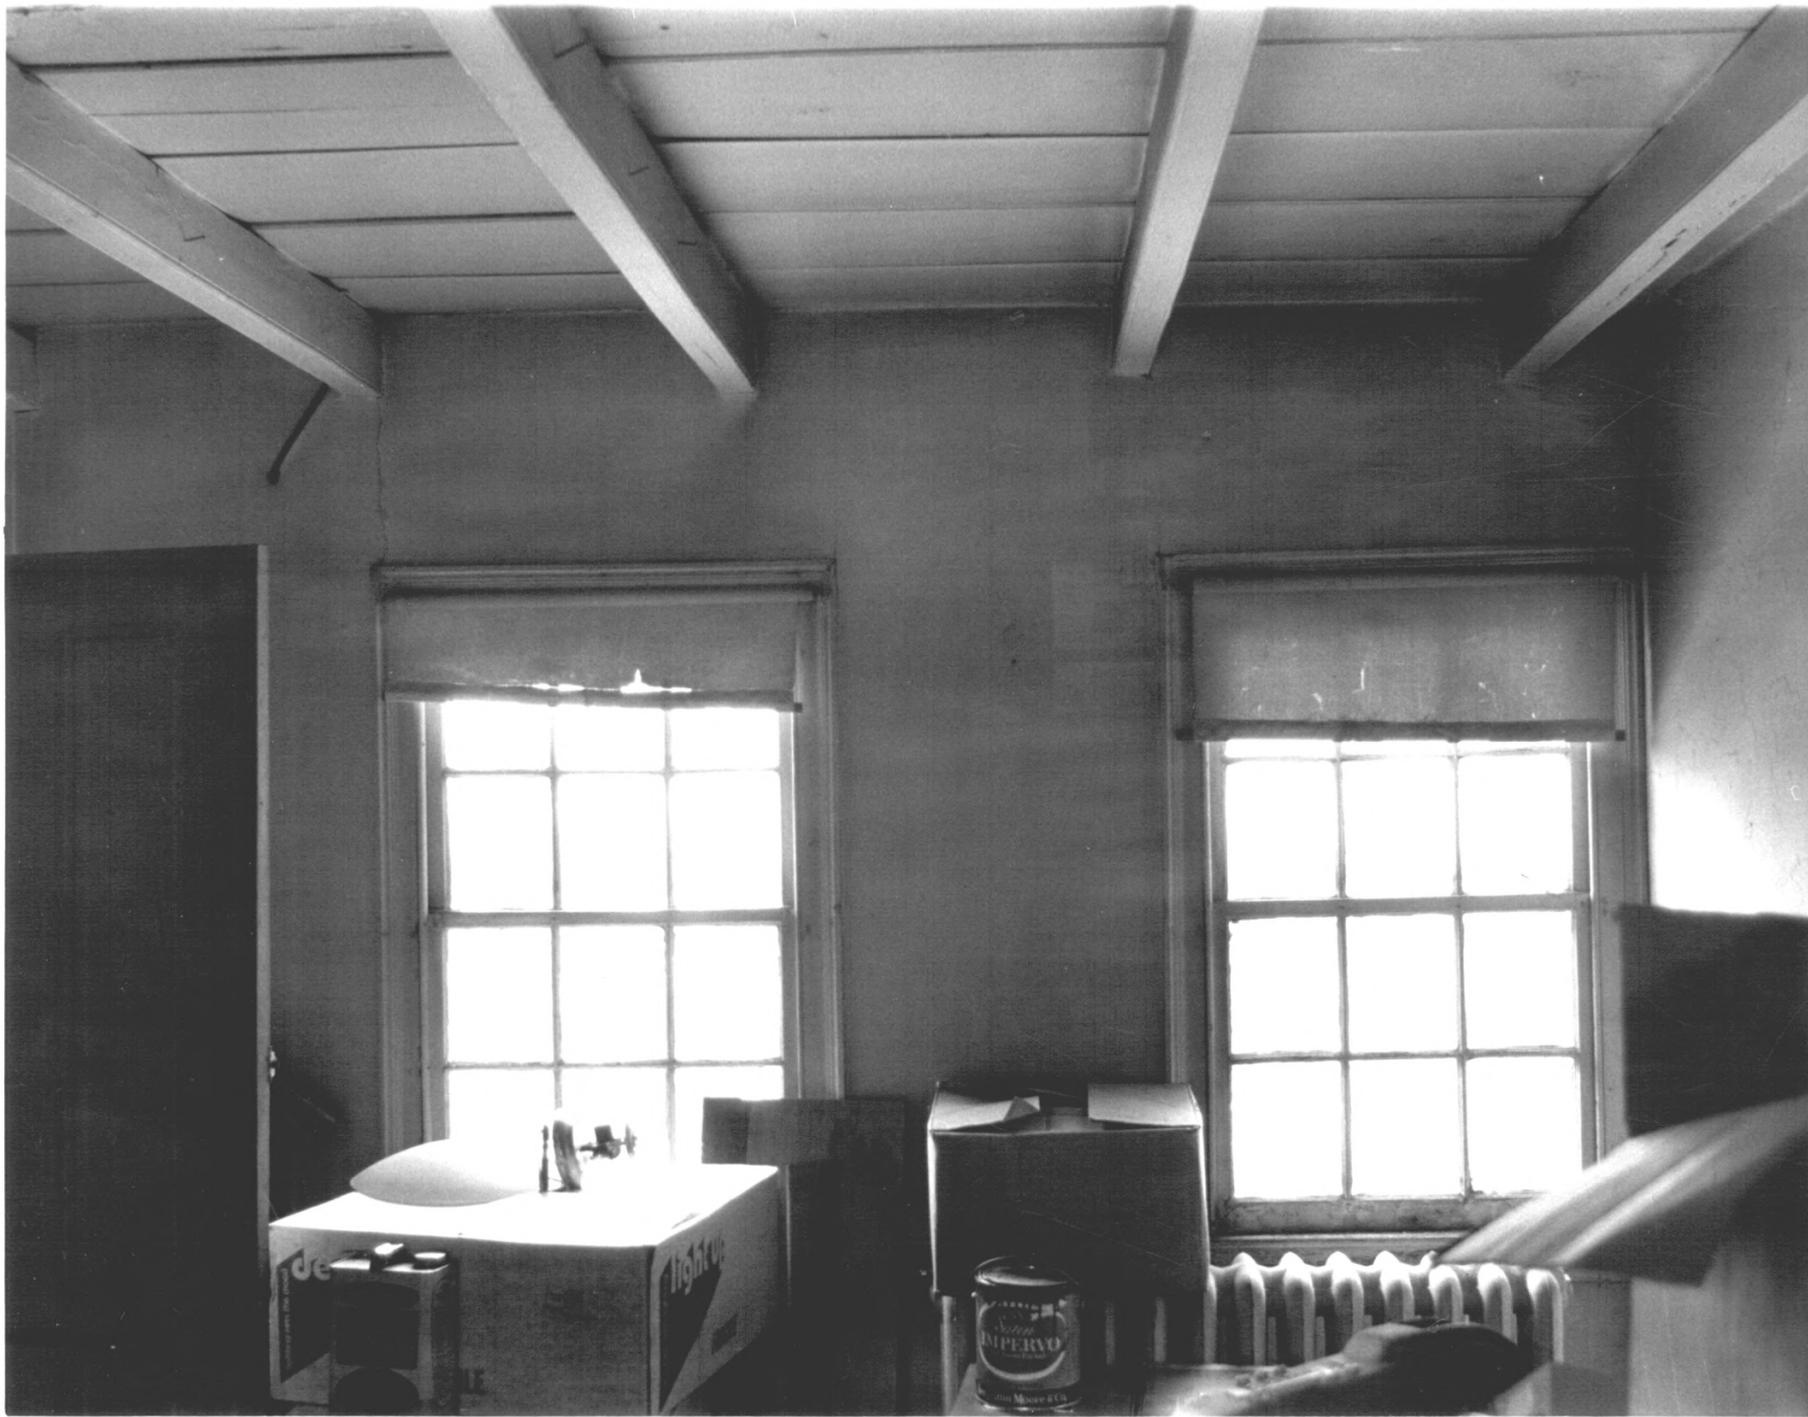
Photograph Number: Twelve of 13

Description: View of second floor bedroom in old section  
of house showing original beaded beams,  
beaded board ceiling, and window trim.

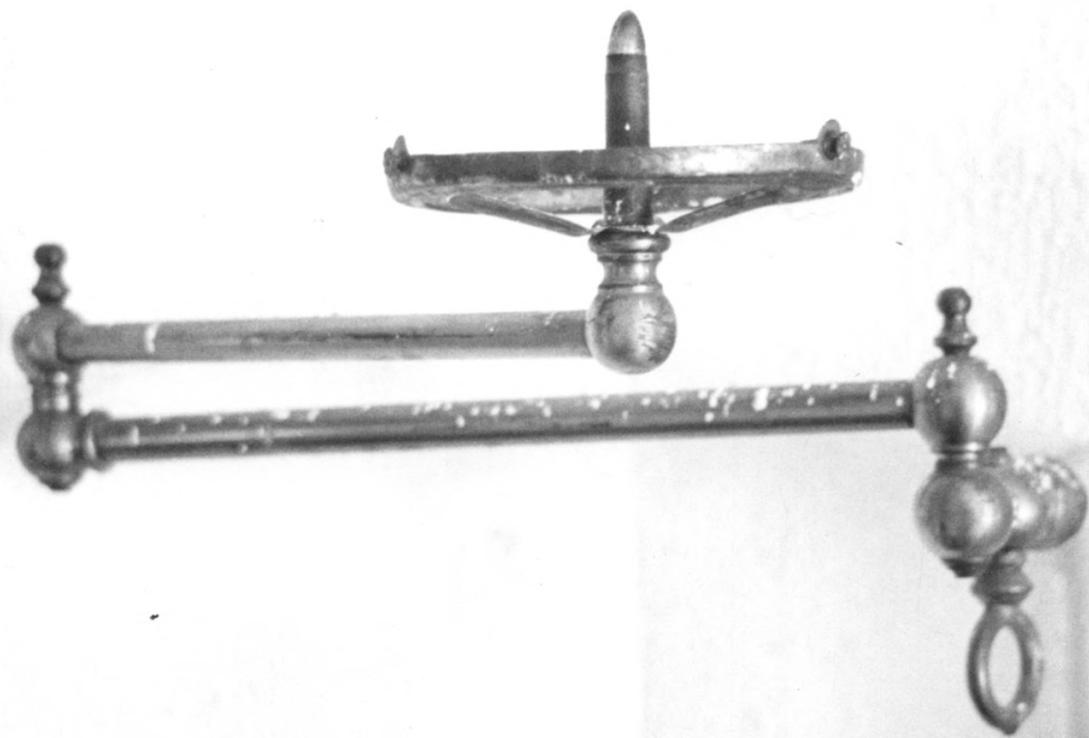
Photograph Number: Thirteen of 13

Name: The Richards Mansion (S-132)  
Location: The Circle and N. Bedford St., Georgetown, DE  
*Sussex Co.*  
Photographer: Dick Carter  
Date: Sept., 1978  
Location of Negative: Hall of Records, Dover, DE  
Description: Detail showing gaslight fixture in third floor hallway of front section of house
