National Register of Historic Places Registration Form

1. Name of Property Historic name: <u>Evans-West House</u>	Nat. Register of Historic Pl
Other names/site number: CRS#S11566	National Park Service
Name of related multiple property listing: N/A	
(Enter "N/A" if property is not part of a multip	ple property listing

Evans-West House

vans-West House	Sussex Co./DE
me of Property	County and State
7. Description	
Architectural Classification	
(Enter categories from instructions.)	
Late 19th & 20th Century Revivals - Late Victorian-Gothic Revival

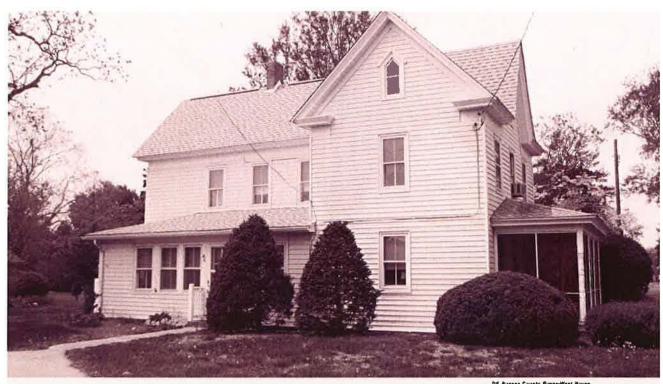
Northeast three-quarter elevation

03 of 14 three-quarter view of east elevation

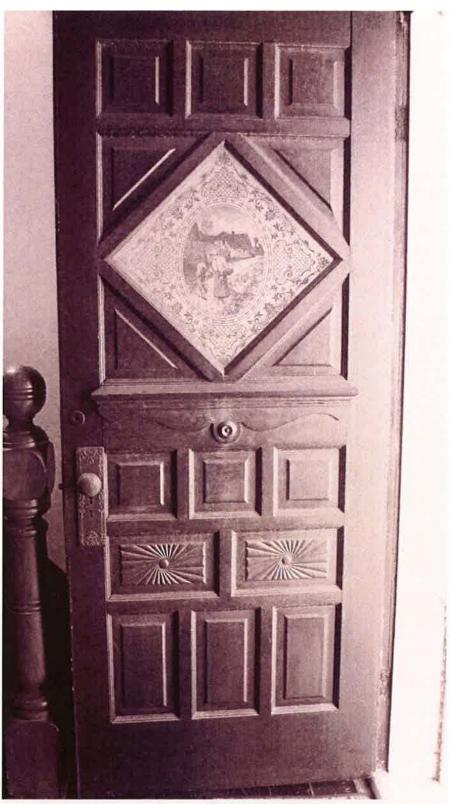
DB Jussex County Evens-West House original exterior door (main fecade) with decorative wood panel trim and frosted etched glass window

04 of 14 detail of decorative front door with original frosted etched glass

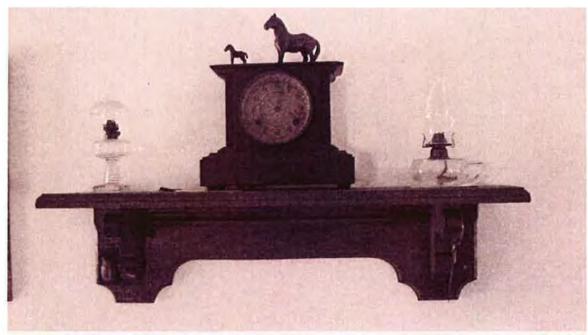
DE Eurese County Evana-West House Original mantel shell with bracket sepports and molded edges 07 of 14

07 of 14 original mantel shelf with bracket supports and molded edges

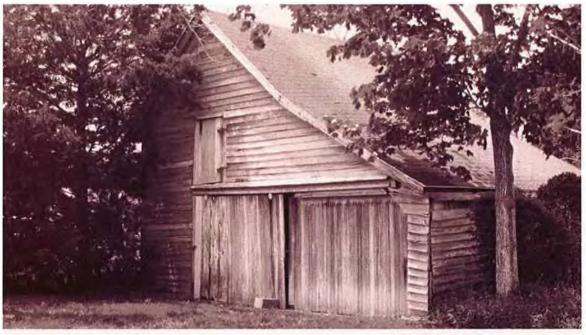
East signation of the bernjangonius/riage harn) nanotracted in 1800 11

- □ Barn (Contributing Resource) This building, designed as a wagon/carriage barn, was constructed in 1900 near the southern boundary of the property. Living in a house on the adjoining property, James M. Evans, constructed this frame building one year before building the Evans-West House. This rectangular building with loft, gable roof, lean-to addition, and double-sliding doors retain its original siding. Clapboards were placed on the south, east, and north elevations. Board-and-batten construction was used on the western elevation. Though many of the original structural members and roof rafters remain intact, several of the sills and sections of the flooring have deteriorated. According to family histories, the barn housed a cow in an interior stable as well as a buggy and farm equipment. The Ocean View Historical Society plans to restore this historic building.

11 of 14 east elevation of wagon/carriage barn

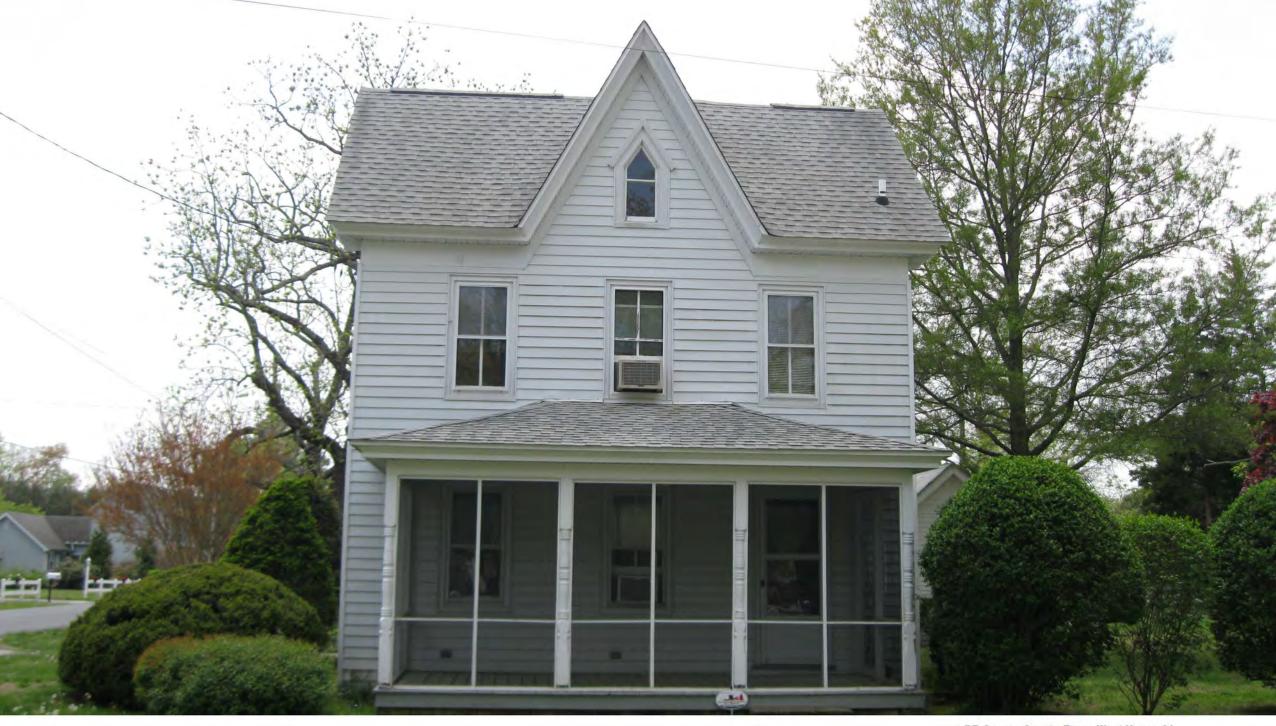
DE_Sussex County_Evans-West House_01

01 of 14 north elevation, main façade

The Evans-West house, built in 1901 on a brick foundation, is characterized as a two-and-one-half story, three-bay, single-pile, L-shaped, frame dwelling. Similar in design to the 1868-1890 Tunnel-West House (listed in the National Register in 2012), it represents the continuation of a locally popular vernacular Gothic Revival style characterized by a cross-gable façade with one-over-one lancet-shaped window in the middle of the gable. Its northern façade features a screened-in, one-story, hipped roofed porch supported by four turned columns with plain capitals and bases. Original fenestration includes two-

over-two double hung-sash windows. The positioning of a front door at the northwest corner of the façade indicates an interior defined by a parlor and side hall plan. Original clapboards are covered with aluminum siding. The gable and hipped porch roofs are covered with fiberglass shingles (2001). A plain, wide band frieze is located below the gable roof.

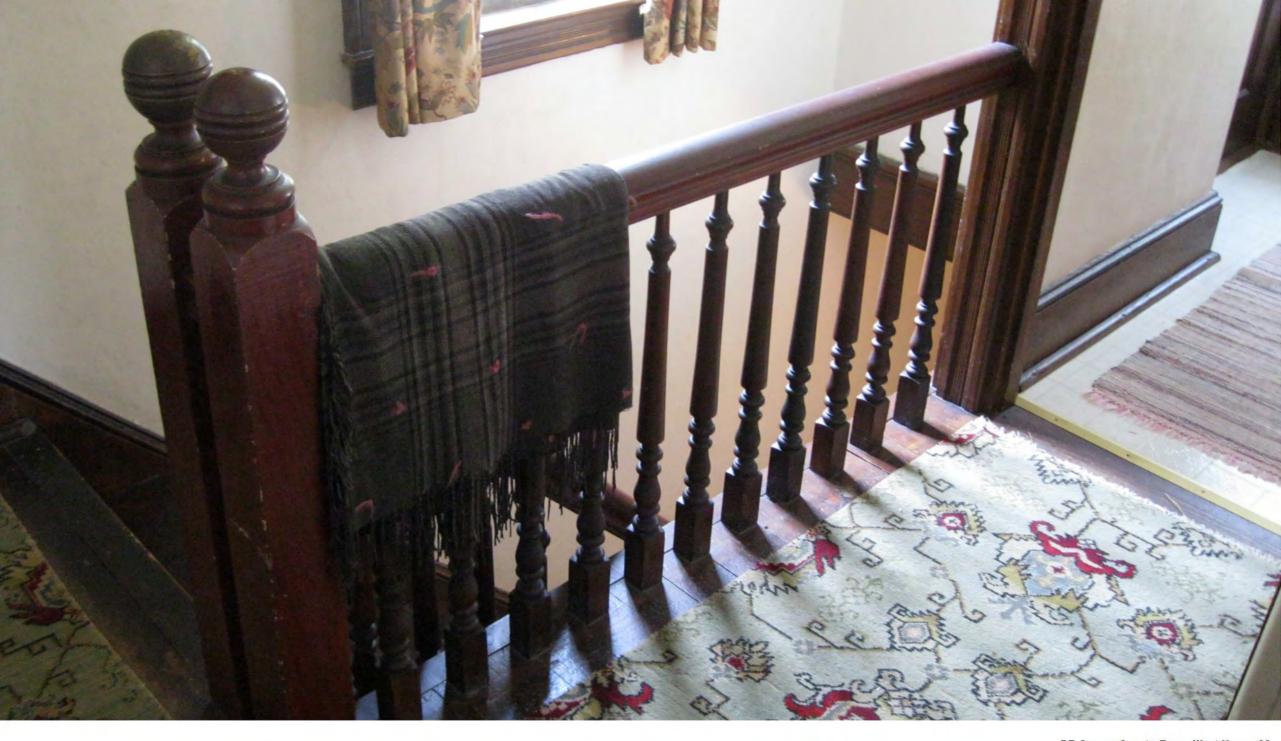
DE_Sussex County_Evans-West House_06

06 of 14 2nd floor double newel posts and turned stair balusters

The second story is accessed by two staircases. One is in the kitchen and the other is in the stair hall at the front of the house. The walkway at the top of the front steps features a railing with a molded handrail, turned balusters, and squared newel posts with boldly rounded caps. This area also contains a storage closet with a door that opens to another set of steps which give access to the attic. Three bedrooms are located in a row on the second floor. A portion of the third bedroom above the kitchen features a bathroom (added in 1930s and modified 1980s). Each of these areas on the second floor retain their original floors, lath and plaster walls, baseboard trim, grained doors with elongated panels, as well as electroplated hardware and porcelain doorknobs. Like the first floor, each window and door is trimmed with reeded surrounds and bulls-eye corner block trim.
