**NATIONAL REGISTER OF HISTORIC PLACES
REGISTRATION FORM**

historic name Profile Cotton Mills Historic District
other names/site number Ide Cotton Mills

street & number Alexandria Street, A Street, H Street, and D Street not for publication N/A
city or town Jacksonville vicinity N/A
state Alabama code AL county Calhoun code 015 zip code 36265

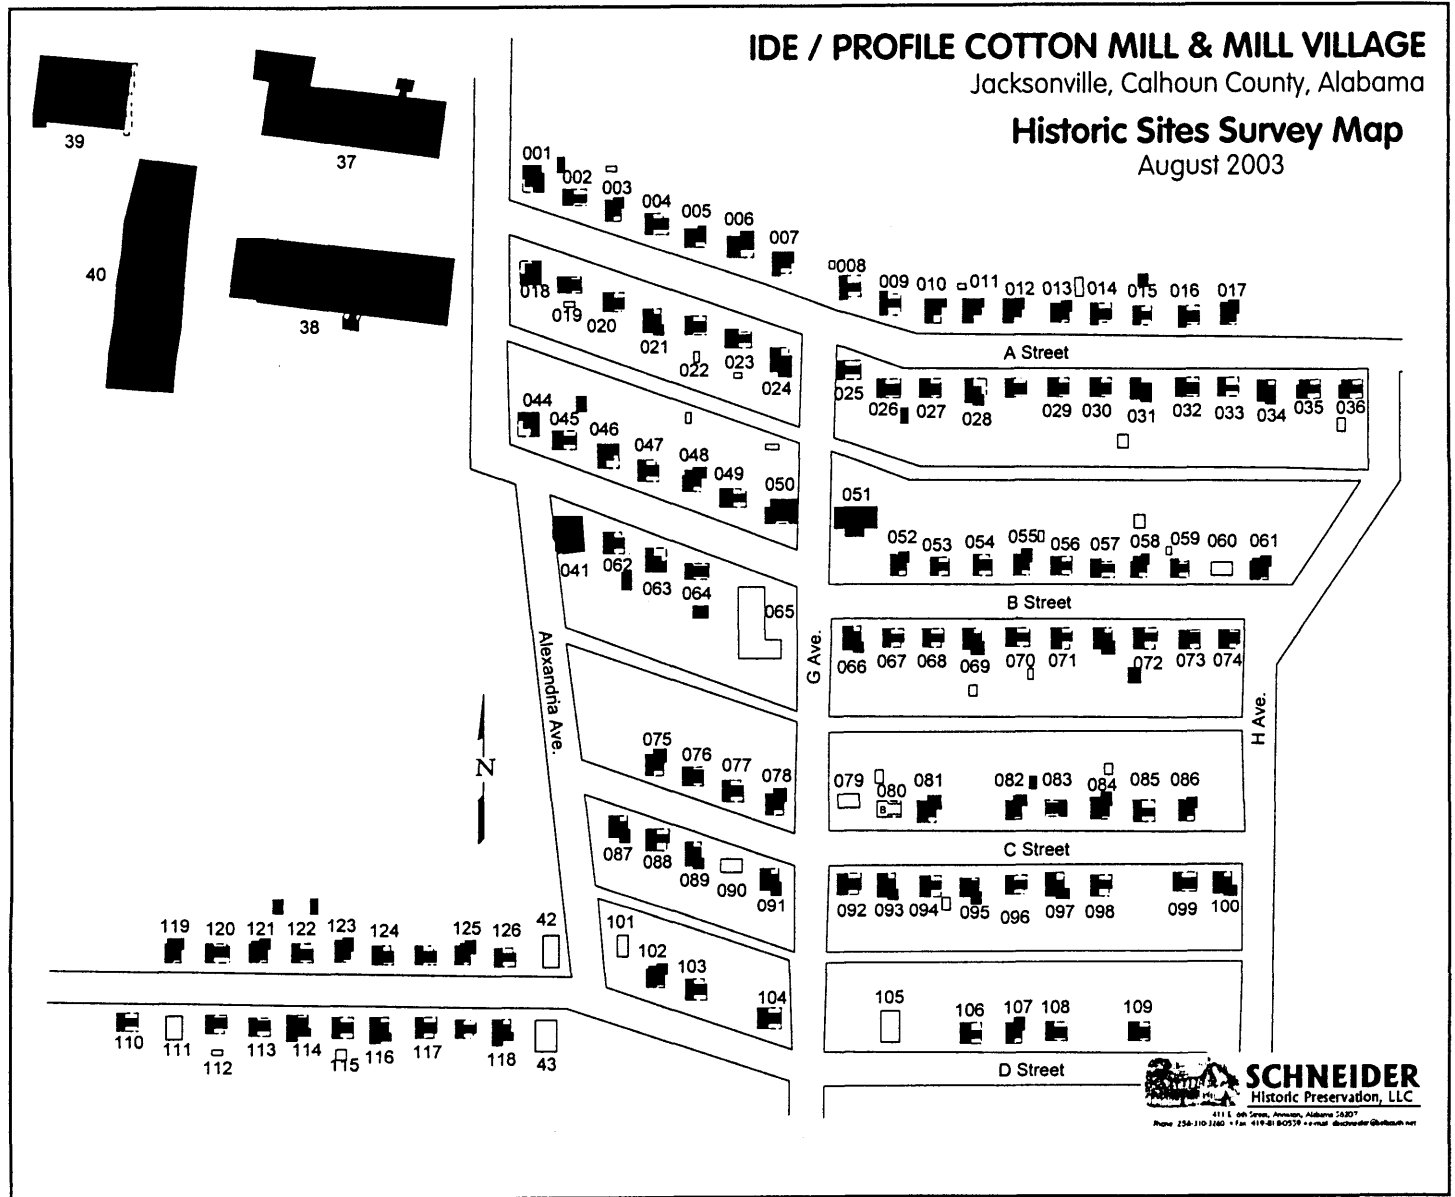
Accompanying Documentation Continuation Sheet #4

District Map (with Photo Directions Indicated):

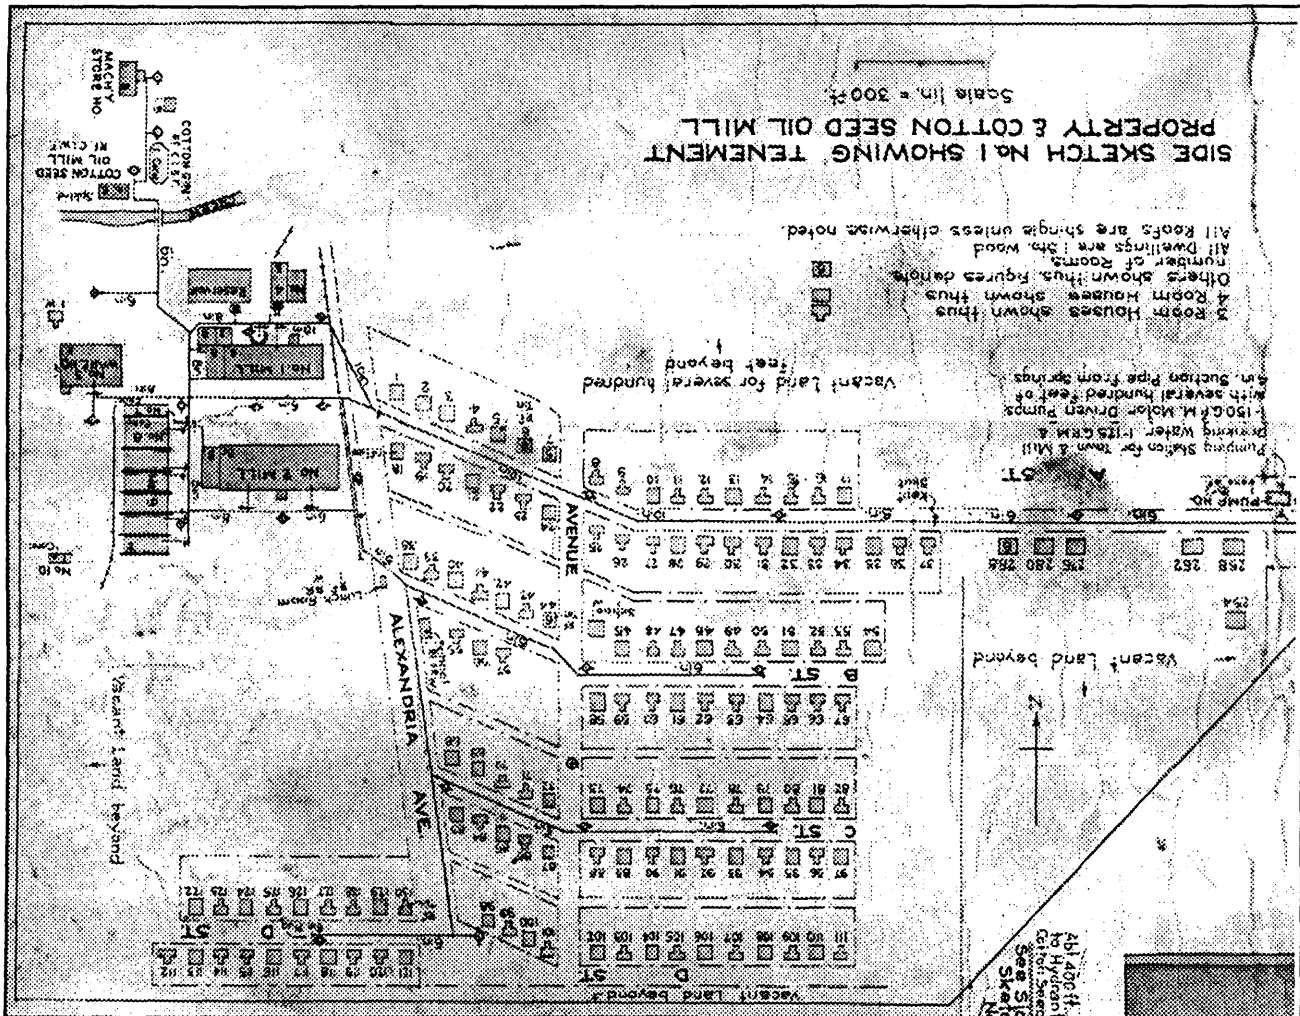
Accompanying Documentation Continuation Sheet #2

**Plat of the Profile Cotton Mills
1938. Note that graphic has been rectified.**

**PROFILE COTTON MILLS
Jacksonville, Ala.**

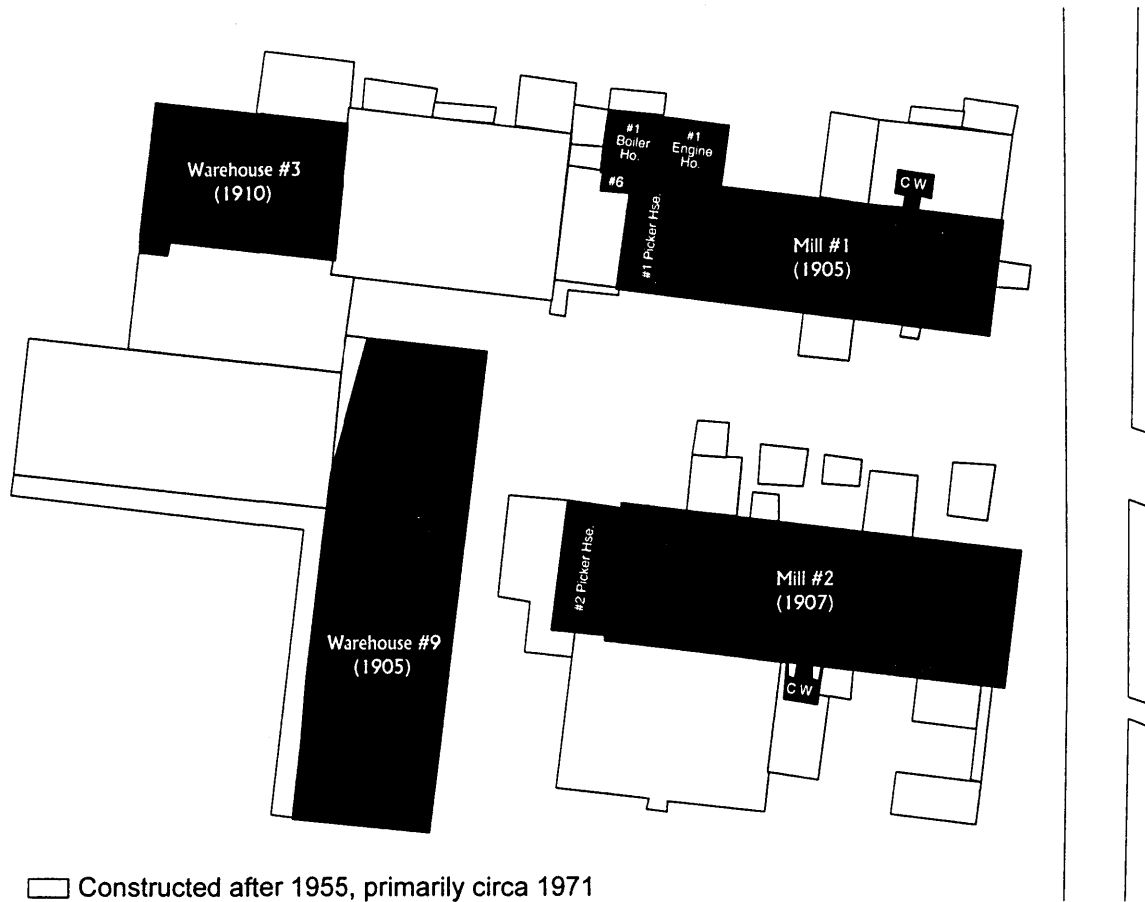
Accompanying Documentation Continuation Sheet #3

Mill Site Plan and Evolution
