**NATIONAL REGISTER OF HISTORIC PLACES  
CONTINUATION SHEET**

**SUPPLEMENTARY LISTING RECORD**

Lassen Volcanic National Park

Highway Historic District

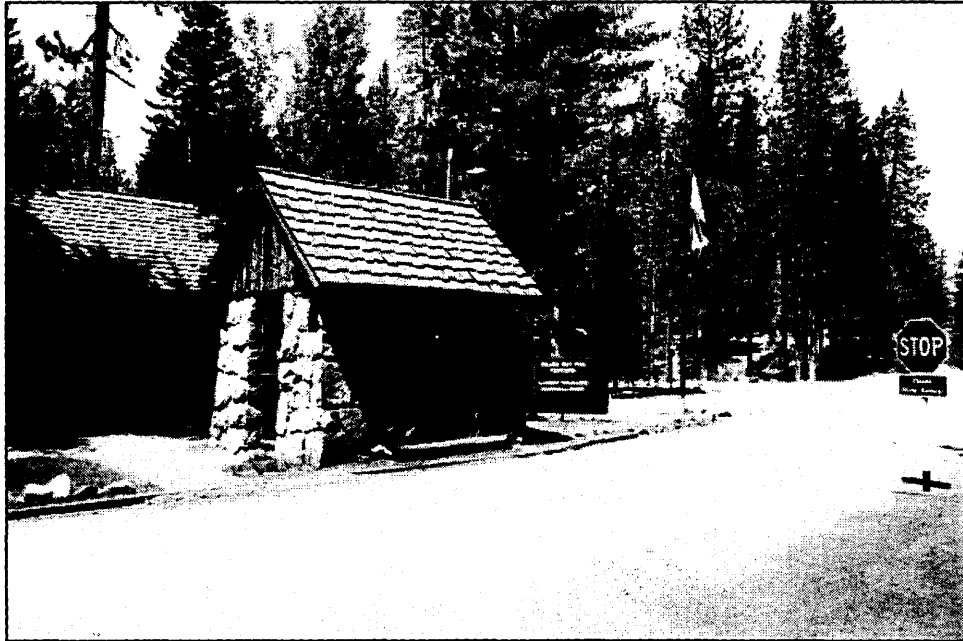
Photo 2: Northwest Entrance Station – Entrance Kiosk and residence, view to west.

The Northwest Entrance Checking Station, completed in 1931, is located near the western shore of Manzanita Lake. It is positioned in the center of the road, opposite the ranger residence, and serves entering and exiting traffic. The checking station features a rough-cut lava-rock foundation and walls and is surmounted by a steeply gabled, wood-shake roof. Exposed rafter tails, and vertical, split, unpeeled logs on the gable ends contribute to the building's rustic character. Details include mullioned windows and copper lanterns. A non-historic, narrow turf island edged with barrier rocks frames the checking station and accommodates a seasoned, peeled wood flagpole. A flagpole appears in the same location in historic photographs, and, although the age of the current example cannot be determined, it should be considered contributing.

The residence, designed and built in association with the entrance station, is of largely the same design. The residence features a rough-cut lava rock foundation and walls and is surmounted by a steeply gabled, wood-shake roof. Exposed rafter tails, and vertical, split, unpeeled logs on the gable ends contribute to the building's rustic character. Details include mullioned windows.

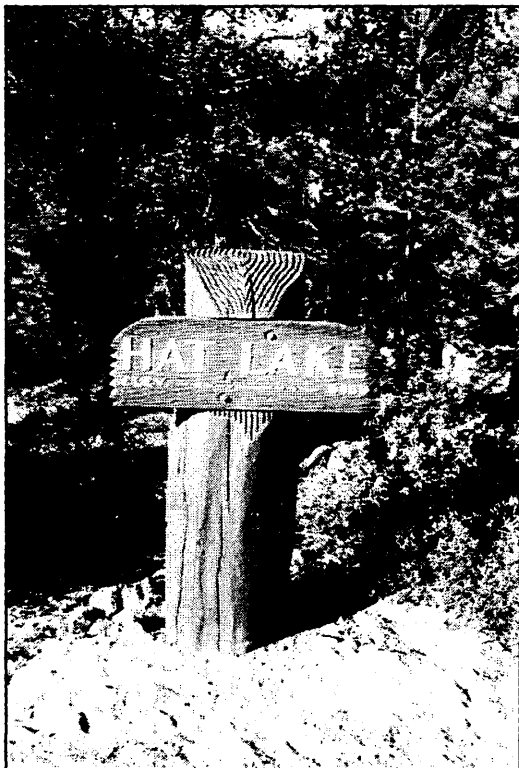
Photo 5: Interpretive sign of routed wood (design also found on Raker Peak and Diamond Peak signs)

Only five signs that date to the periods of significance remain along the road. The Brokeoff Mountain, Diamond Peak, Hat Lake, Raker Peak, and Manzanita Lake signs are all wooden, exhibit rustic design principles of log construction, and date from the CCC era. All have a consistent appearance of dark brown stain as a background for raised Art Deco styled lettering, painted white. According to Good's "Park and Recreation Structures" (1938), the Brokeoff, Diamond, and Raker Peak signs are categorized as Low Horizontal Signs, while Hat Lake is a Post Sign, and Manzanita Lake a Single Post Suspended Sign. These five features contribute to the integrity of the road.

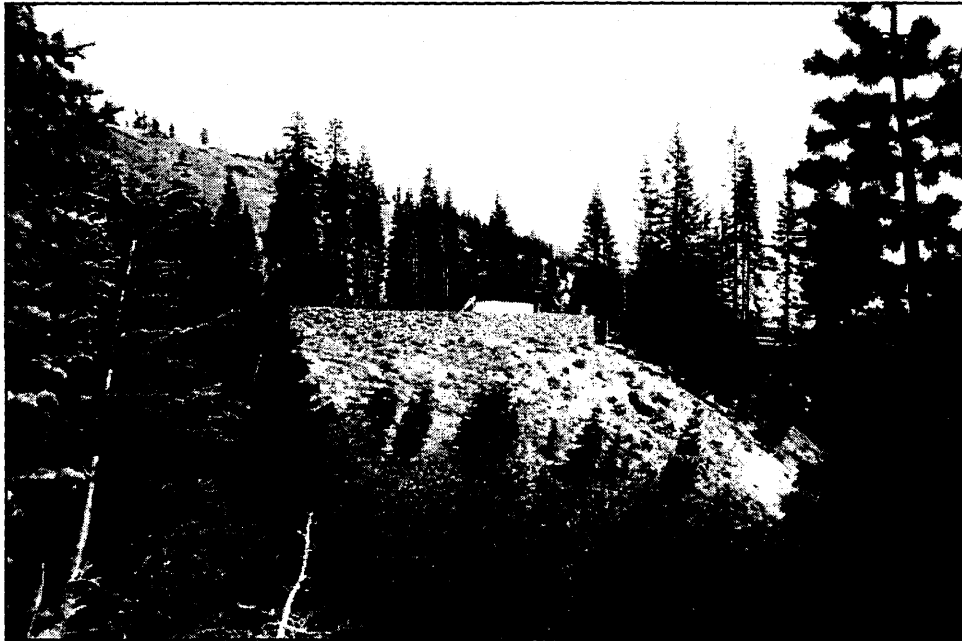
Photo 10: Guardrail near bridge project – Sulphur Works, view to east.

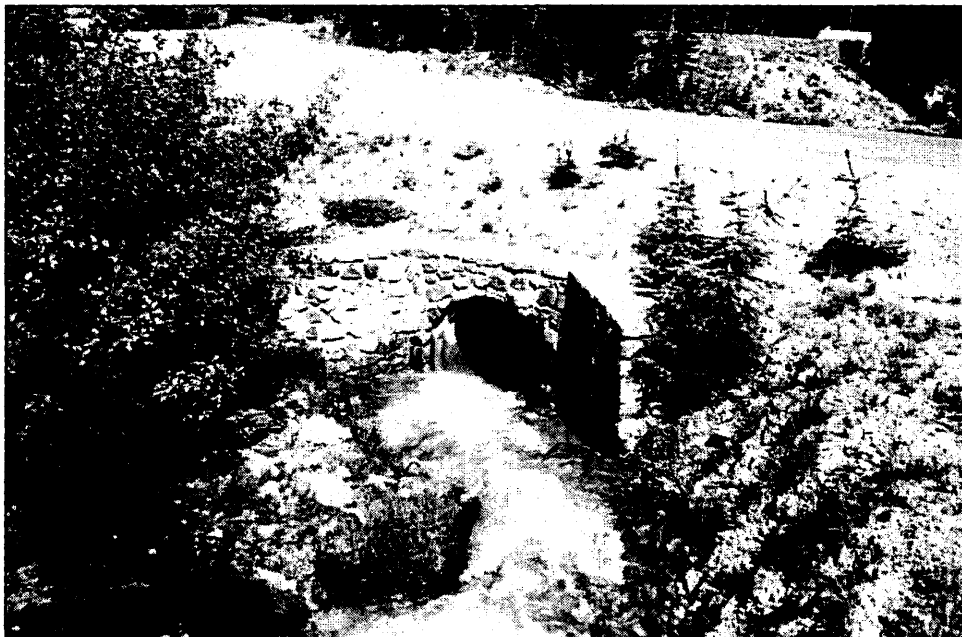
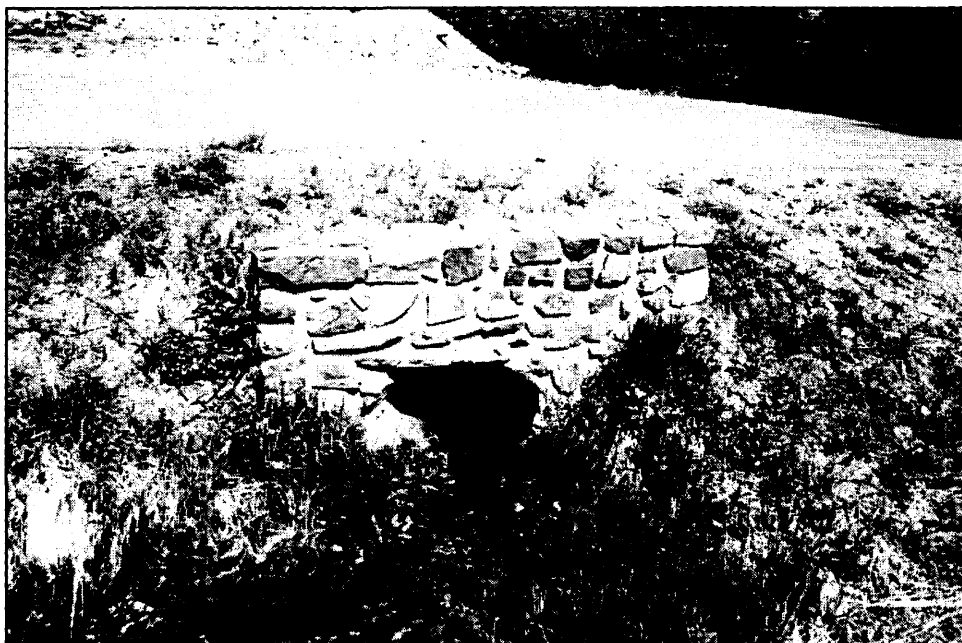
Photo 11: Stone Headwall on concrete culvert – on West Sulphur Creek, view to SE.

Photo 12: Stone Headwall on concrete culvert – on West Sulphur Creek, view to east.

Culvert headwalls and drainage culverts are the predominant National Park Service rustic design feature on the road. Headwalls were designed to serve a practical function as well as to produce an aesthetic effect; they provided passage for perennial and intermittent streams while masking the corrugated iron pipes within. The use of locally obtained lava rock was both an economic expedient and a design contrivance as it was readily available and served to blend the structures into the landscape. While headwall dimensions vary in relation to culvert diameter, the majority of

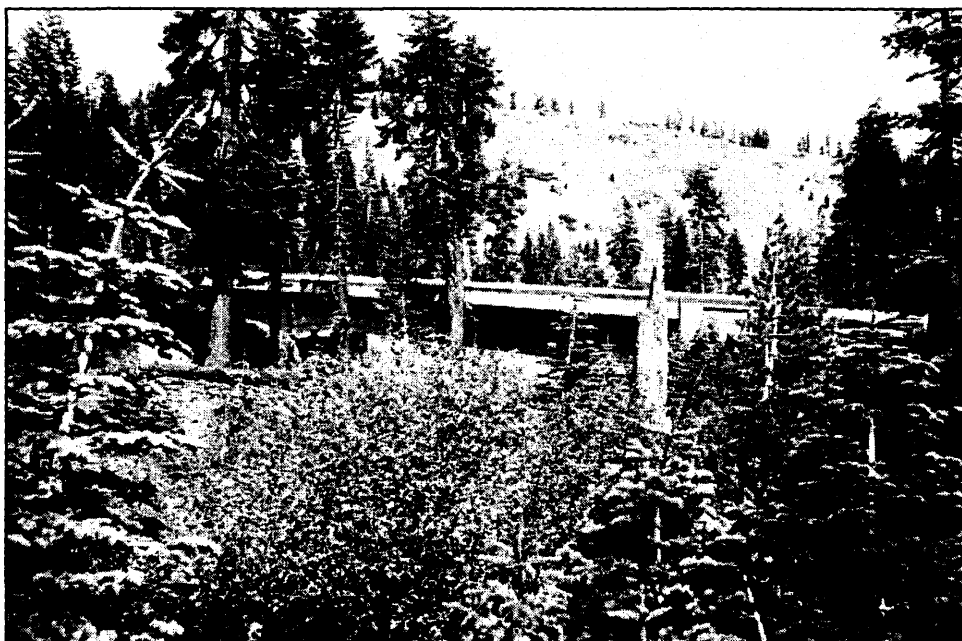
Photo 13: Bridge over West Sulphur Creek, view to east.

Photo 14: Concrete bridge deck, view to NW.

The Sulphur Works bridge replaced a large fill and culvert drainage system along the west fork of Sulphur Creek. Construction on the bridge began in 1964, and it was opened to traffic in the spring of 1966. The continuous deck steel stringer bridge spans 214 feet, 3 inches abutment-to-abutment. The design was based on the prevailing (1961) AASHO (American Association of State Highway Officials) standards for highway bridges. The concrete used for the footings and pier was classed as Type V Portland cement, a sulphate-resistant cementing material appropriate for the location.
