KENTUCKY HISTORIC RESOURCES Individual Inventory Form

Resource #	Ma-231
Madison	County

KENTUCKY HISTORIC RESOURCE INVENTORY SUPPLEMENT BOUNDARY AND LOCATION INFORMATION

Page 4 of 4 Ma-231 Taylor House

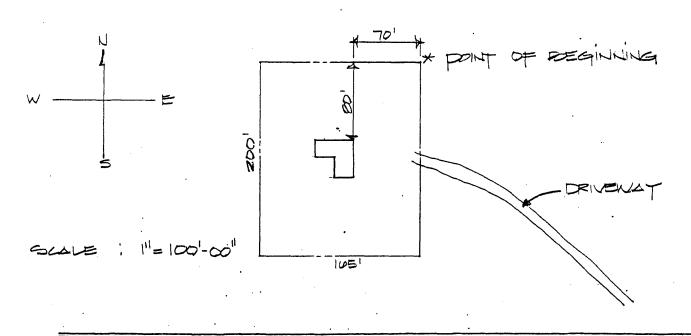
Sketch of Site Plan (Showing outbuildings, structures, landscape features and the site boundary as described above.)

Beginning at a point 80 feet north and 70 feet east of the northeast corner of the house; then south 200 feet to a point; then west 165 feet to a point; then north 200 feet to a point; then east 165 feet to a point.
