National Register of Historic Places Registration Form

historic name West Hill

street & number 1114 Oxmead Road not for publication

West Hill is a 2 ½-story brick Federal-style house with a center-hall, double-pile plan, a gable roof, and several stages of additions on the rear around an original one-story kitchen, as well as a one-story addition off the south elevation. The foundation is stone and brick, the walls are primarily brick, and the roofs are asphalt shingle. The symmetrical façade exhibits Federal detailing, including Flemish bond brick, a water table with molded brick wash, a string course, a central entrance with a fanlight and broken pediment surround, twelve-over-twelve sash windows on the first floor, and eight-over-eight windows on the second. (Photograph 3) Similar detailing, along with gable-end fanlights, characterizes the two side elevations. Federal period detailing is reflected on the interior of the house as well, with punch-and-gouge detailing on some of the fireplace mantels, fanlights over interior doorways, and other period trim. (Photographs 25, 26, 27, 29,30, and 36) The floor plan reflects the transition from earlier Colonial period arrangements t

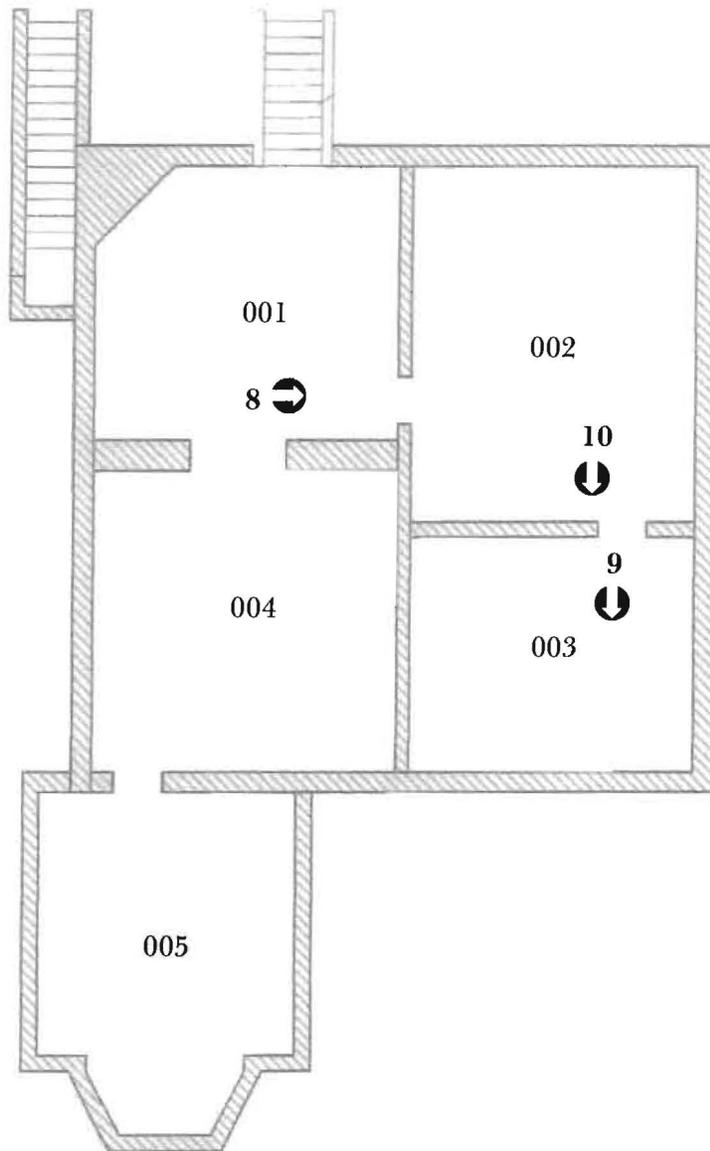
**Basement - Annotated**

The basement extends under the main block of the house as well as under the addition off the south elevation. (Photograph 17) The floors throughout the basement are concrete slab. The foundation walls of the main block are stone, while those of the addition are brick. The openings between the main basement rooms have round arches constructed of brick. These openings connect the northwest room (room 001) to the southwest (room 004) and northeast (room 002) rooms and the northeast to the south east (room 003) room. There is no connection between the two south rooms. A final opening between the southwest room and the addition basement room (room 005) is not arched and is trimmed in CMU. The ceiling in the southeast room (room 003) in the main basement is plaster with riven lath. (Photograph 18) The ceiling in the southwest basement room (room 004) has plaster on riven lath between the joists up against the floorboards for the first floor. There are no finish ceilings in the other rooms. Remnants of metal hardware at the openings into the south rooms indicate that doors once secured these openings. (Photograph 19) The evidence of doors and finish ceilings in those rooms suggest that they were used for storage. Interior access to the basement space is via a modern opening in

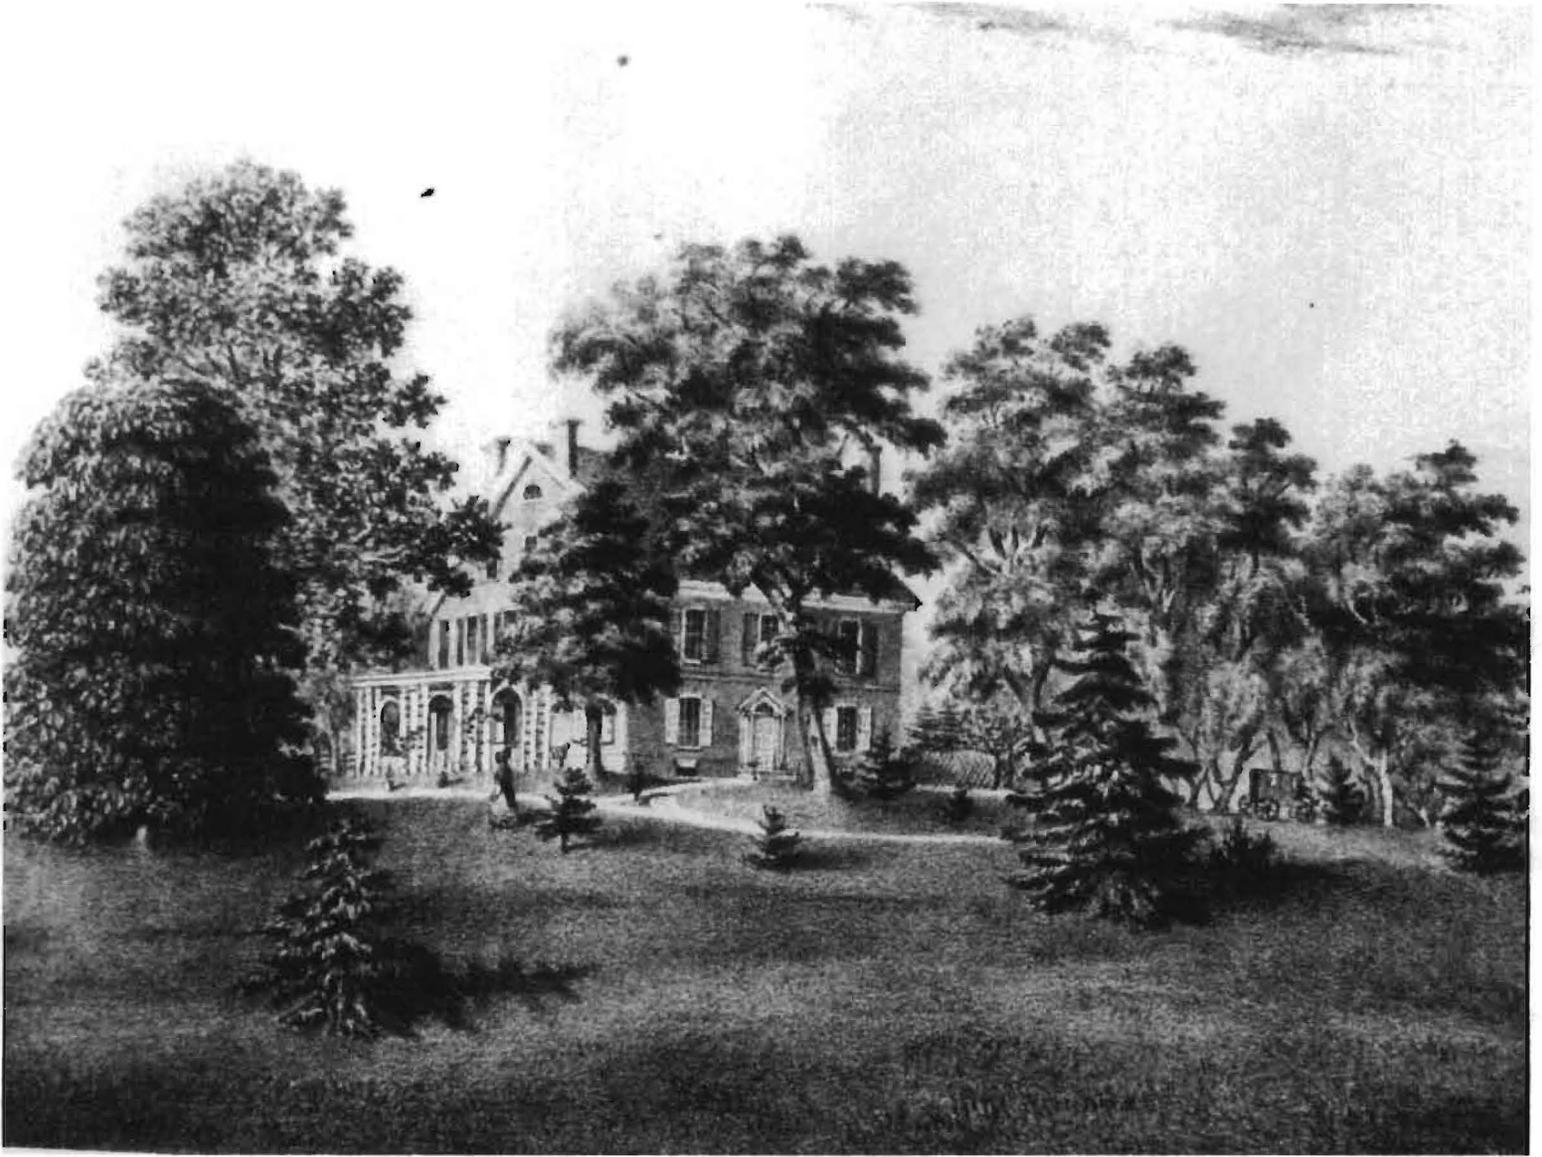
Undated drawing of West Hill showing a side porch, mature landscaping, a circular drive, and a carriage leaving the house.

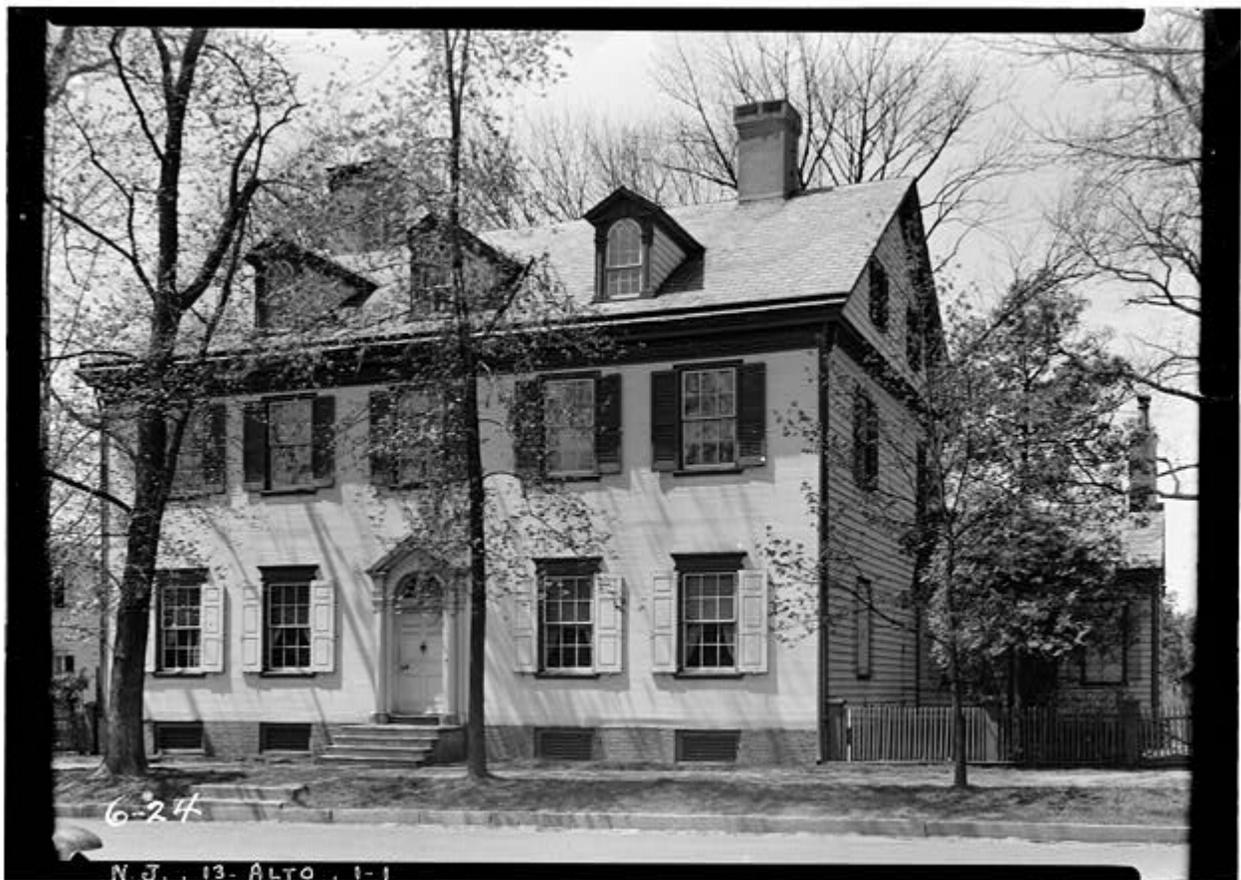
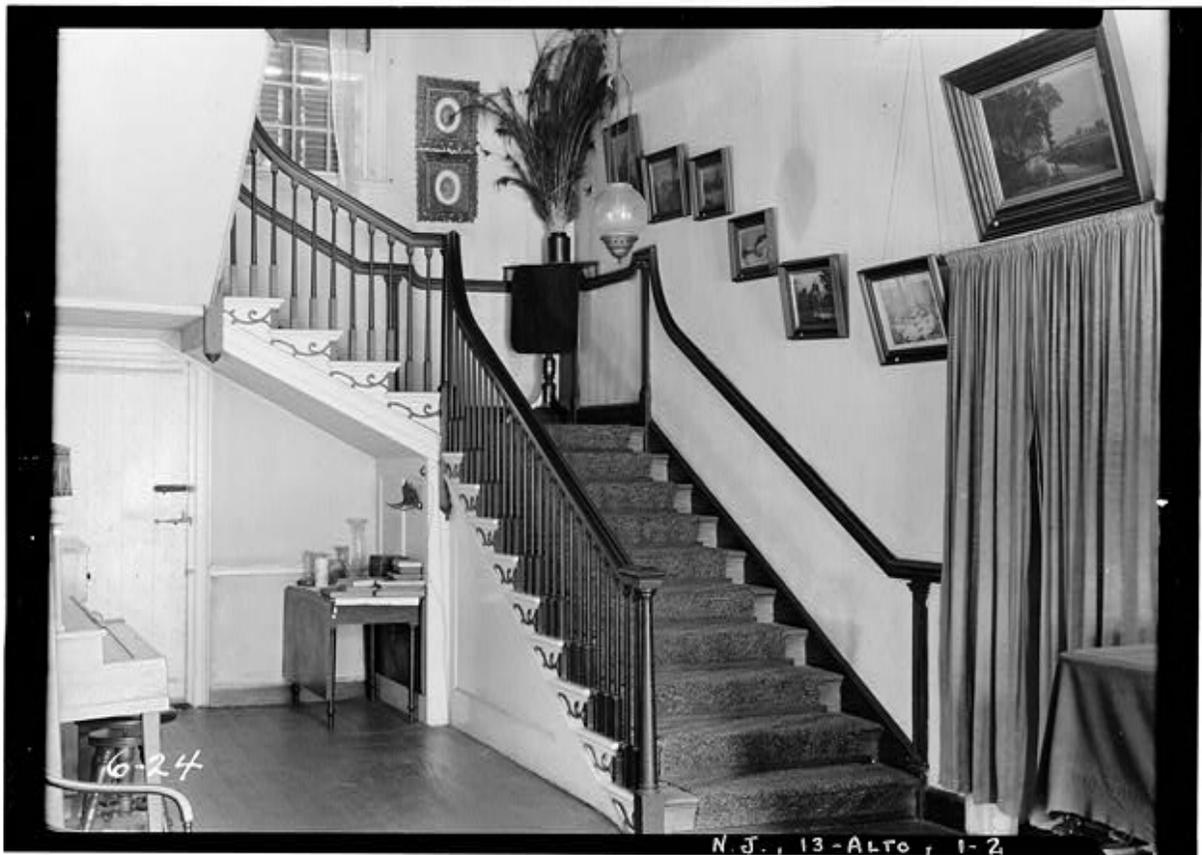
Supplemental Photographs #1 & 2

Imlay Mansion, Monmouth County, NJ

with broken pediment found at West Hill, but with much more intricate woodwork and delicate radiating webbing in the fanlight. Its windows are the more traditional six-over-six, double-hung sash with solid shutters at the first floor and louvered at the second and its three dormers have rounded arch windows and decorative surrounds. Its cornice is embellished with modillions. The kitchen was incorporated into the main block of the house, leaving only three formal rooms on the first floor. The interior finishes are elaborate with decorative overmantels around the fireplaces, cornices, and wainscoting or chair rails. The staircase is similar to that at West Hill, with turned balusters and a draped handrail and pilasters outlining the same pattern on the wall for balance. While not larger in overall size, the Imlay Mansion incorporates a higher level finishes that in turn gives it a formality not matched by other country houses of the period. It may also reflect the greater wealth of the John Imlay, who owned a prosperous shipping business.

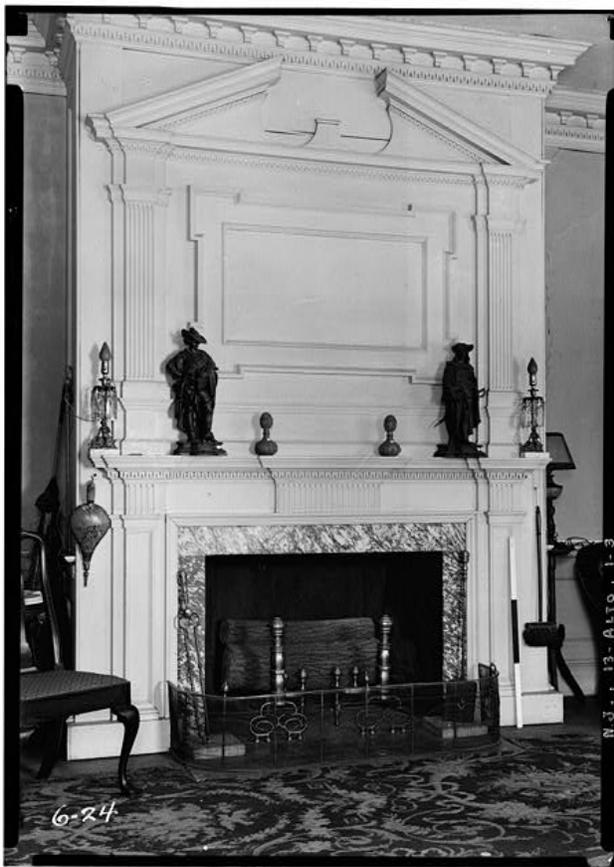
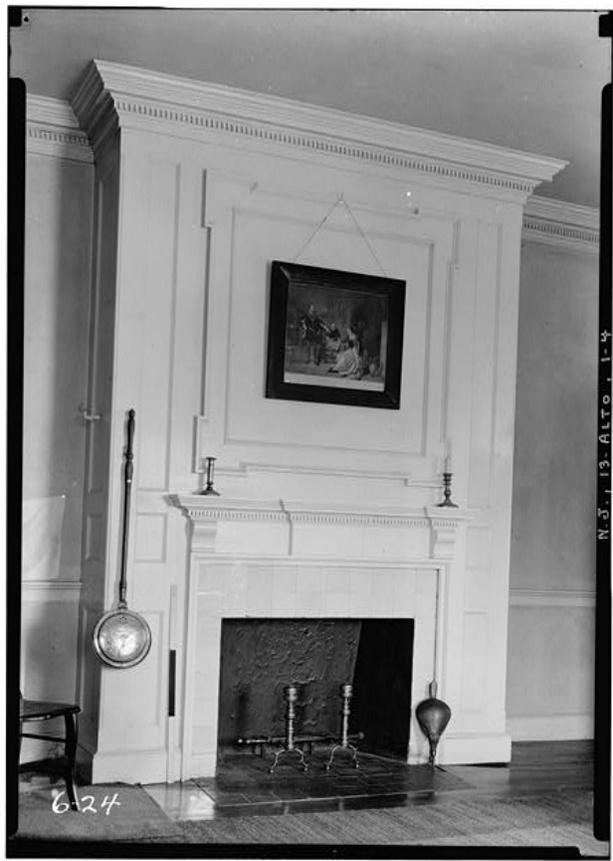
The Imlay Mansion (1790), located in Allentown, Monmouth County, is a five-bay, 2 ½ story frame example that shares some similarities with West Hill, but also exhibits a greater number of ornate finishes. (Supplemental Photographs 1 through 5) The house, constructed by another wealthy Philadelphia merchant, John Imlay, has a center hall, double-pile configuration and a symmetrical façade, as well as two small wings. Perhaps because it was constructed in frame, it has interior chimneys rather than interior end chimneys. It shares the six-panel door with fanlight and decorative surround

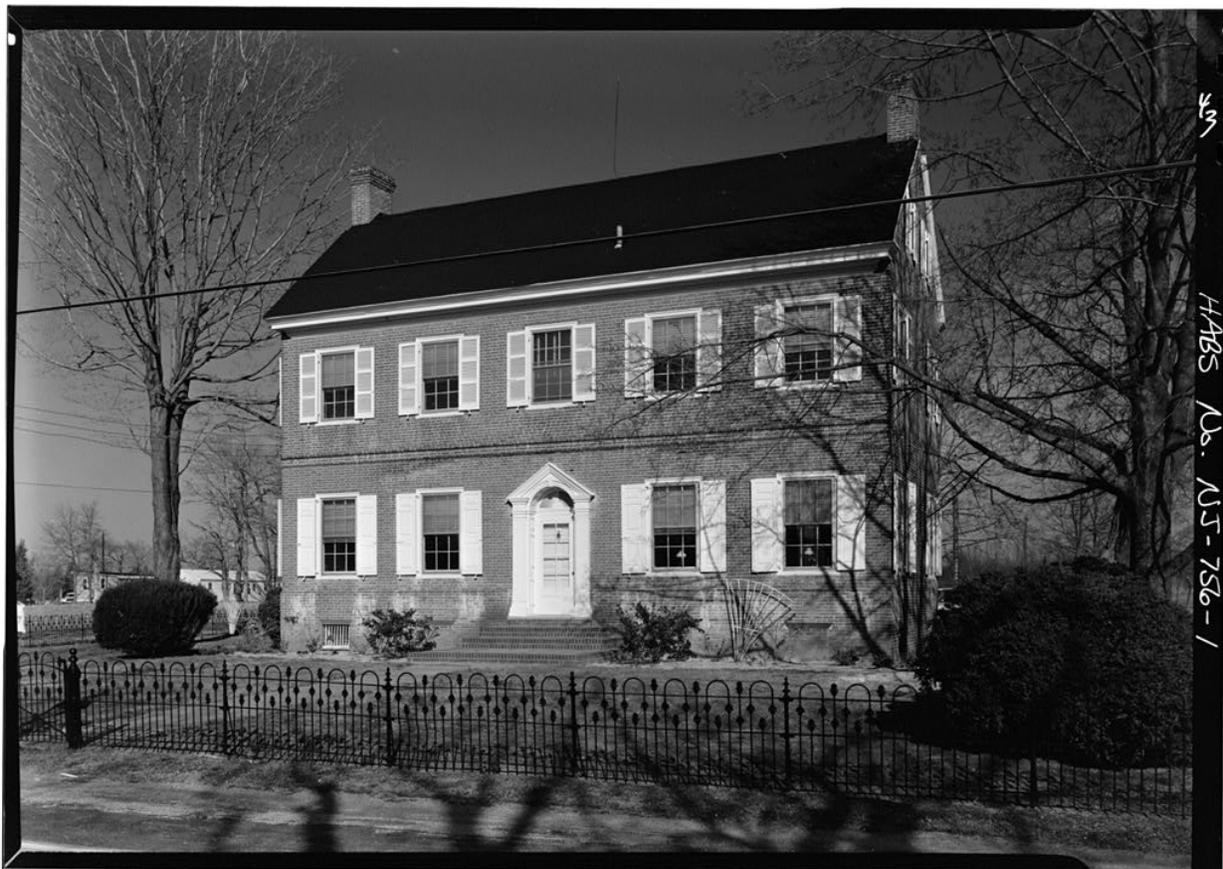
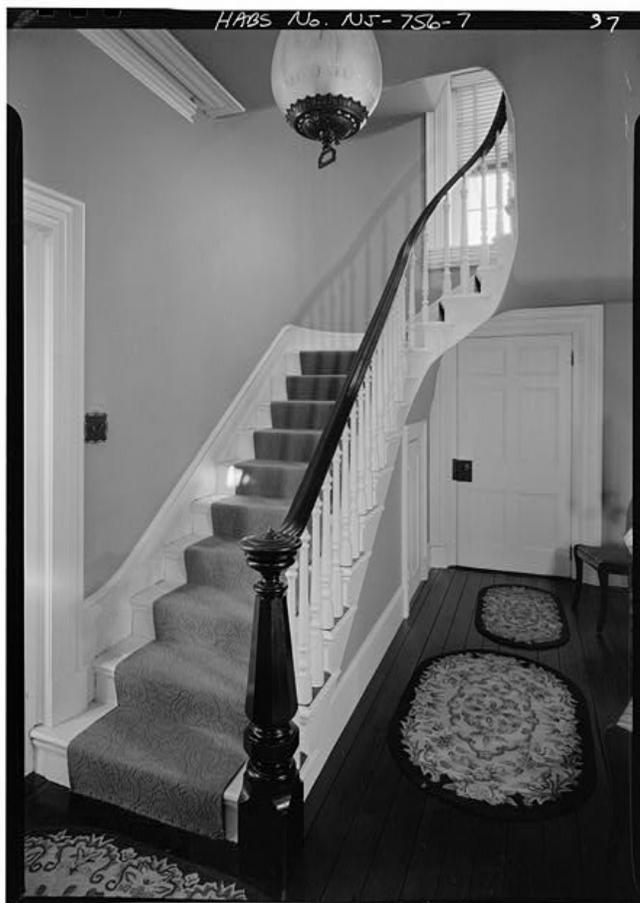
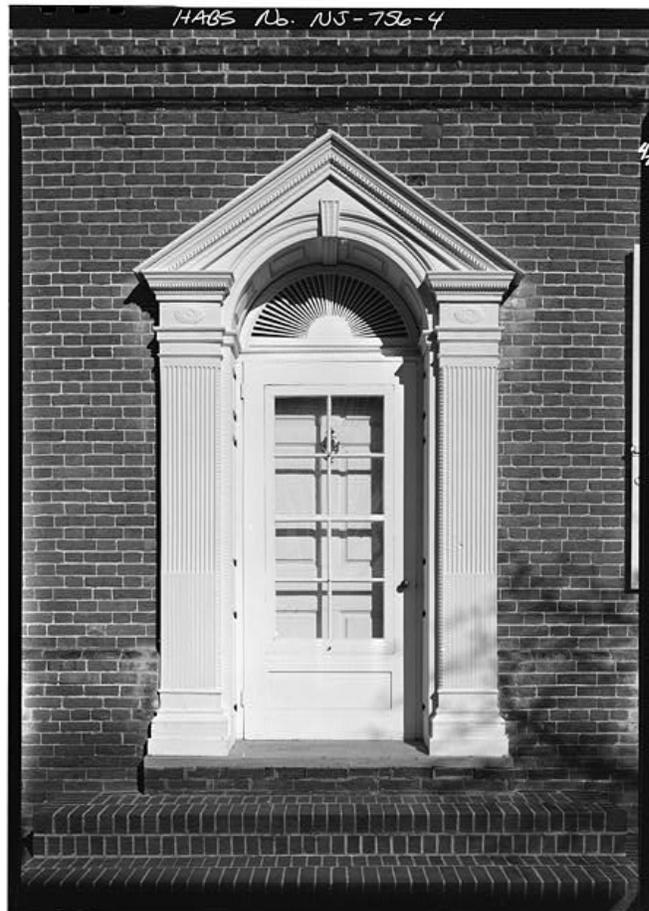
Supplemental Photographs #10, 11, & 12

Joseph Falkinburge House, Cape May County, NJ

The Joseph Falkinburge House (c.1806), located in South Dennis, Cape May County, is similar in type and finishes to West Hill. (Supplemental Photographs 10, 11, and 12) Joseph Falkinburge was, like Samuel Emlen, a wealthy merchant and gentleman farmer. Like West Hill, the house was representative of Falkinburge's wealth and status. The Falkinburge House, like West Hill, is 2 ½ stories, constructed in brick with a water table with molded wash, a string course, and laid in Flemish bond on the façade. The house also once had a rear kitchen wing that was later removed and replaced with other additions. This house, unlike West Hill, has more of a raised basement and only a single interior end chimney at each end. The house is only single-pile, allowing for a side gable roof that is lower than that at West Hill, which has to be higher to accommodate the greater depth. Like West Hill, it has a six-panel door with a fanlight transom, and broken pediment frontispiece. This frontispiece exhibits some decorative punch-and-gouge work. The windows are six-over-six, double hung sash with louvered shutters at the second

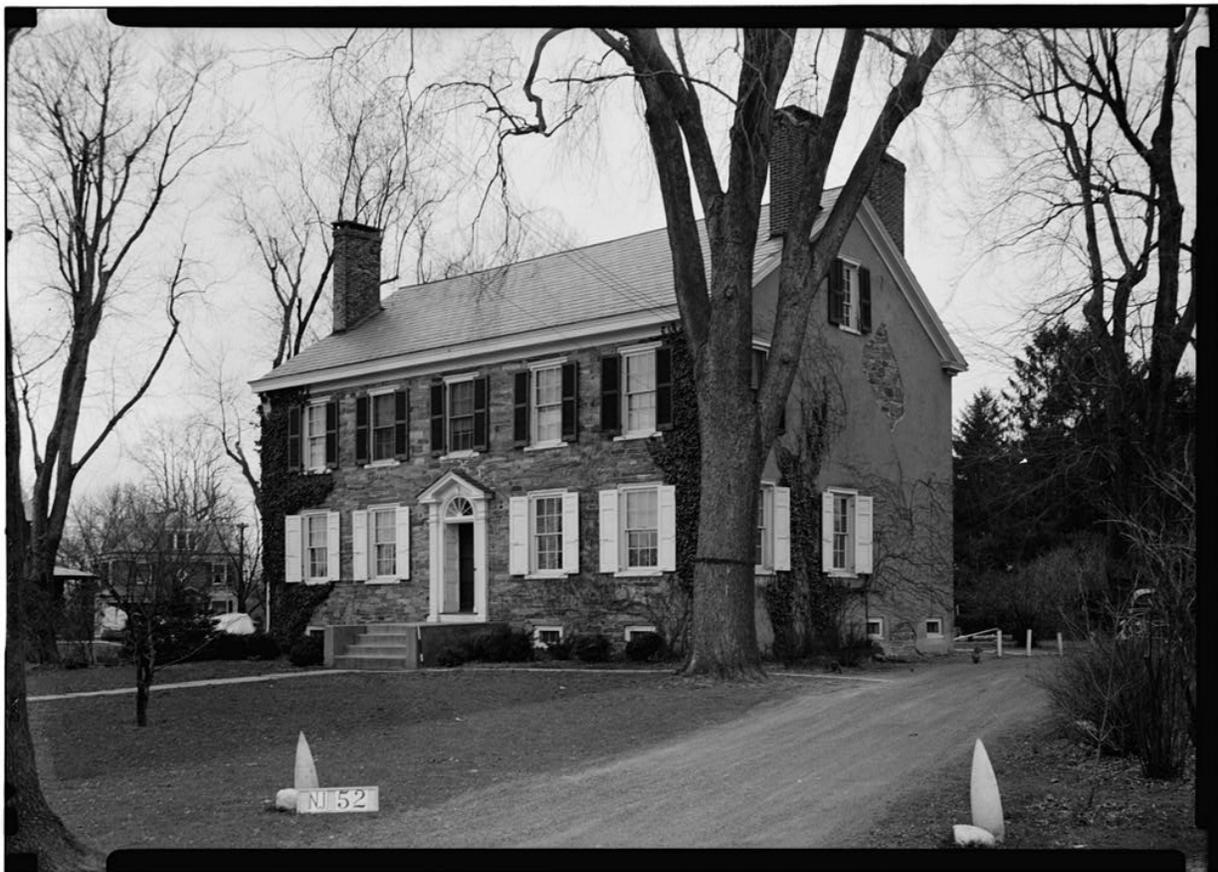
Supplemental Photographs #13 and 14

An example of the side hall Federal style house is the Collins-Jones House (c.1785, c.1808) in Burlington City, Burlington County. (Supplemental Photographs 13 and 14) Its Federal style details include a six-panel door with a fanlight transom, a one-bay entrance porch, nine-over-nine and nine-over-six, double-hung sash windows, dormers with round-arched windows and decorative surrounds, a side-hall plan with a half-turn open staircase, parlor wall fireplaces with interior end chimneys, elliptical arched openings on the interior, interior six-panel doors, and three-part fireplace mantels. As an urban, side-hall configuration plan, the Collins-Jones house is deeper than it is wide, like West Hill. West Hill is substantially larger than the Collins-Jones house, however, and was constructed as a country rather than town home.
