National Register of Historic Places Registration Form

historic name Veta Pass
other names/site number La Veta Pass, Old La Veta Pass, Uptop, 5HF.2410

Veta Pass-Uptop Historic District
 Name of Property

Huerfano County, Colorado
 County and State

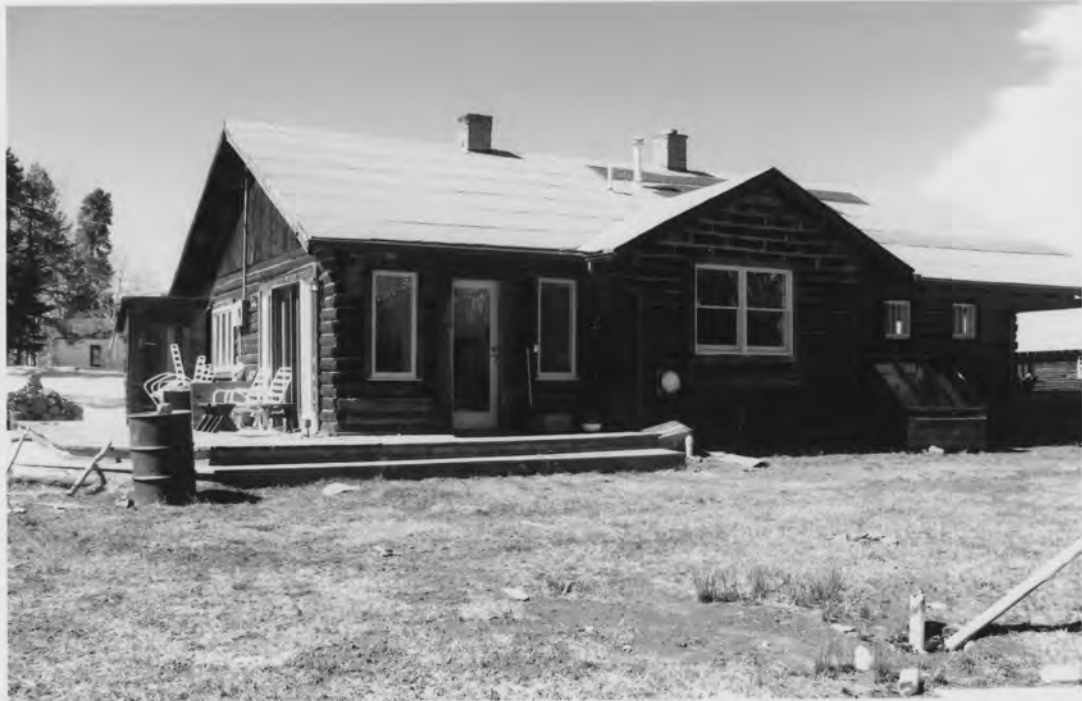
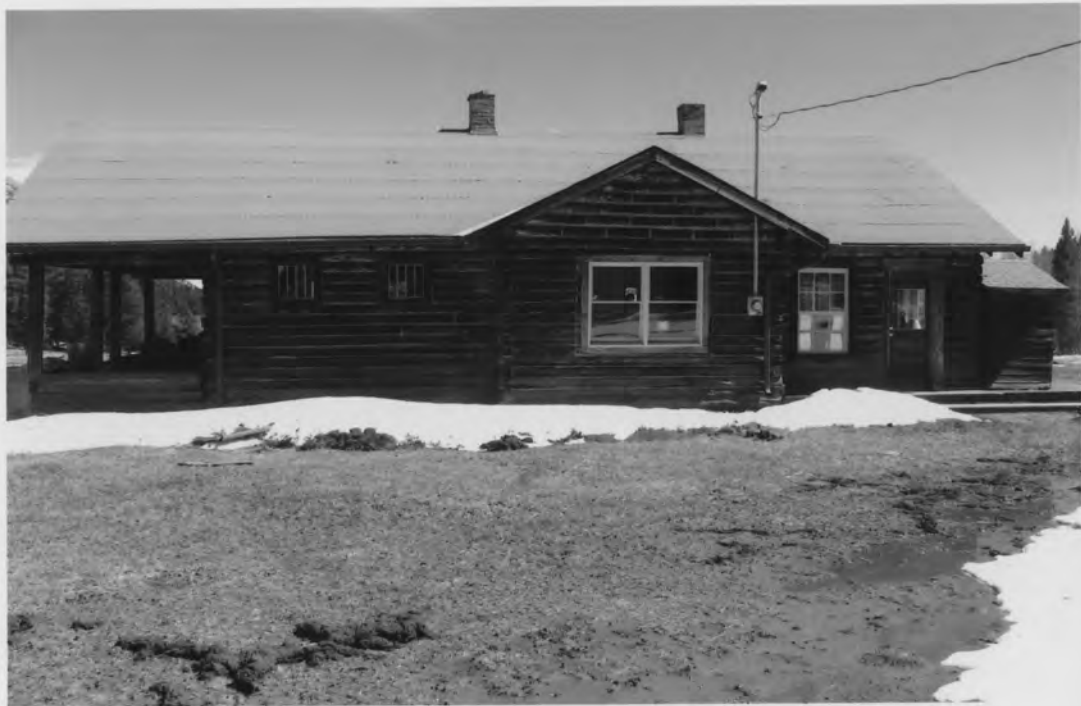
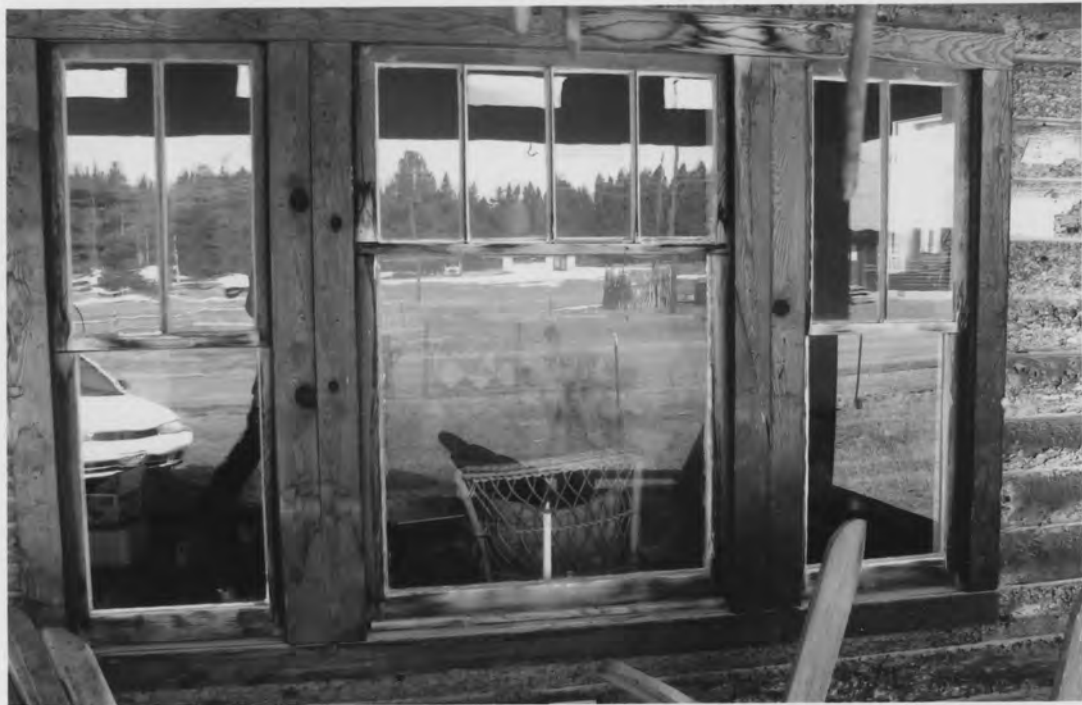
Head Quarters (HQ) is a large, rectangular chinked log building (28' x 40' including the portico) on a concrete foundation, running northwest to southeast (Photos 4, 5, 6). This building originally served as the headquarters for operations at this property when it was a stop for automobile tourists in the mid-twentieth century. The chinking was reapplied in 2003. The front-gable roof has a projecting side-gable on the east, and its original wood shake roof was replaced with rolled roofing in 2003. The building retains its original large front entry room with a brick chimney for a coal furnace and three smaller rooms in the back with a common brick chimney for wood stoves in each room. Original wood floors remain throughout the building.

When the property was purchased in 2000, many windows were missing and leaks had caved in the ceilings. As a result, all of the doors in the building and most of the windows were replaced in 2004 during interior remodeling in order to secure the interior and protect it from further intrusions. The back three rooms of the cabin have been remodeled with two vinyl sash windows, two vinyl casement windows and a wood and glass door installed on the east wall and on the west wall, three sash windows and a half-glass wood door. On the south wall, vinyl French doors with side lights have been added along with two original wood casement windows. The doors lead out to a wrap-around deck on the southern end of the building; the deck was widened from the original deck in 2004. While most of these exterior changes were intended to stop further deterioration of the building, all are reversible and do not overly impact the integrity of the resource, which is still able to speak to its historic associations.

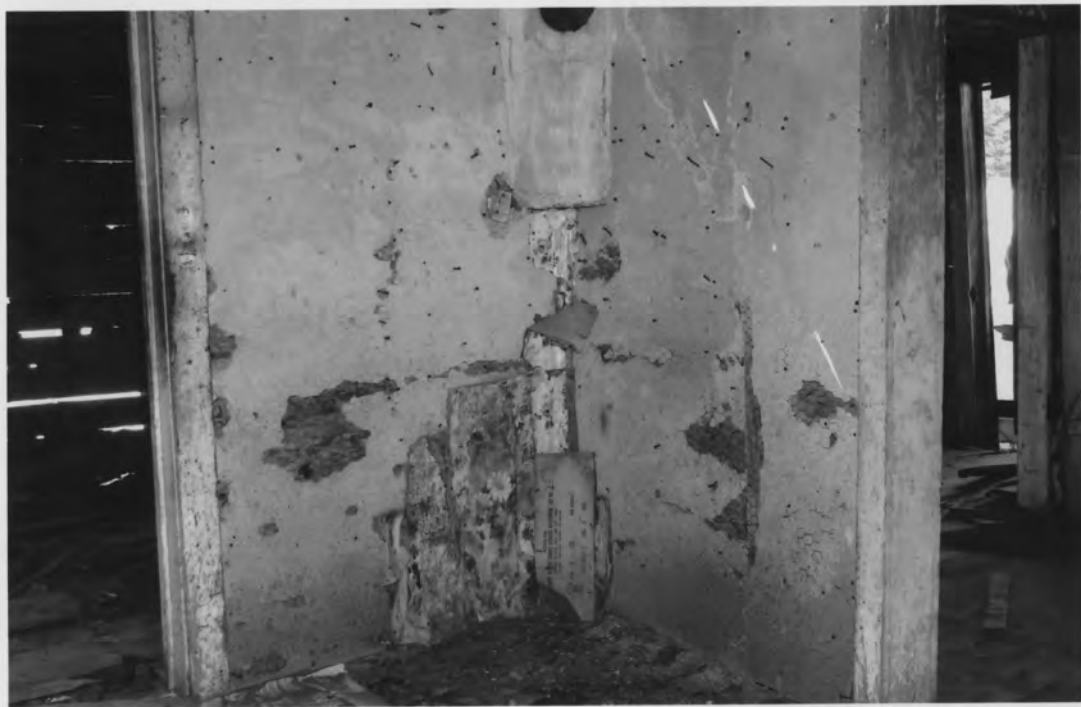
Veta Pass - Uptoy Historic District 29
Huerfano County, Colorado

around 1940 by moving together two smaller log cabins extant on the property that dated from the 1920s, adding onto the east end of one and putting them under a common hipped roof of asphalt shingles, which remains intact (Photo H007). In this process the existing roofs of the cabins were never removed, producing an odd combination of interior roof lines in the attic. At the same time a 40' x 33' extension for a dancehall was built on the center of the north side of the building and covered with a continuous, adjoining gabled roof. Externally, the tavern looks all of a piece; internally, a 3' gap exists where the two cabins come together (Photo 29).

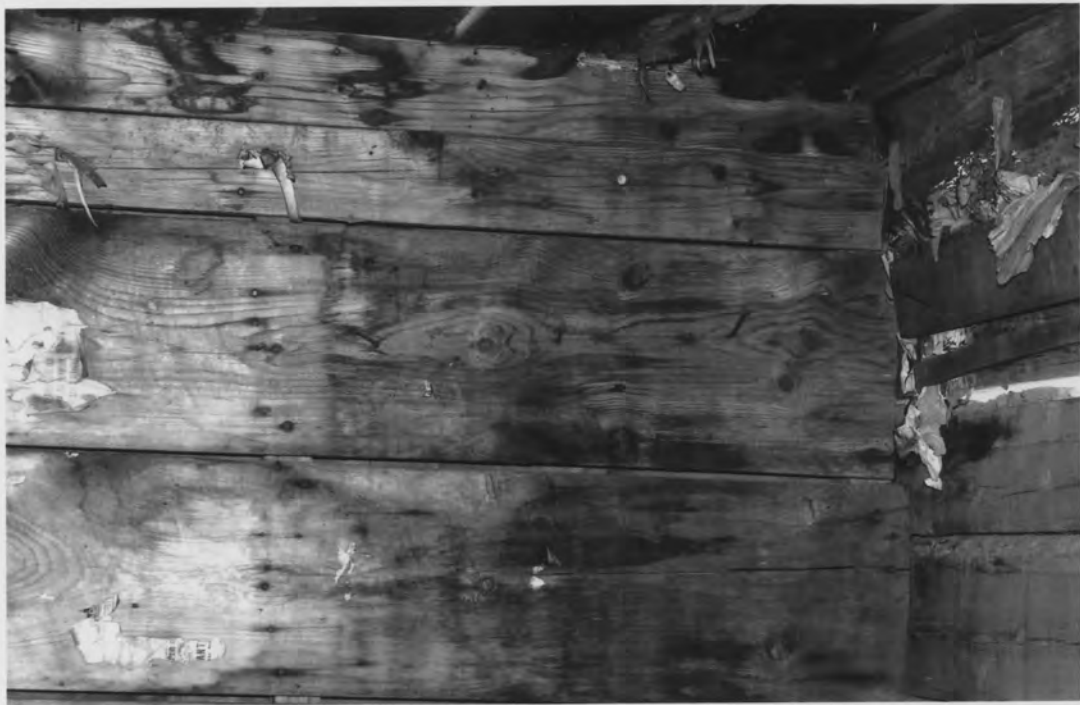
Veta Pass - Uptop Historic District 30
Huerfano County, Colorado

A 40' x 33' dance hall extends from the back of the tavern. Seven original wood windows are located on the dancehall's east, north, and west sides. Each window is a two-sectioned, three-over-three sliding window (Photo 30). A wood double door that opens out is also on the east side, close to where the extension joins the tavern. The building has a single brick chimney that served a coal furnace in the dancehall. The floor of the dancehall is made of maple, imported from Missouri, to provide a quality dancing surface. The rest of the building has pine floors. The foundation is concrete with a negligible crawl space underneath. Sometime in the 1970s, squatters pulled down the smoke-stained ceiling panels, exposing the rafters. A small raised stage is located in the northeast corner of the dancehall (Photo 31).

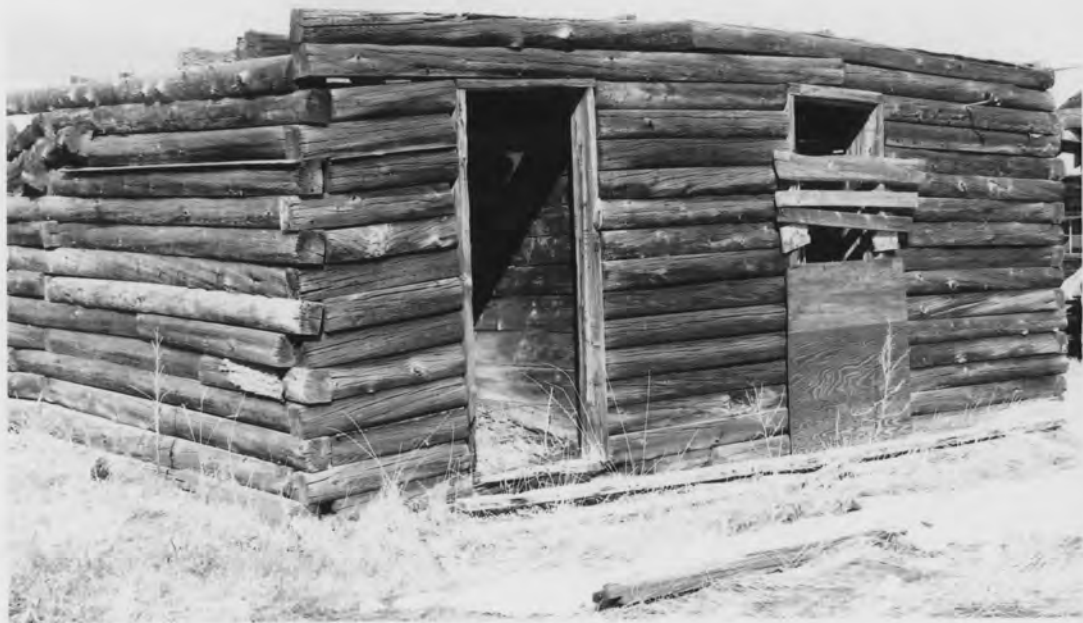
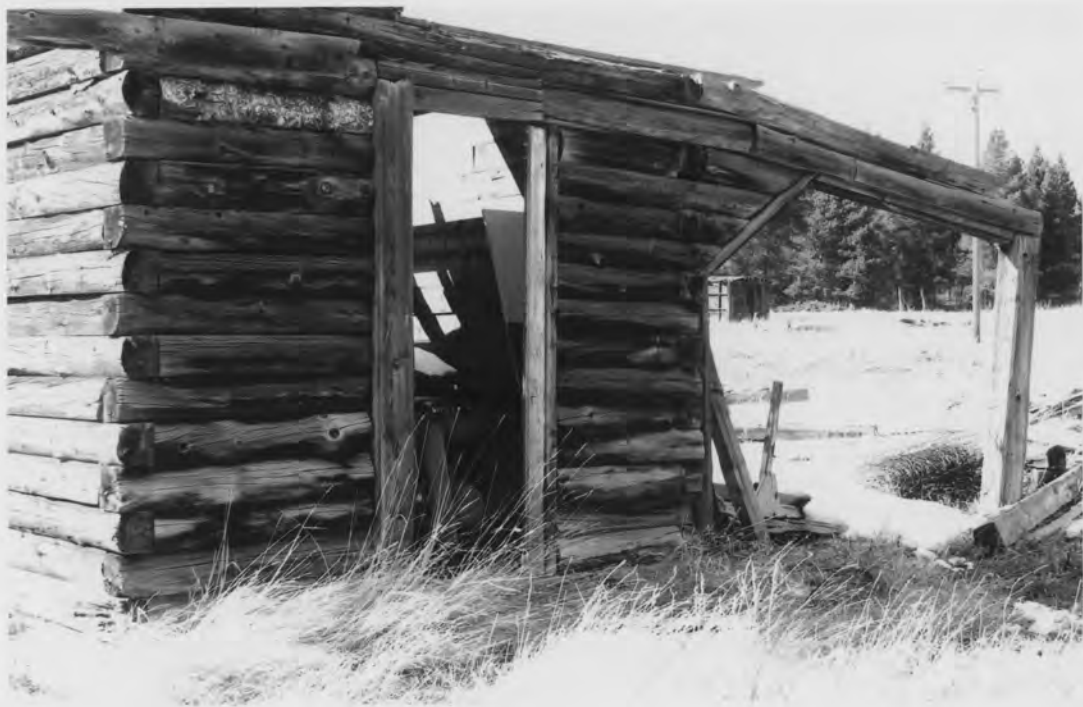
The bunk house is a square log cabin (24' x 25') with no foundation (Photos 33, 34). It has a front-gable roof on which only a few wood shakes remain, pierced by a central brick chimney, which opened into four rooms, each one a separate living quarters (Photo 35). All four sides have windows that are badly deteriorated, as are the three exterior wood doors (south, east, north), and the flooring. Inside, the rooms have patches of period wallpaper that was often put over old newspapers. Newspapers were also used as chinking throughout (Photo 36). The southeast room has an interior access to a root cellar in its southeast corner. No changes have been made to this building, allowing it to retain a "ghost town" feel.

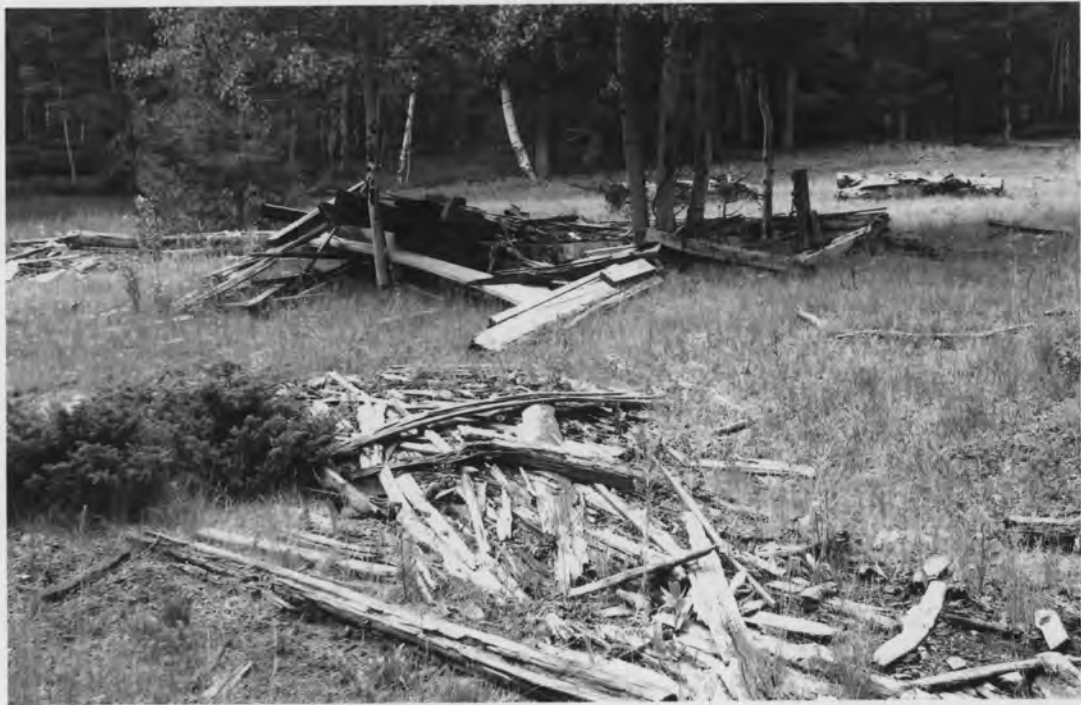
38

The miner's cabin is a slightly rectangular, one-room building (13' x 15'), made of lapped rough-sawn, 4"-wide lumber (Photo 37, 38). Originally a boxcar that has been repurposed as a cabin, the wood shake roof is slightly curved. The building has two window openings that are lacking glass and two damaged doors. A serious fire blackened nearly the entire interior but left the outside unscarred (Photo 39). There is no chimney and no foundation, the boxcar does not retain its truck and sits at grade.
