**HISTORIC RESOURCES INVENTORY  
BUILDING AND STRUCTURES**

1. BUILDING NAME (Common) \_\_\_\_\_ (Historic) Jonathan Root House (Josiah Root per WPA map)

2. TOWN/CITY Southington VILLAGE Southington 06489 COUNTY Hartford

3. STREET AND NUMBER (and/or location) 140-142 N. Main St. (map 108, parcel 52) 0.45 acre

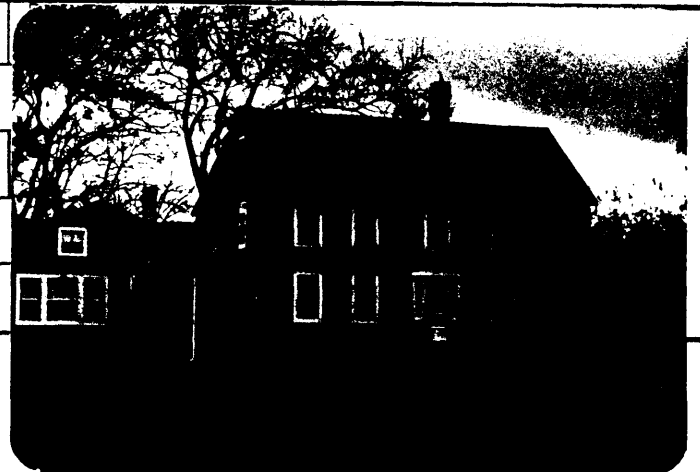
S-25

The house has five bays of 12/12 windows. The Colonial Revival central doorway is new. The chimney is small and offset to the right, the original central chimney having been removed to make way for a central hall. The rear roof slope was raised in 1942 and the front porch, seen in the photo attached to the WPA form, was removed c. 1960. On the interior a stairway rises against the left wall of the new central hall, in the Georgian Revival manner.

Northwest
