National Register of Historic Places
Registration Form

historic name Herron, Anna Farm

Herron, Anna Farm, West Hanson Township, Brown
County, South Dakota

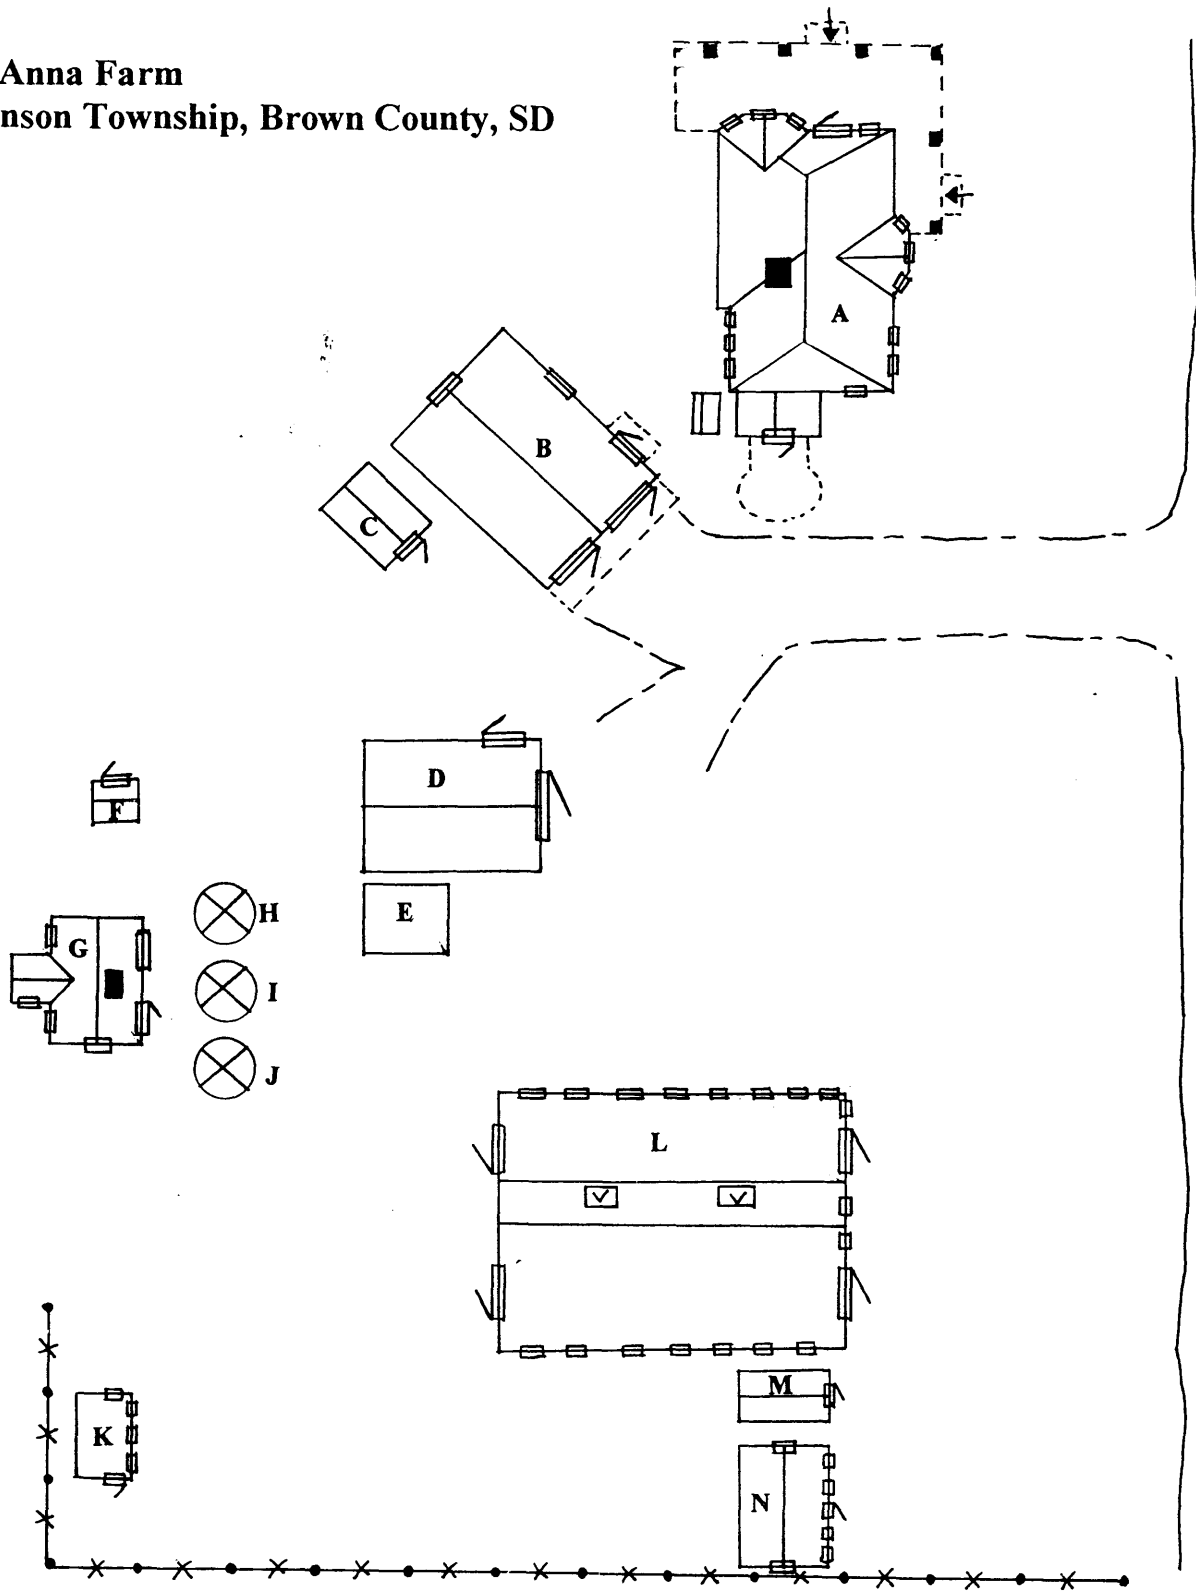
**Herron, Anna Farm
West Hanson Township, Brown County, SD**

| A = House (contributing) | G = Old House (contributing) |
