National Register of Historic Places Registration Form

Historic name: Mill Hill

Other names/site number: High View; 062-0045

City or town: Roseland State: VA County: Nelson

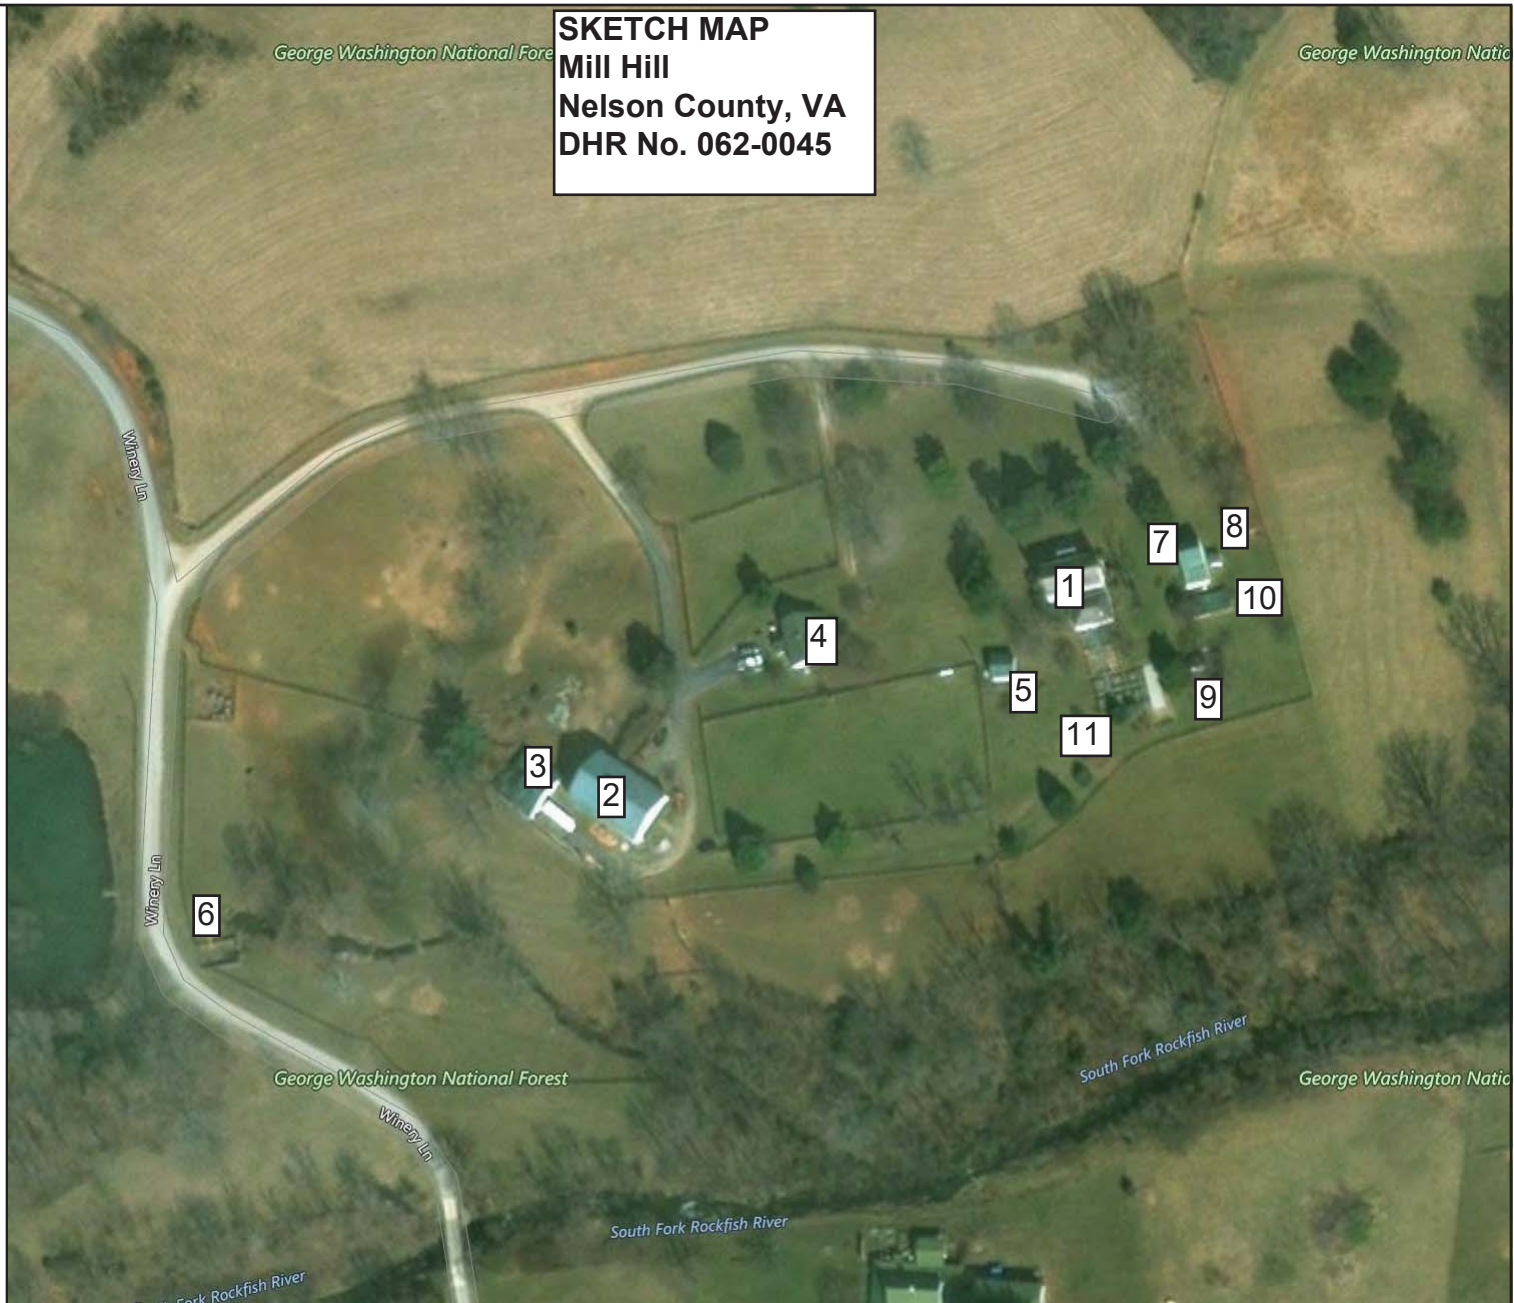
SKETCH MAP
Mill Hill
Nelson County, VA
DHR No. 062-0045

1. Main house, contributing building, ca. 1840.
2. Bank barn, contributing building, ca. 1840.
3. Horse barn, contributing building, ca. 1870.
4. Slave dwelling, non-contributing building, ca. 1840.
5. Schoolhouse, contributing building, ca. 1840.
6. Stone foundation/ruin, contributing site, ca. 1845.
7. Ice house, contributing structure, ca. 1840.
8. Privy, contributing structure, ca. 1840.
9. Dog run, contributing structure, ca 1920
10. Poultry house, contributing structure, ca 1920
11. Garden and Bocce Court, non-contributing site, ca. 2000
