NATIONAL REGISTER OF HISTORIC PLACES
INVENTORY -- NOMINATION FORM

Don Fernando Pacheco Adobe

3119 Grant Street

Concord

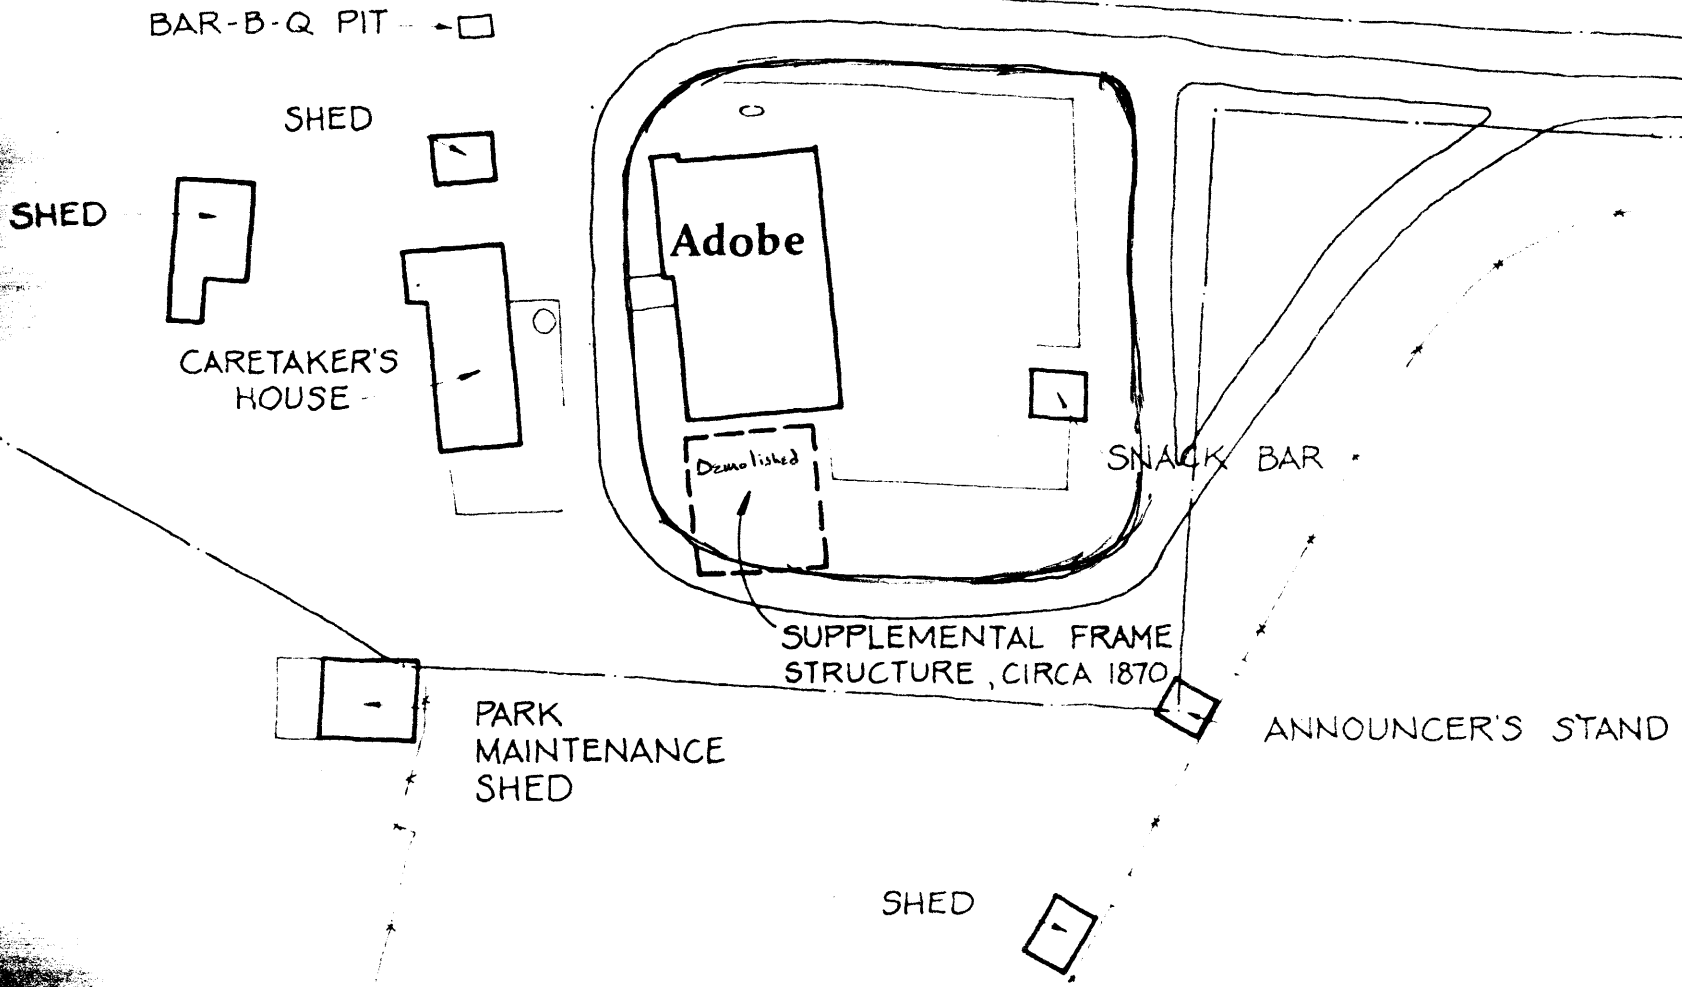
POSSIBLE ZONE OF
OUTHOUSE AND OTHER
ANIMAL SHEDS

Outbuildings would have been constructed at the same time as the adobe. From the configuration of the property, it is assumed that an outhouse and stables or animal sheds would have been located downwind from the main adobe building (wind generally coming from the west or southwest), and possibly also downhill. These assumptions would place sites for these outbuildings down toward the stream in what is now Hillcrest Community Park.
