# National Register of Historic Places Registration Form

Historic name: Montgomery Hall Park

Other names/site number: DHR No. 132-5023

Street & number: 1000 Montgomery Avenue

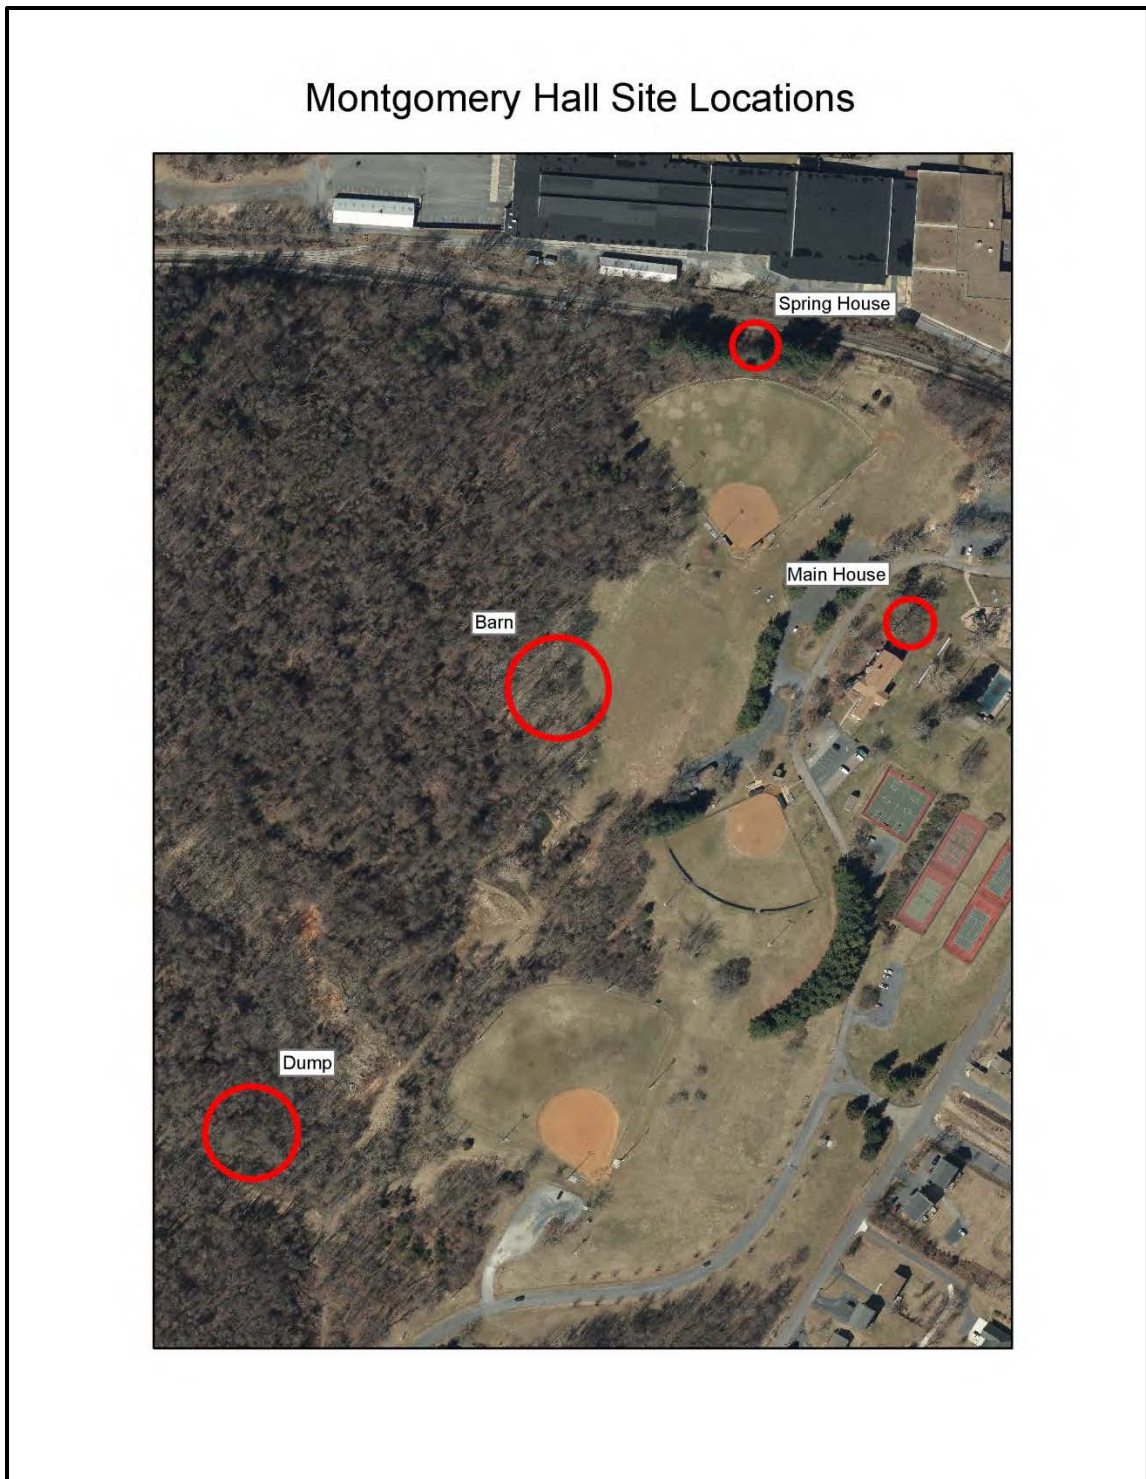
Figure 2. Locations of identified sites.

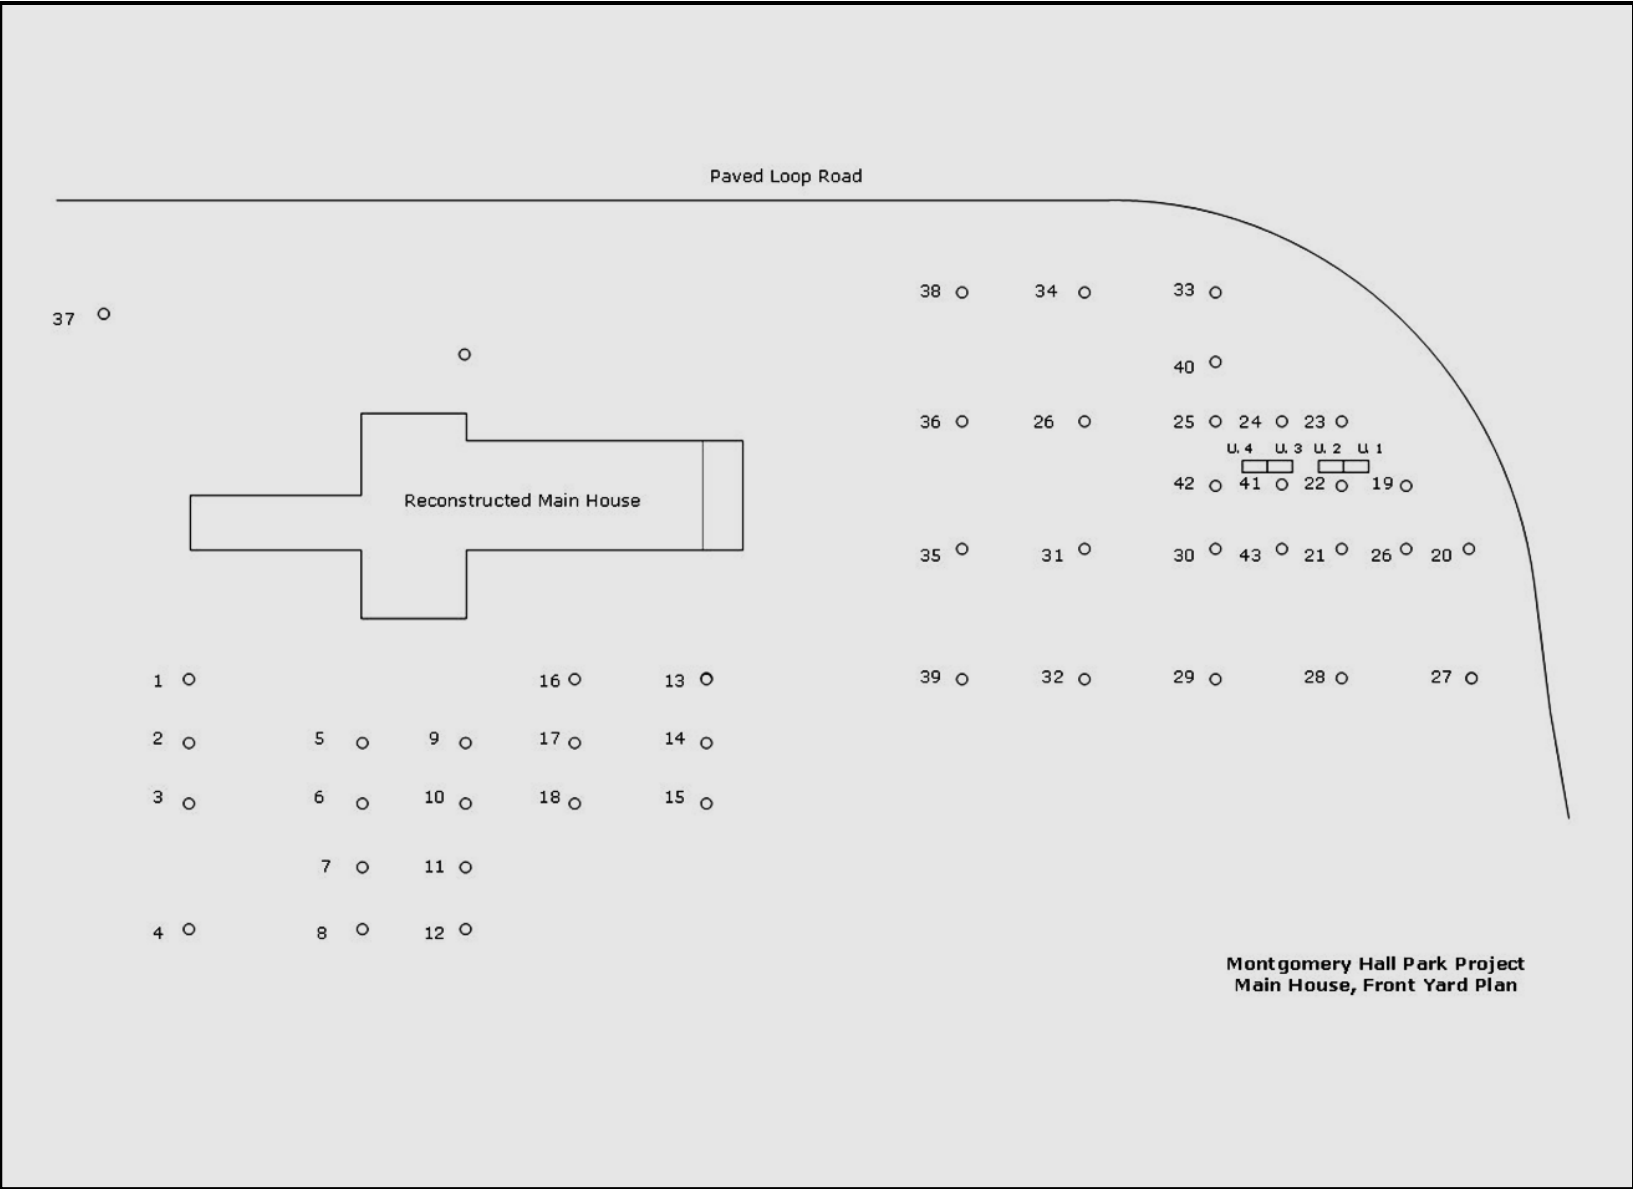
Figure 10. Main House, Plan of investigation.
