f	••• ·	JAIA SI	a main provide to the test	
Form 10-306 (Oct. 1972)		TES DEPARTMENT		OR	TATE:		<u> </u>
		ISTER OF HIST			COUNTY:		
NA		Y – NOMINATIO		' 			
;		EDERAL PROPER		E	FOR NPS U		
6	Type all entries	s - complete appli	cable sections)		AUG	1 1975	
COMMON:							<u></u>
		Blockhouse	Site	· · ·			
AND/OR HIST	· · · · ·					ŕ

TELLICO BLOCKHOUSE HISTORIC SITE

STABILIZATION

Richard Polhemus McClung Luseum Department of Anthropology University of Tennessee Knoxville, Tennessee May 22, 1974

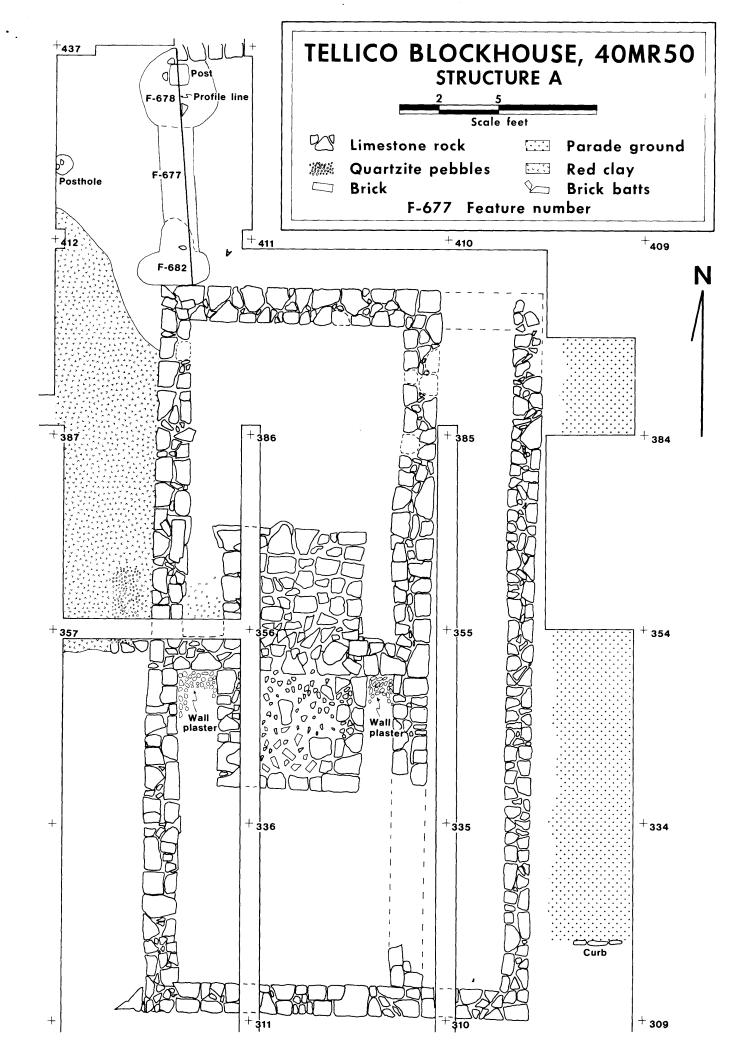
- Figure 3 Excavation plan of the Structure A area.
- Figure 4 Excavation plan of the southwest bastion and Structure B area.
- Figure 5 Excavation plan of the Structure C area.

Structure A consists of the limestone foundation for an horizontal log building two stories in height located south of the main gate (Figure 2). The structure is made up of a pair of rooms flanking a double hearth chimney foundation and a porch is present along the east side. A door way is situated near the center of the west or outer wall of the building and opens into the north room (Figure 3).

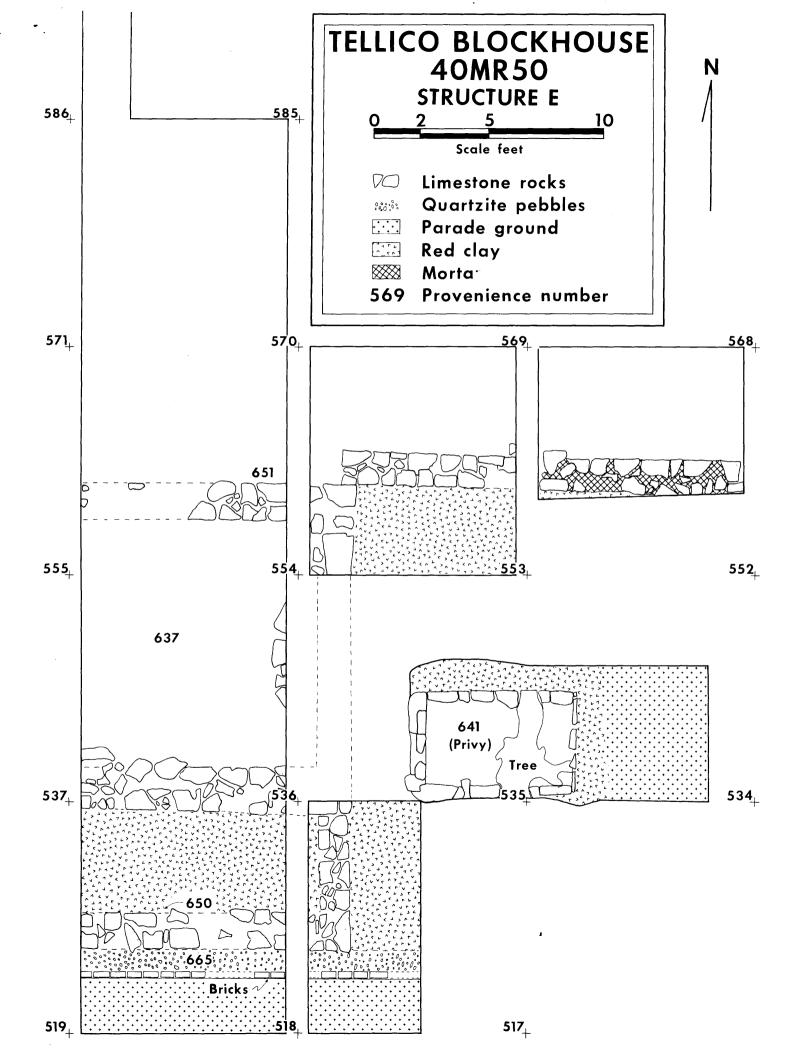
- Figure 6 Excavation plan of the Structure D area, excavated portion.
- Figure 7 Excavation plan of the Structure E area, east end, and privy.
- Figure 8 Excavation plan of the northwest bastion area including the west end of Structure E and Structure F.

of the north fortification wall (Figure 2). This structure is represented by limestone foundation walls and a central double hearth chimney foundation (Figures 7 and 8). The building is 60.0' in length and 20.0' in width. The central portion of the structure has not yet been excavated and, as

Structure E consists of a two story horizontal log structure with a porch along the south side making up most of the north fortification wall (Figure 2). This structure is represented by limestone foundation walls and a central double hearth chimney foundation (Figures 7 and 8). The building is 60.0' in length and 20.0' in width. The central portion of the structure has not yet been excavated and, as a result, estimates concerning stabilization may change after complete excavation in the summer of 1974. The walls average 1.5' in thickness and much of the north wall and west end of the foundation will need to be replaced. The west foundations were deposited in the well in the northwest bastion in an attempt to bring the land back into cultivation during the depression. The south walls and east wall will need to be stabilized and perhaps a course added to raise the foundation above the surrounding ground surface. The chimney foundation should be stabilized and should be well enough preserved to make any additions unnecessary. The size of the chimney has not been determined through excavation but should approximate that of Structure A.

North Wall	60.0' x 1.5' x 1.5'h.	needs replacement throughout
East Wall	20.0' x 1.5' x 1.5'N - 1.0'S	needs some stone
West Wall	20.0' x 1.5' x 1.5'N -	
South Wall	1.0'S 60.0' x 1.5' x 1.0'	needs replacement needs some stone
South Porch Wall	60.0' x 1.5' x 0.5 -	
Chimney (approx.)	0.75' 7.0' x 13.0' x 2.0'	needs some stone needs some stone

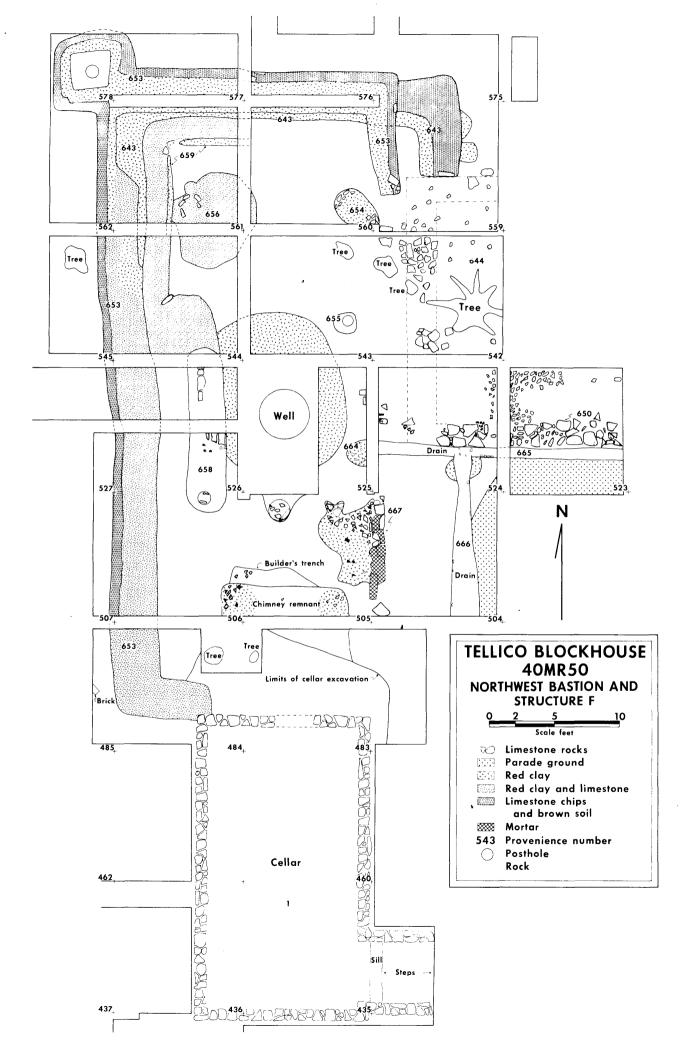
The last phase of the northwest bastion consists of an unequally faced extension of the northwest corner capped by a small bastionette (Figure 2). The north face of the bastion is 25.0' in length; the south face 50.0' in length and both flanks are extended 5.0' out from the adjoining wall line. The bastionette is 4.0' on a side, flanks and faces, and is centered on a large posthole (1.5') which may be for a swivel

gun mount. Figure 8 illustrates the form and position of the northwest bastion.

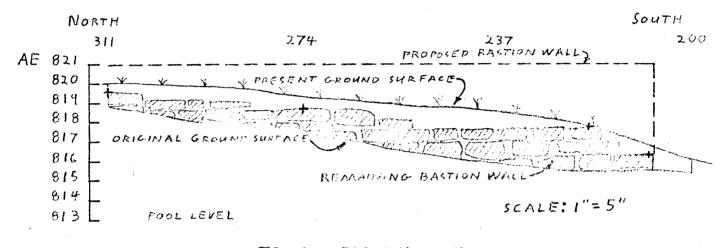
FIGURE 11

SOUTHWEST BASTION: SCHEMATIC PROFILE OF THE WEST. FACE, PROVIDING ELEVATIONS ON STONE REPLACEMENT. Cotter, John L.,Archeological Excavations at Jamestown Colonial1958National Historical Park and Jamestown NationalHistoric Site, Virginia.Archeological ResearchSeries Number 4, National Park Service, U.S.Department of the Interior, Washington, D.C.

- Figure 11 Schematic profile through the southwest bastion providing elevations on stone replacement and bastion fill.

Comment: The amount of wall to be rebuilt is about 5' to 6' high on the south side and becomes less as one moves up the west wall to the north, until it is about 1' above the outer ground surface. See schematic profile Figure II. Structure 3:
