National Register of Historic Places Registration Form

Historic name: Warm Springs Bath Houses 2019 Boundary Increase

Other names/site number: DHR No. 008-0007

City or town: Warm Springs State: VA County: Bath

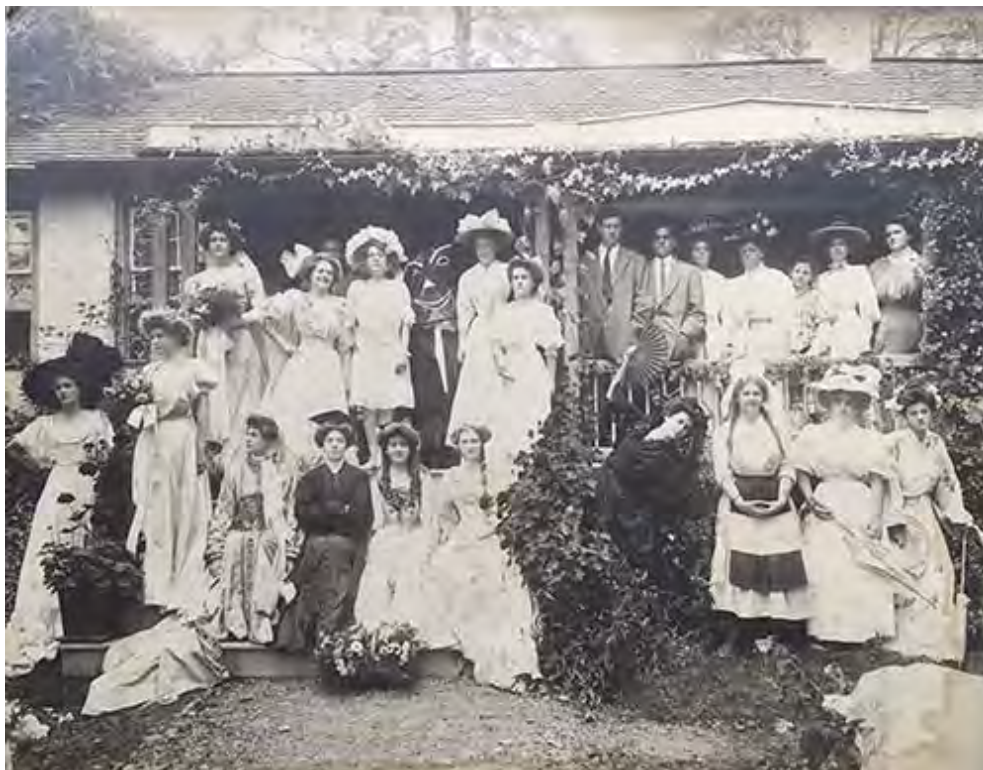
Gibson Cottage, early twentieth c., Bath County Historical Society.

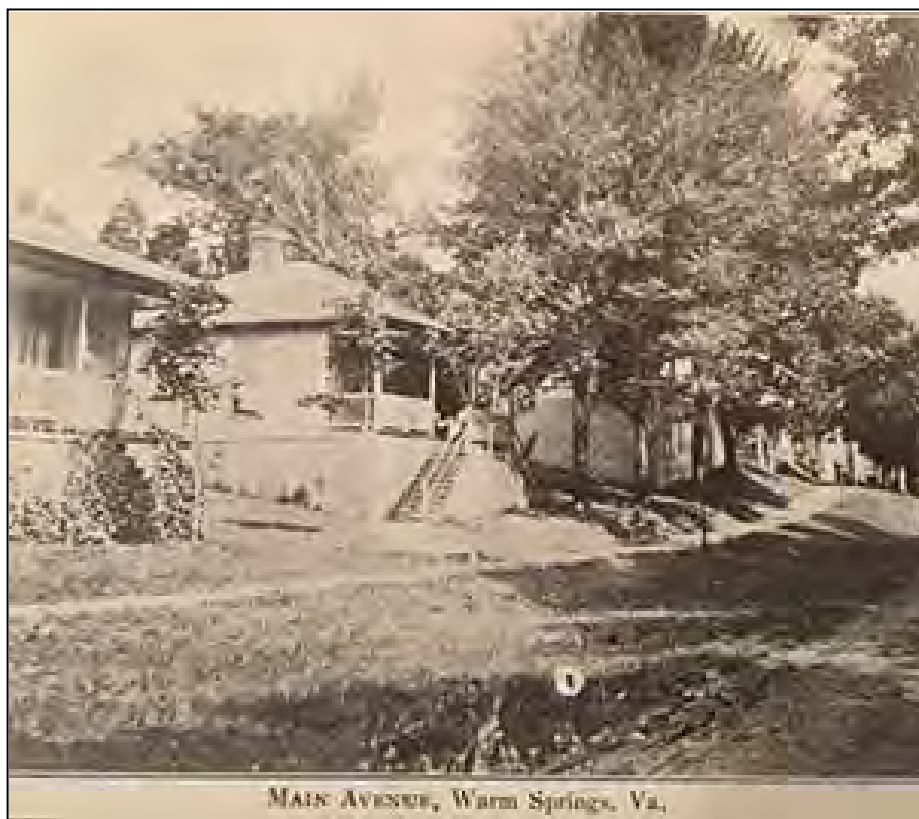
Postcard, Main Avenue, Warm Springs VA, no date, Library of Virginia. The cottage at far left has been demolished. The extant Cottages One, Two, and Three are from left to right.
