Name of Property: Ocoee Hydroelectric Plant Number Two

City and State: Ocoee, Tennessee, *Polk County*

GENERAL PLAN OF
OCOEE #2 POWER STATION
OF THE TENNESSEE ELECTRIC POWER
CORPORATION
CHATTANOOGA, TENN.

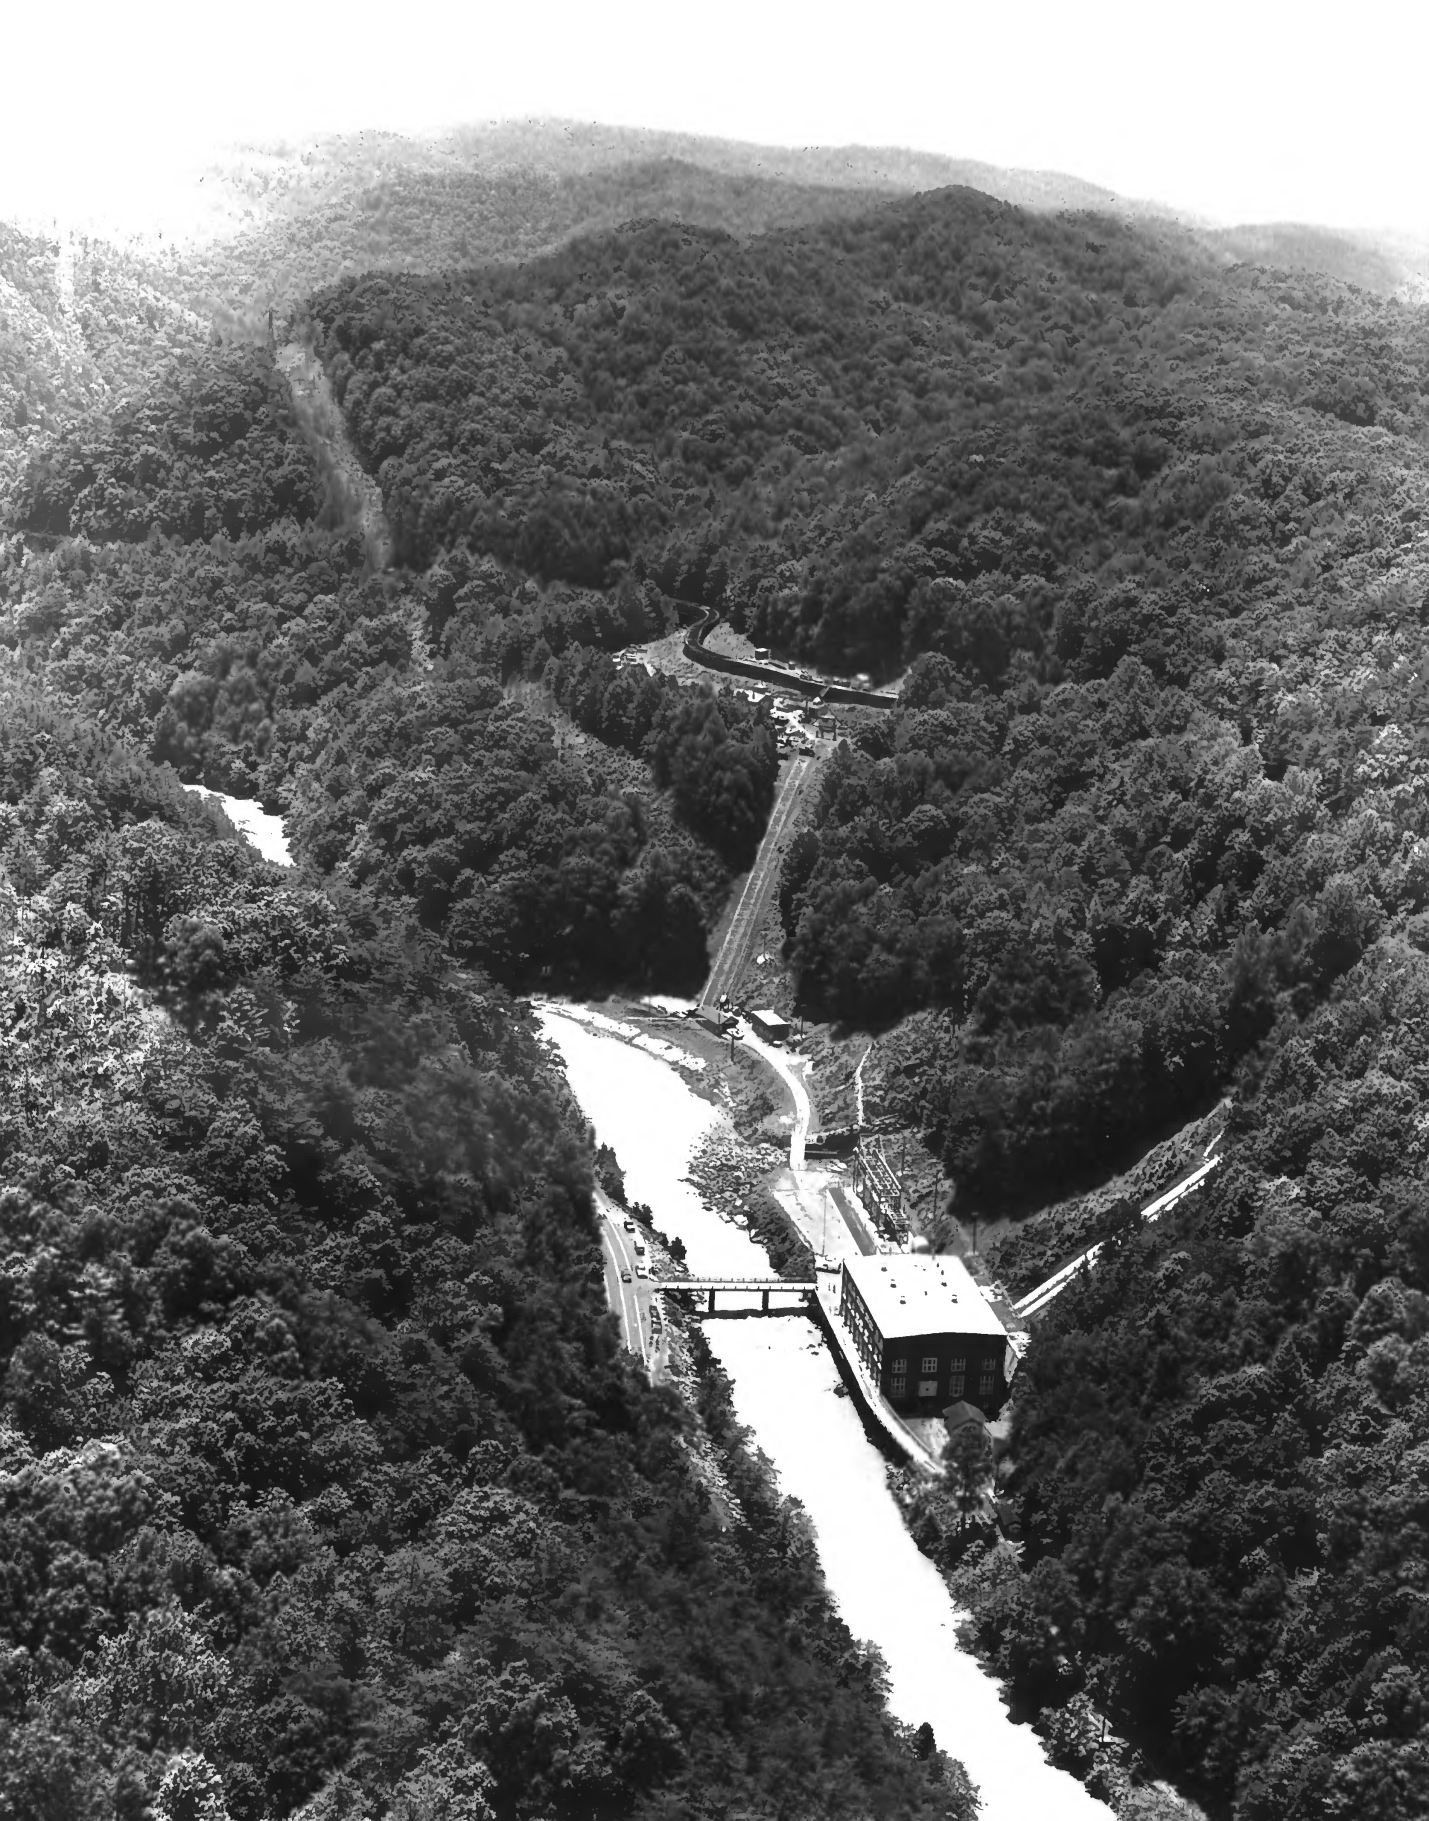
Photograph Number: 1 *of 26*

Description of View: View is of powerhouse, flume and incline.
Note penstocks at right (rear of powerhouse) and transmission lines
to Ocoee No. 3 at left in background. Transformers in switchyard
can be seen above the powerhouse. Location of former railroad
tracks can be seen along the right bank of the river below the
powerhouse. Photograph is looking south-southeast.

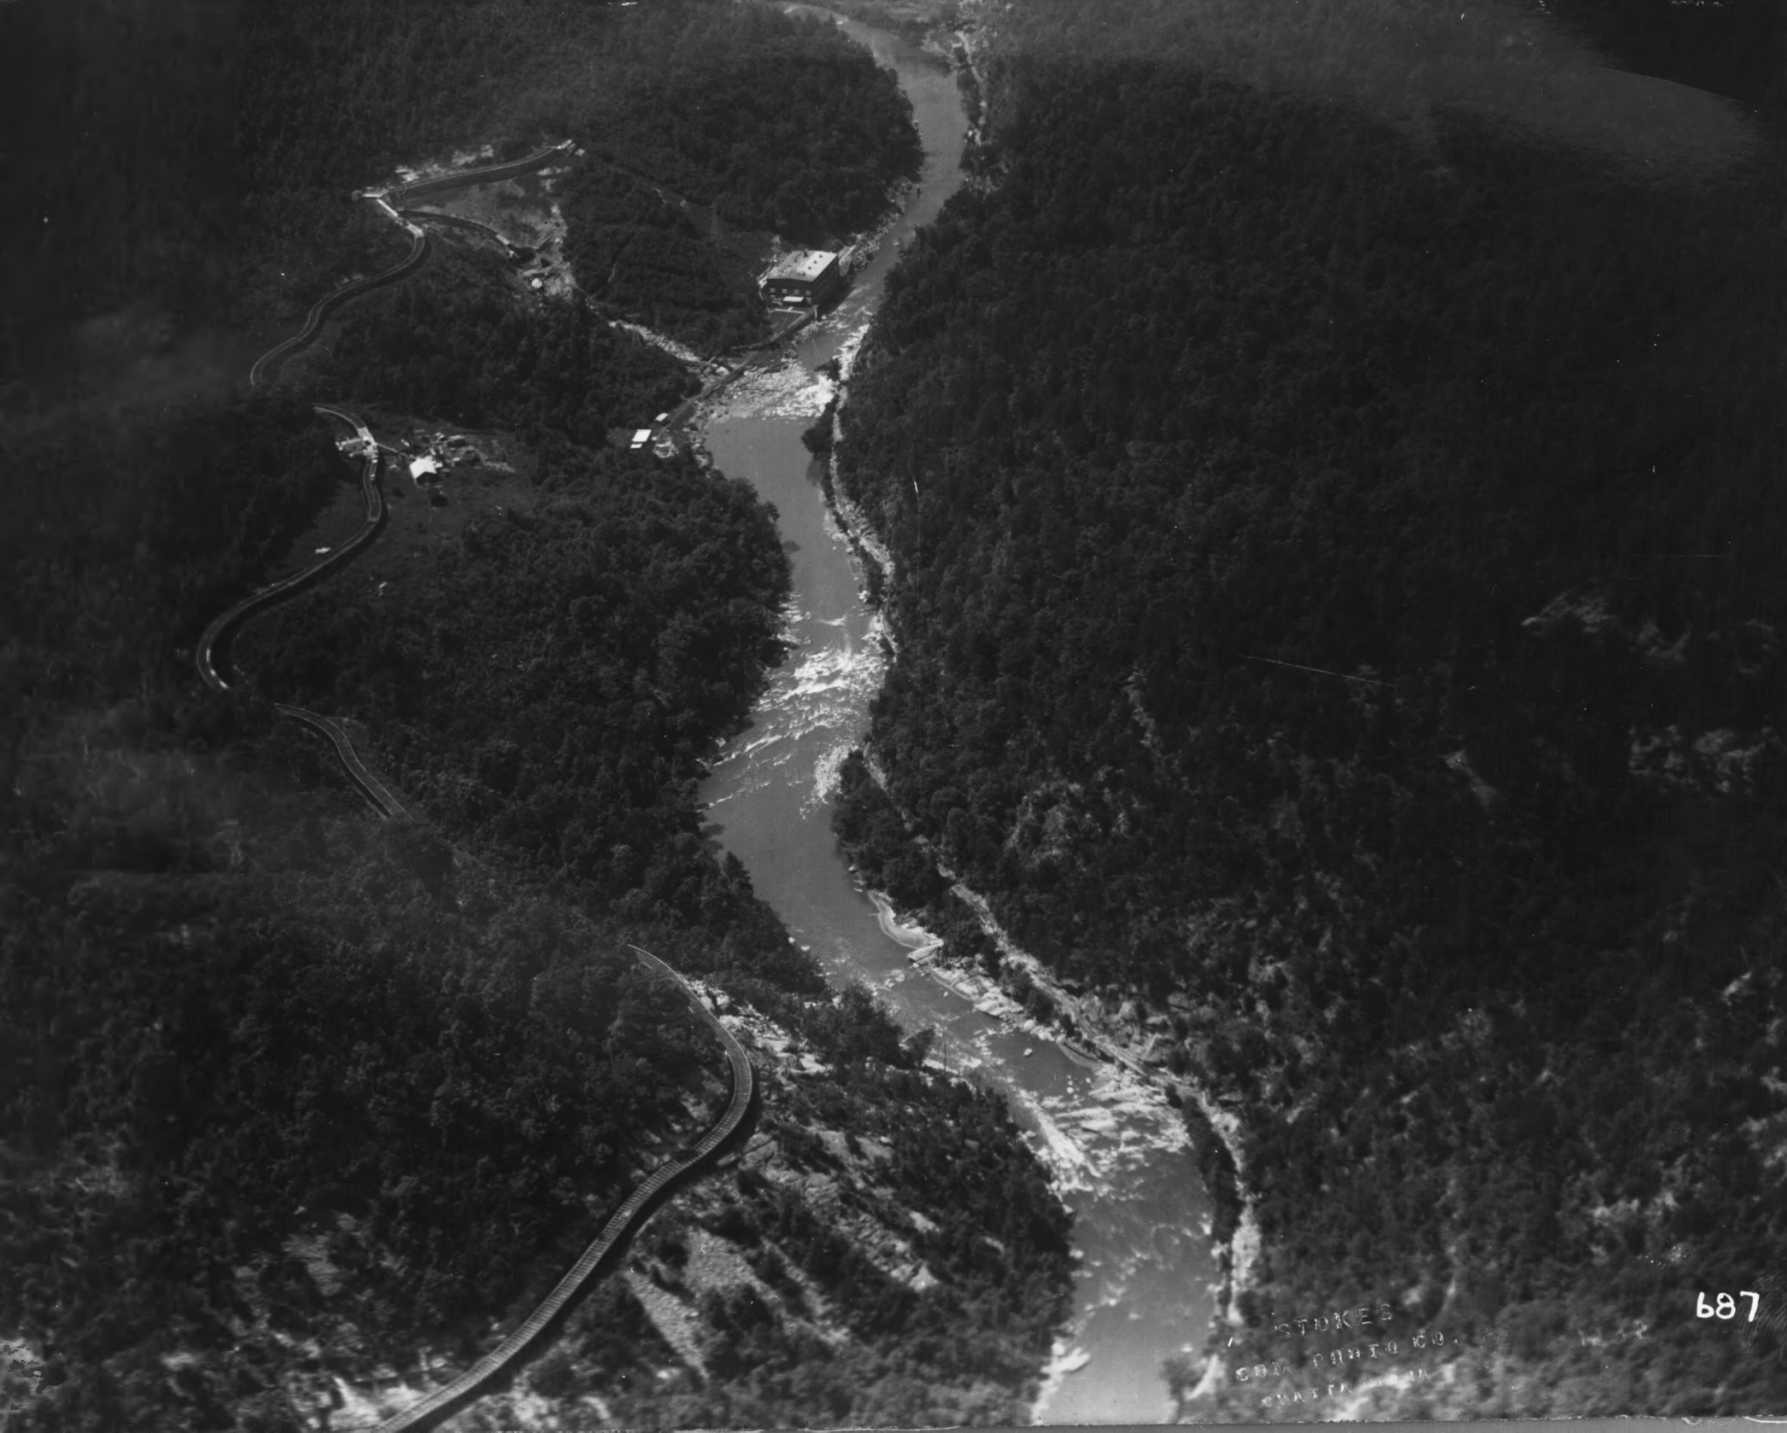
Photograph Number: *3426*

Description of View: Aerial photograph of the Ocoee River and the last half mile of the flume. The powerhouse is visible at the center top, the forebay directly to its left, and the upper terminus of the incline slightly below the forebay. The entire flume extension is visible above the powerhouse. A waste flume seen below the flume extension carries excess water from the forebay to the river in the event of the siphons opening. Photograph is looking northwest.

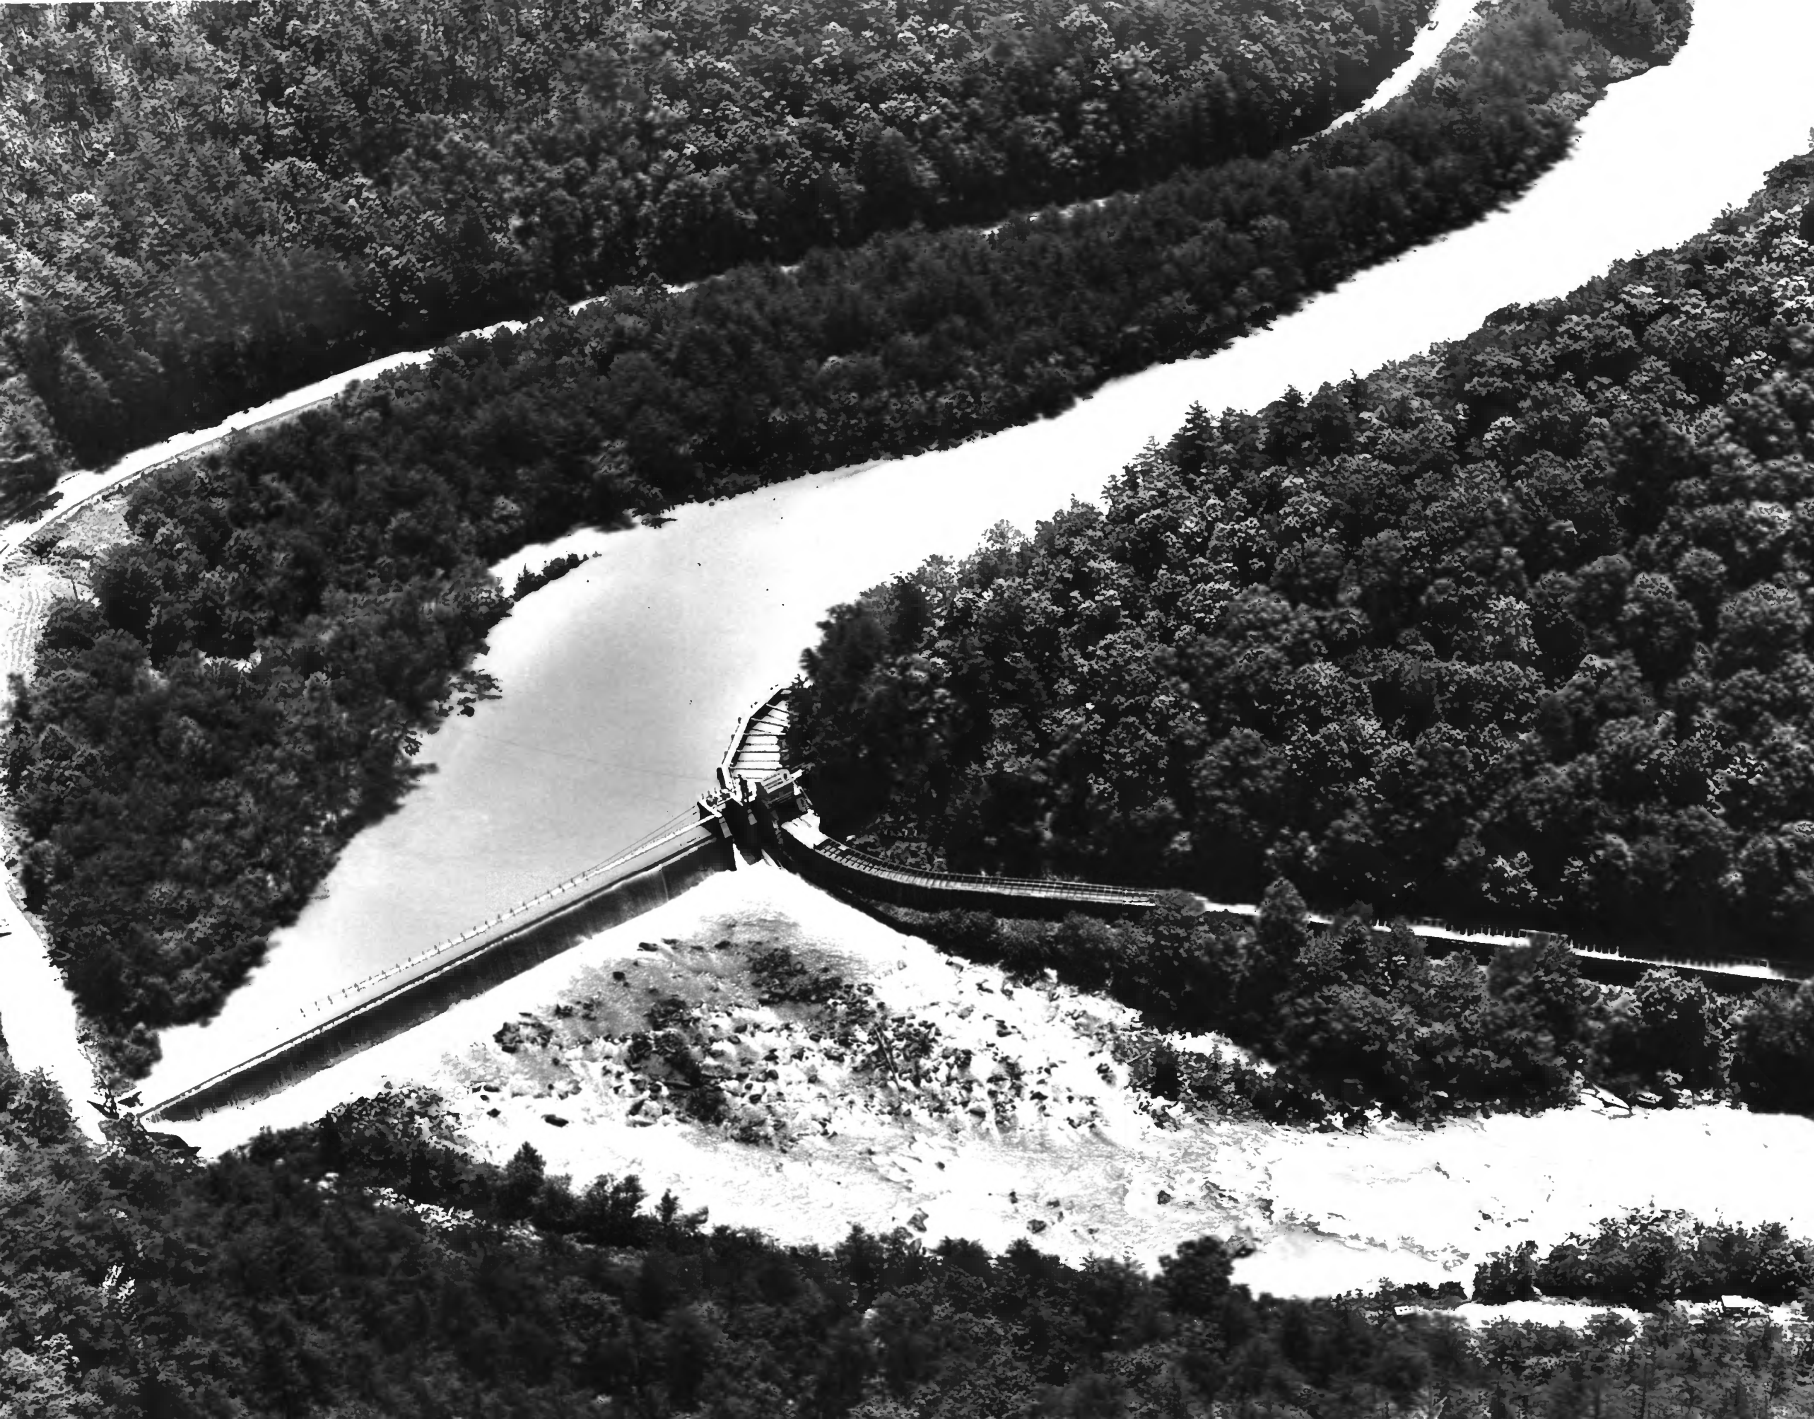
Photograph Number: 4 *0/26*

Description of View: View is of diversion dam and beginning of flume.
Intake gate is at center of photograph. Trash racks above gate
prevent large floating and submerged objects from entering flume.
U.S. Highway No. 64 can be seen in the background. Photograph is
looking southeast, upstream towards Ocoee No. 3.

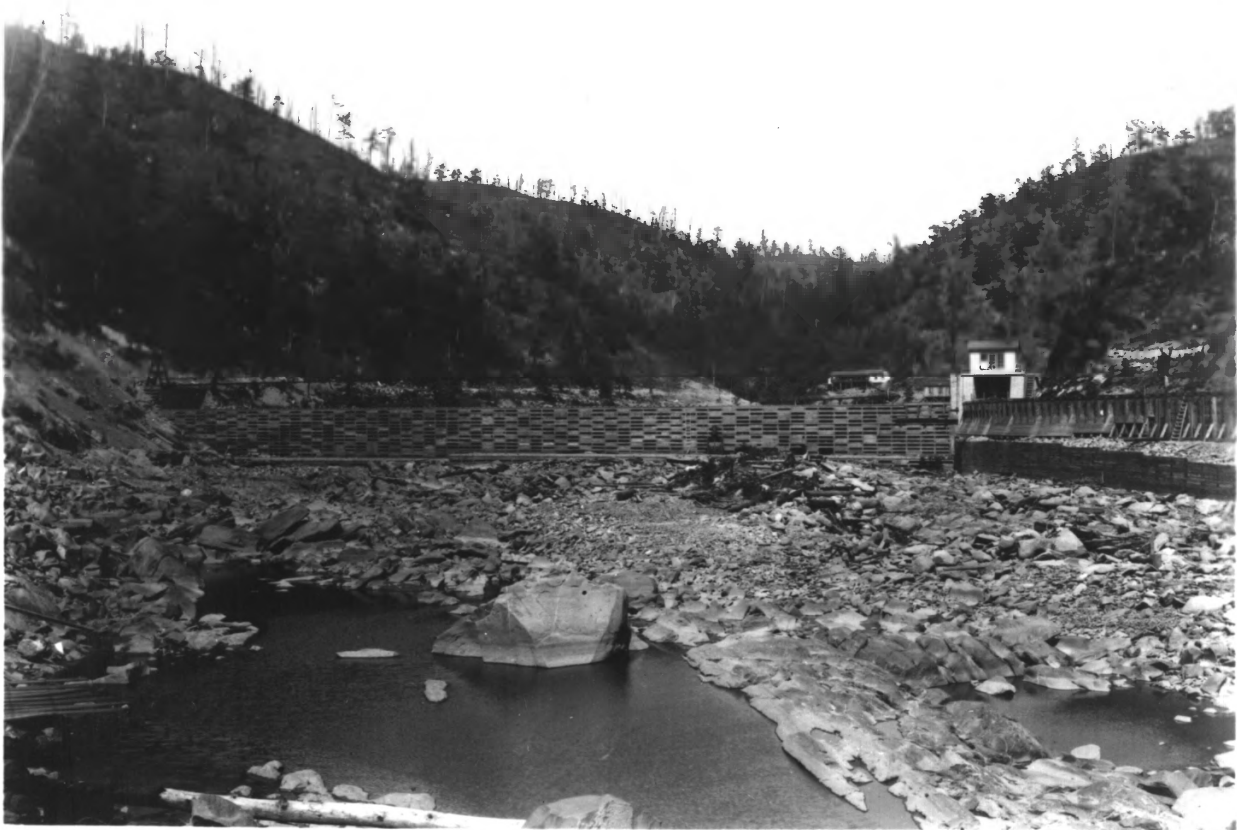
Photograph Number: 5 *9/26*

Description of View: View is of downstream side of diversion dam.
Flume intake gatehouse and beginning of flume are visible to the
right. River is dry due to the diverting of all of the water into
the flume. Note layering of crib construction in the face of the
dam. Photograph is looking east.

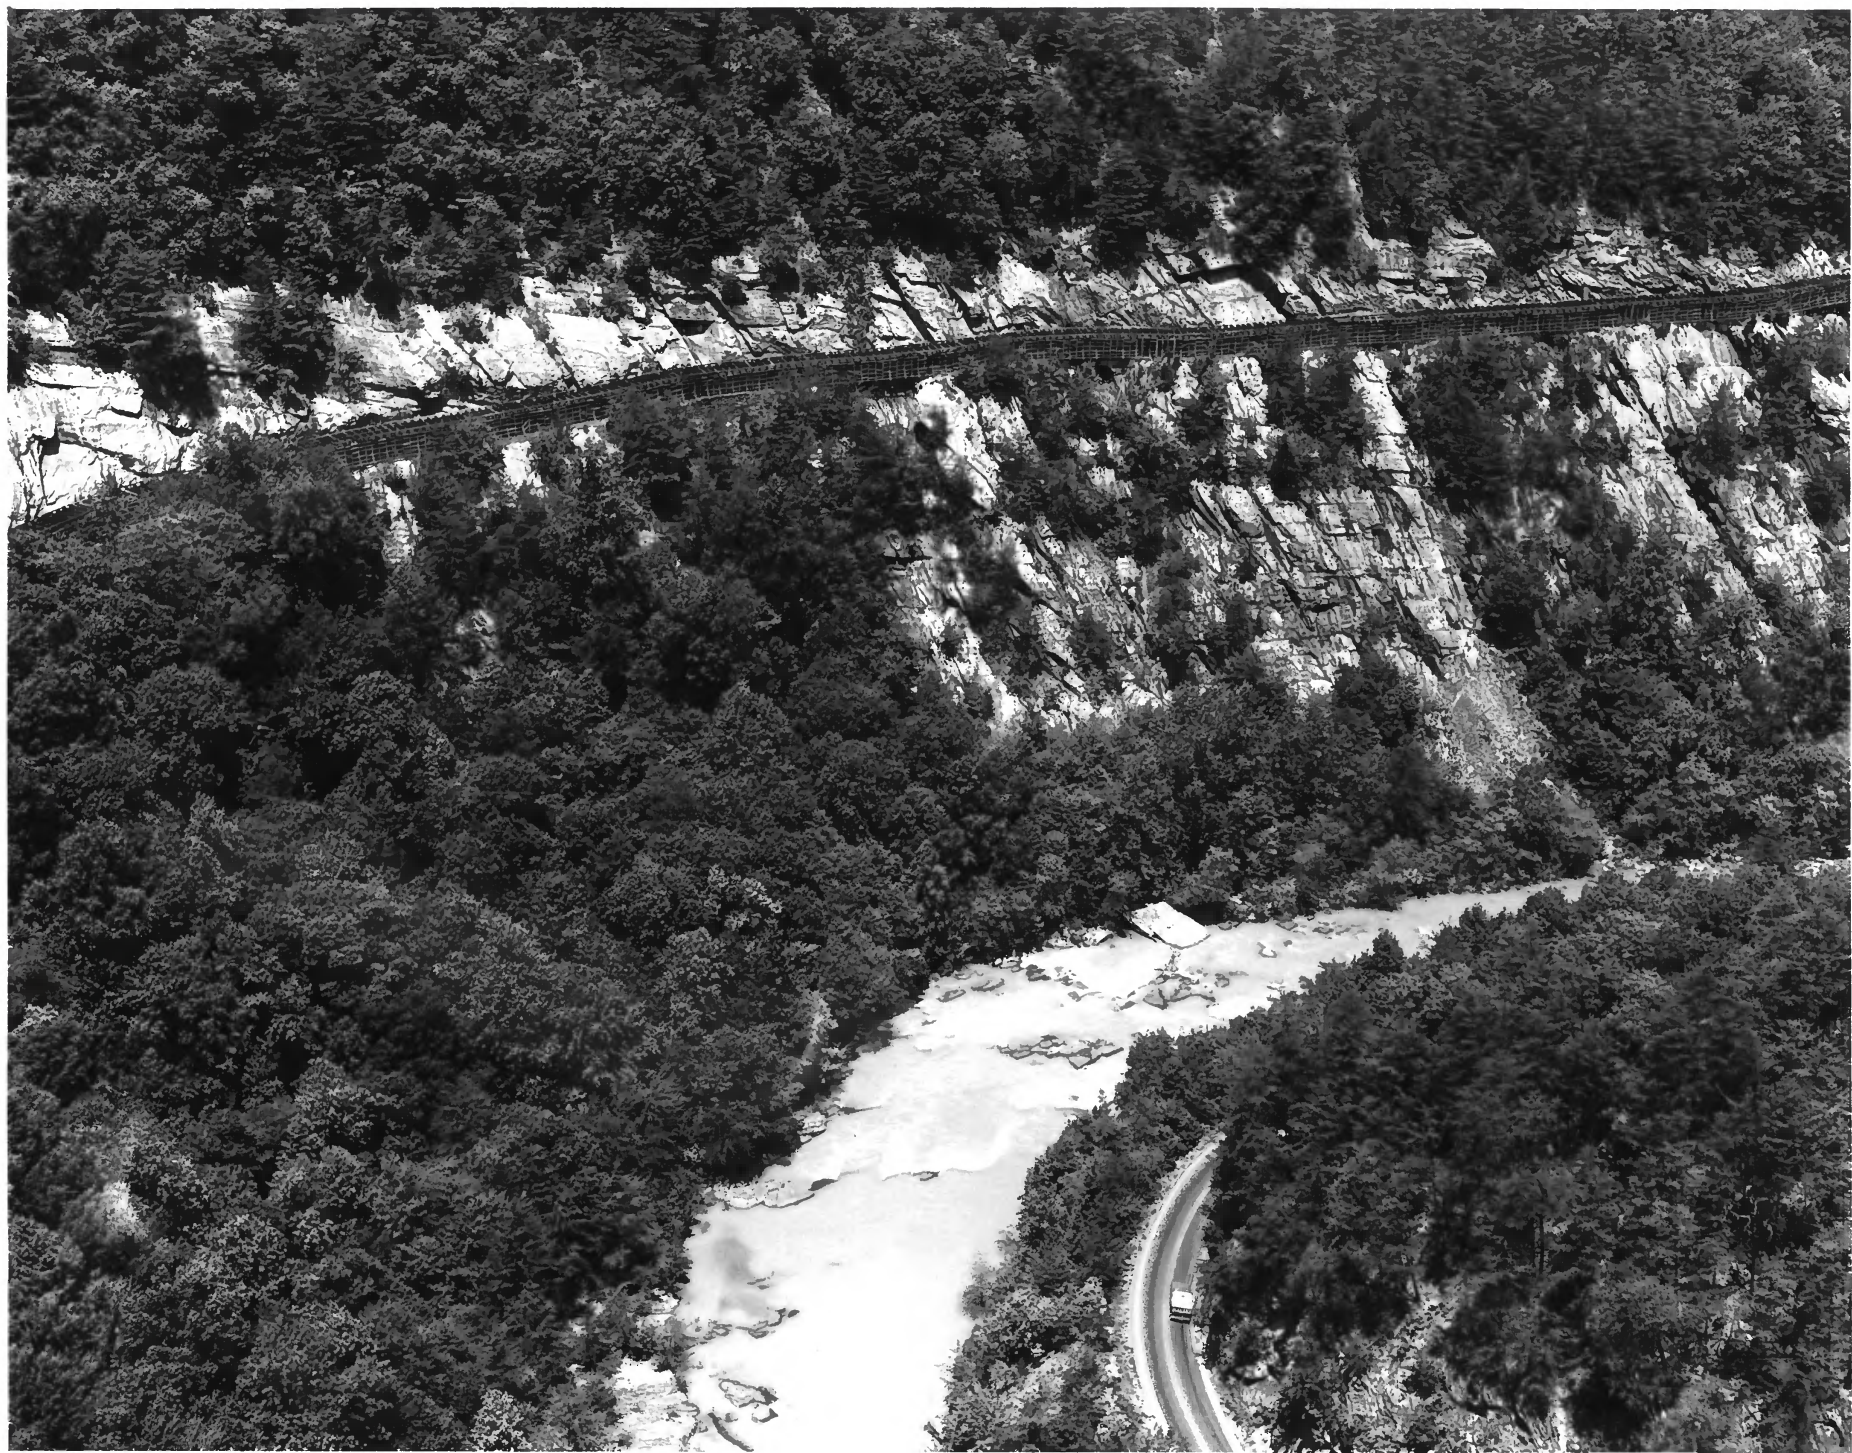
Photograph Number: *60/26*

Description of View: View is of the flume on the mountainside, with the Ocoee River and U.S. Highway No. 64 below. In this photograph, water inside the flume is flowing from left to right, towards the powerhouse. Note that the flume appears to be sloping up in that direction. This illusion of the water seeming to flow uphill appears both in photographs and in fact, and is visible at several points along the flume.

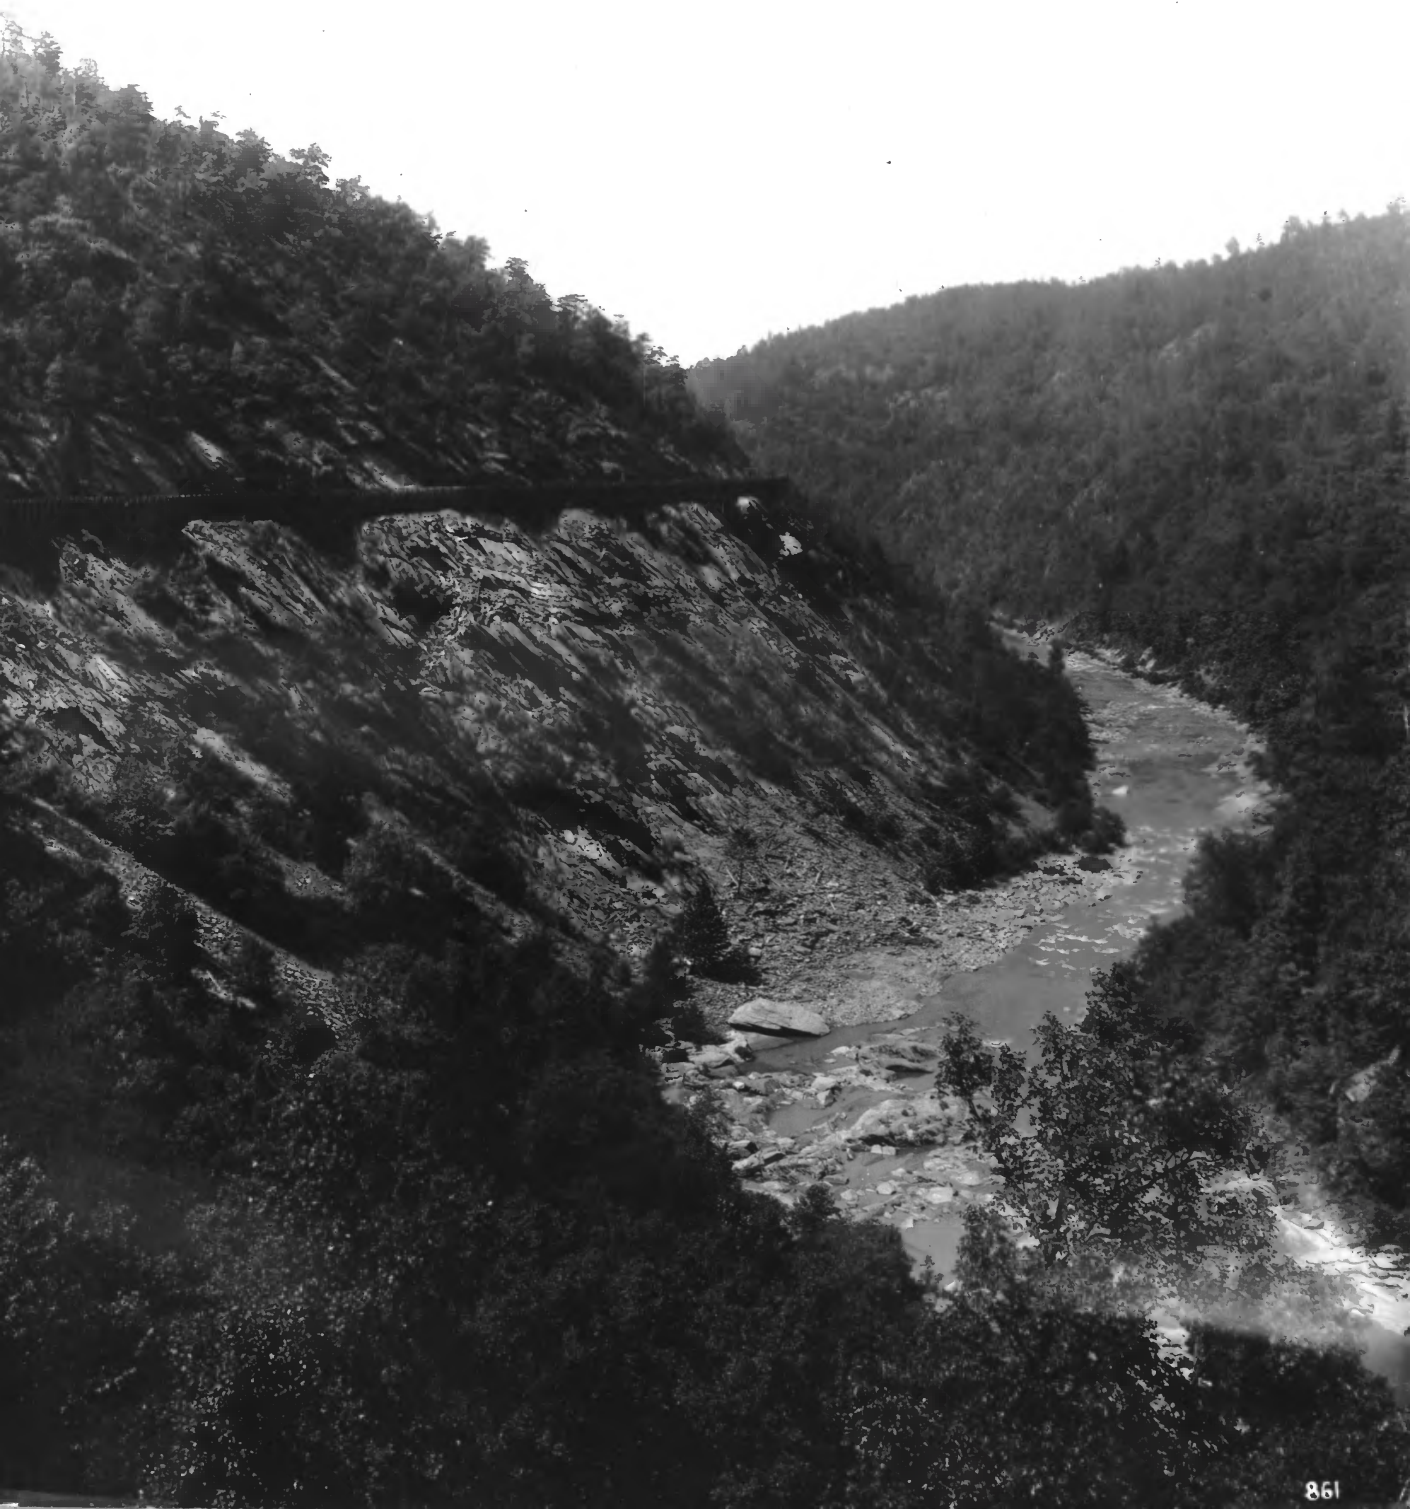
Photograph Number: *7426*

Description of View: View is of the flume box above the Ocoee River.
Note how the flume is carved into and set on the bedrock of the
mountainside. Also note the poles for telephone and 440 volt
power lines on the flume, bringing operating current from the
powerhouse to the intake gatehouse. Direction and location of
photograph is undetermined.

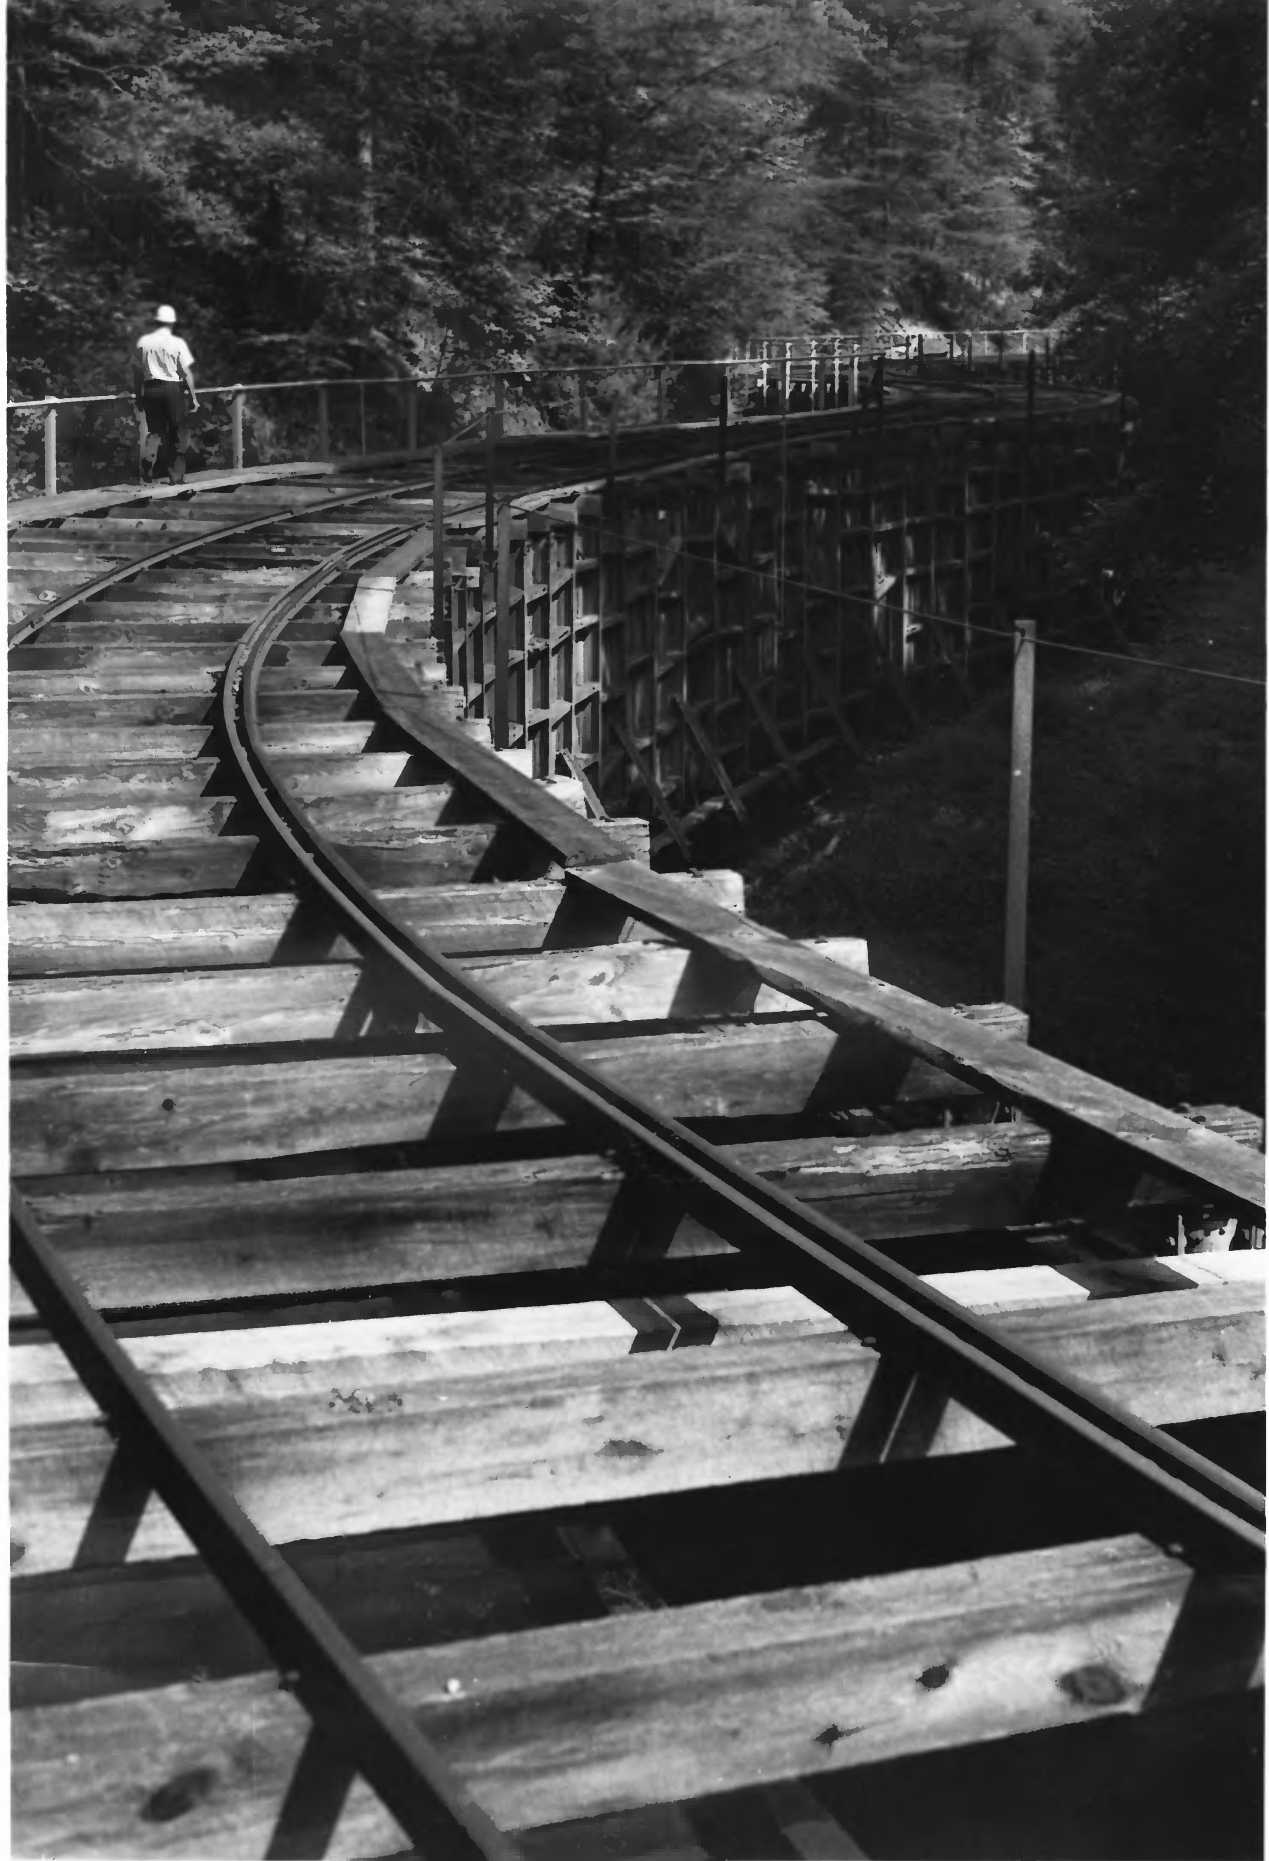
Photograph Number: *89/26*

Description of View: View of the top of the flume box. Note flume
box is not fully covered; standing water can be seen below the
collar ties. Walkways are included on each side where the top is
open.

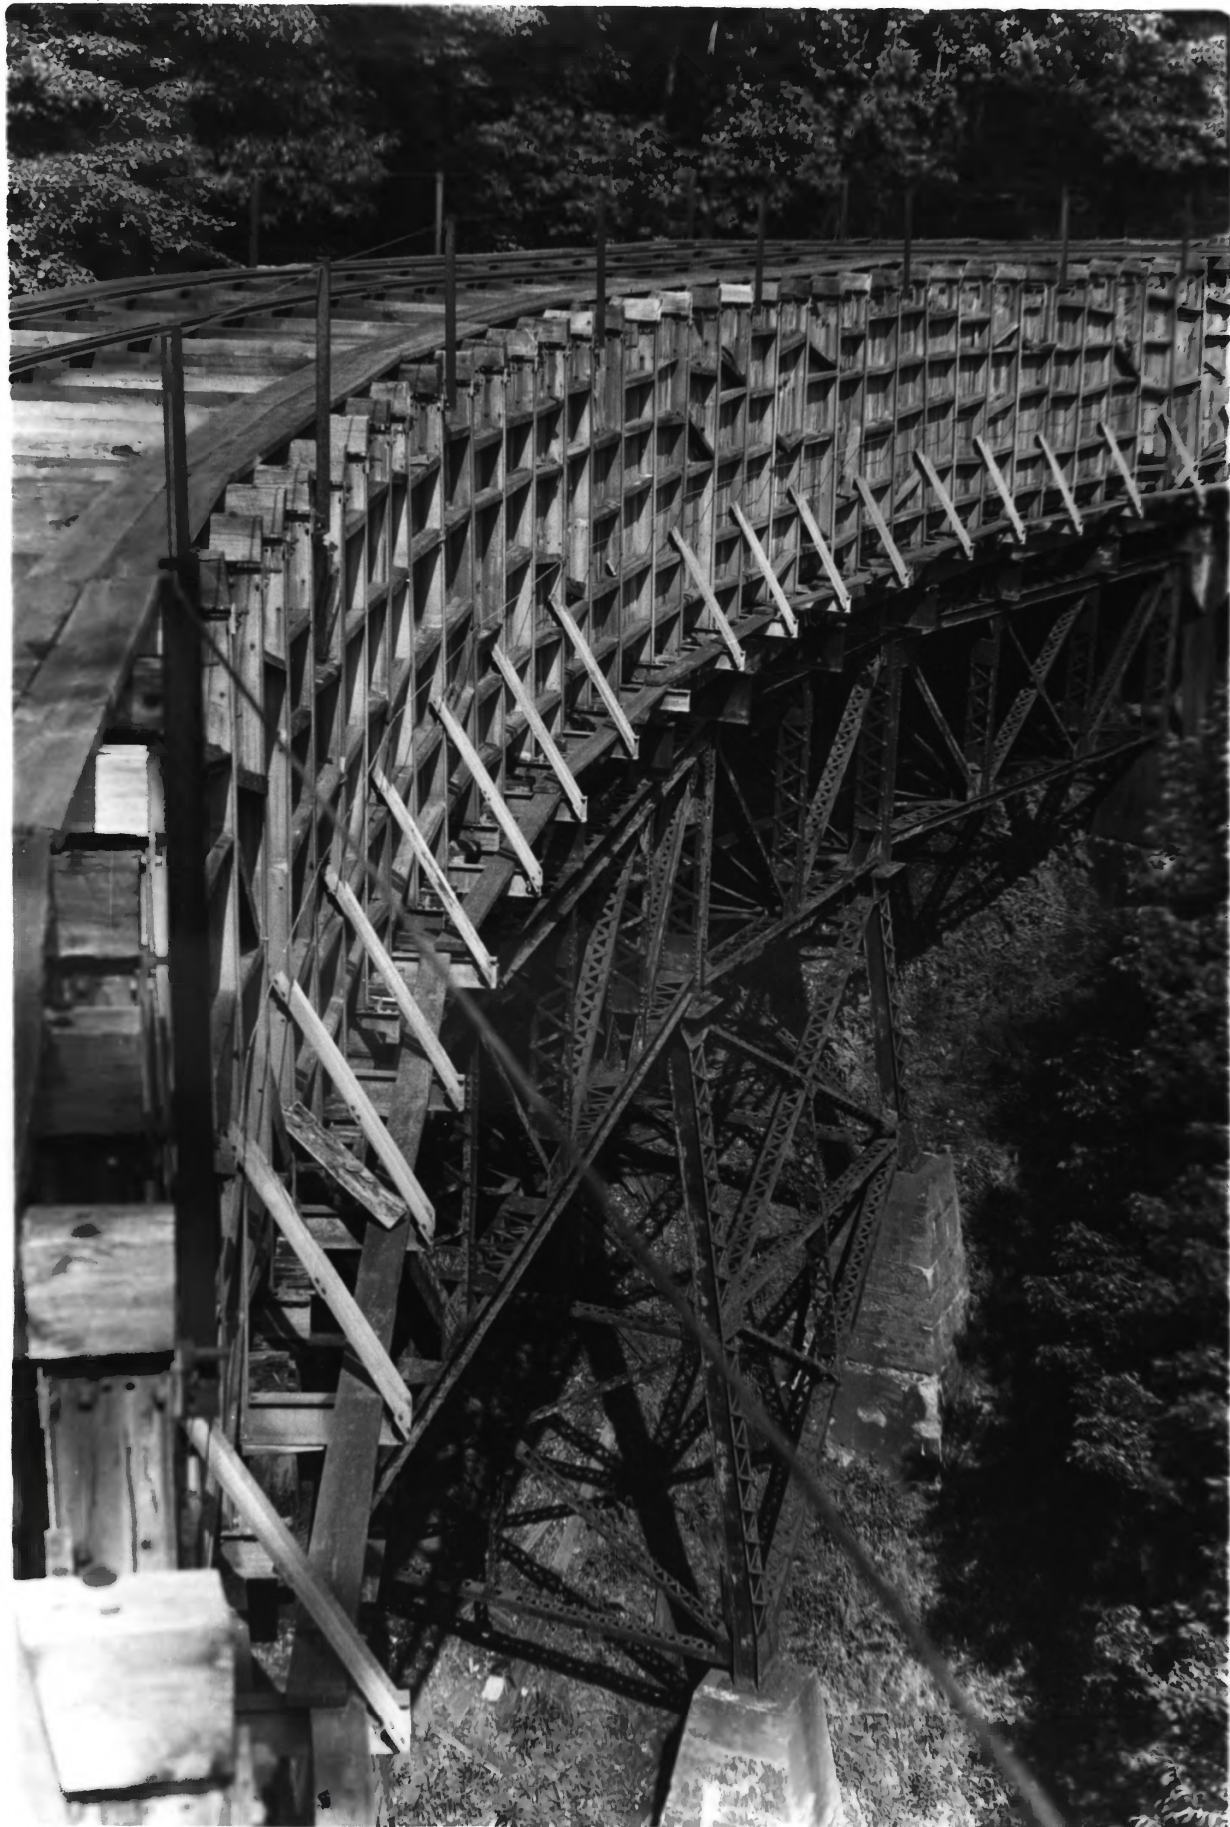
Photograph Number: *9/26*

Description of View: View is of flume as it crosses trestle no. 5.

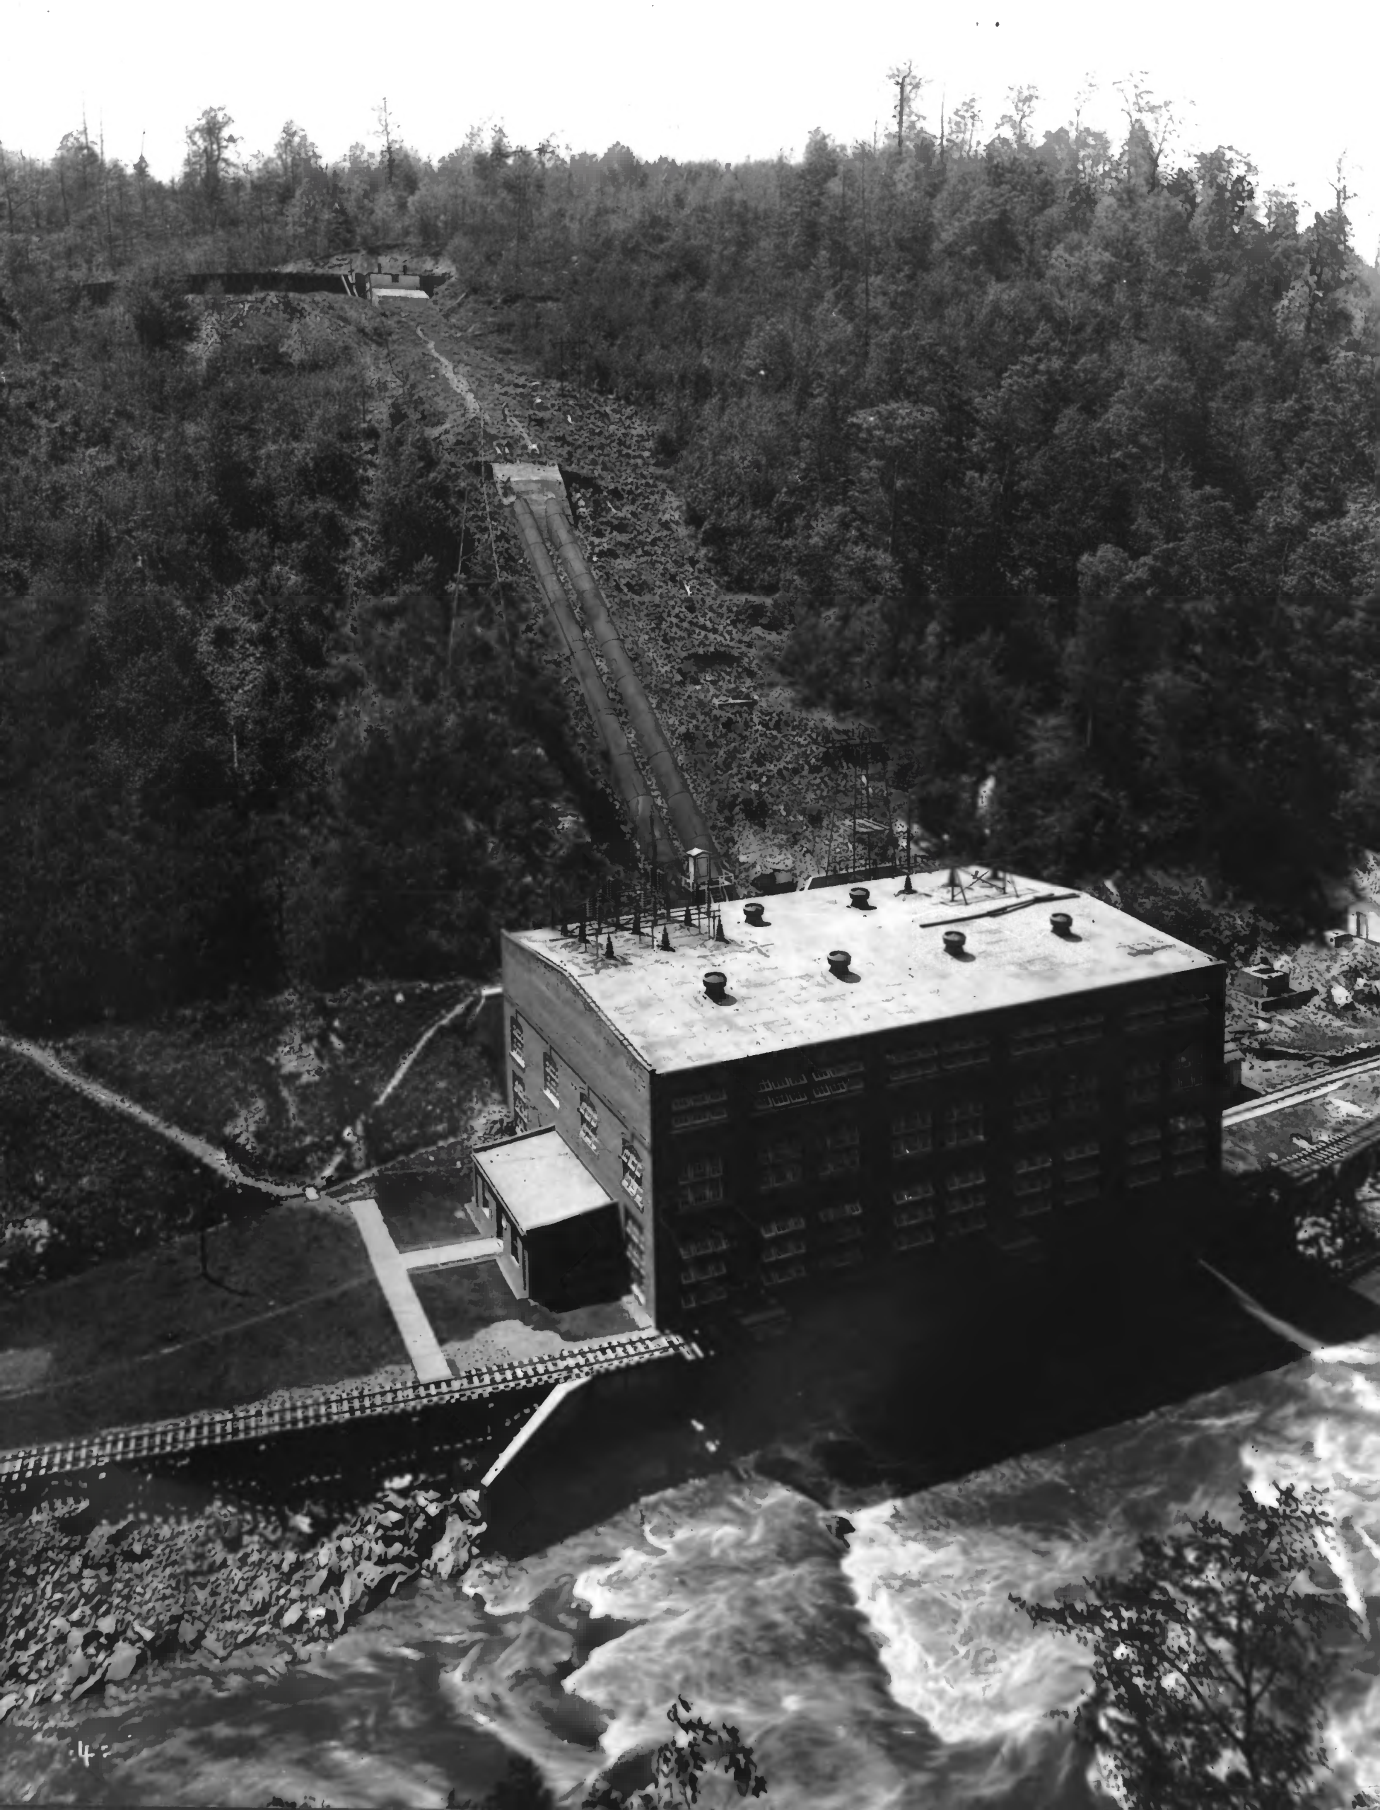
Photograph Number: 10 *926*

Description of View: View is of the powerhouse, prior to the removal of transformers to the switchyard for fire safety reasons. Note the penstocks above and the tracks of the industrial railroad between the powerhouse and the river. The railroad was used to carry construction materials upstream from Ocoee No. 1 to the base of the incline. Note also the original insulators and transmission equipment on the roof of the powerhouse.
