Name of Property: Ocoee Hydroelectric Plant Number Two

City and State: Ocoee, Tennessee, *Polk County*

GENERAL PLAN OF
OCOEE #2 POWER STATION
OF THE TENNESSEE ELECTRIC POWER
CORPORATION
CHATTANOOGA, TENN.

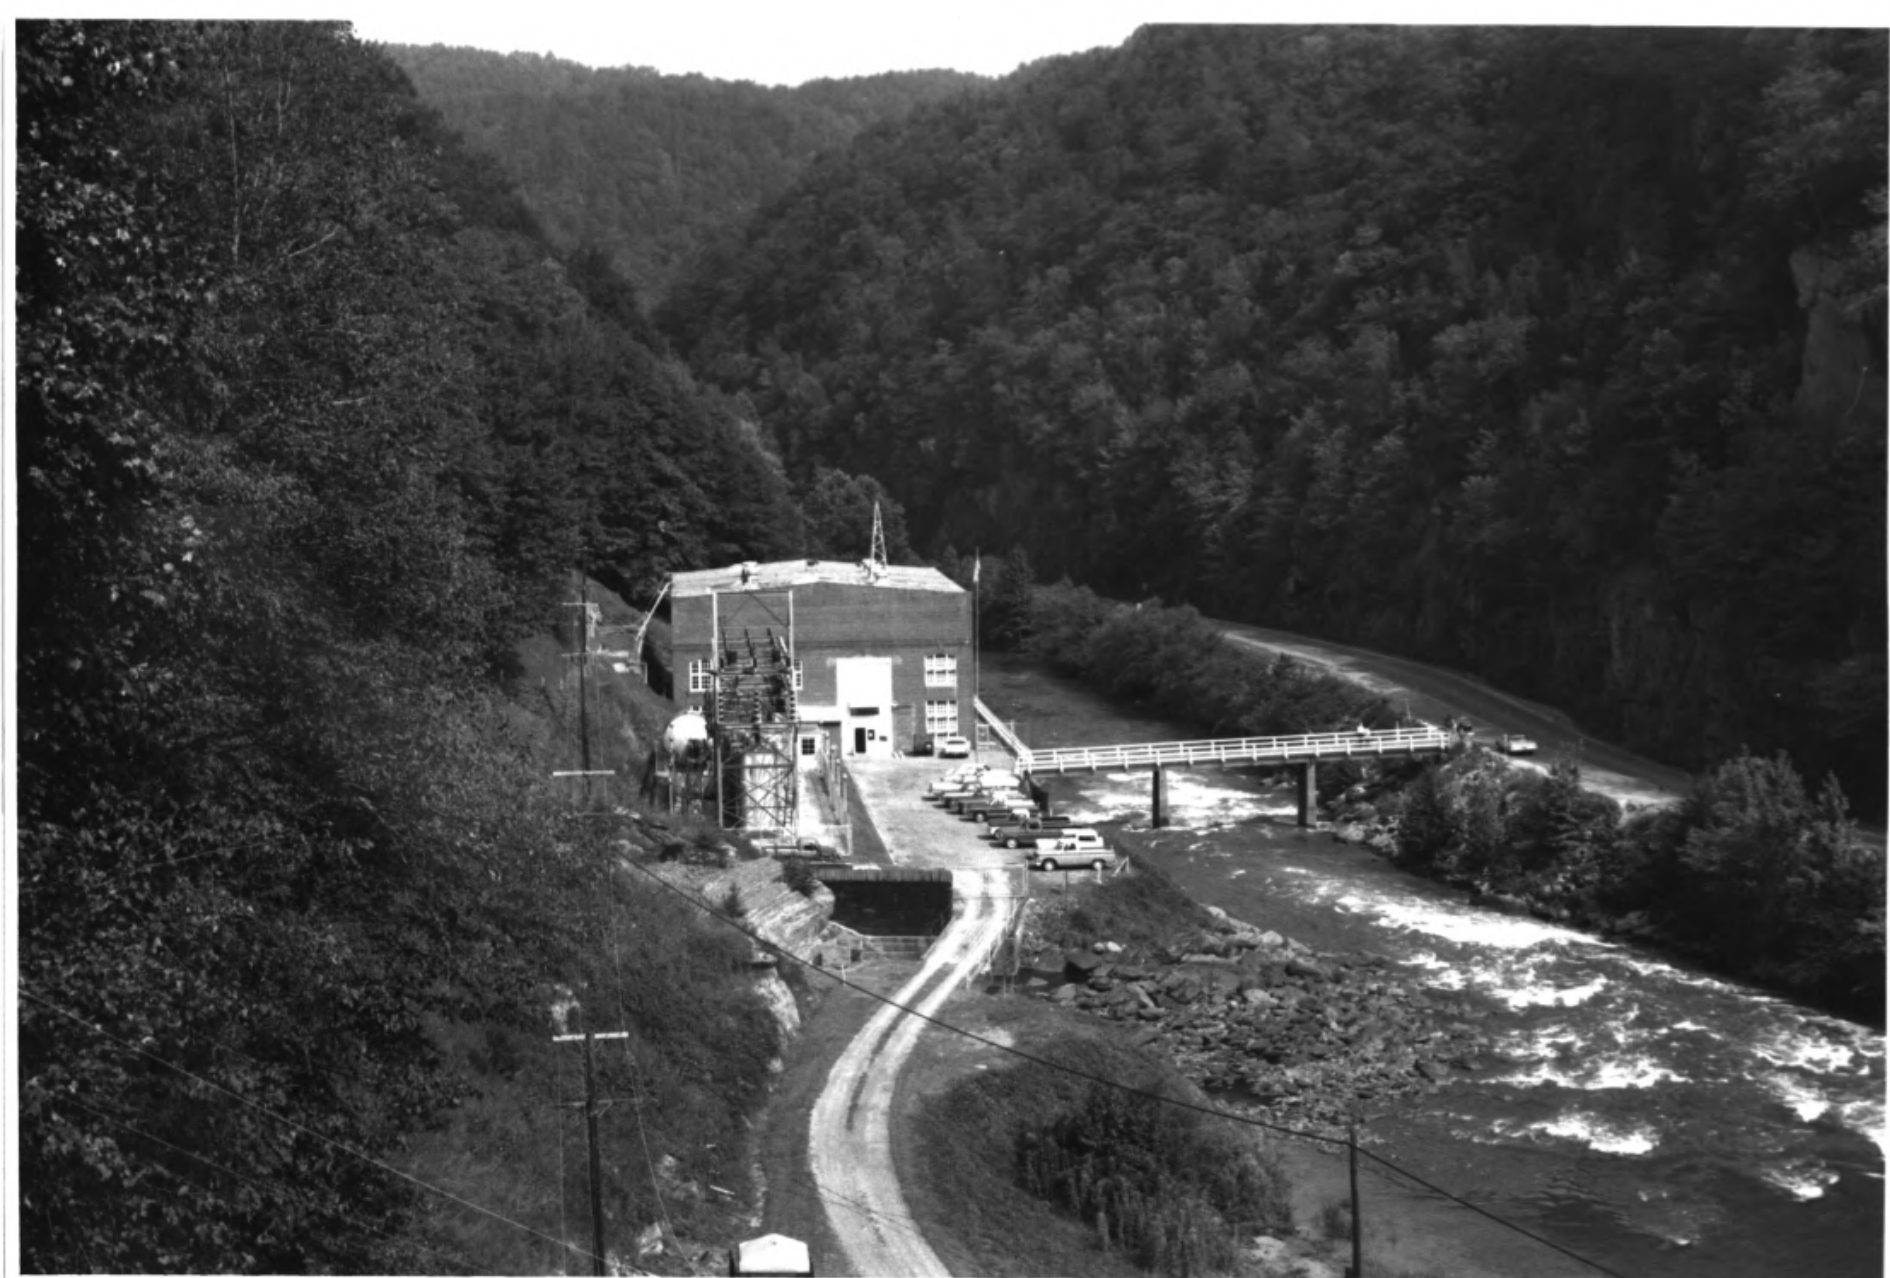
Photograph Number: 11 of 26

Description of View: View is of the powerhouse and switchyard.
Note the present location of the transformers and oil circuit
breakers outside the powerhouse. The outlet of the waste flume
carrying excess water from the forebay is visible in front of the
switchyard. Photograph is looking north-northwest, taken from
the incline.

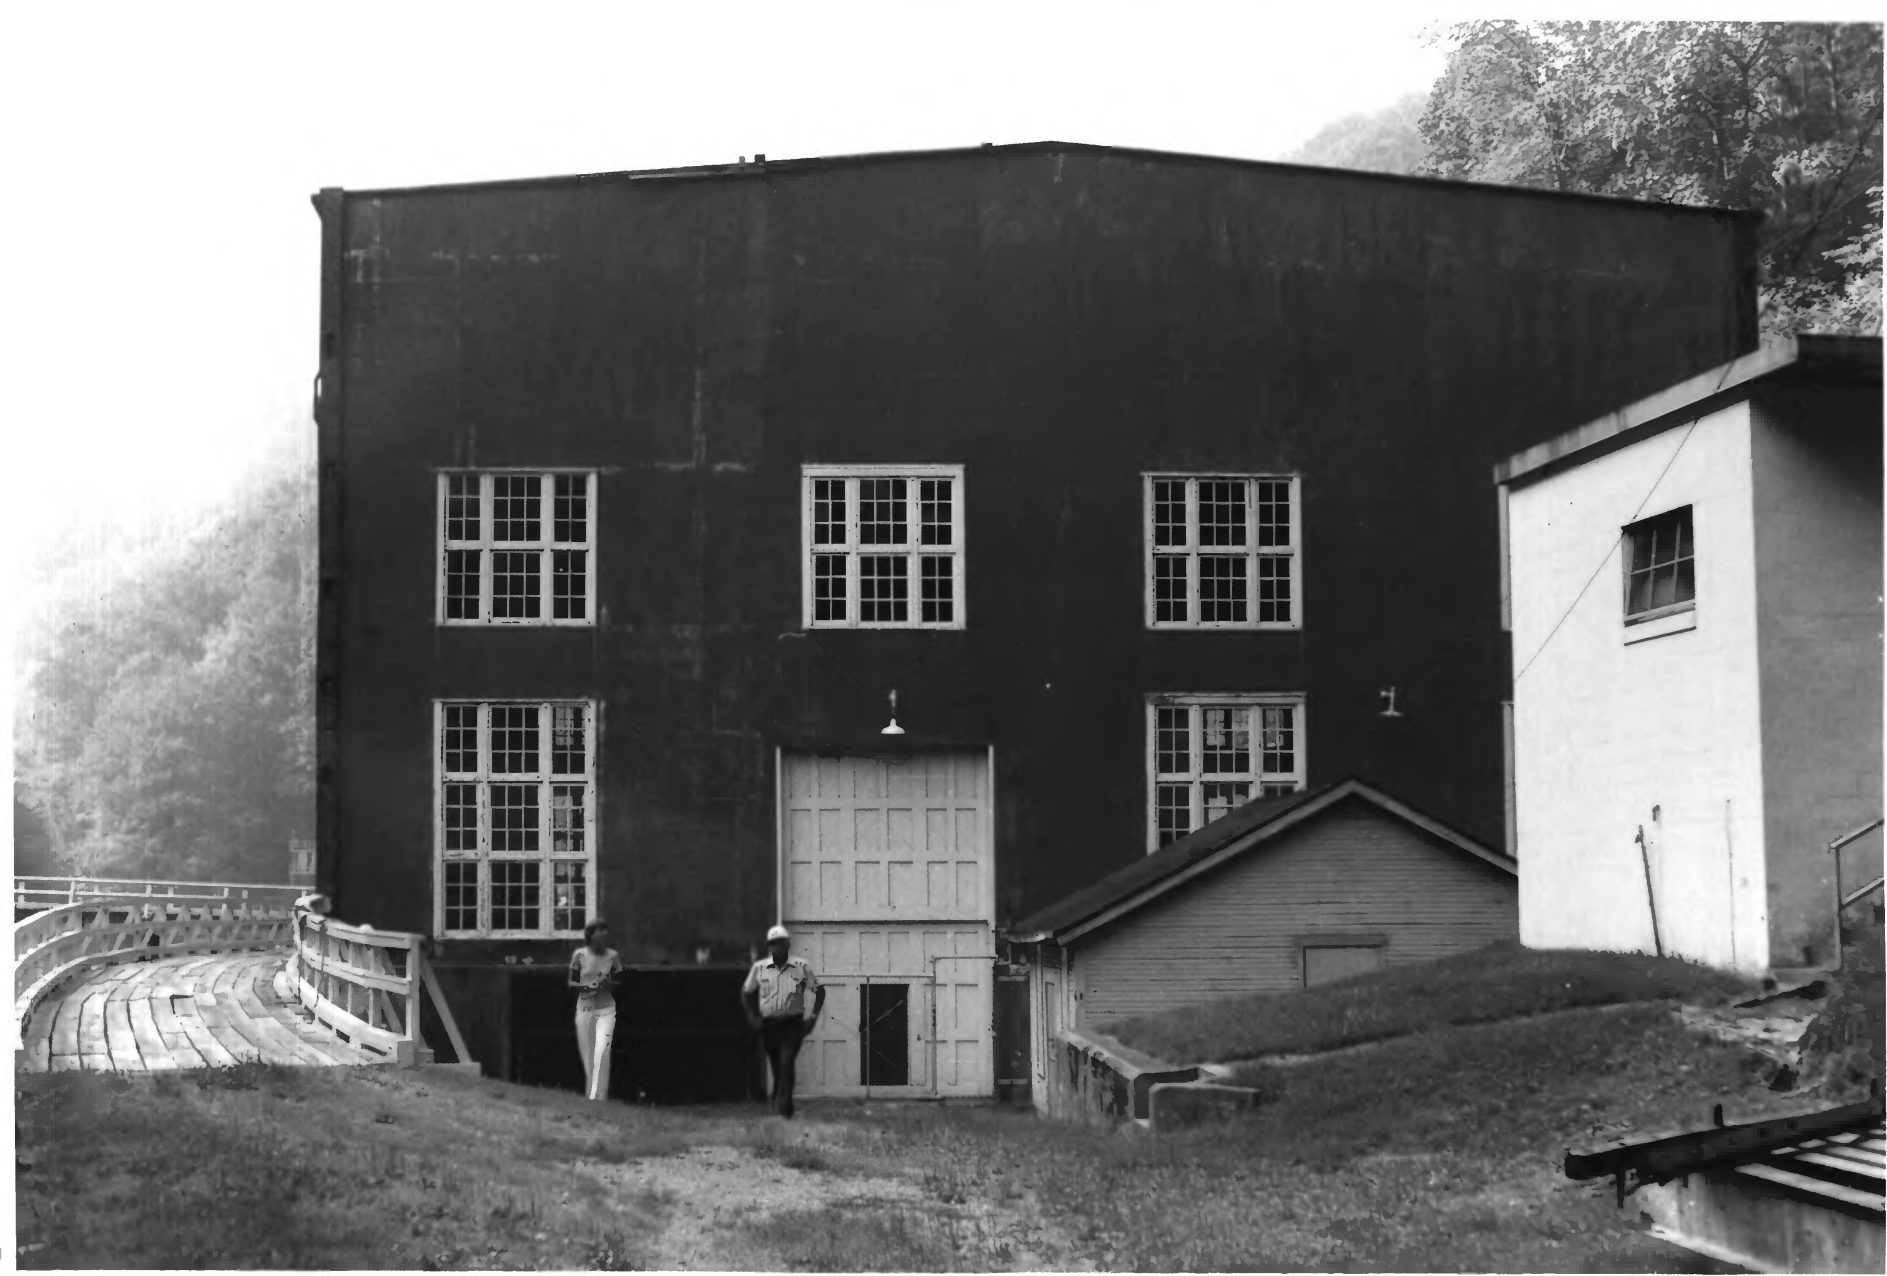
Photograph Number: 16 *4/26*

Description of View: View of the exterior of the powerhouse, showing the "unfinished" north wall with main equipment access doors. The unfinished wall and provisions for the never-installed third penstock earned the development a deferred tax status for theoretically being under construction. Compare the brickwork with the east and south elevations, illustration number 12. Note the former railroad bed circling to the left of the powerhouse. Photograph is looking south-southwest.

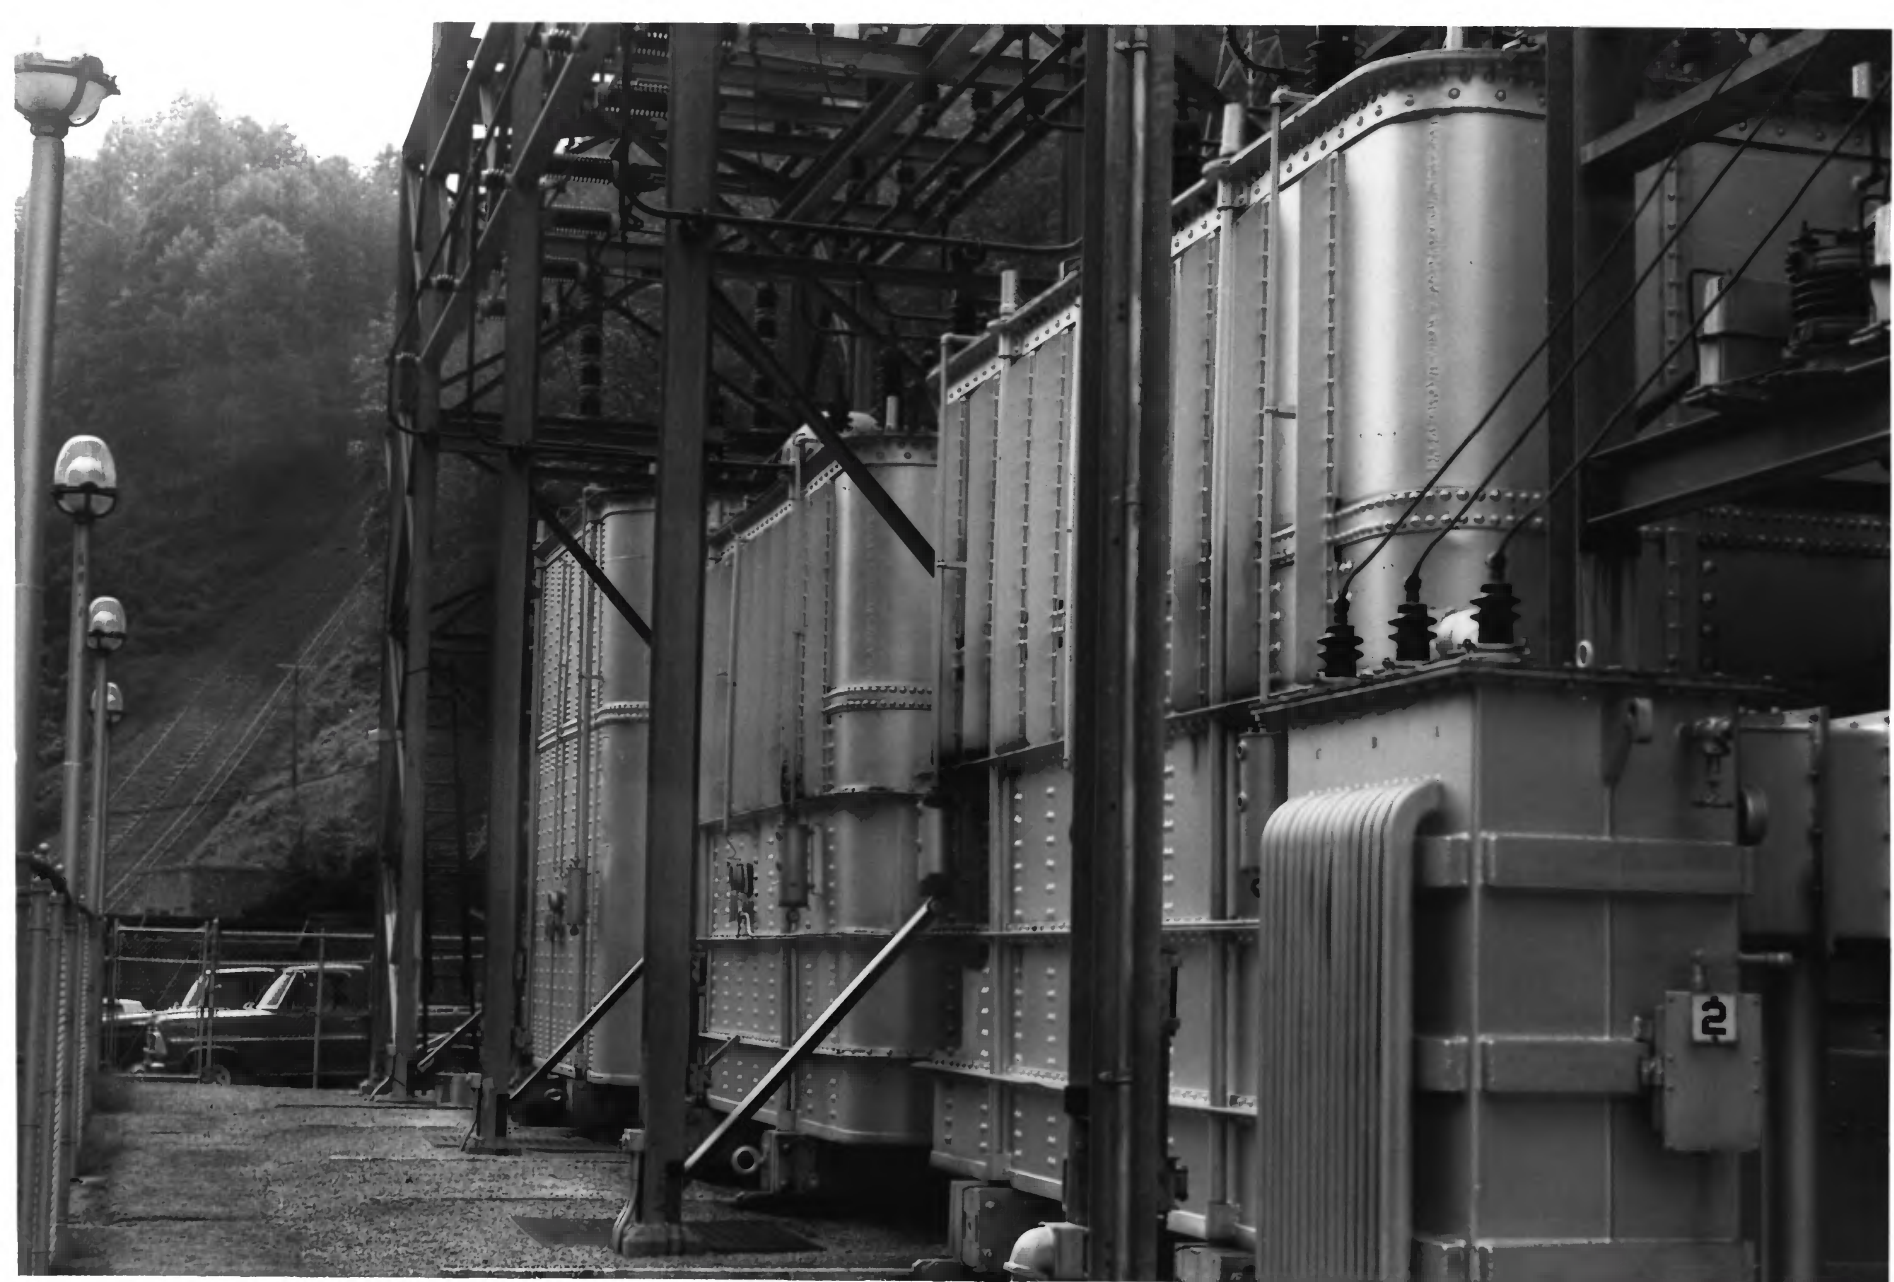
Photograph Number: 18 *426*

Description of View: View is of the main transformers, located in the switchyard. The taller unit at the rear is a later addition, installed to supplement the two main units (center foreground) which were originally located inside the powerhouse. The two original transformers were moved out into the yard for fire safety reasons following the runaway of generator unit no. 2. All three transformers are now bus connected in parallel to the two generating units and put out the power at 69,000 volts. Station service transformer unit no. 2 can be seen in the right foreground. Note the incline visible in the left background. Photograph is looking southeast.

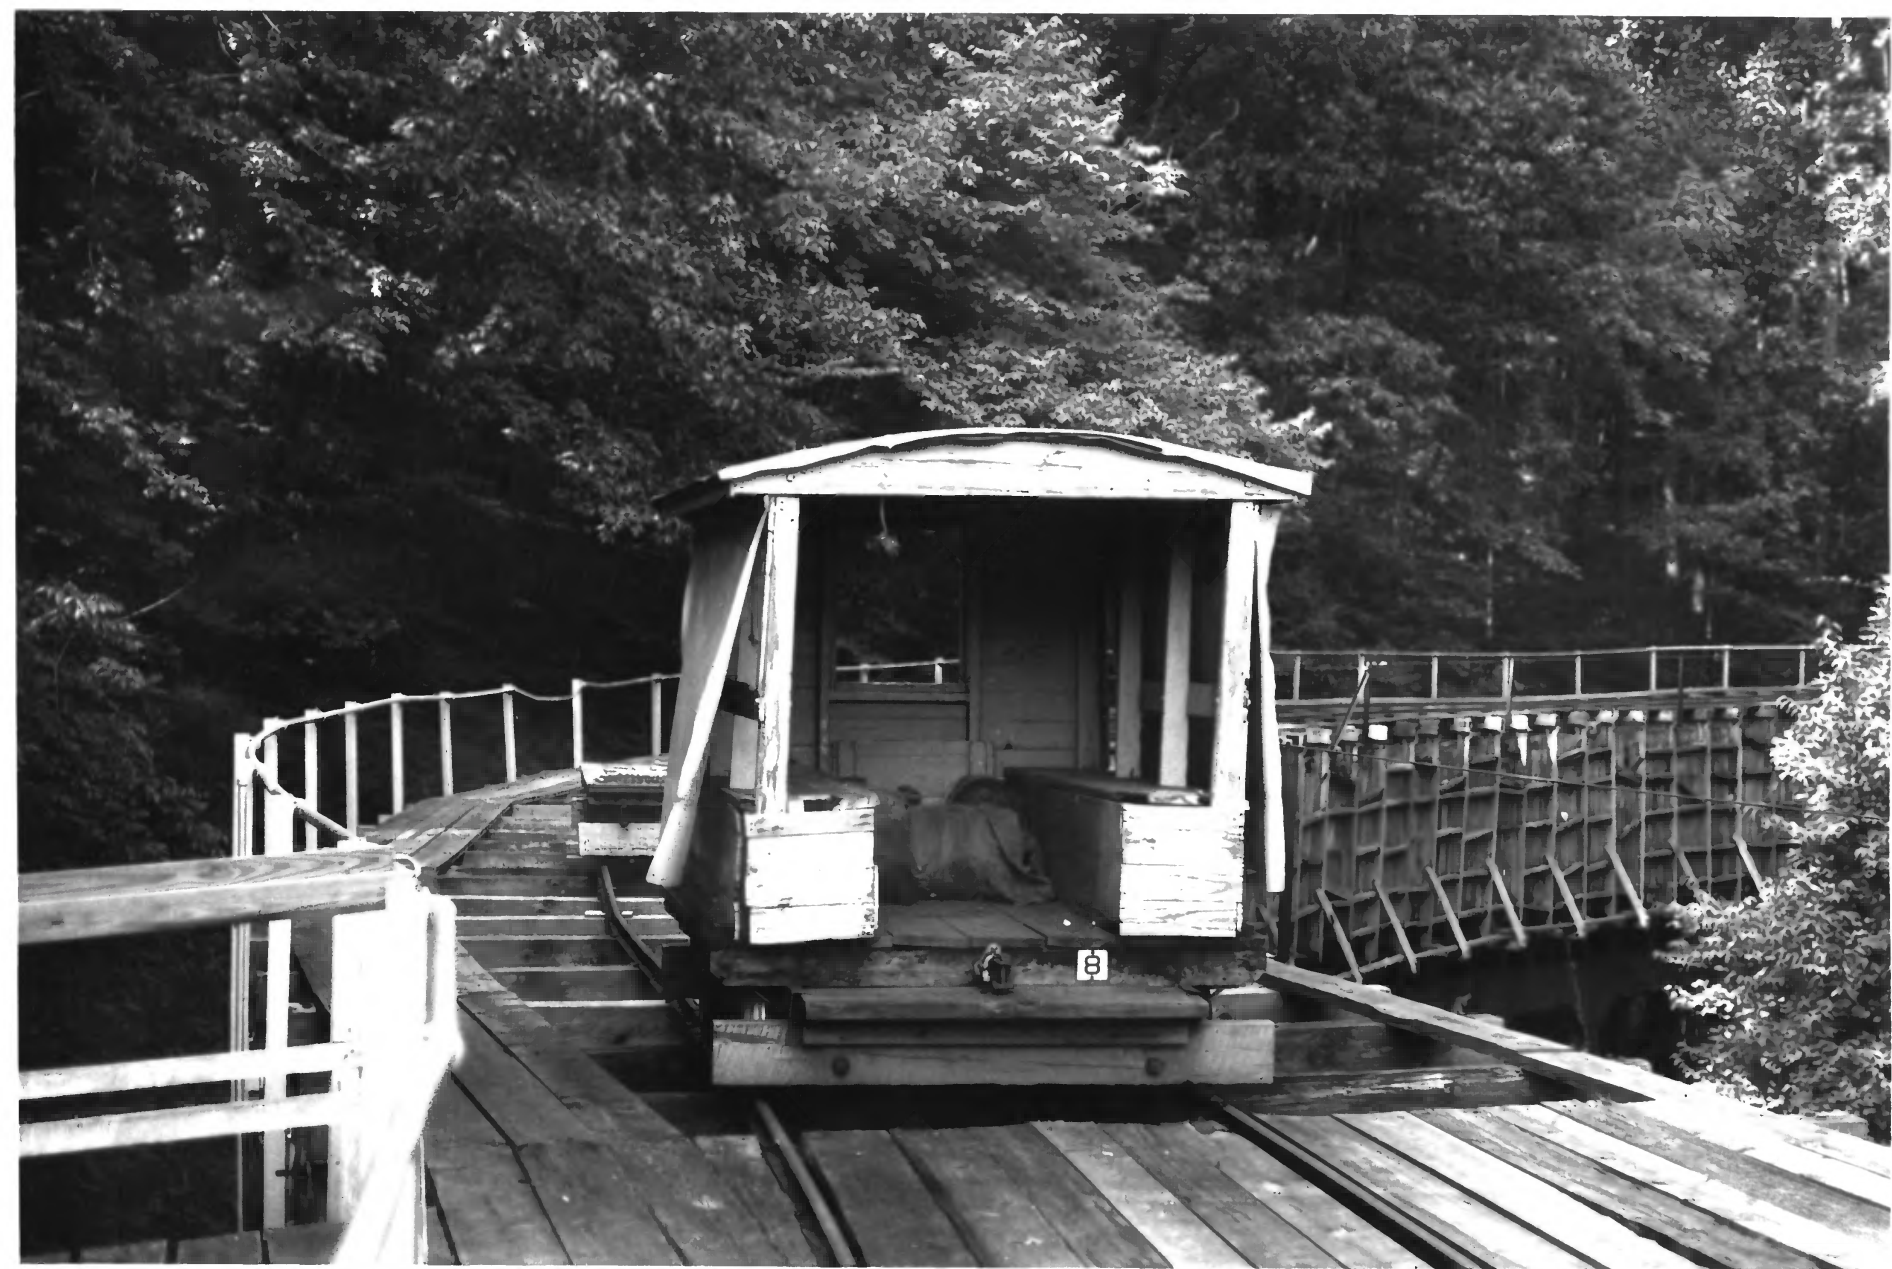
Photograph Number: 22 *426*

Description of View: View is of the top of flume box, showing the workers' "Pullman" car, used for servicing the flume. Note the presence of boardwalks after the fully covered flume top ends. Note also the concrete trestles below the flume, used over small ravines where large steel trestles were not originally necessary. Concrete trestles completely replaced the original wooden trestles around 1927. Photograph is taken at the covered section of the flume above the upper terminus of the incline; direction is looking north-northeast towards the forebay.

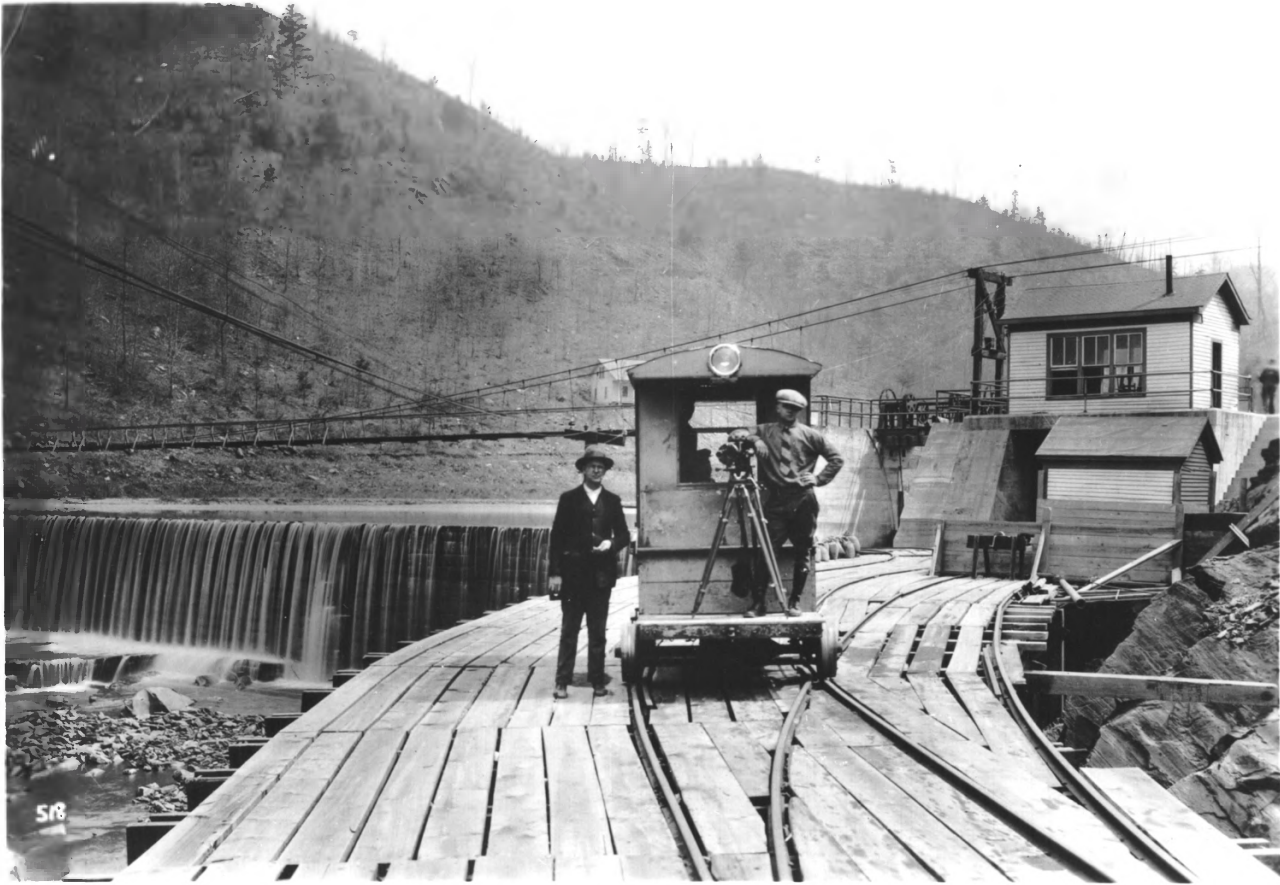
Photograph Number: 23 *of 26*

Description of View: View of start of flume showing downstream side
of diversion dam, 400 foot swinging footbridge, Taintor gate and
flume intake gatehouse. Note: top of flume is fully covered at
beginning of flume. Photograph is looking east. .

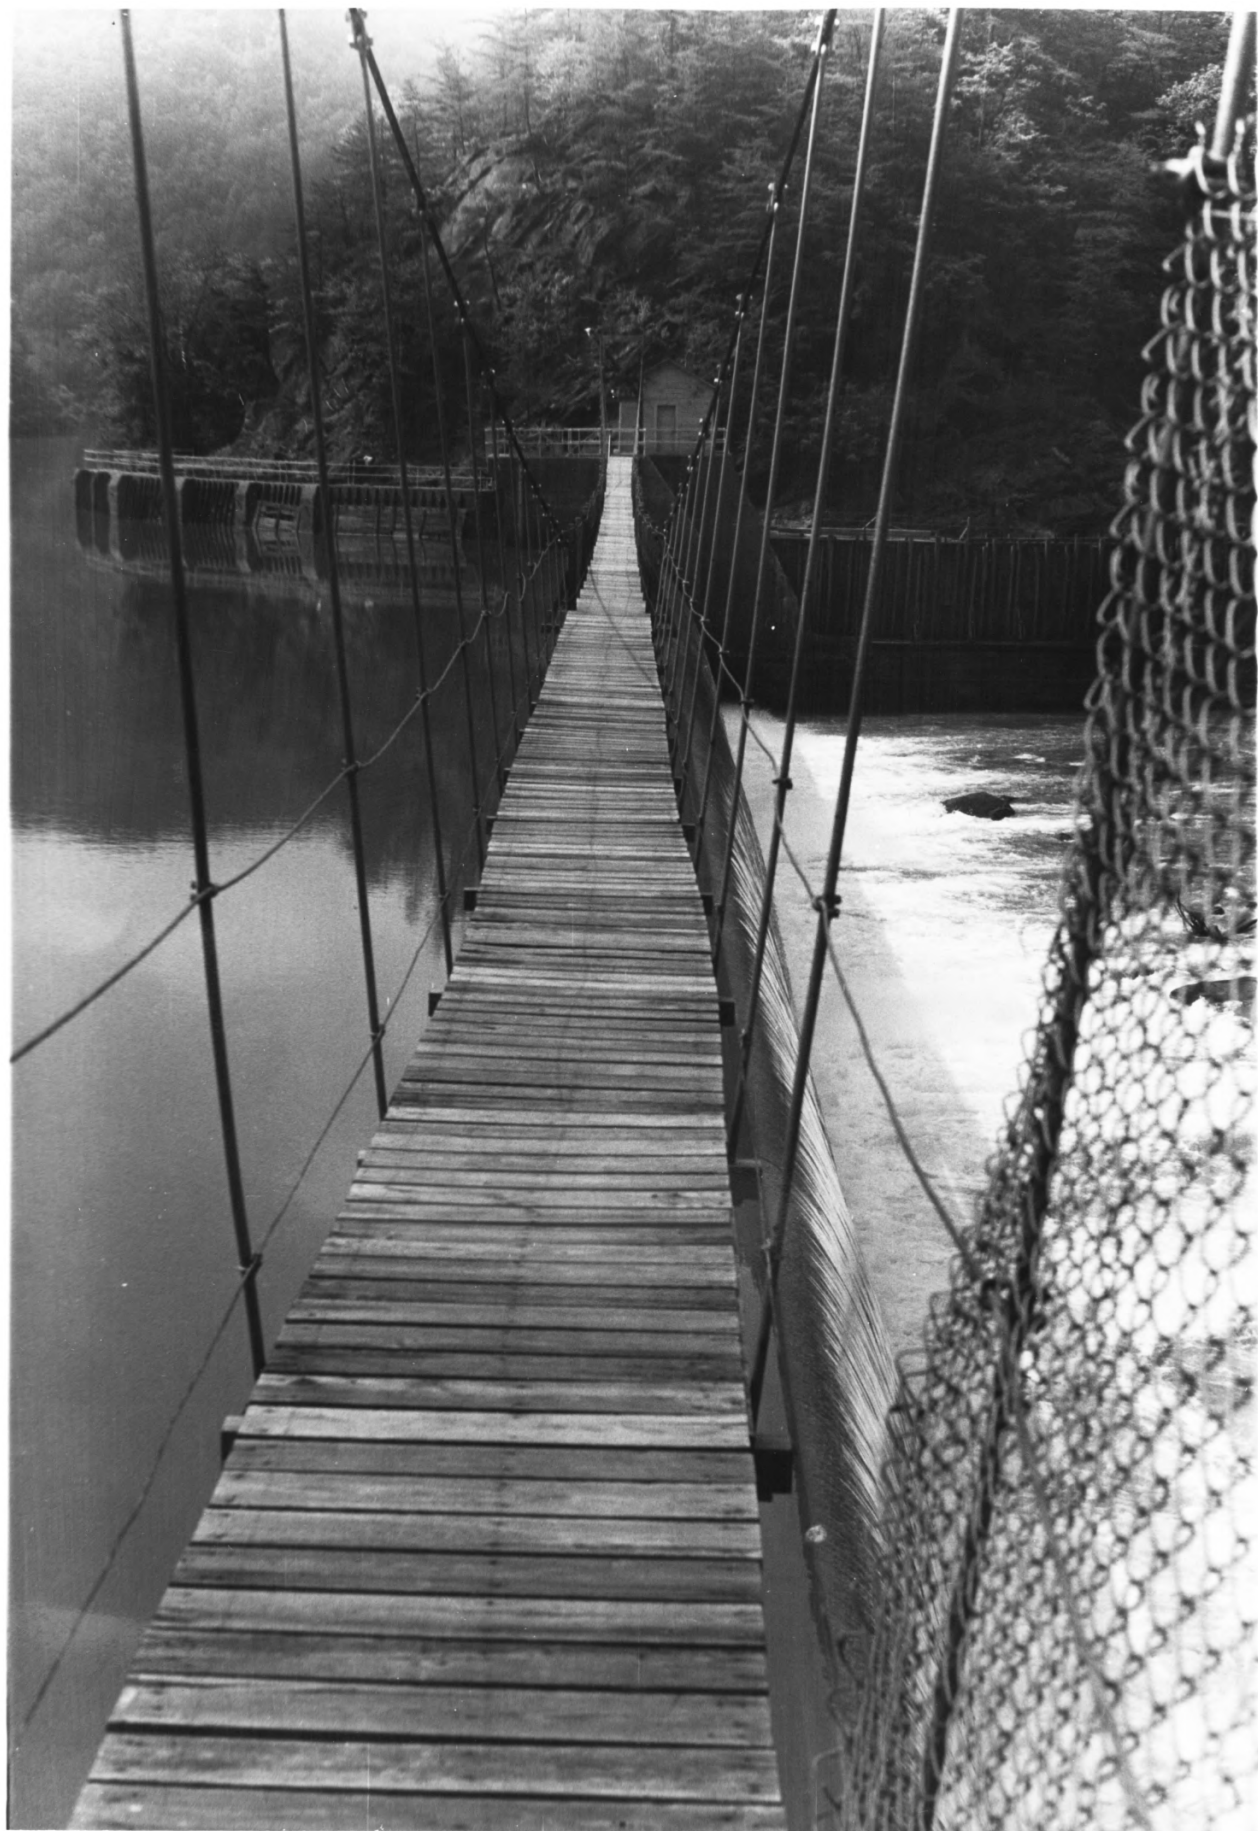
Photograph Number: 24 *9/26*

Description of View: View is of the 400 foot suspended swinging bridge over the top of the diversion dam. The beginning of the flume, the intake gatehouse and trash racks are visible in the background; right, center and left respectively. Water spilling over the diversion dam is visible below the right side of the bridge. Photograph is looking south.

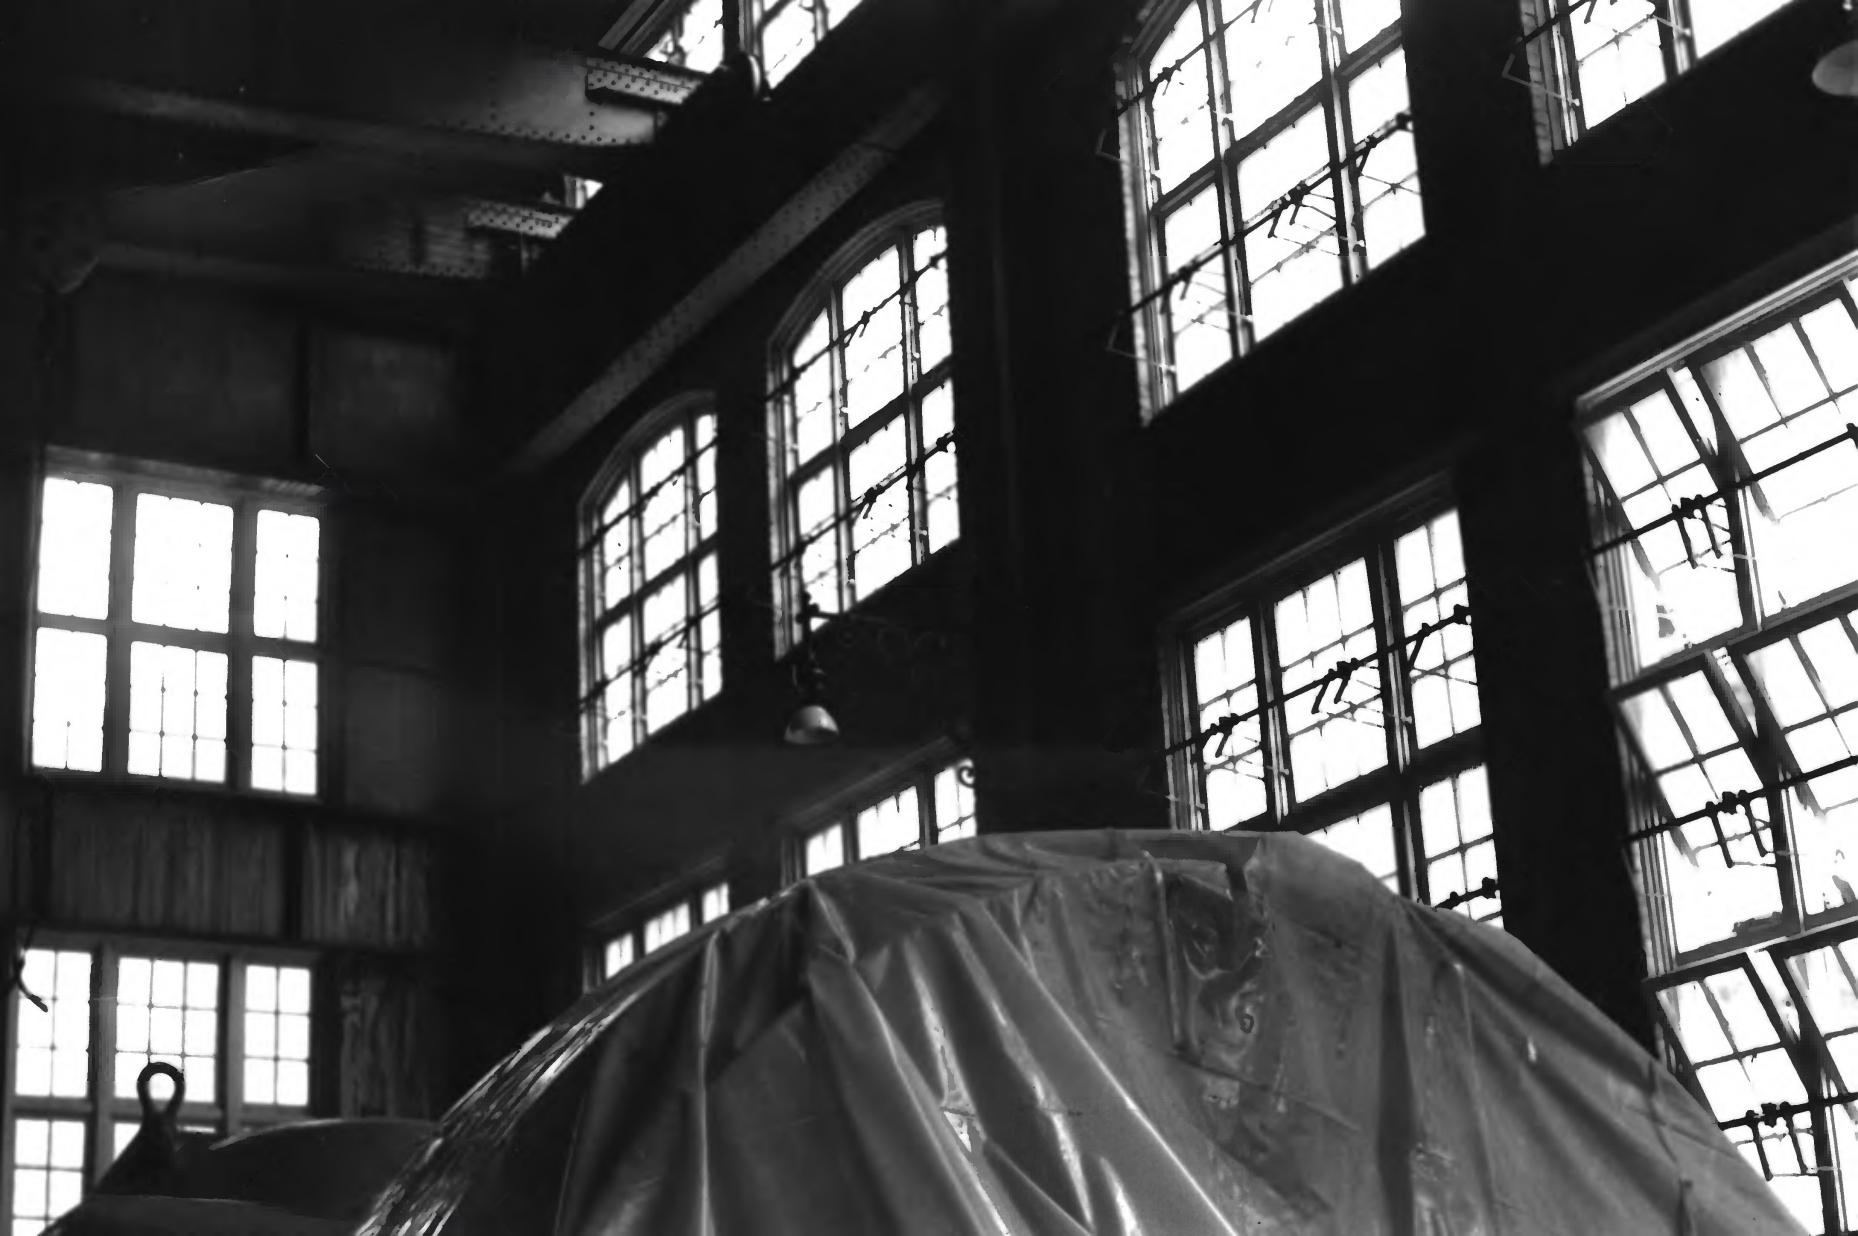
Photograph Number: 26 *of 26*

Description of View: View is of the interior of the powerhouse and the original powerhouse light fixture. Note the change in the color of brickwork at the center pier where the wall was destroyed by the generator runaway. Note also generator unit no. 2 (under plastic cloth in center of photograph), the eye on top of the turbine for lifting and removing for service, (lower left), and the overhead 30 ton service crane (upper left).
