National Register of Historic Places Registration Form

1. Name of Property				
historic name Hamlin, Charles Hunter, House				
other names/site number Hamlin-Johnson House (preferred)				
Name of Multiple Property Listing N/A				
(Enter "N/A" if property is not part of a multiple property listing)

2. Location				
street & number 1322 SE 282 nd Ave				
city or town Gresham				
state Oregon code OR county Multnomah code 51 zip code 97080				
3. State/Federal Agency Certification				
As the designated authority under the National Historic Preservation Act, as amended,				
I hereby certify that this X nomination request for determination of eligibility meets the documentation standards for registering properties in the National Register of Historic Places and meets the procedural and professional requirements set forth in 36 CFR Part 60.				
In my opinion, the property <u>X</u> meets <u>does</u> not meet the National Register Criteria. I recommend that this property be considered significant at the following level(s) of significance: <u>national</u> <u>statewide</u> <u>X</u> local				
Applicable National Register Criteria: A B X C D Quittine Quittine 4.13.16 Signature of certifying o

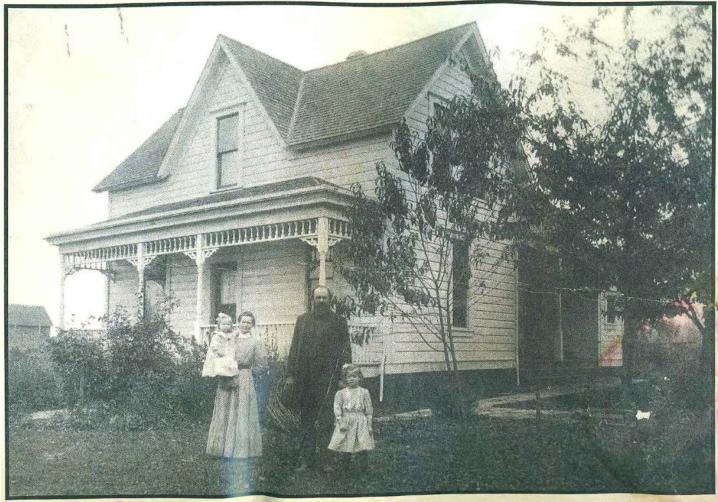
Figure 16: Photo of house with Johnson family, 1908

Former Parsonage, October, 1908, still standing across the street from present church. Rev. Jonas Johnson with his family pictured.

The front façade of the house displays excellent integrity. It appears nearly identical to the earliest photograph of the house, which dates from ca. 1908. The Queen Anne style architectural detailing on the front and side porches was likely added ca. 1903, after the tenure of a contractor who owned the house for a short time before selling it and relocating. The small chase on the right side of the porch, which was added when the second floor bathroom was added in the 1960s or 1970s, is inconspicuous.

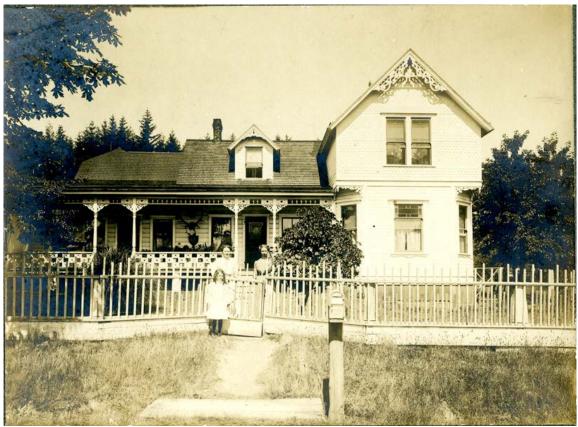
Figure 20: The 1867 Roberts House (Elkhorn Ranch) was modified in the 1890s, incorporating Queen Anne stylistic features

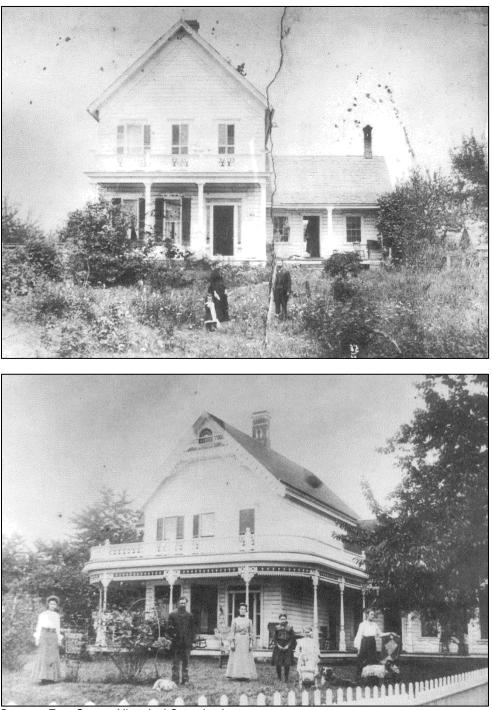
Figure 21: The 1874 Zimmerman House was first photographed ca. 1887-88, after its first expansion. It was modified and expanded again in 1899, incorporating Queen Anne stylistic features
