KENTUCKY HISTORIC RESOURCES
Individual Inventory Form

Resource # GpG-6

1. Name of Resource:
Warnock House

5. Location:
404 Harrison

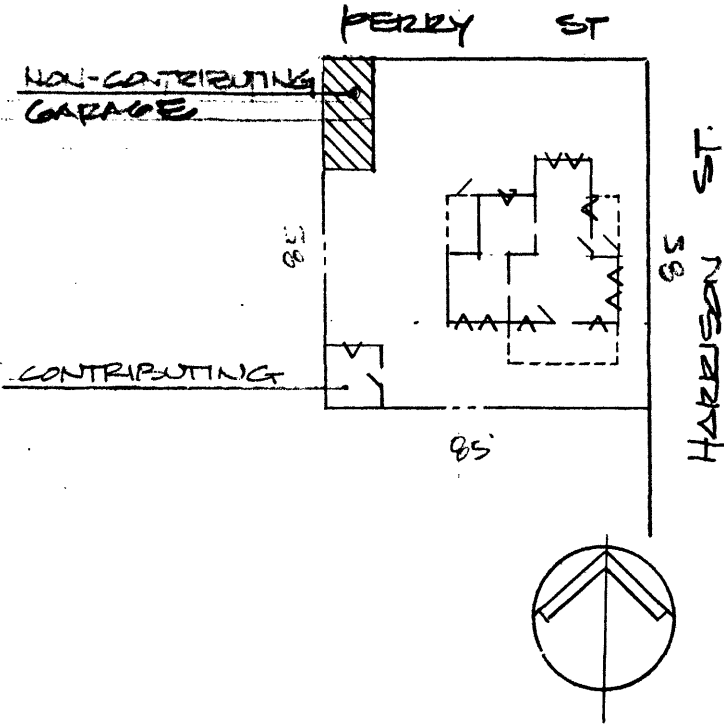
44. Site Plan (and boundary description and justification for N.R. sites):

Starting at a point in the southwest corner of the intersection of Harrison and Perry Streets; then south 85 feet south along the west side of Harrison St. to the SE corner of the lot of 404 Harrison; then west 85 feet along the south property line to the SW corner of 404 Harrison St.; then north 85 feet along the west property line of 404 Harrison to the NW corner; then east along the south side of Perry Street 85 feet to the NE corner of 404 Harrison.

The boundary contains two contributing buildings and one non-contributing structure and contains all the buildings and structures associated with the domestic space of the Warnock House.
