United States Department of the Interior  
National Park ServiceNational Register of Historic Places  
Inventory—Nomination FormSee instructions in *How to Complete National Register Forms*  
Type all entries—complete applicable sections

historic Arlington Mills Historic District

## 7. Description Arlington Mills Historic District, Lawrence & Methuen, MA

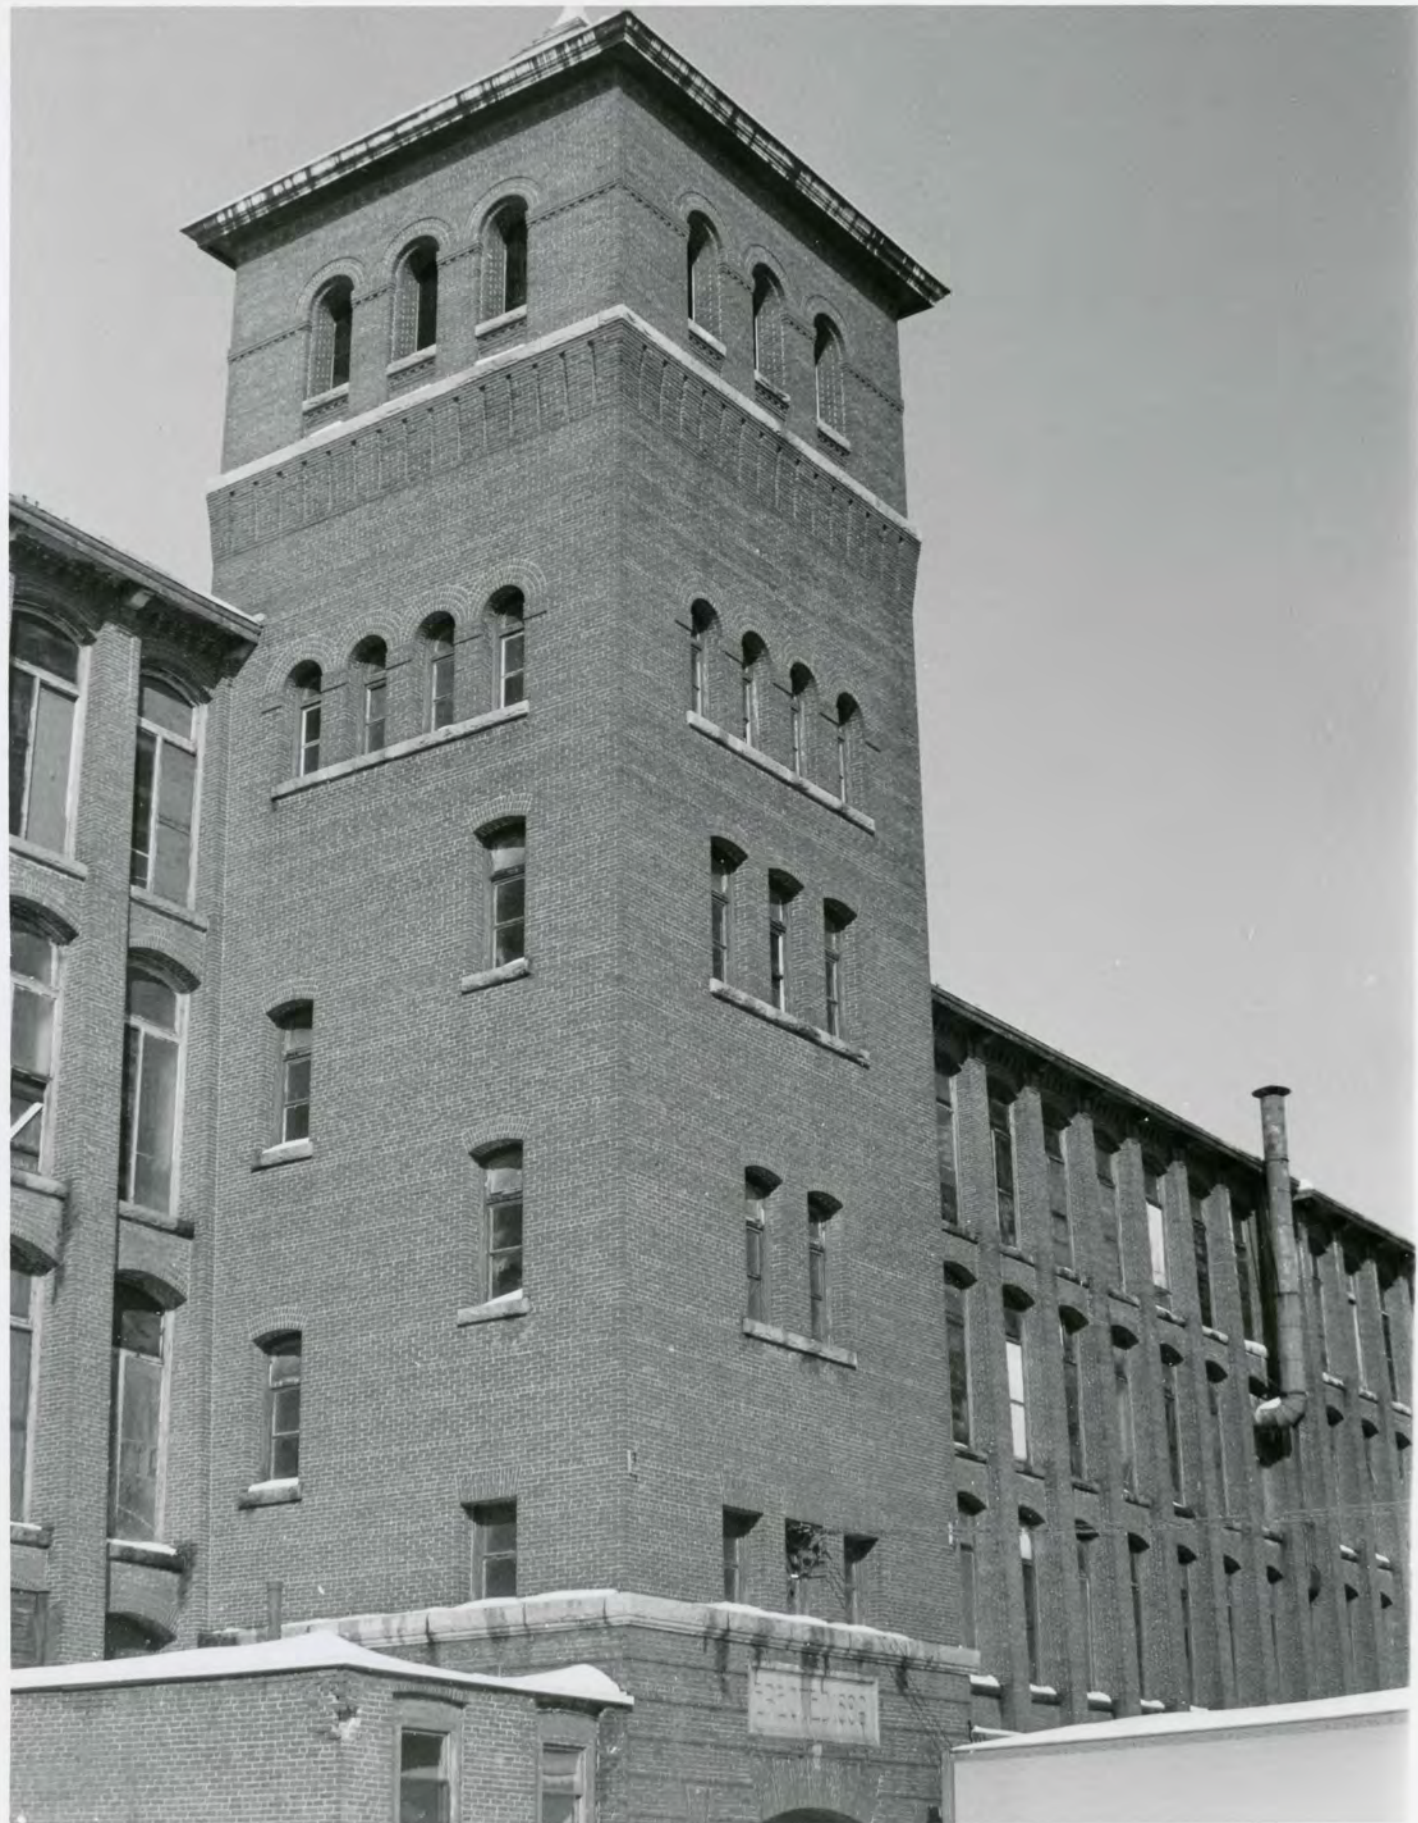
Photo 2  
Tops Mill, central  
tower  
Arlington Mills  
Historic District  
Lawrence/Methuen, MA

The four-story, flat-roofed tops (or wool-combing) mill was one of the largest mill buildings in the United States when constructed in 1896 (Map 6, 12, Photo 2). The 750-by-109-foot mill, which includes a later 1903 wing, has splayed buttresses which terminate in a simple cornice. The front facade has a broad central pier flanked by ten and twelve bays of segmental arched windows with granite sills. Vertical members rest on shaped granite plinths and foundations. A prominent pyramidal-roofed stairtower/bell tower at the south elevation has grouped small round-arched windows and an open belfry articulated by a granite stringcourse and corbelling. Above the stair entry "ERECTED 1896" is set in granite below another granite stringcourse. An iron gate set between massive rusticated granite posts and flanked by granite capped brick halls with round-arched pass-throughs is situated between the tops mill and the 1887 worsted spinning mills.

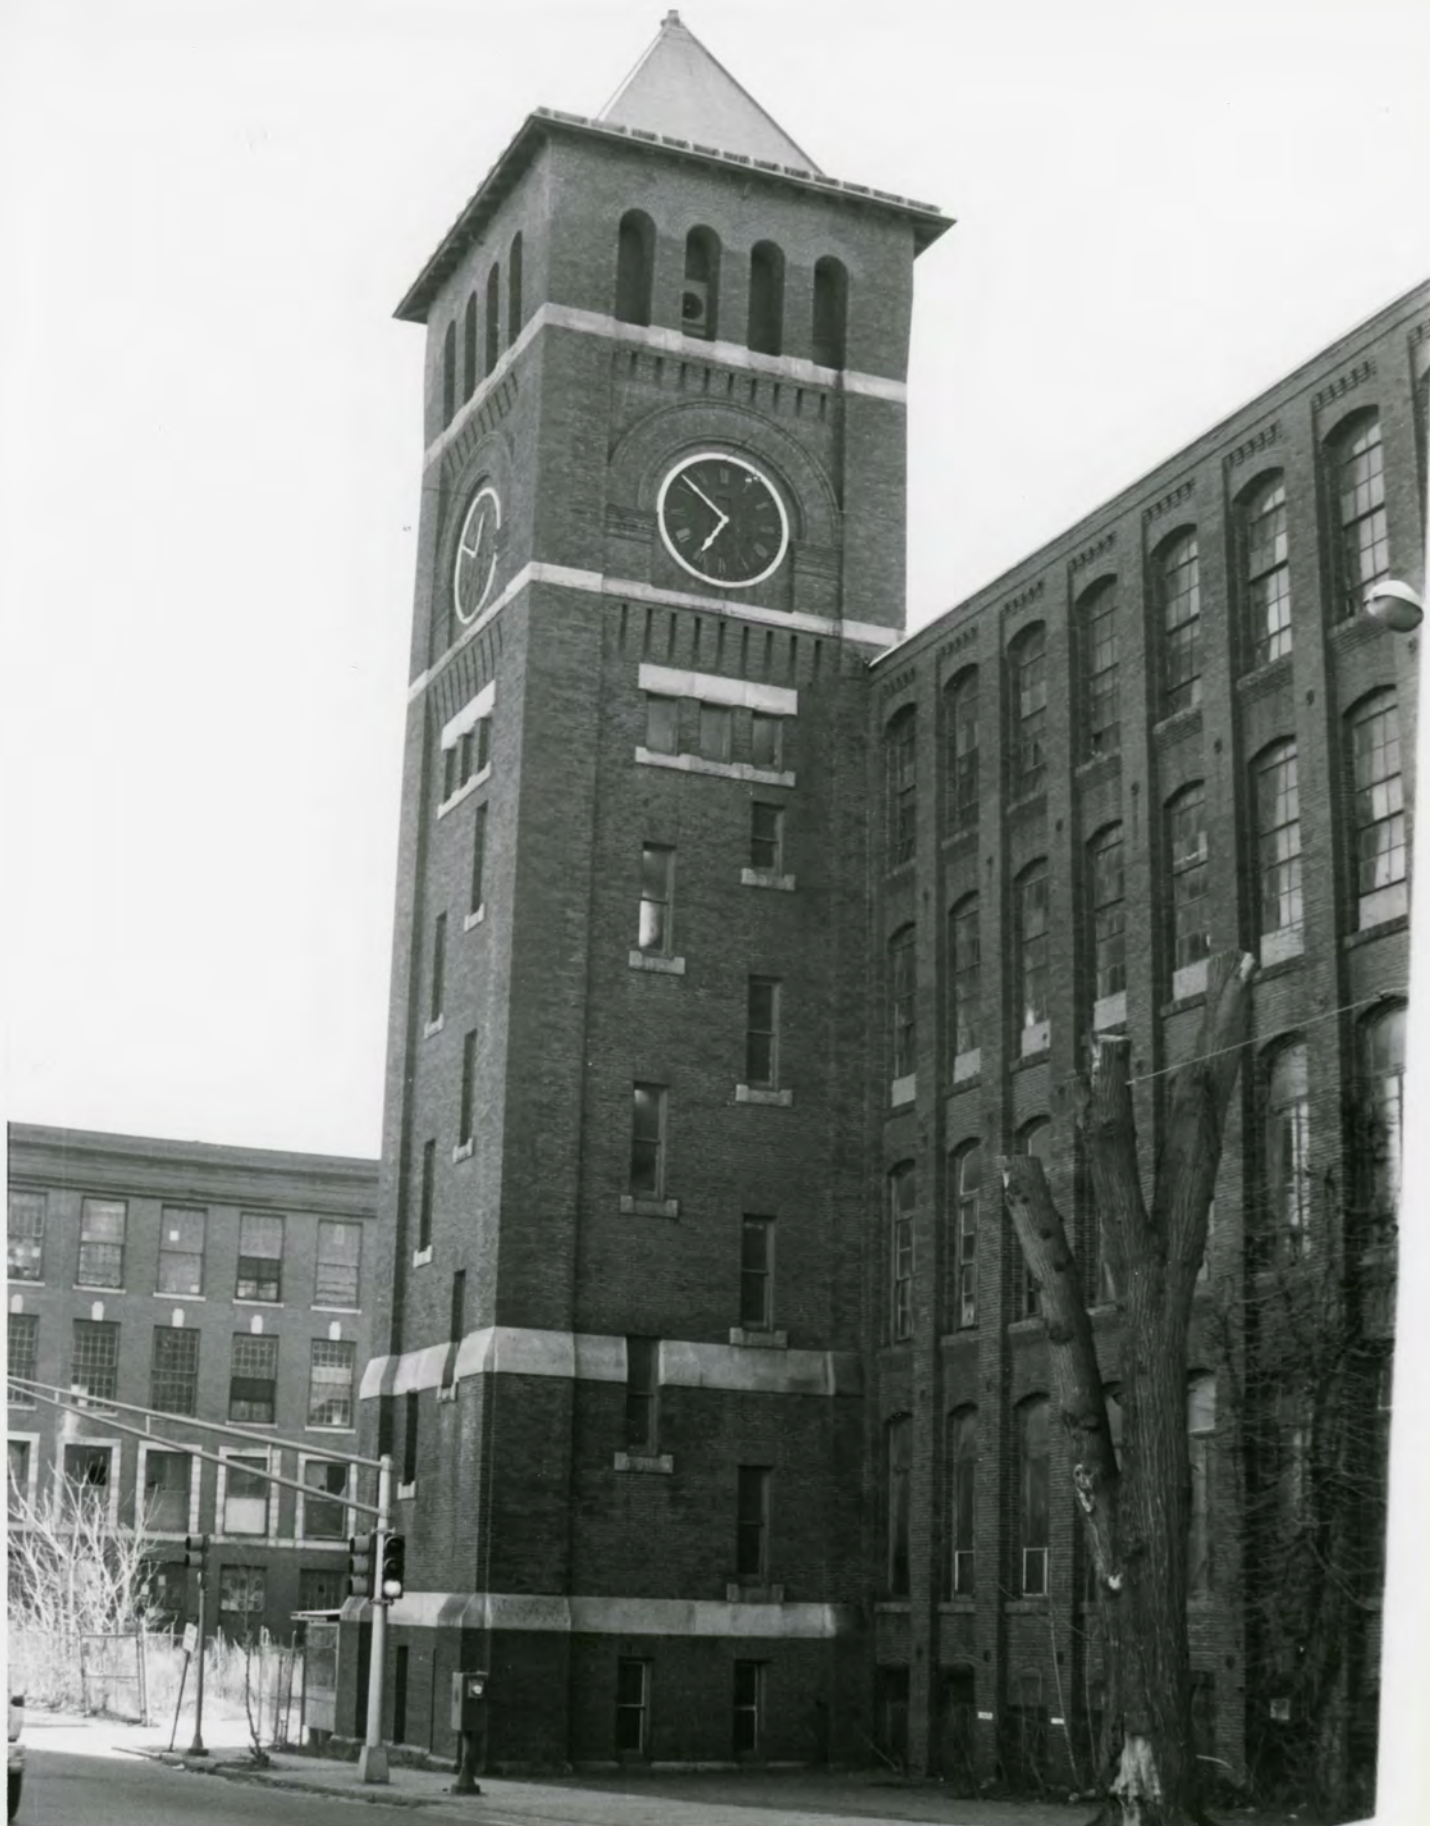
Photo 4  
Spinning Mill and  
Clock Tower  
Arlington Mills  
Historic District  
Lawrence/Methuen, MA

The storehouse abuts extensions to the 295-by-100-foot worsted spinning mill built in 1886-87, the east wing of which was added in 1890 (Map 7, Photo 7). The four-story plus basement structure has a flat roof capped with a low monitor, and provides 143,419 square feet of floor area. Two prominent stairtowers at the south and northeast corners have corbelled cornices and pyramidal roofs; the tower buttresses terminate in metal-flashed crowns. The 1890 addition gave the worsted spinning mill its present L shape and added a prominent pyramidal-roofed clock tower (Map 7, Photo 4).

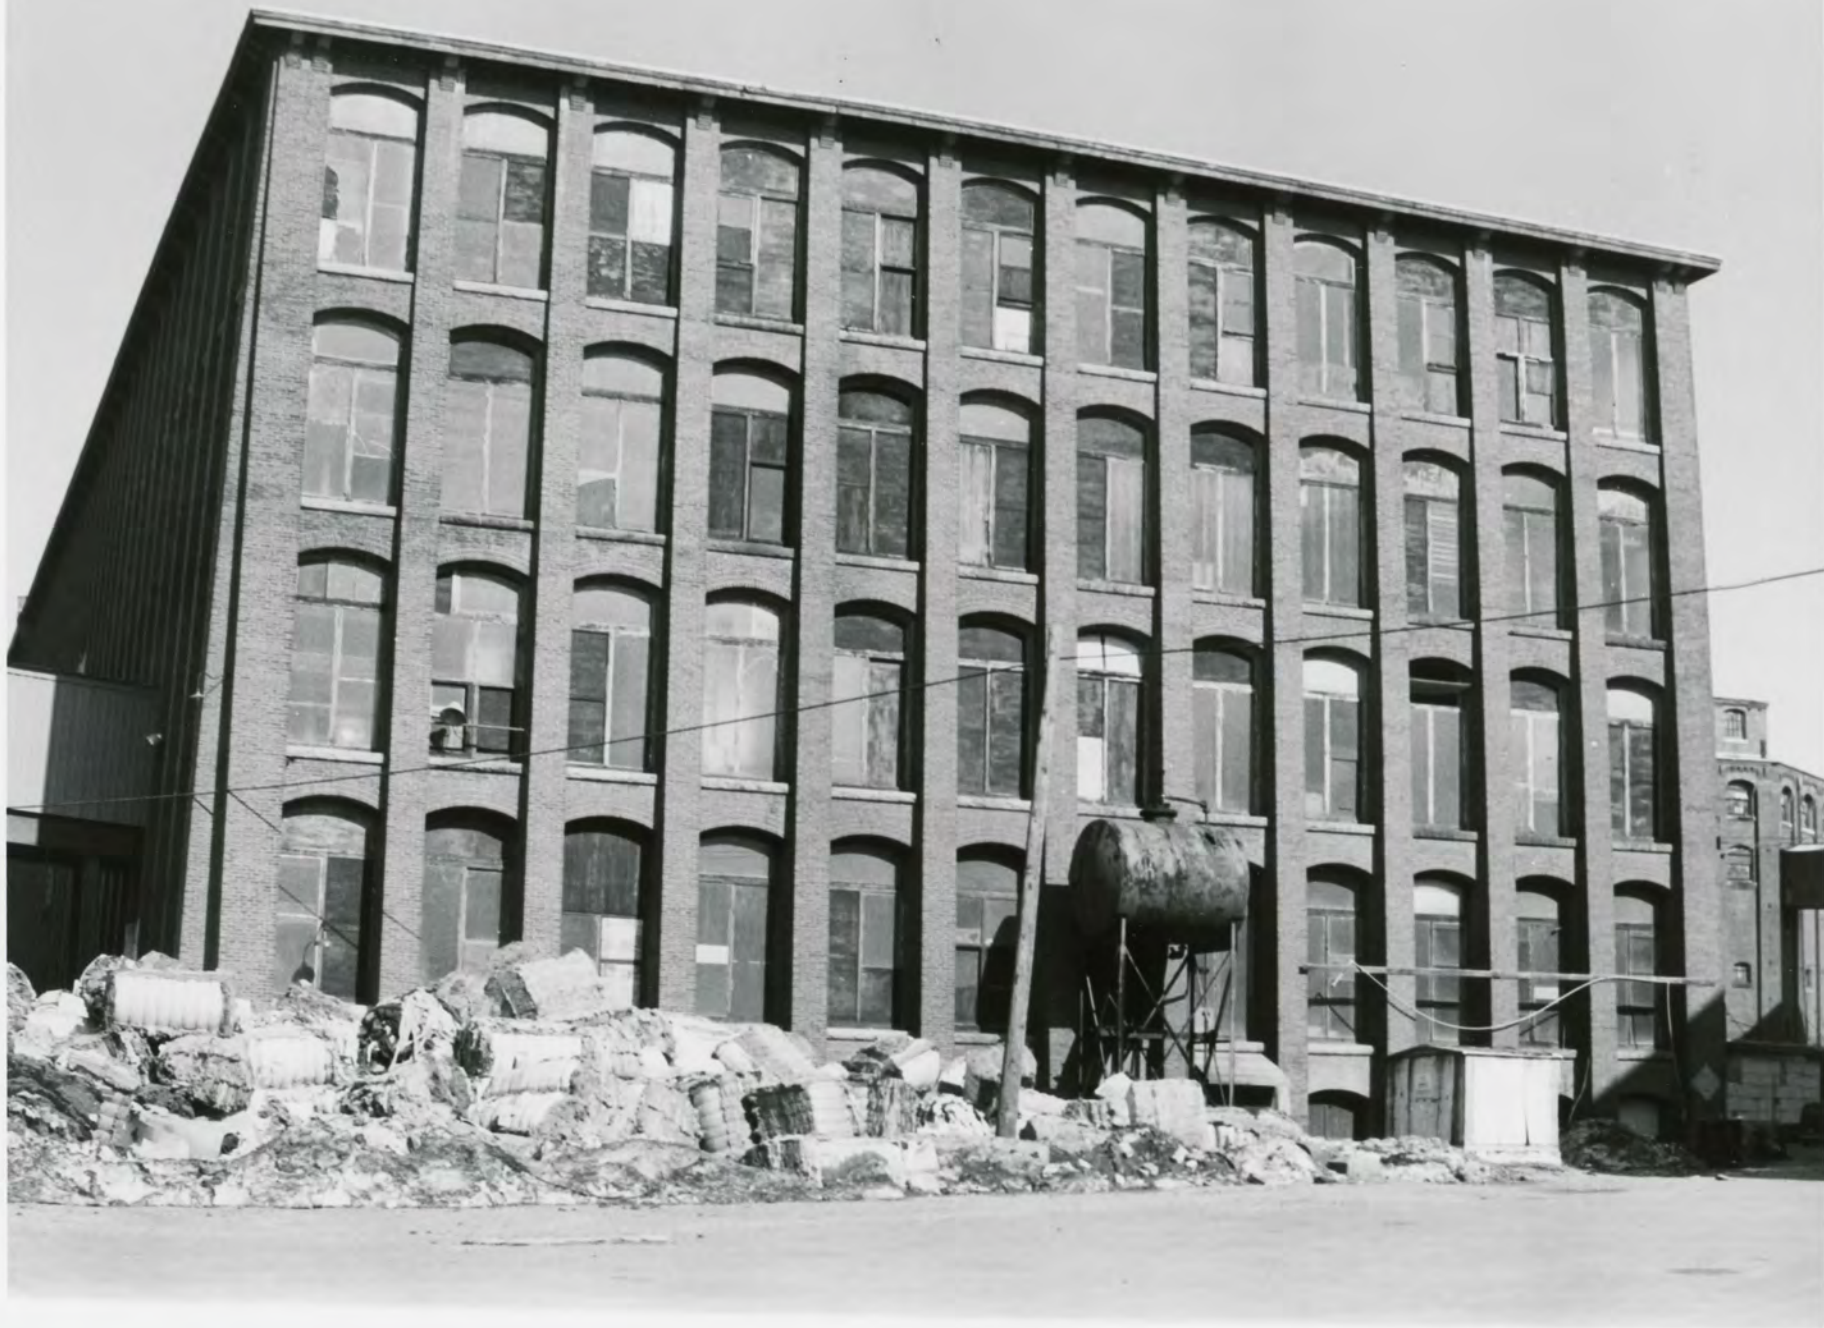
Photo 6  
Tops Mill, rear elevation,  
east Storehouse  
at far right  
Arlington Mills  
Historic District  
Lawrence/Methuen, MA

Typical of the textile storehouses built in the 1880s is the six-story, trapezoidal 125-by-135-foot wool storehouse, built in 1886 (Map 6, Photo 6). The timber-frame, masonry-clad structure was served by the Boston and Maine tracks and provided sorting rooms at the upper floors for the variety of imported wools stored below. A corbelled cornice is the only surface ornamentation; the segmental arch windows on granite sills are staggered at the lower floors; sorting rooms at the upper two stories are identified by large multi-paned units.

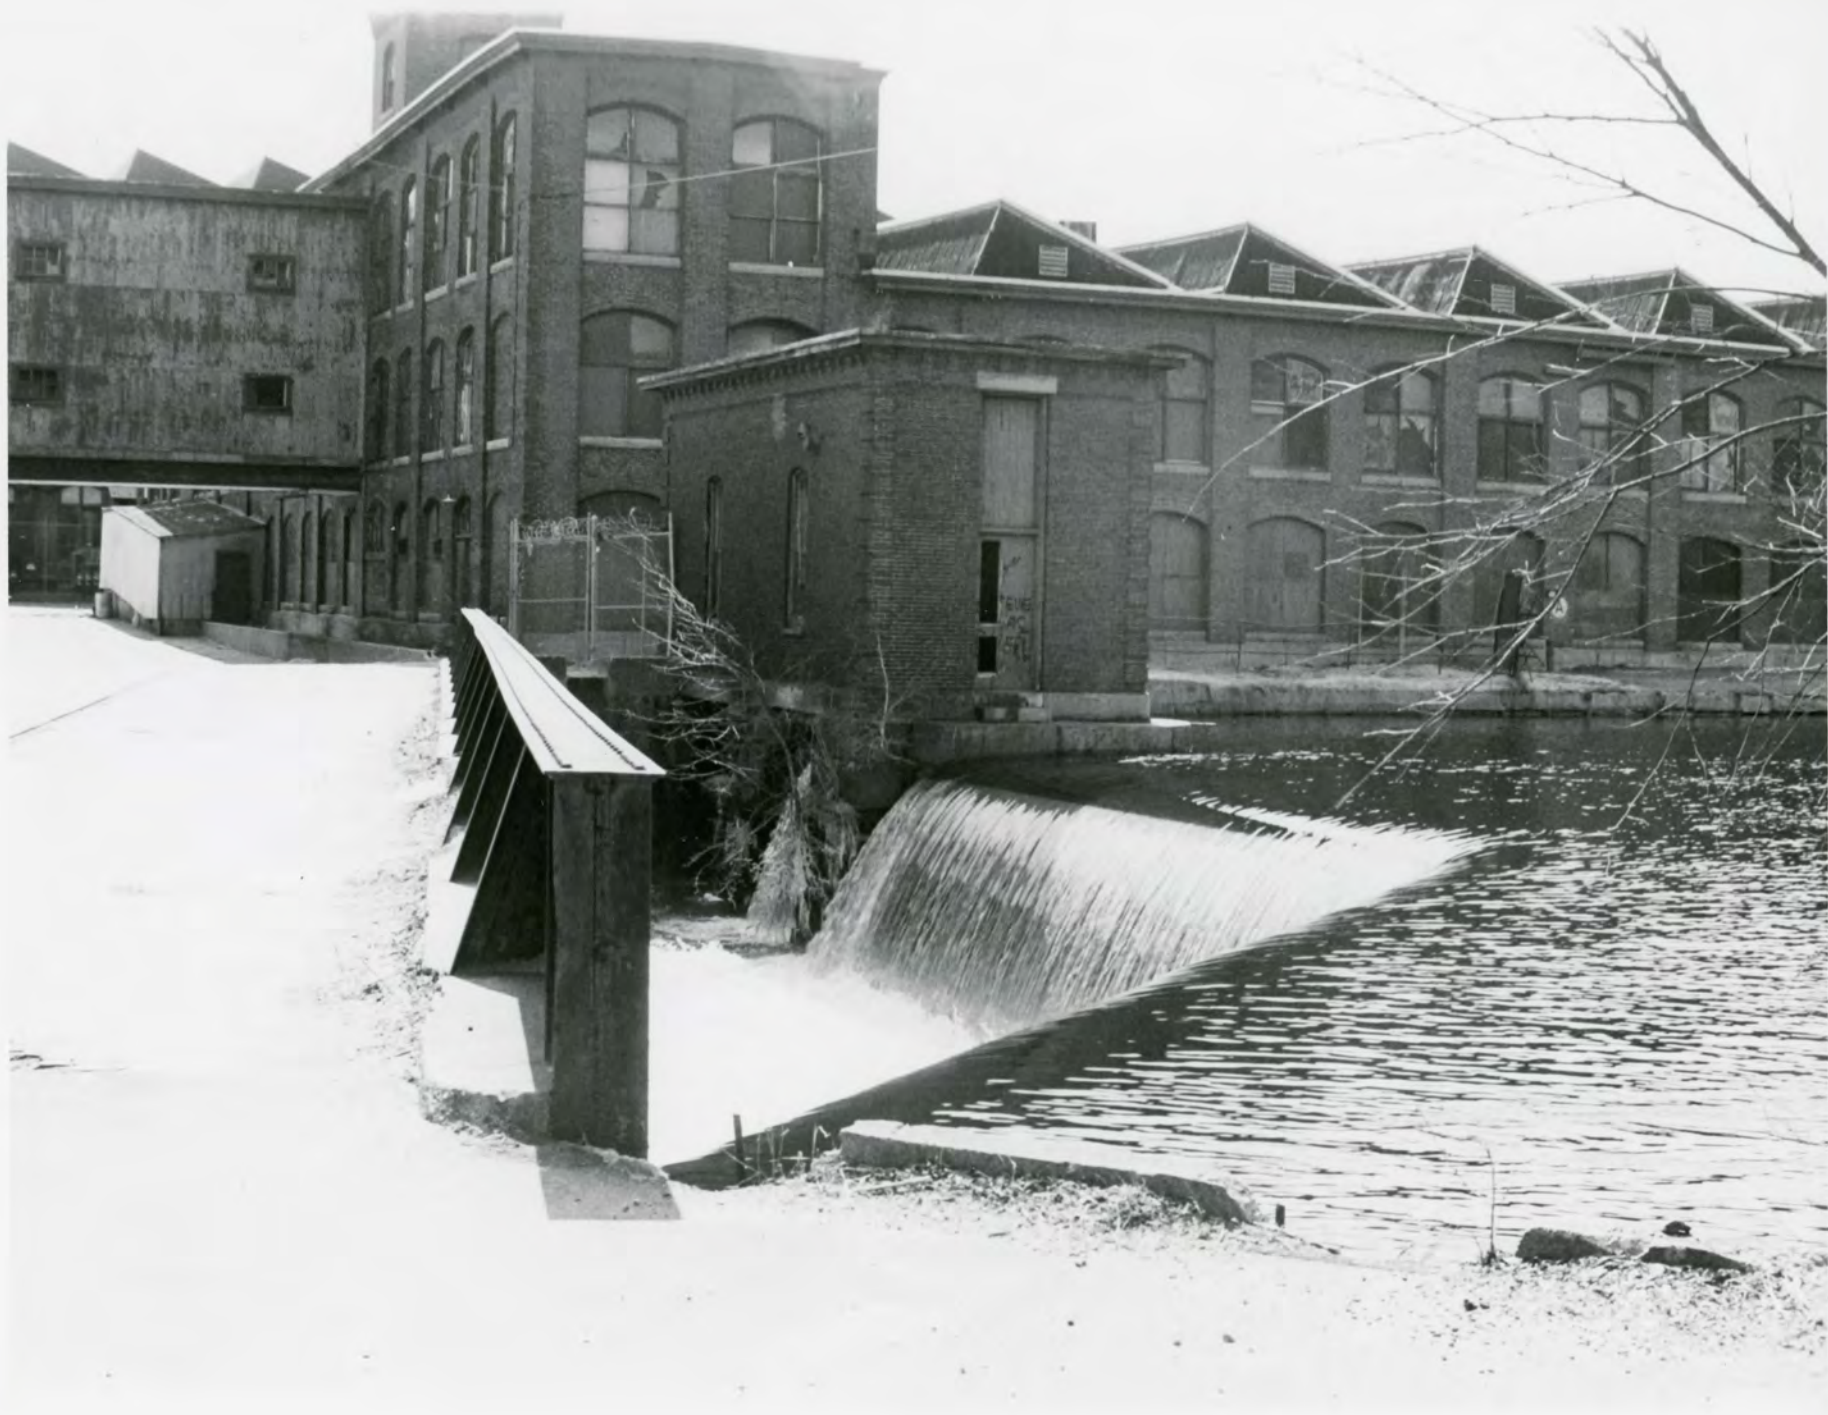
Photo 8  
Spicket River Falls and  
Dam, Loom Weave House,  
background  
Arlington Mills  
Historic District  
Lawrence/Methuen, MA

In 1906 a new worsted weaving mill was erected (Map 3, Photo 8). The 600-by-200-foot, two-story structure was designed to accommodate the wide looms, then in common use for worsted weaving.

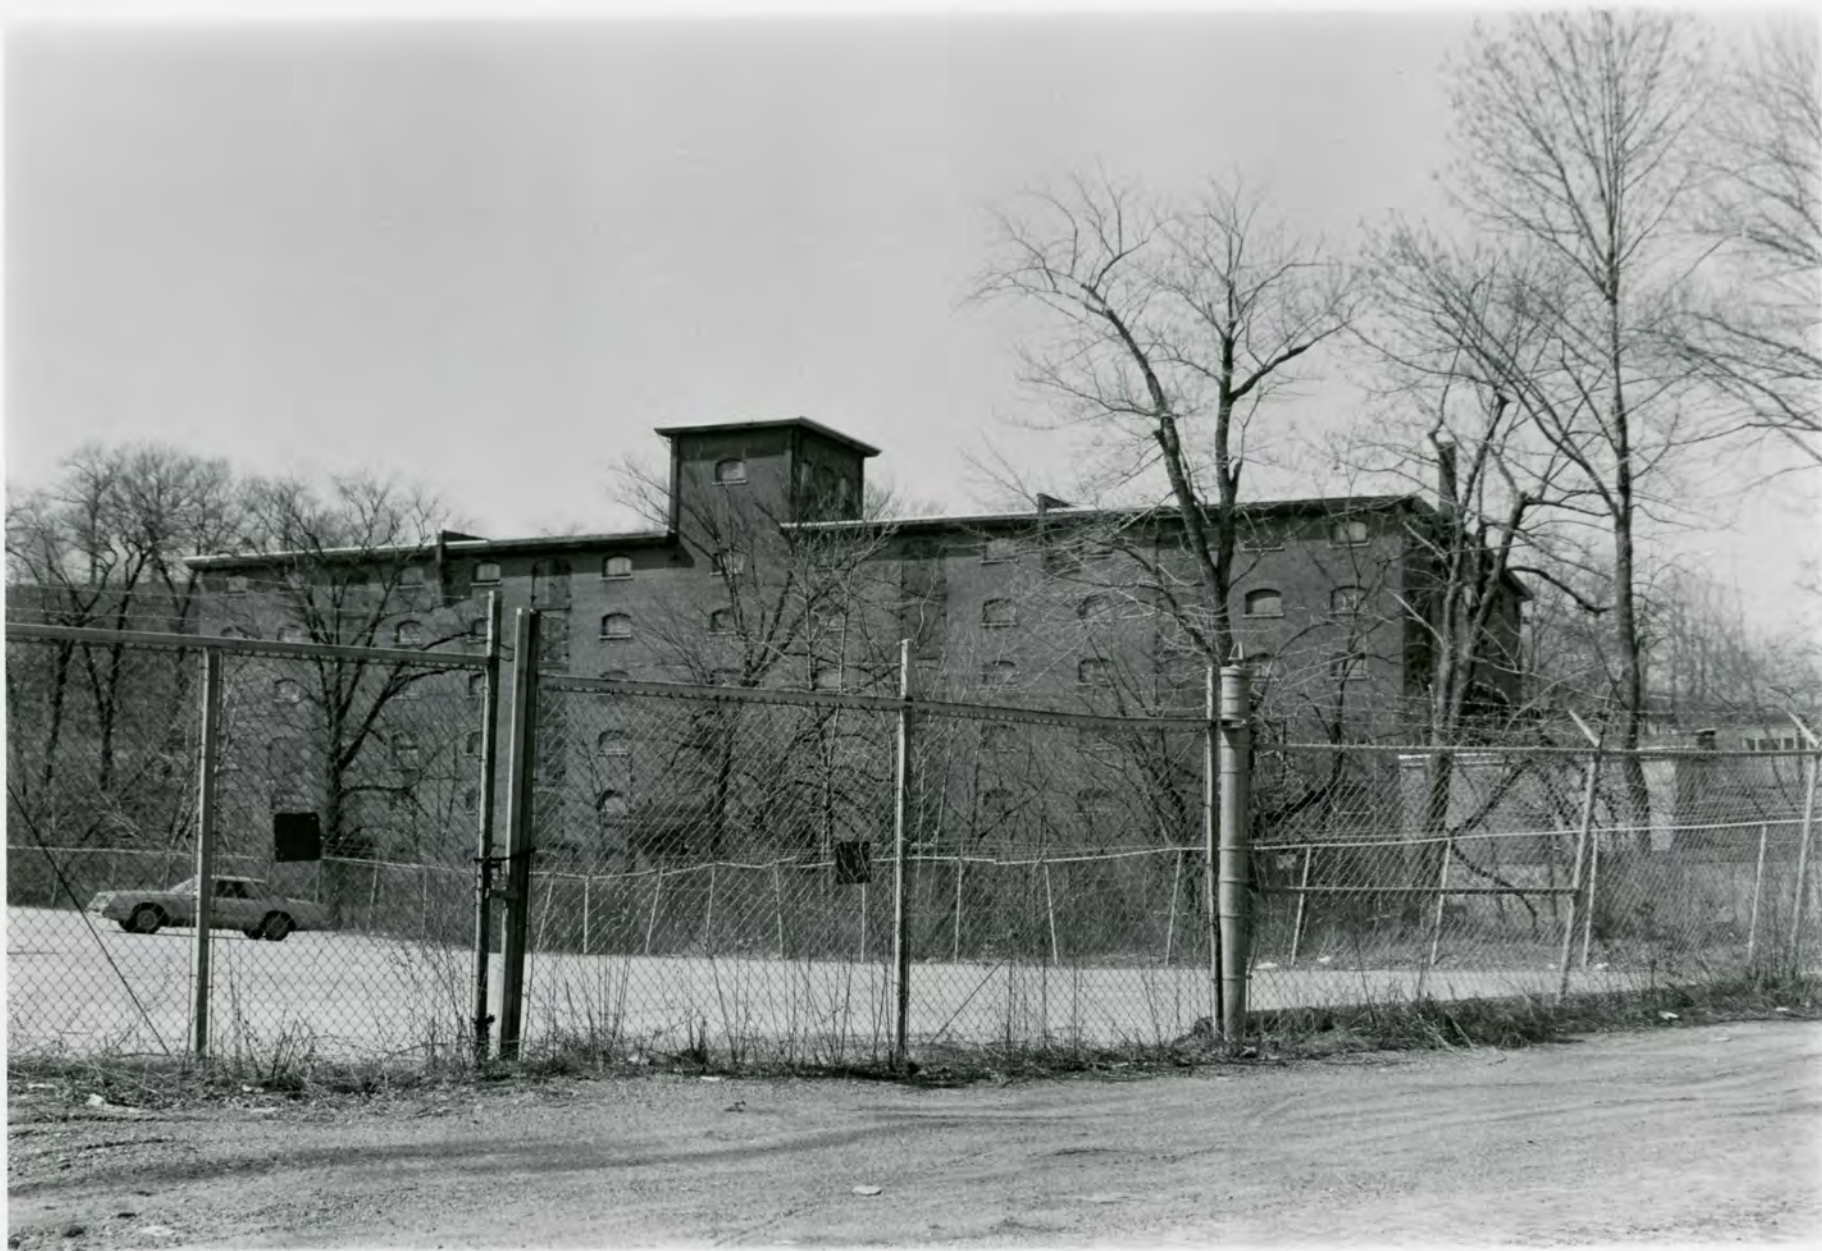
Photo 9  
Arlington Mills Store  
House  
Arlington Mills  
Historic District  
Lawrence/Methuen, MA

Other buildings within the Arlington Mills complex are a boiler engine house (Map 19) of ca. 1890 and a cotton storehouse (Map 22, Photo 9). The boiler engine house is of utilitarian brick construction but the cotton storehouse features a well-proportioned design with a low pitched roof and staffered segmental-arch windows with granite lintels.
