National Register of Historic Places Registration Form

Historic name: Homestead Hall

Street & number: 362 Grears Corner Road

City or town: Townsend State: DE County: New Castle

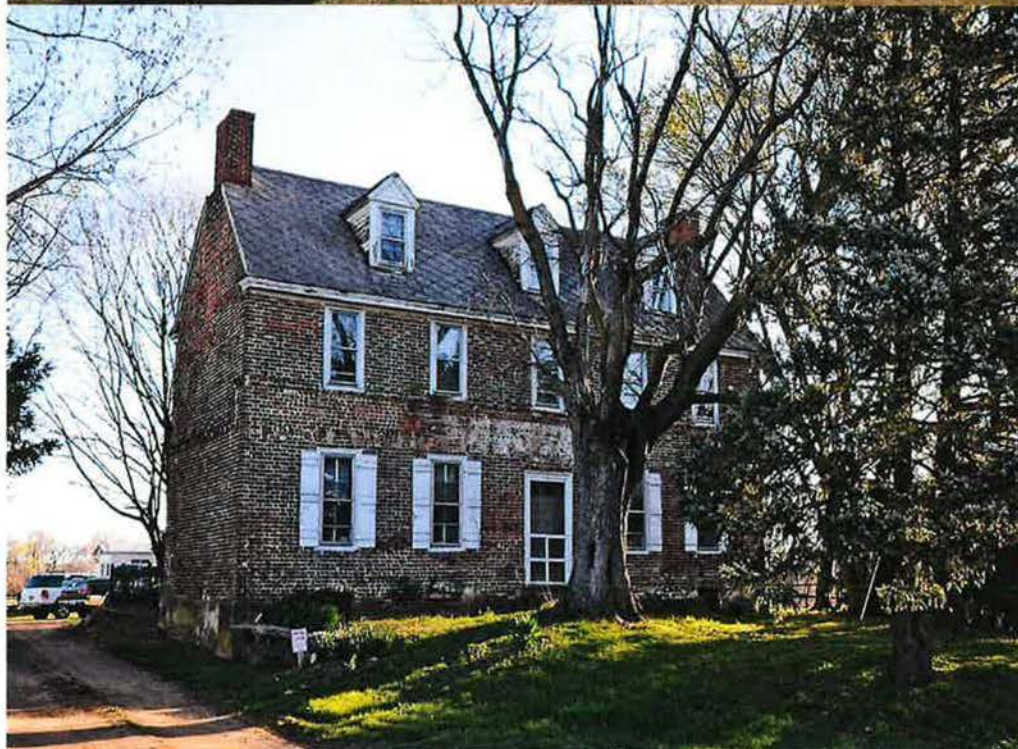
Figure 2: Top photo: Homestead Hall's four-bay front elevation with paired entry doors. Bottom photo: Hill Island Farm (Noxontown Farm), Thomas Rothwell III's later five-bay Georgian dwelling with central entry door and stair hall.

The four-bay, southeast-facing façade of the c. 1773 main block features Flemish bond brickwork with glazed headers and a four-row brick belt course that demarcates the first floor

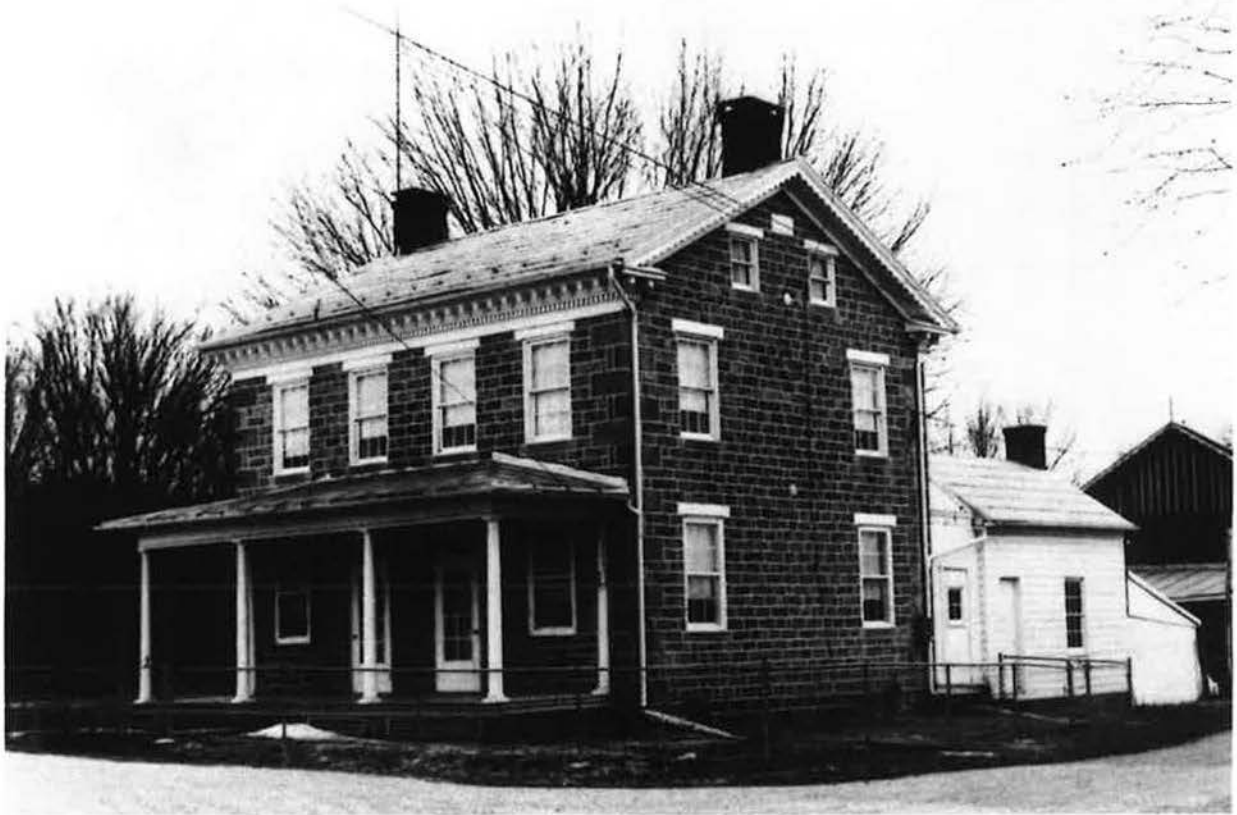
The Pennsylvania Farmhouse Type. This is an orderly and elegant nineteenth-century example of the synthetic Georgian-Germanic house; other examples can be seen in Figs. 9, 12, 14, 23, and 27. It is located south of Wellsville, York County, Pennsylvania. (Photo, the author.)

Figure 3: Illustration of a four-bay Pennsylvania German exterior, with paired entry doors on the façade, from Henry Glassie's "Eighteenth-Century Cultural Process in Delaware Valley Folk Building."
