NATIONAL REGISTER OF HISTORIC PLACES  
PROPERTY PHOTOGRAPH FORM

Millwood (Lambert Brewer House)

Salvisa

Kentucky

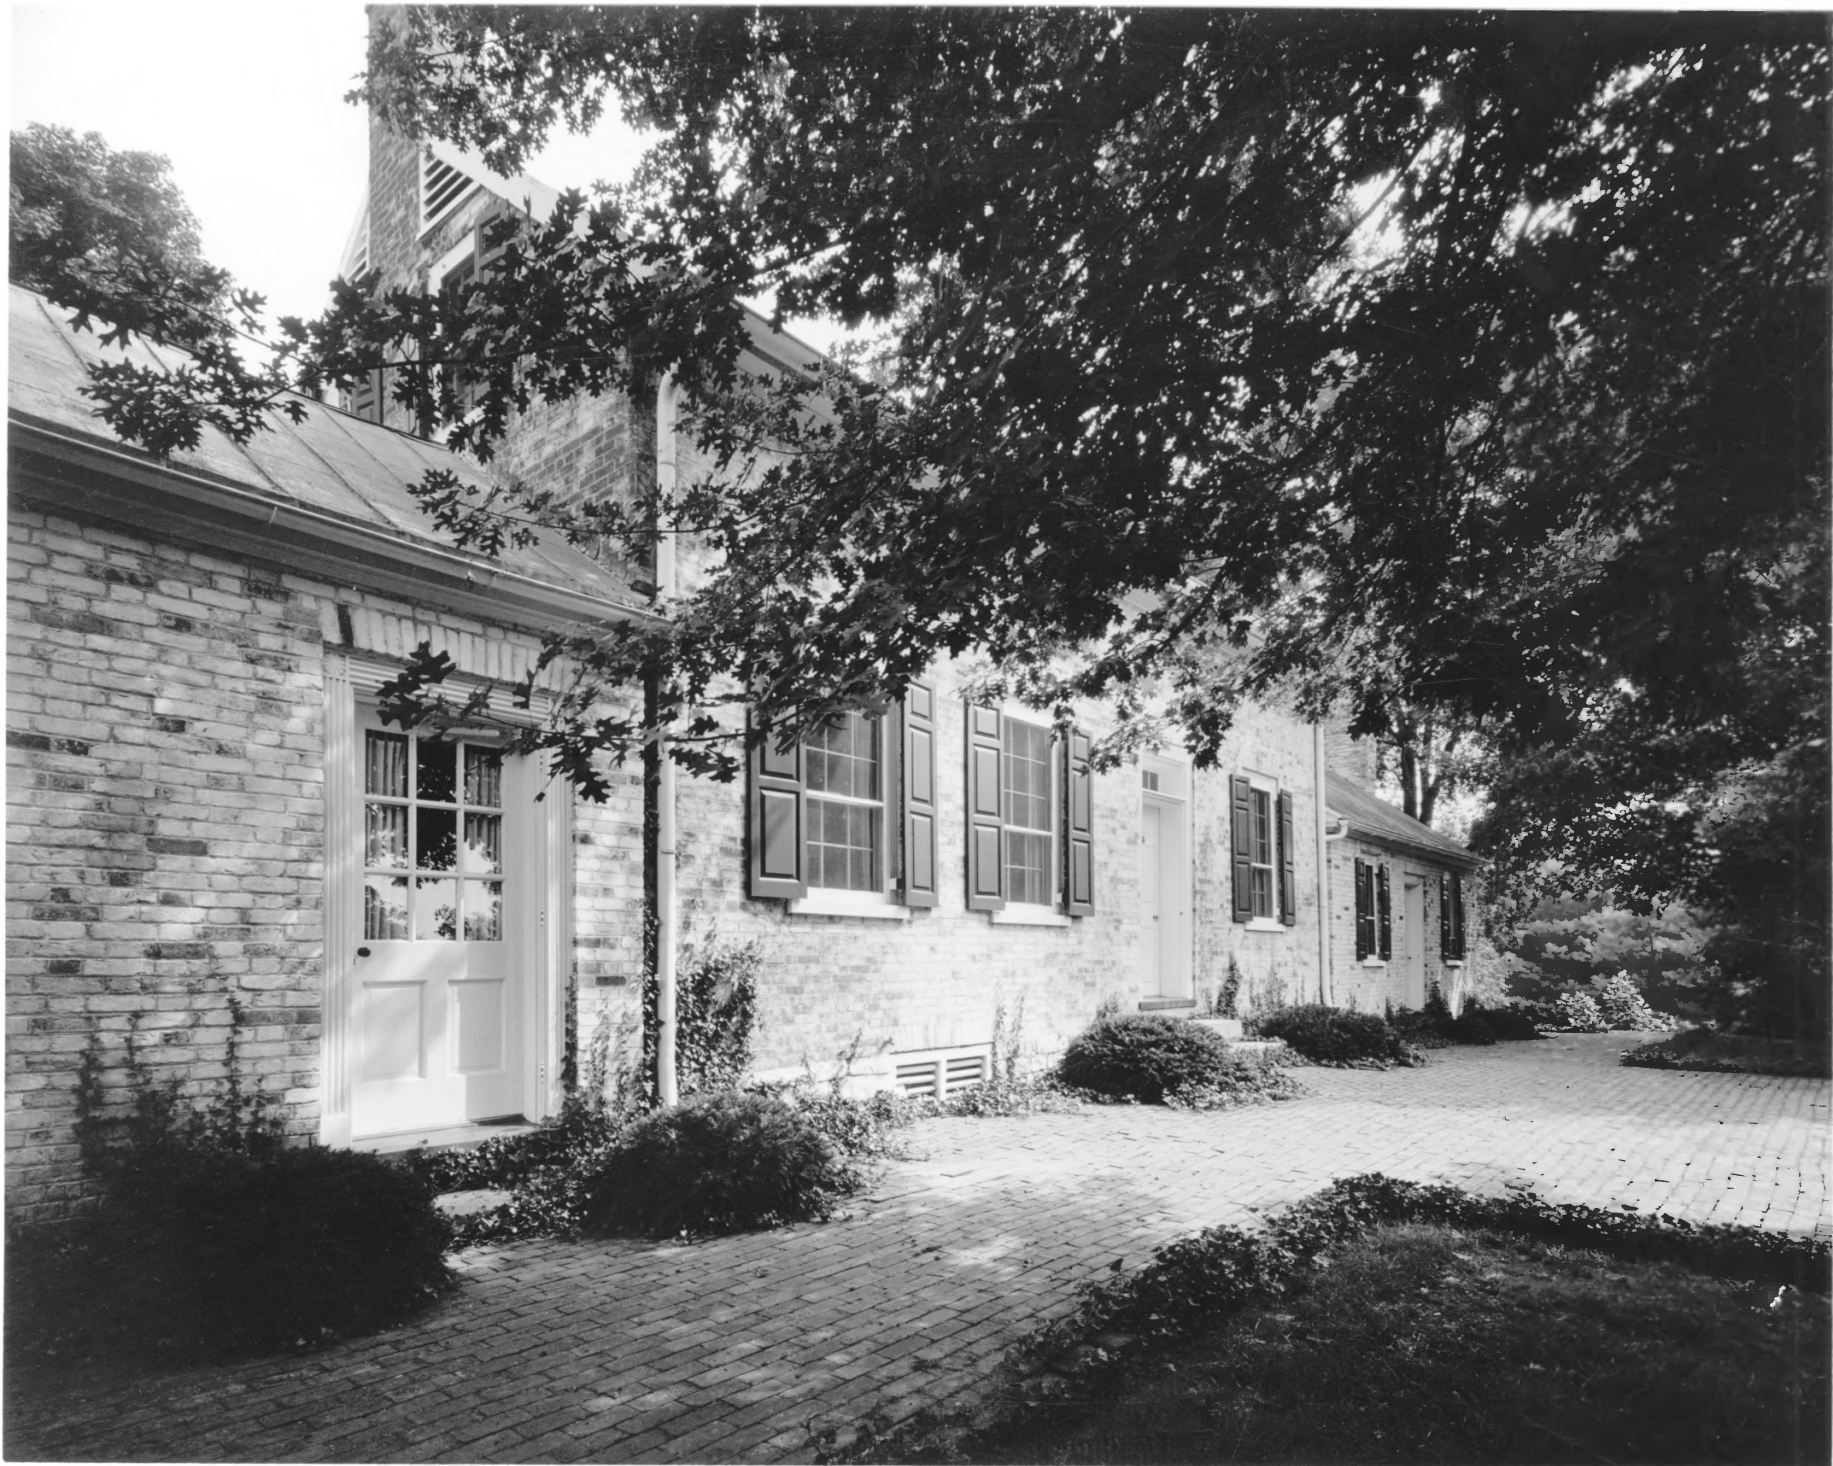
1 of 6

View of the original front of the house taken from the southwest. The center portion is the original section of the house. The door on the foreground opens into the "dog-trot."

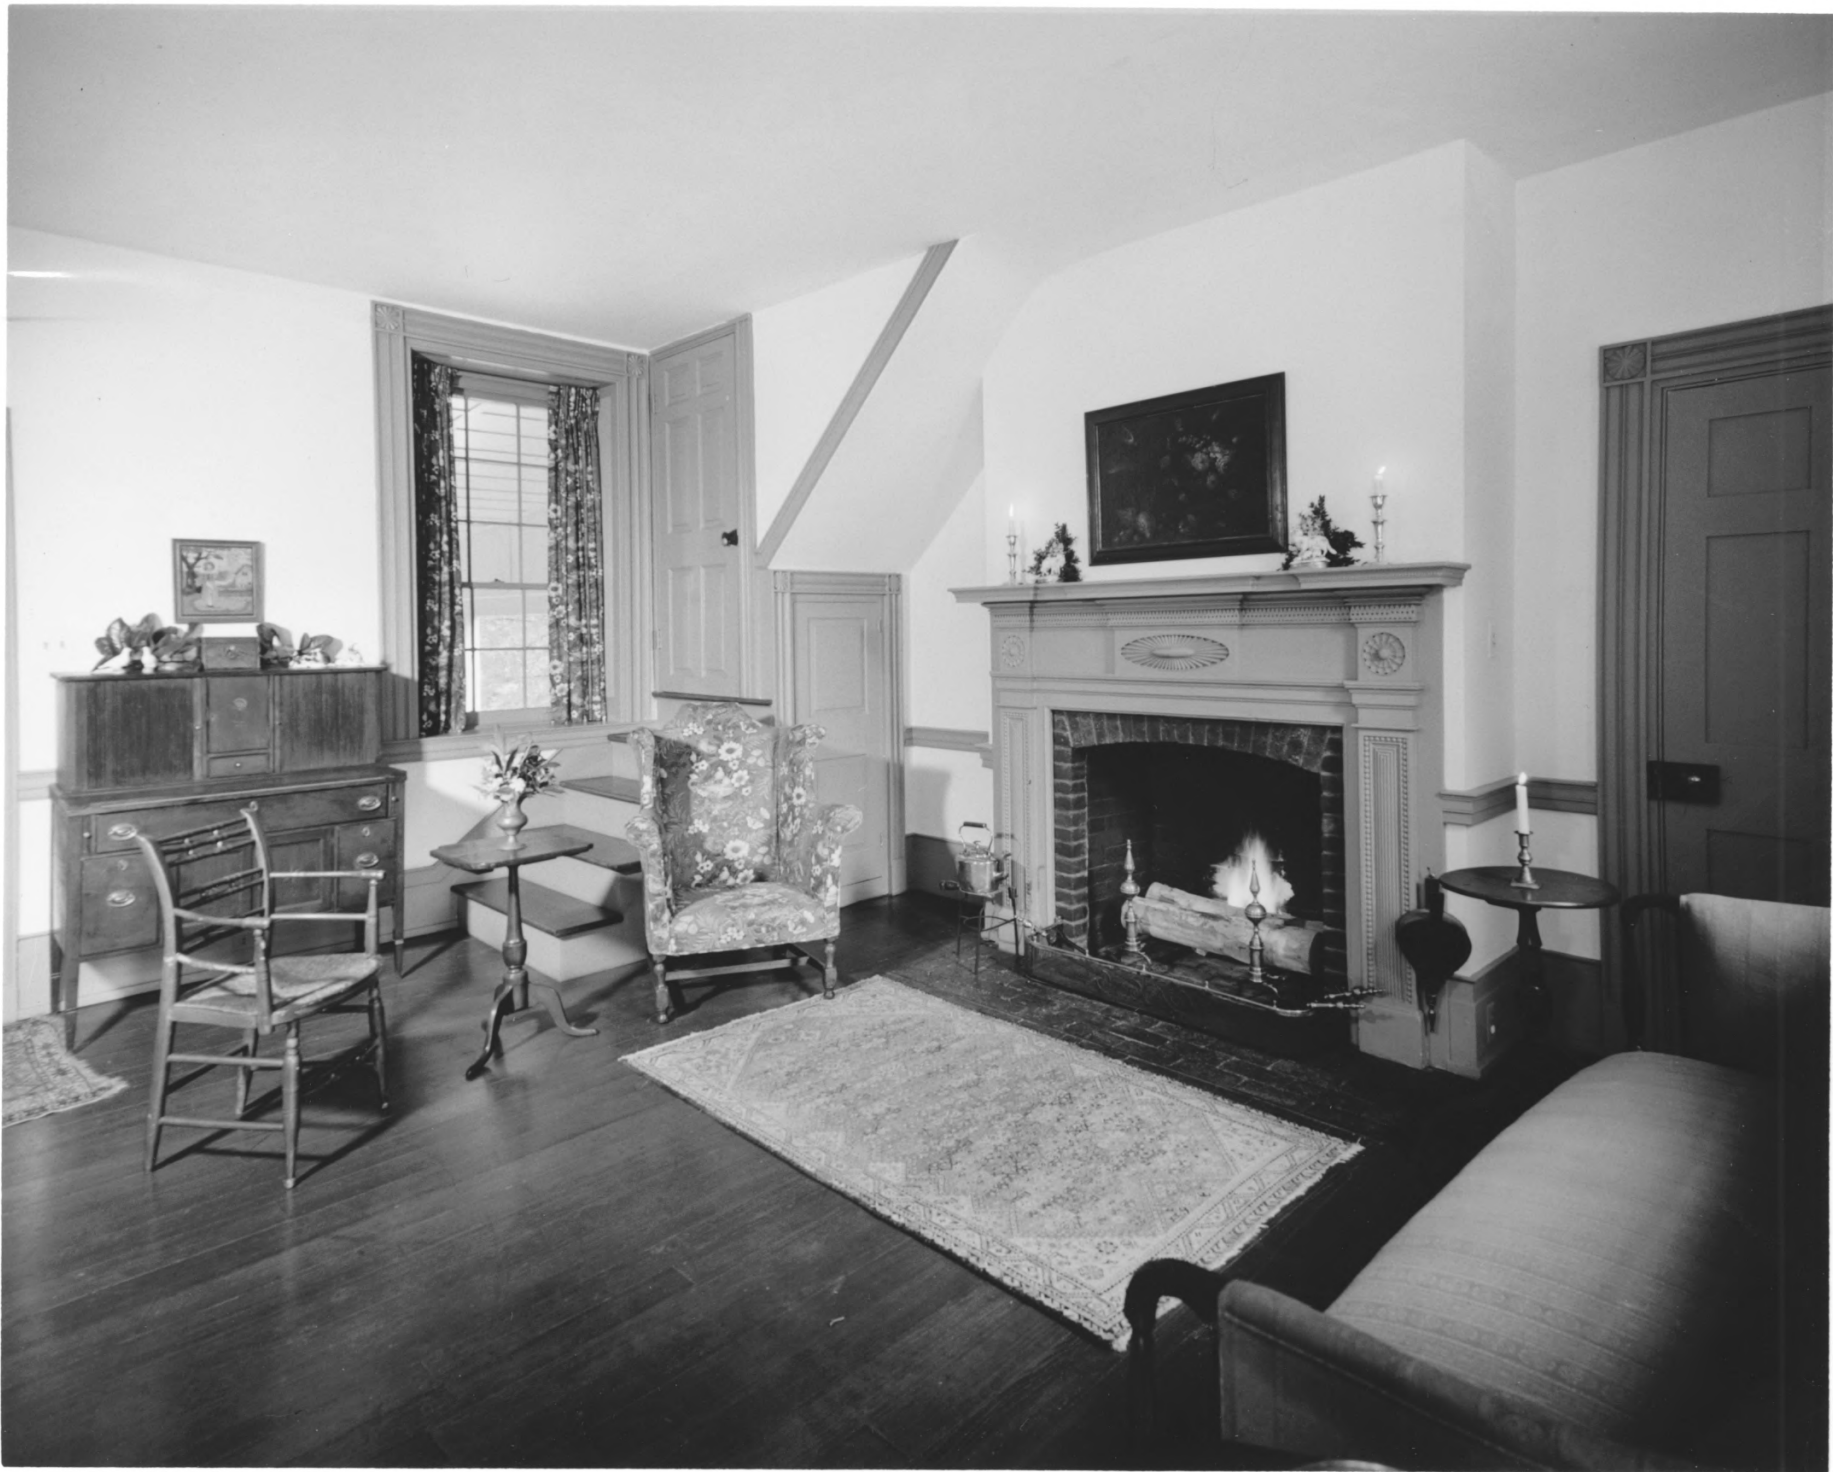
Interior photo of the hall-parlor showing the enclosed corner staircase, and the mantel. The door on the right leads to the east wing. 2 of 8

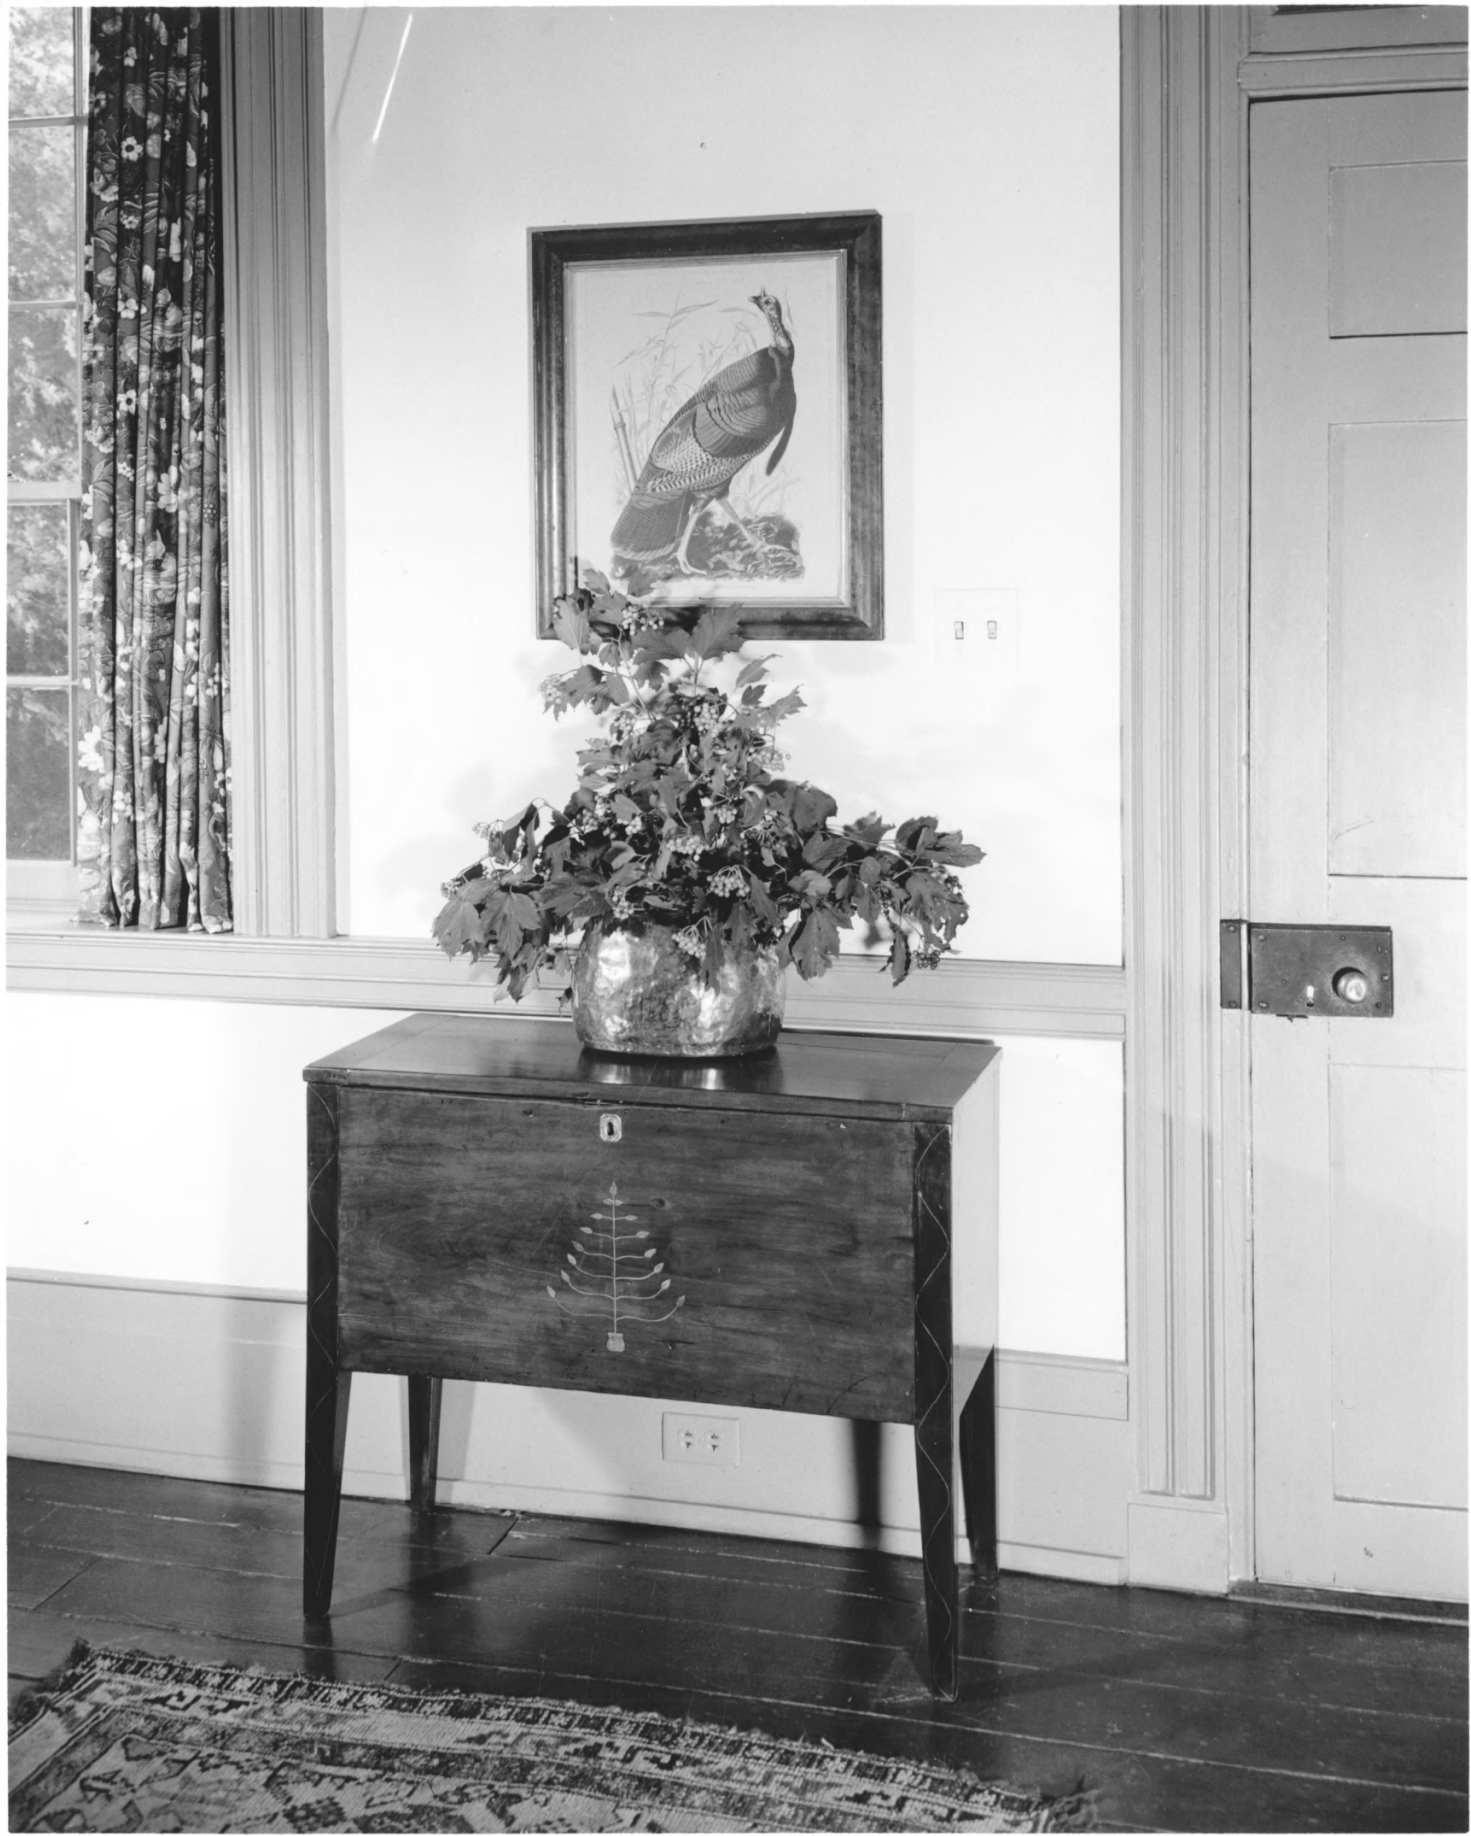
3 of 8

Interior photo of the south wall in the hall showing distinctive woodwork  
of the exterior door on the right.

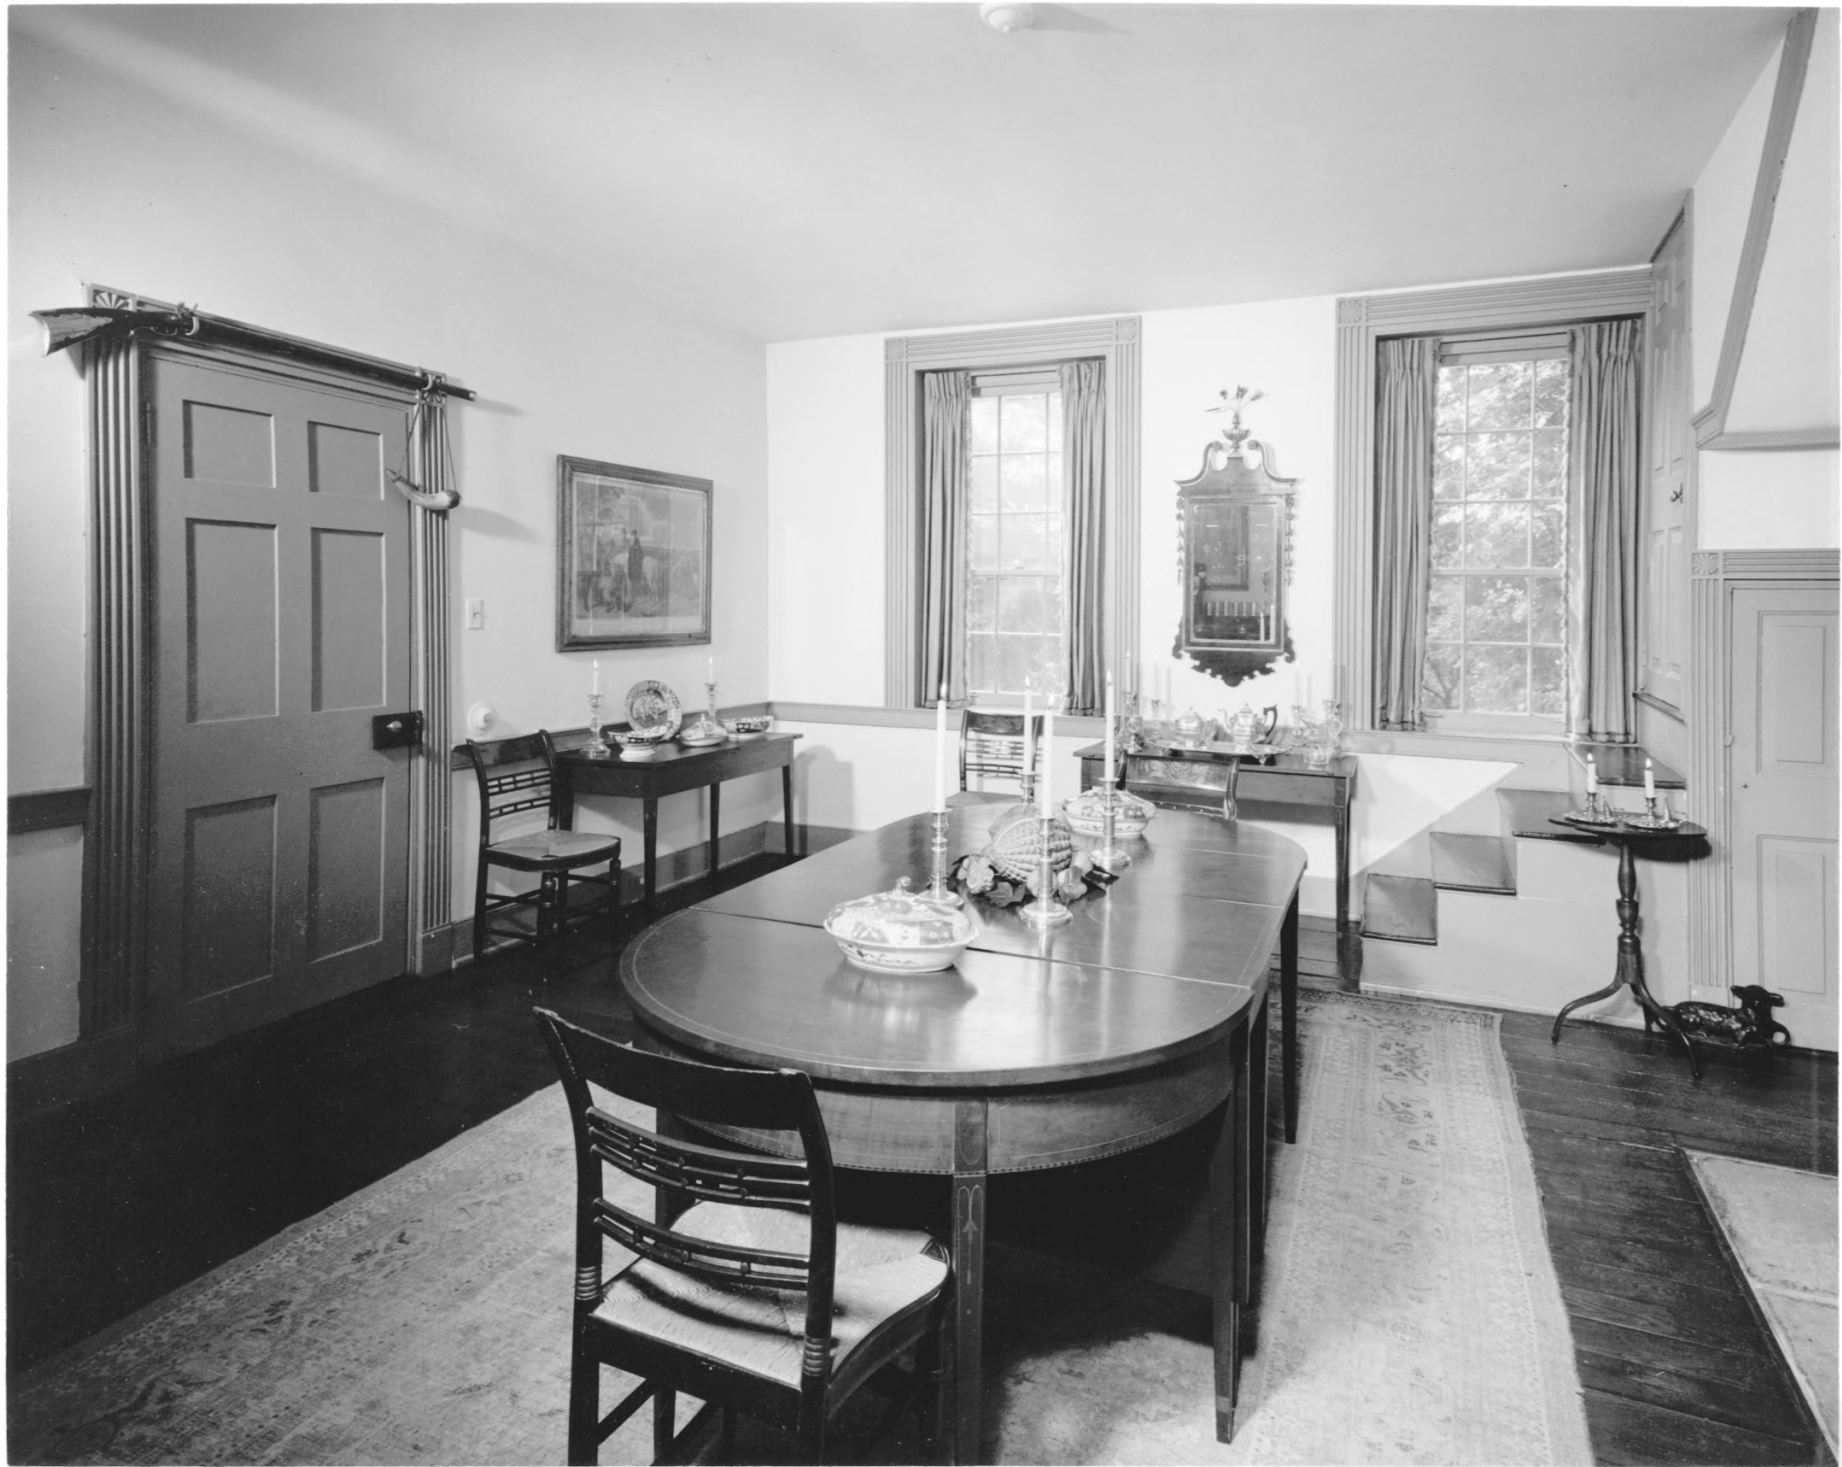
4 of 8

Interior photo of the dining room. Notice the window and door moldings.

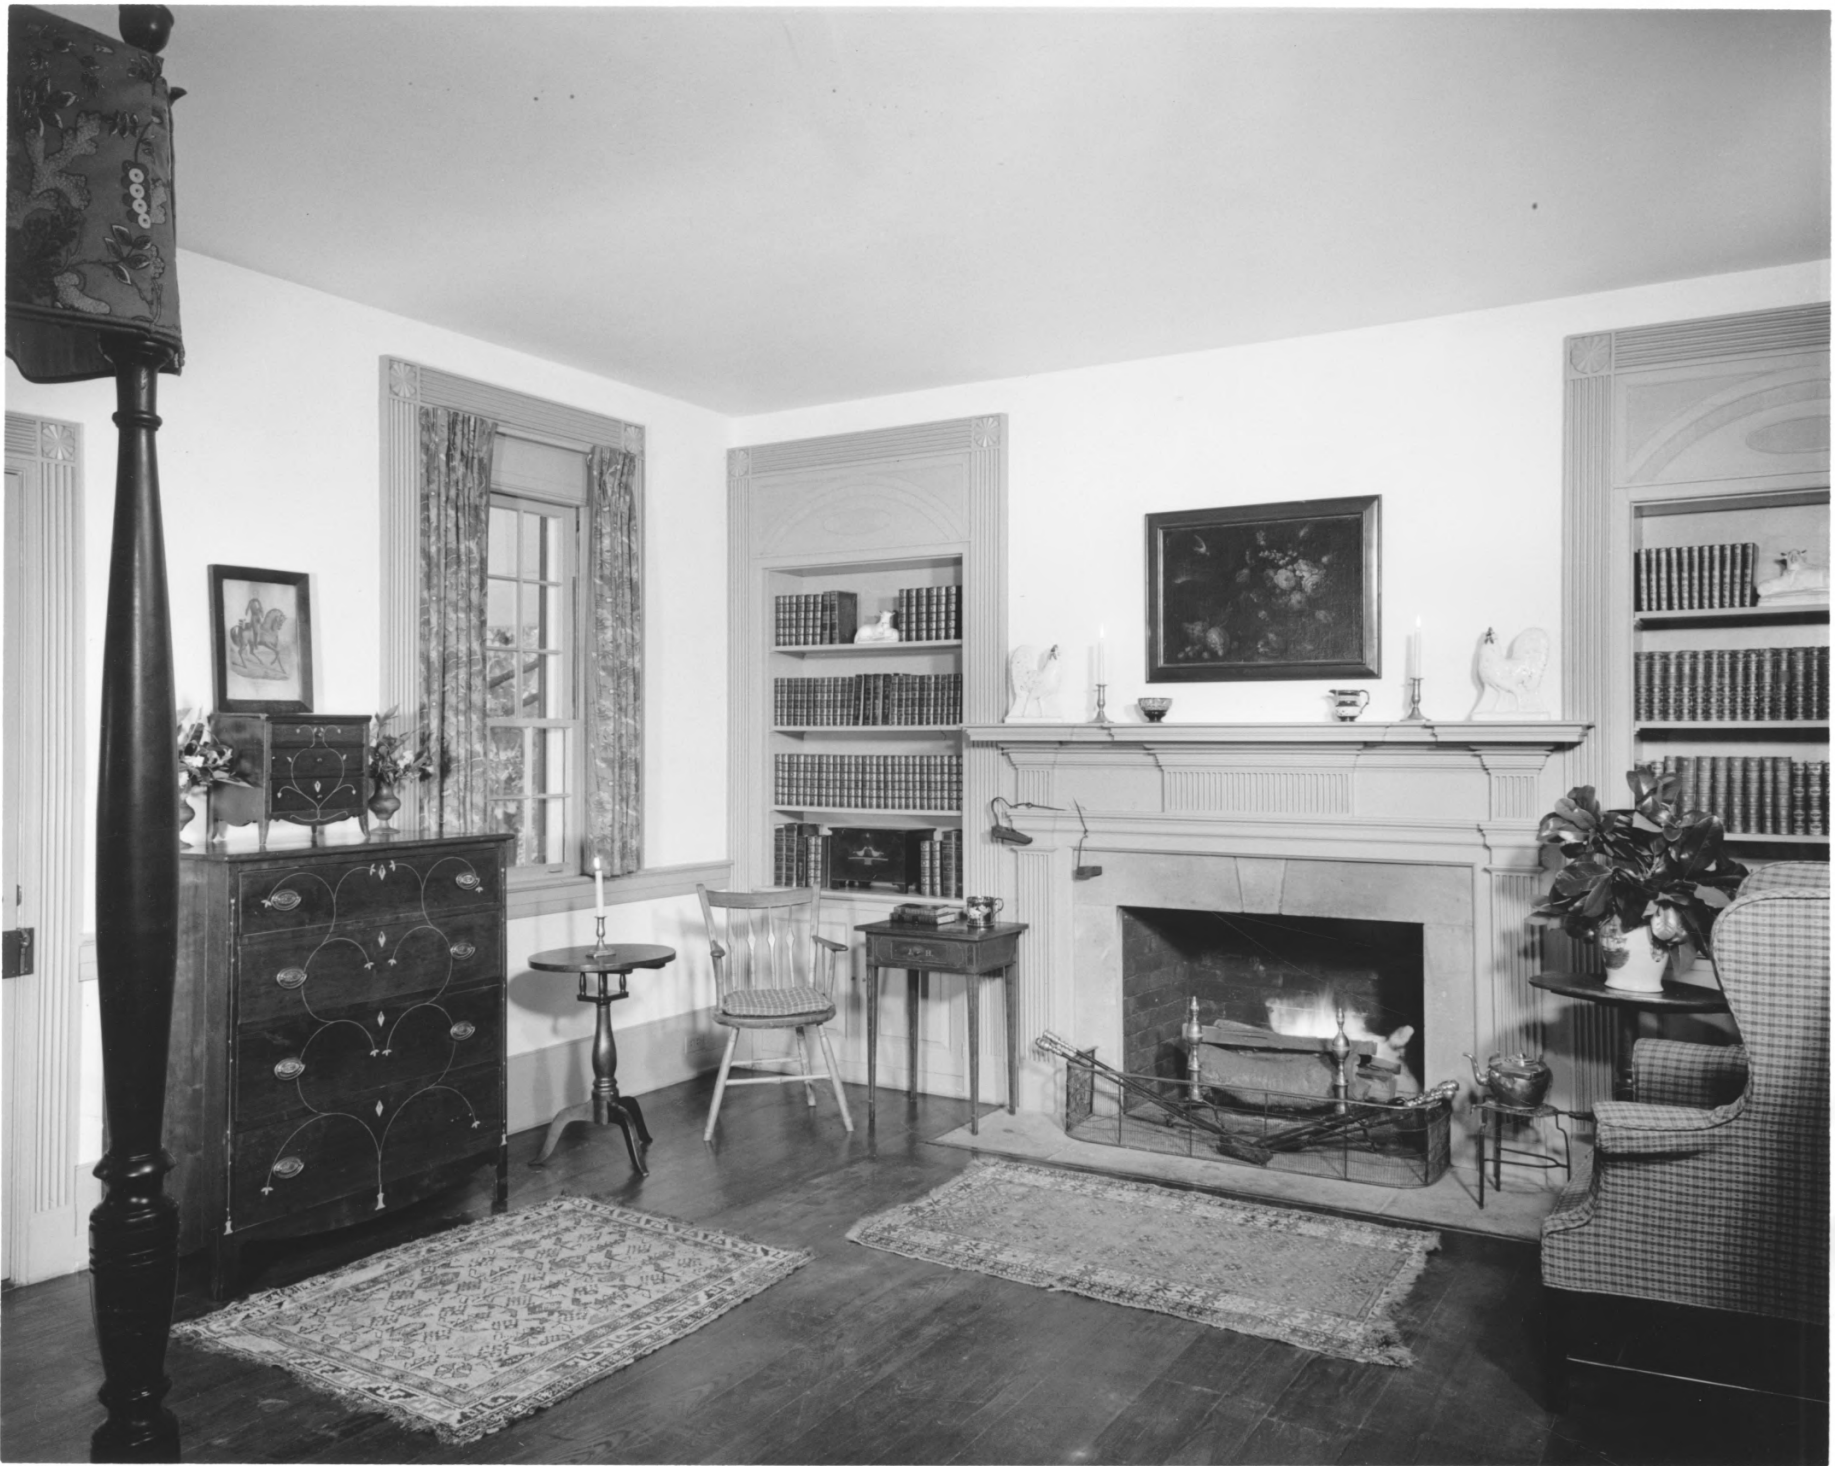
5 of 8

Interior photo showing the cupboards and fireplace in the master  
bedroom.

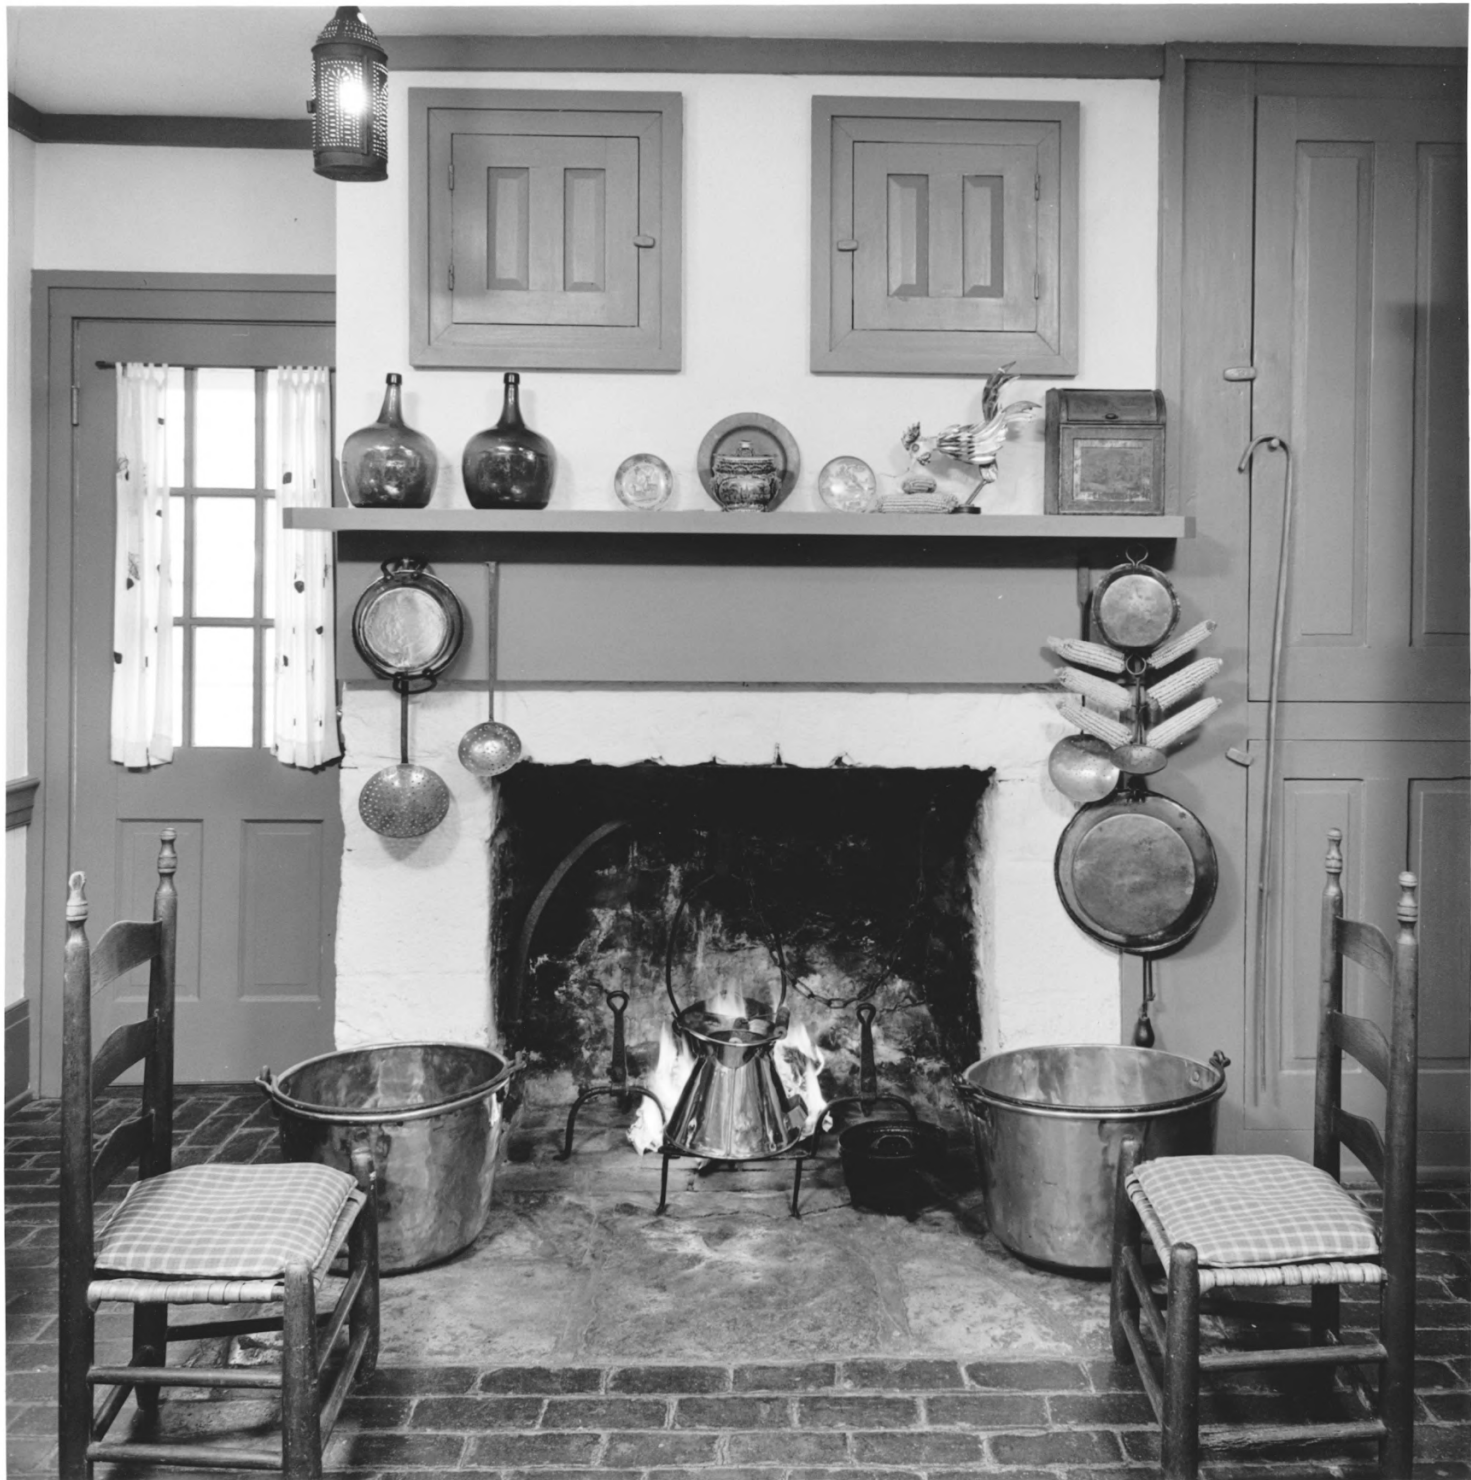
6 of 9

Interior photo of the kitchen fireplace. The side of the smokehouse can be  
seen through the door.

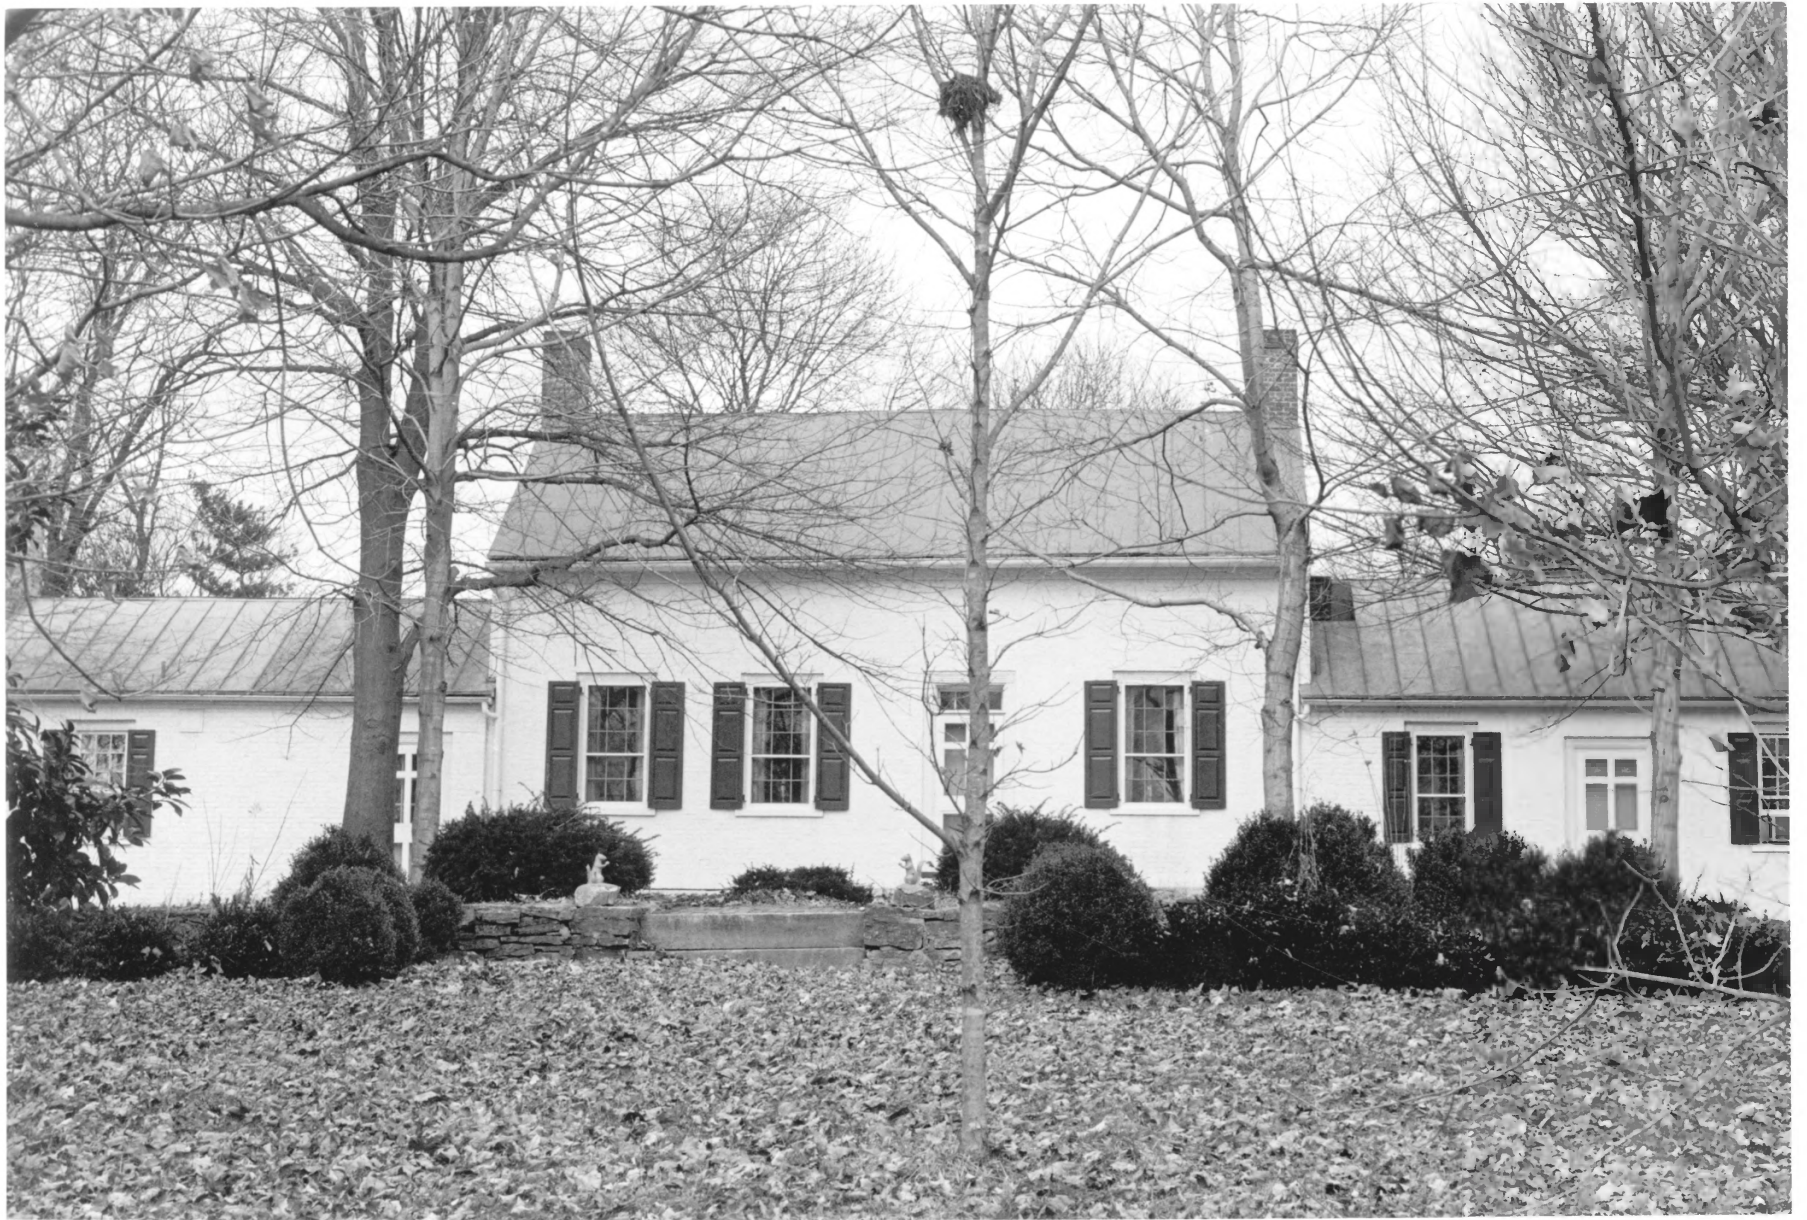
PHOTO NO. 7 of 8

Photo taken from the south showing the original facade of Millwood. The one-story wing on the left is the kitchen and the wing on the right, the master bedroom. Both were added ca. 1826.

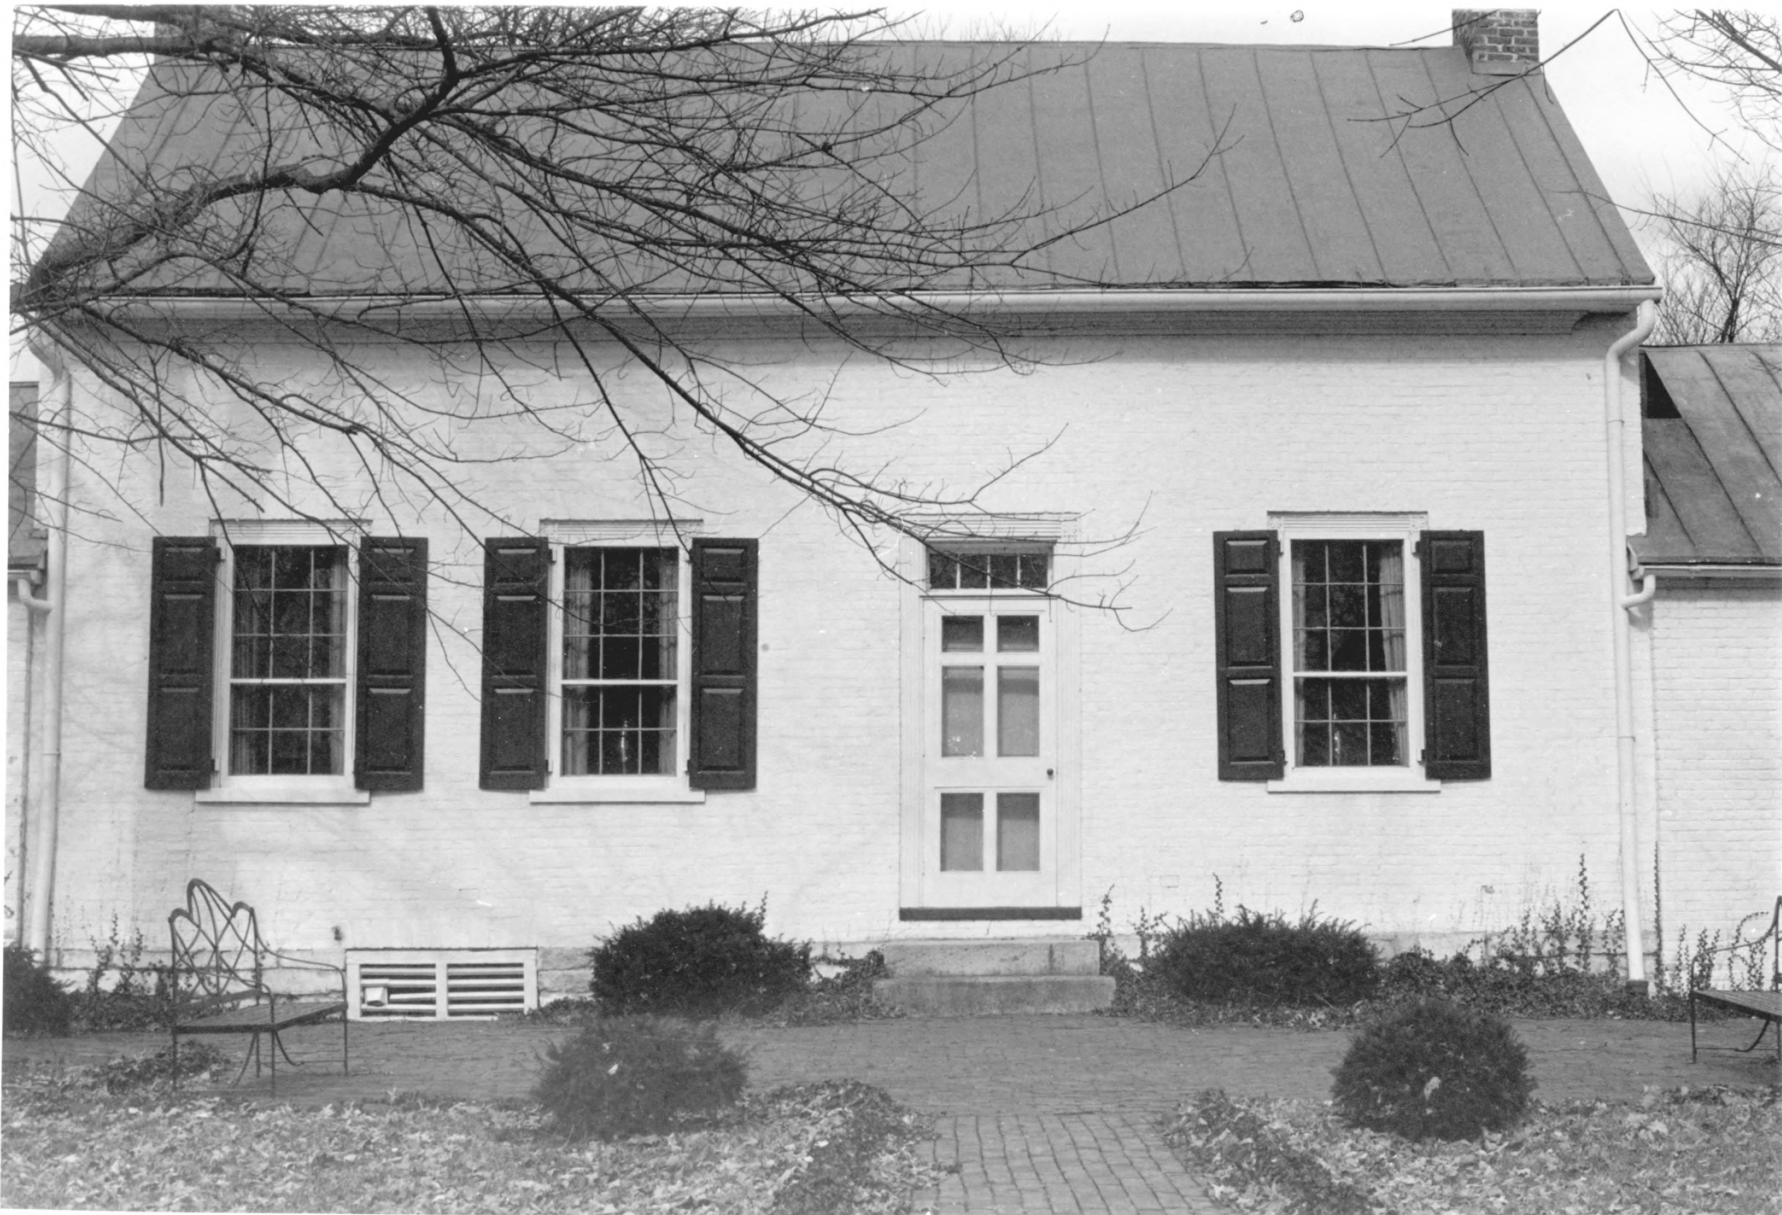
PHOTO NO. 2 of 8

Taken from the south, photo of the original section of Millwood, ca. 1795. Notice the molding around the door and windows.
