National Register of Historic Places Registration Form

historic name Building at 760-768 Confederate Avenue

street & number 760 Confederate Avenue, SE

Building at 760-768 Confederate Avenue
Atlanta, Fulton County, Georgia
First Floor Plan
 North:

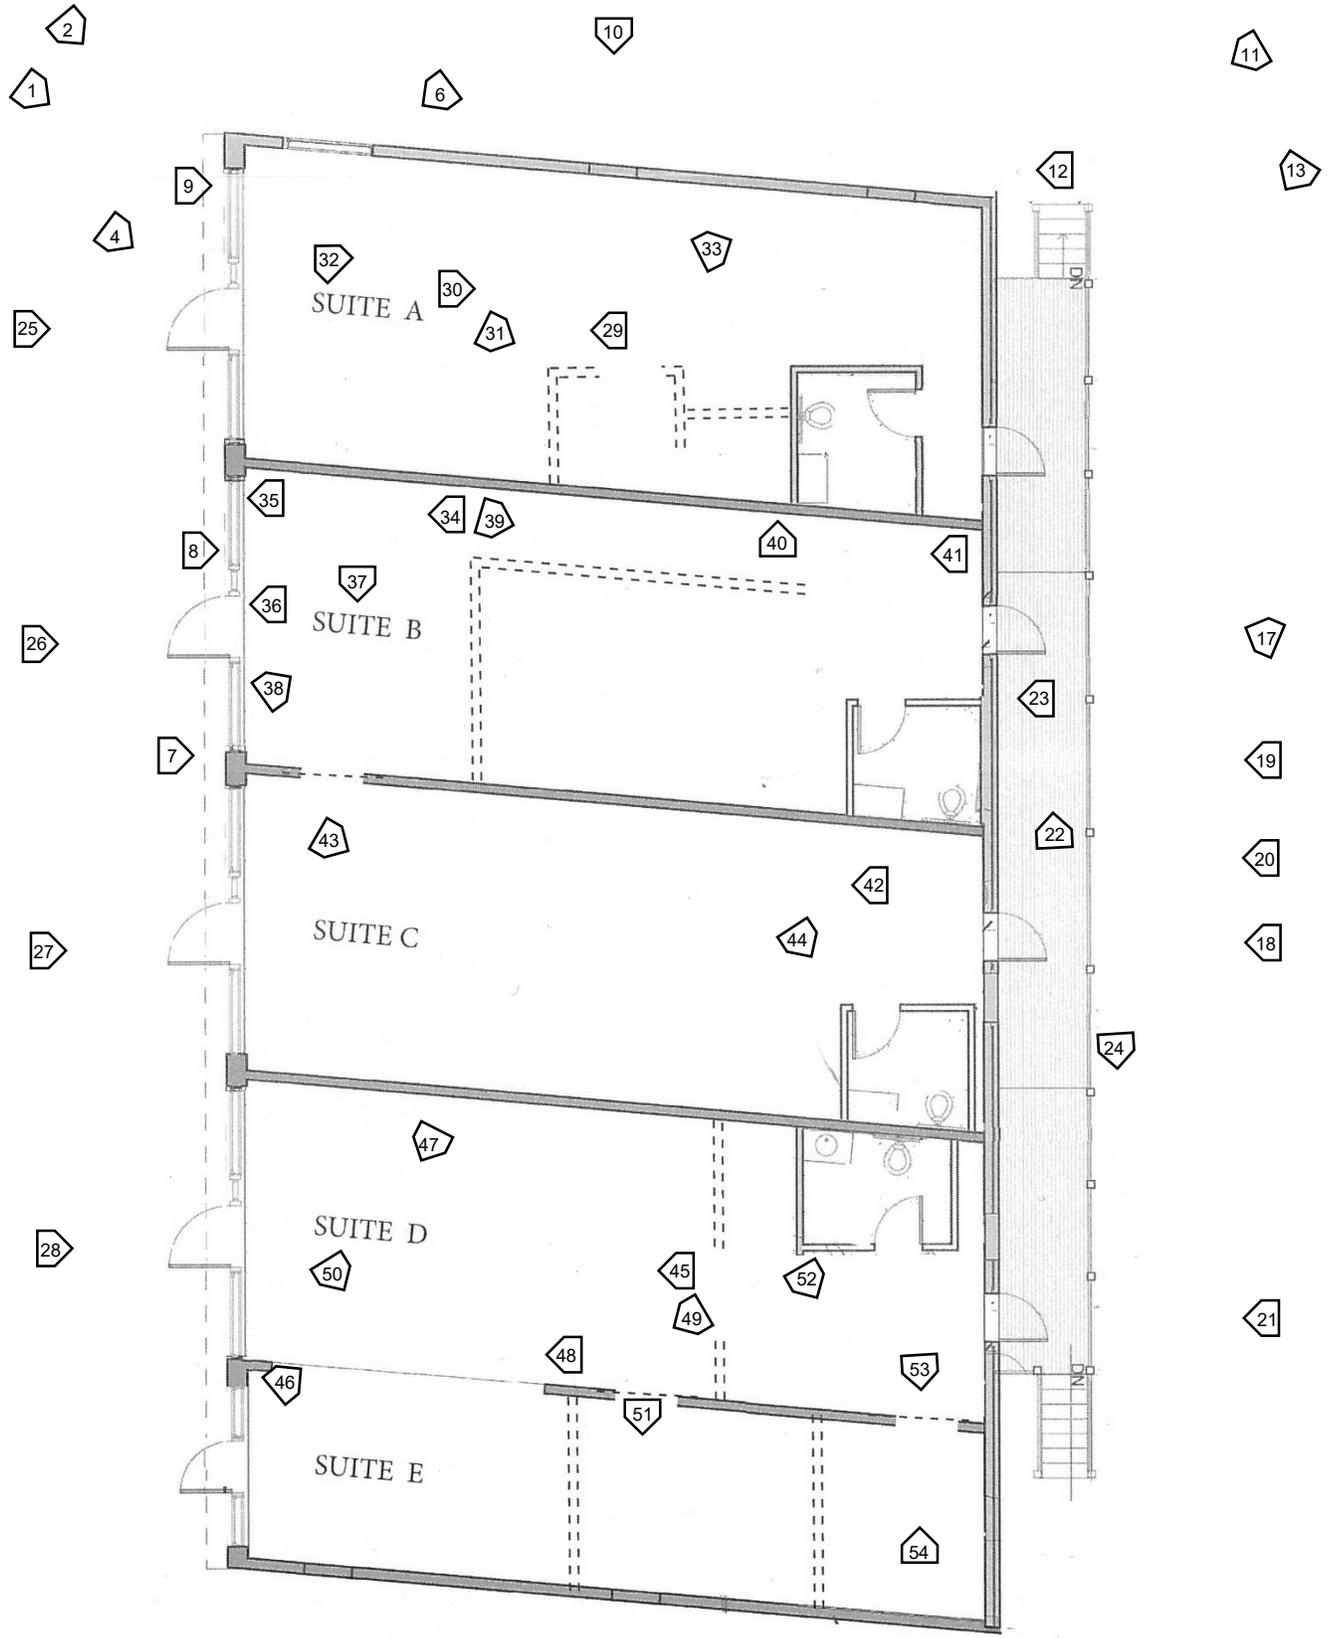
The Building at 760-768 Confederate Avenue is a one story, five-bay, and one-part commercial building (photograph 1). The building has a unique parallelogram footprint built site-specific to the slightly skewed angles of the road intersection, indicating that the building came subsequent to, and was dictated by, the existing road system. Interior walls and ceiling joists run parallel to exterior east and west walls in their parallelogram form to create non-perfect right angles. There is a slight uphill grade of the site from north to south and a steep downhill grade of the site and sidewalk west to east towards the rear, where the building's foundation is almost 8 feet above ground at the rear and level with the sidewalk at the front (photograph 11). Minimal grass and shrub vegetation exists on the rear of the property. The brick bulkheads on the front of the building become slightly taller as the sidewalk lowers, allowing all the display sills to remain level across the five storefronts, and for nearly 100 linear feet of the façade (photograph 5). The difference in the door placement height into each bay along the graded sidewalk is compensated by a solid wood framed inset panel just above each door and below the line of transoms. A concrete slab floor steps up at three points along the length of the building with the grade of the land. A prominent and continuous wood-framed and terra cotta tile-roofed front canopy forms the front parapet, and runs across all five retail bays (photograph 3) with decorative wooden brackets at each masonry pier division (photographs 25-28). Exterior masonry walls are brick and painted (possibly originally) on the front and sides (photographs 12, 16). The rear exterior wall retains its natural, standard wire cut brick face with original soft (partial cement based) mortar (photograph 17). The building appears in form exactly as illustrated on all Sanborn Fire Insurance maps over time, and has had no additions. The building has elements of the Mediterranean Revival style, one of the common styles on streetcar commercial rows from the 1920s. There is no dedicated on-site auto parking, and it is sited immediately adjacent to residences, a small apartment building and a historic church.

Four masonry piers divide the five retail bays visually on the exterior, with five storefronts framed between these piers. The building contains five internally framed retail bays. Storefronts for each of the bays face west along Confederate Avenue. Each door threshold is set directly on the zero lot line of the sidewalk. The bays historically had street addresses of 760, 762, 764, 766 and 768, and are now designated A, B, C, D, and E respectively, from north to south (photographs 25-28). Each bay has nearly identically framed storefronts that fit into the storefront bay openings, with most retaining their original
