### National Register of Historic Places Registration Form

historic name Upper Main Street Historic District District boundary increase

street & number 909, 951, 955, 965 Main Street [N/A] not for publication

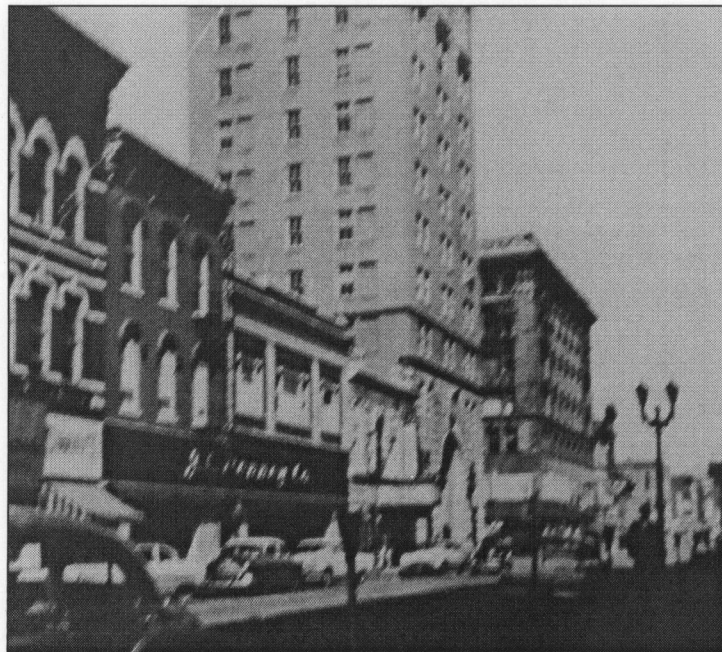
Figure 32: c.1956 view northwest along Main Street, looking towards 9<sup>th</sup> Street  
(Loras College, Center For Dubuque History)

Note that the Bank and Insurance Building retains its original cornice and has not gained another floor, while the storefront level has been covered with a slipscreen.
