National Register of Historic Places  
Inventory—Nomination Form

historic Solomon Gans House

and/or common Rommel Building

street & number 1010 West Third Street N/A not for publication

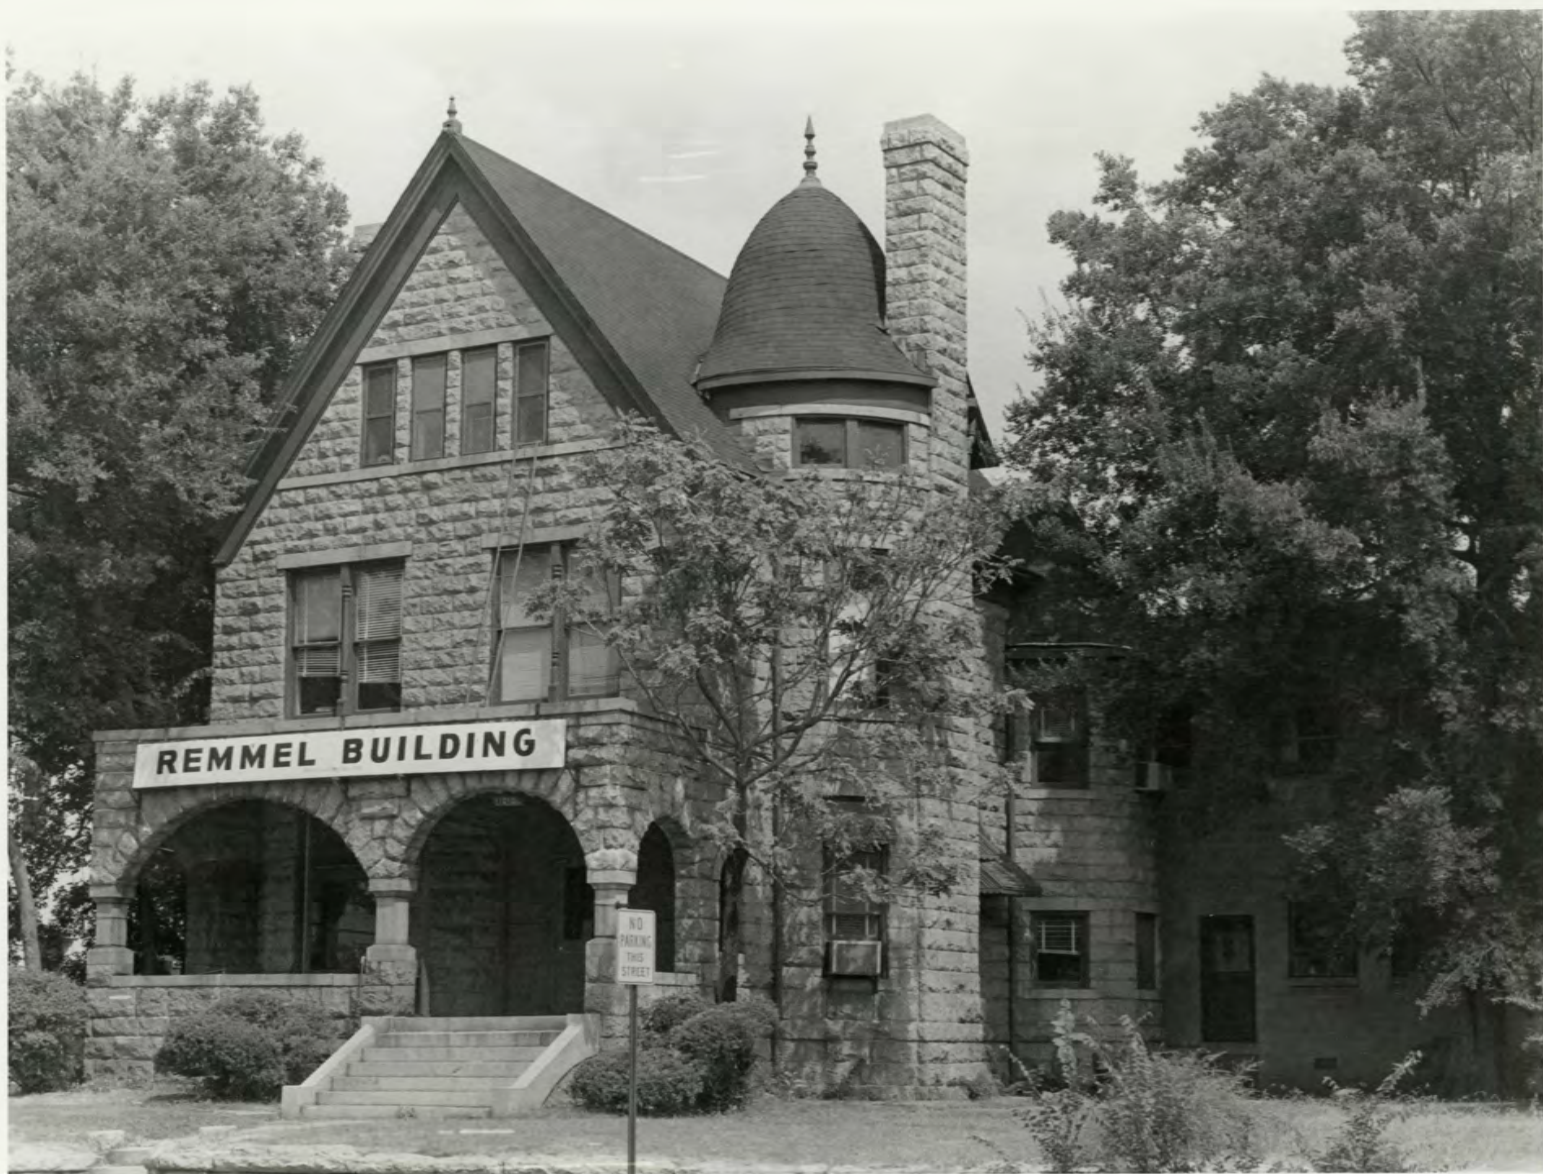
Solomon Gans House  
Little Rock, Pulaski County  
Photographed by Alice Jones  
September, 1983  
Negative on file at AHPP  
Viewed from the Southeast

Aside from the rock-faced gray granite of which the Solomon Gans House is built, the most prominent elements of the Richardsonian Romanesque are found on the principal (south) facade of the house. The one-story, flat-roofed front porch, reached via a flight of seven granite steps on the right (east) side of the elevation, is enclosed by a low stone wall. Like most of the house, the porch sits on a stone foundation which is barely distinguishable from the stone walls by a projecting water table. Round arches spring from three squat, smooth-dressed stone columns, one positioned just right of the center of the porch and the other two at either end of the porch. Because the middle column is off-center, the two arches springing from it are of unequal width. The narrower of these two arches frames the entrance to the porch. Two more round arches, one at each end of the porch, spring from the porch's end columns and meet the front wall of the house. All four round arches are characterized by radiating rock-faced stone voussoirs.

The east side of the house is distinguished by two round towers, one taller than the other but both breaking through the roofline. The tower at the south end of the east elevation is two and one-half stories tall. An unembellished chimney, built of the same rock-faced granite as the main body of the house, runs up the east side of the tower. One-over-one, double-hung windows are located on either side of the chimney on the first and second floors. The first-floor windows have stained-glass transoms. Pairs of square, fixed-sash windows form bands on either side of the chimney on the attic floor. Again, the band effect is heightened by courses of smooth stone above and below the windows. The bell-shaped roof of this tower is topped by a metal finial. The tower near the north end of the east elevation is part of the configuration of the main interior staircase, and its height--something less than two full stories-- was dictated by that role. Enclosed in the lower level of the tower is a circular "under-the-stairs" room from which the basement steps descend. The upper level of the tower encloses a landing which breaks the ascent of the interior staircase between the first and second floors. Three windows define each level of the tower. Those on the first level have single sashes. One-over-one, double-hung windows mark the upper level of the tower, which is capped by a conical roof ending in a metal finial. The section of the east side of the Gans House between the two towers has, on the first floor, a semi-circular stained-glass window fully surrounded by bands of smooth-dressed stone. Above this window, on the second floor, is a small round-arched, double-hung window. Still higher, above the boxed cornice and frieze, a gabled dormer projects from the side of the main roof. A pair of round-arched, double-hung windows pierce the vertical face of the dormer, and another turned finial tops the dormer's gable. The section of wall at the northern end of the east elevation is solid and unadorned, except for a single one-over-one, double-hung window at the second-story level. At the northeast corner of the house begins the two-story concrete-block

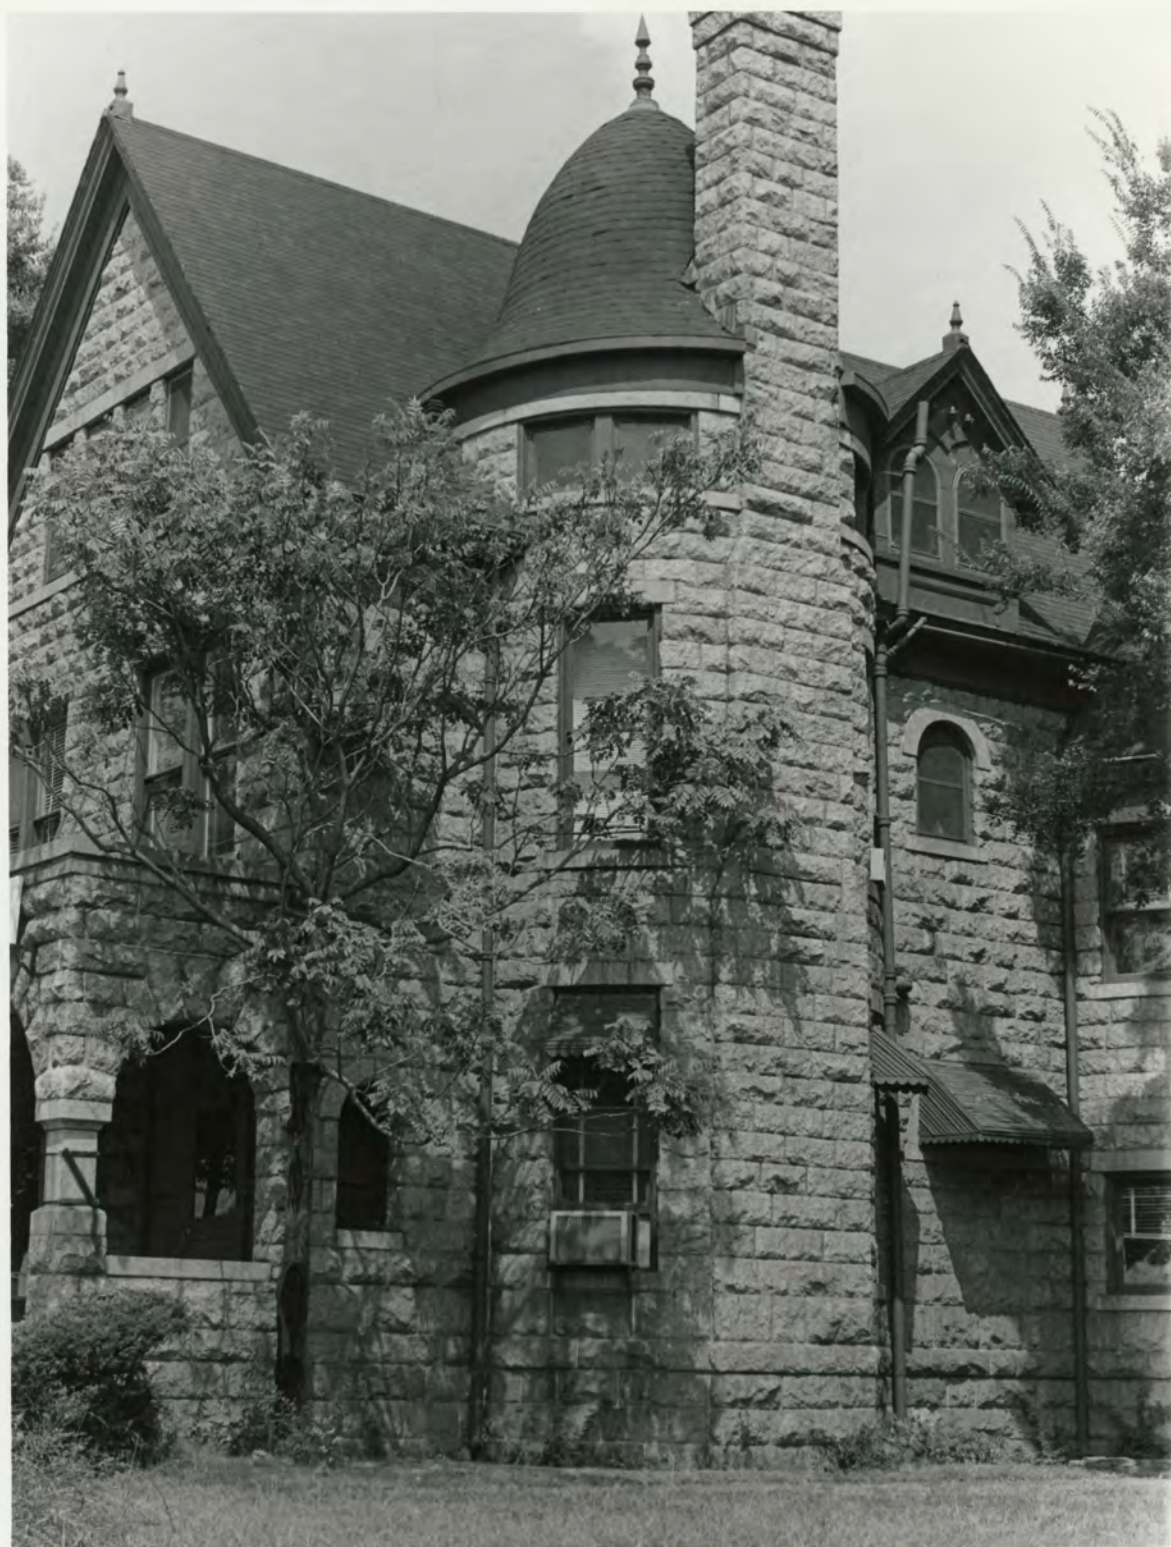
Solomon Gans House  
Little Rock, Pulaski County  
Photographed by Alice Jones  
September, 1983  
Negative on file at AHPP  
Viewed from the Southeast

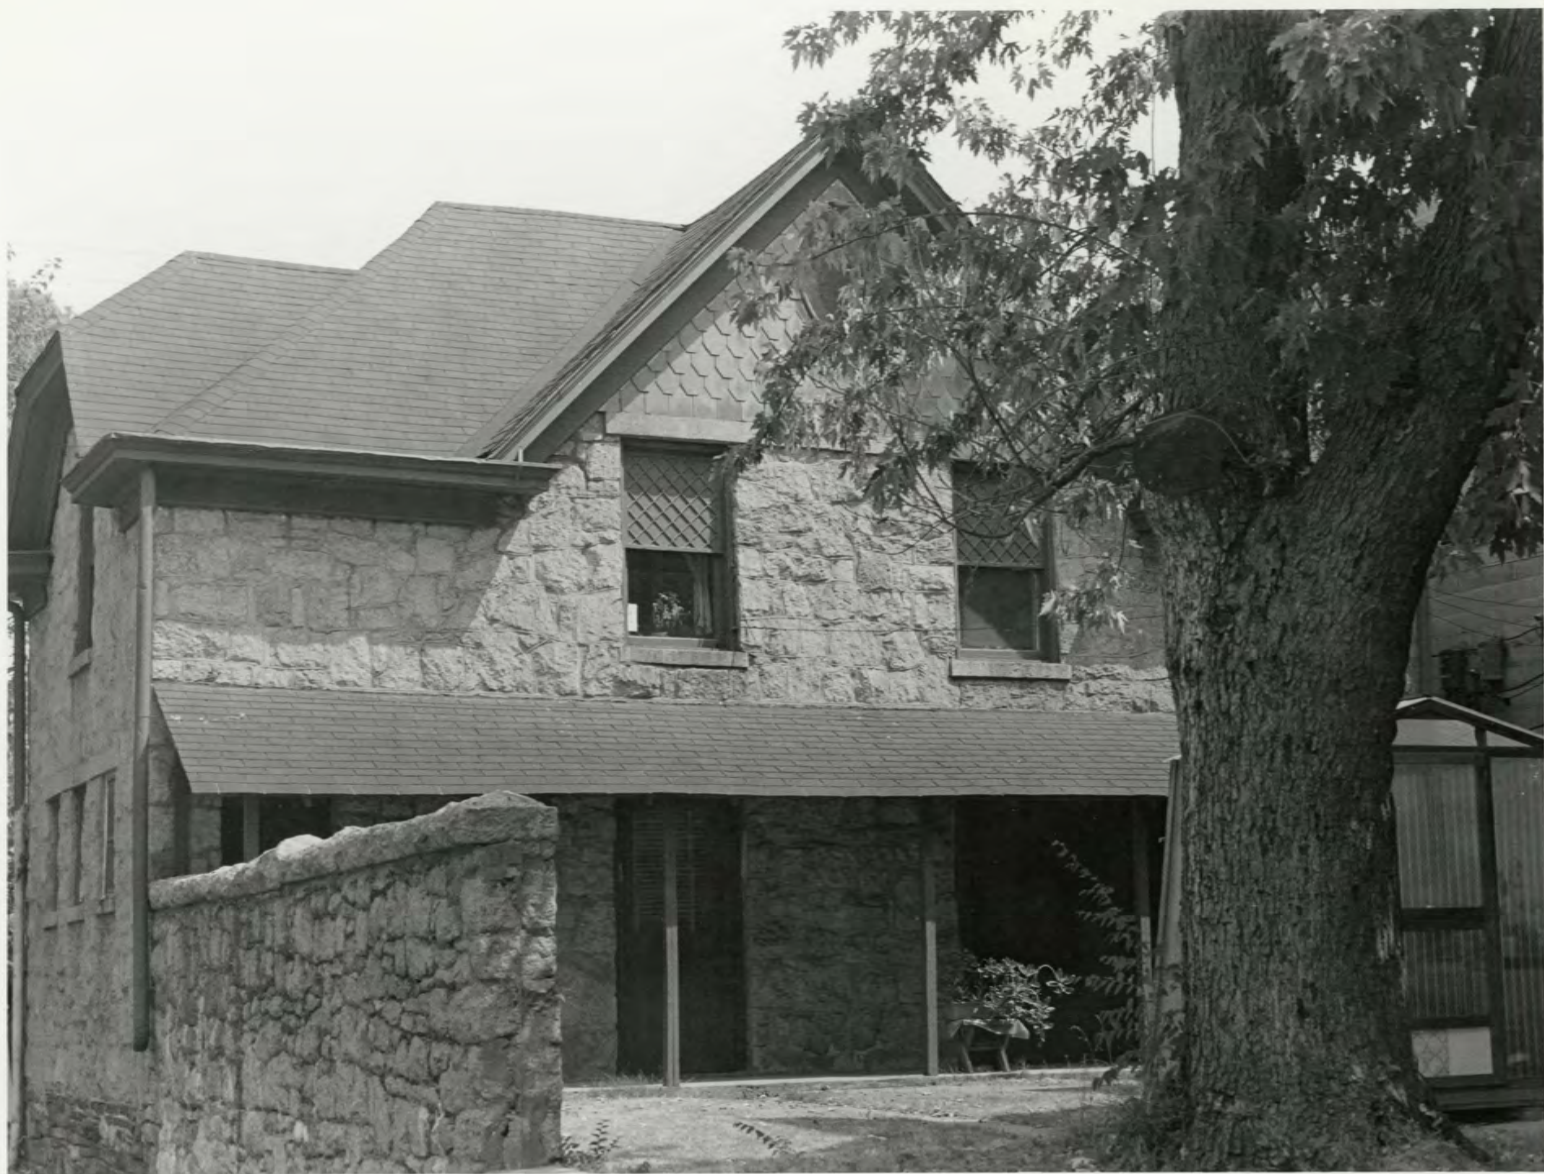
Solomon Gans House  
Little Rock, Pulaski County  
Photographed by Alice Jones  
September, 1983  
Negative on file at AHPP  
Viewed from the South  
Carriage House

At a point in line with, but several feet west of the rear wall of the brick wing, the low granite wall that encircles the Gans property rises in height to about six feet. This taller wall leads north to the west end of the carriage house still standing at the northwest corner of the property. Like the main house, the carriage house is constructed of rock-faced granite. Two sets of double doors, which once admitted the carriages and horses, have been filled in, and a shed-roofed porch has been added to the principal (south) facade. Otherwise, the exterior of the carriage house has changed little since its construction. Even the bars on the windows in what once were horse stalls are still in place. The configuration of the roof of the carriage house is more complex than that of the main house, for it consists of a hipped roof with a central gable projecting in front, twin gables in back, and jerkinhead gables at either end. The vertical face of the central gable is covered with slate and penetrated by an oval window. Across the bottom of the face of the gable runs a course of smooth stone which tops two double-hung windows, the upper sashes of which are divided into diamond-shaped panes.

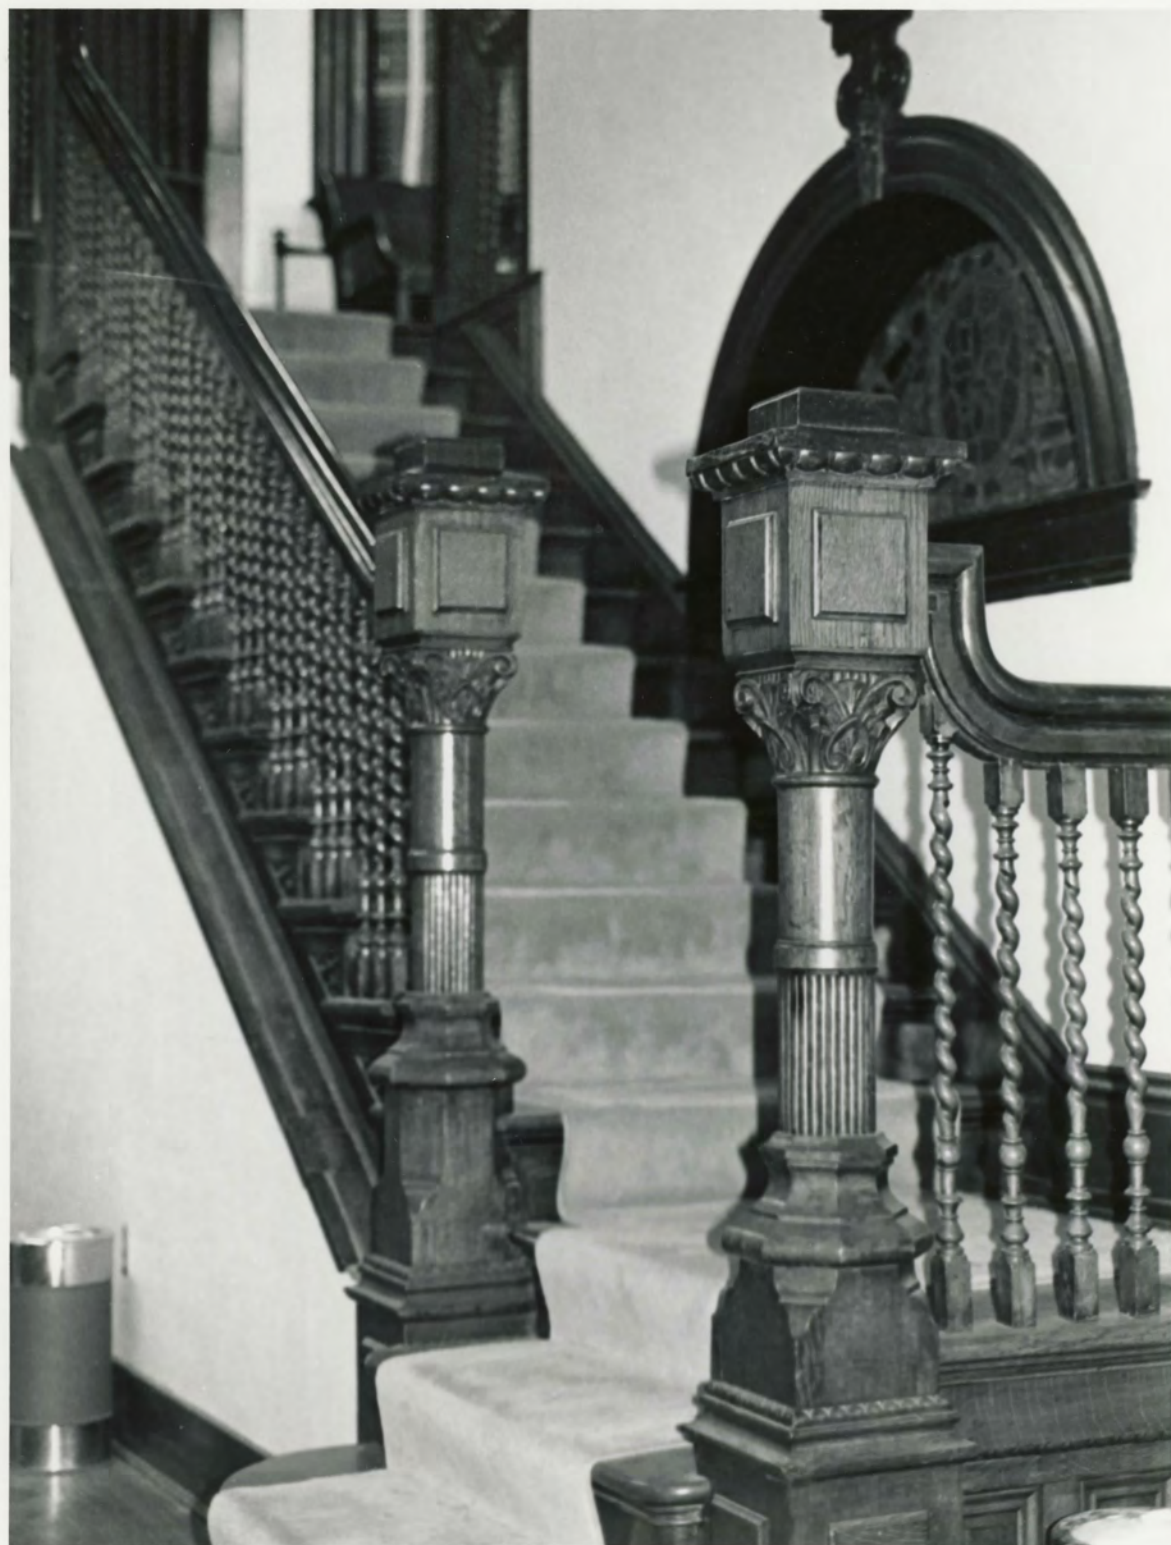
Solomon Gans House  
Little Rock, Pulaski County  
Photographed by Alice Jones  
September, 1983  
Negative on file at AHPP  
Stairway

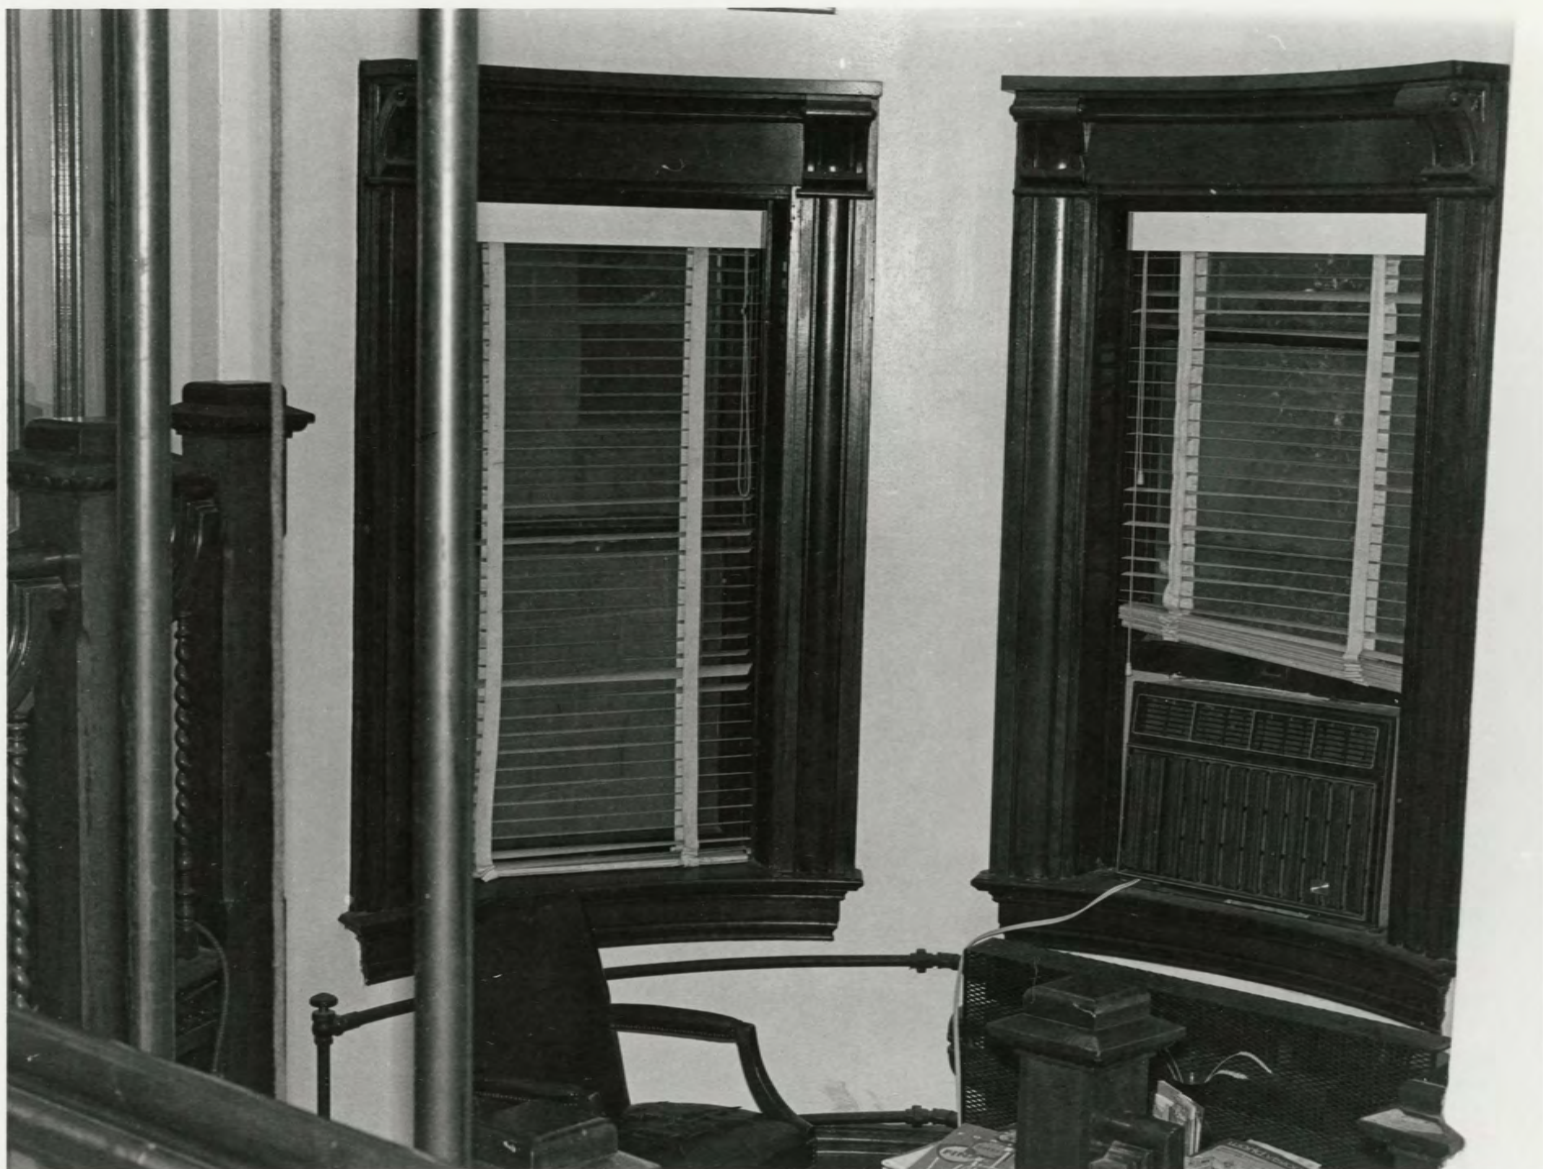
Solomon Gans House  
Little Rock, Pulaski County  
Photographed by Alice Jones  
September, 1983  
Negative on file at AHPP  
Windows in Tower

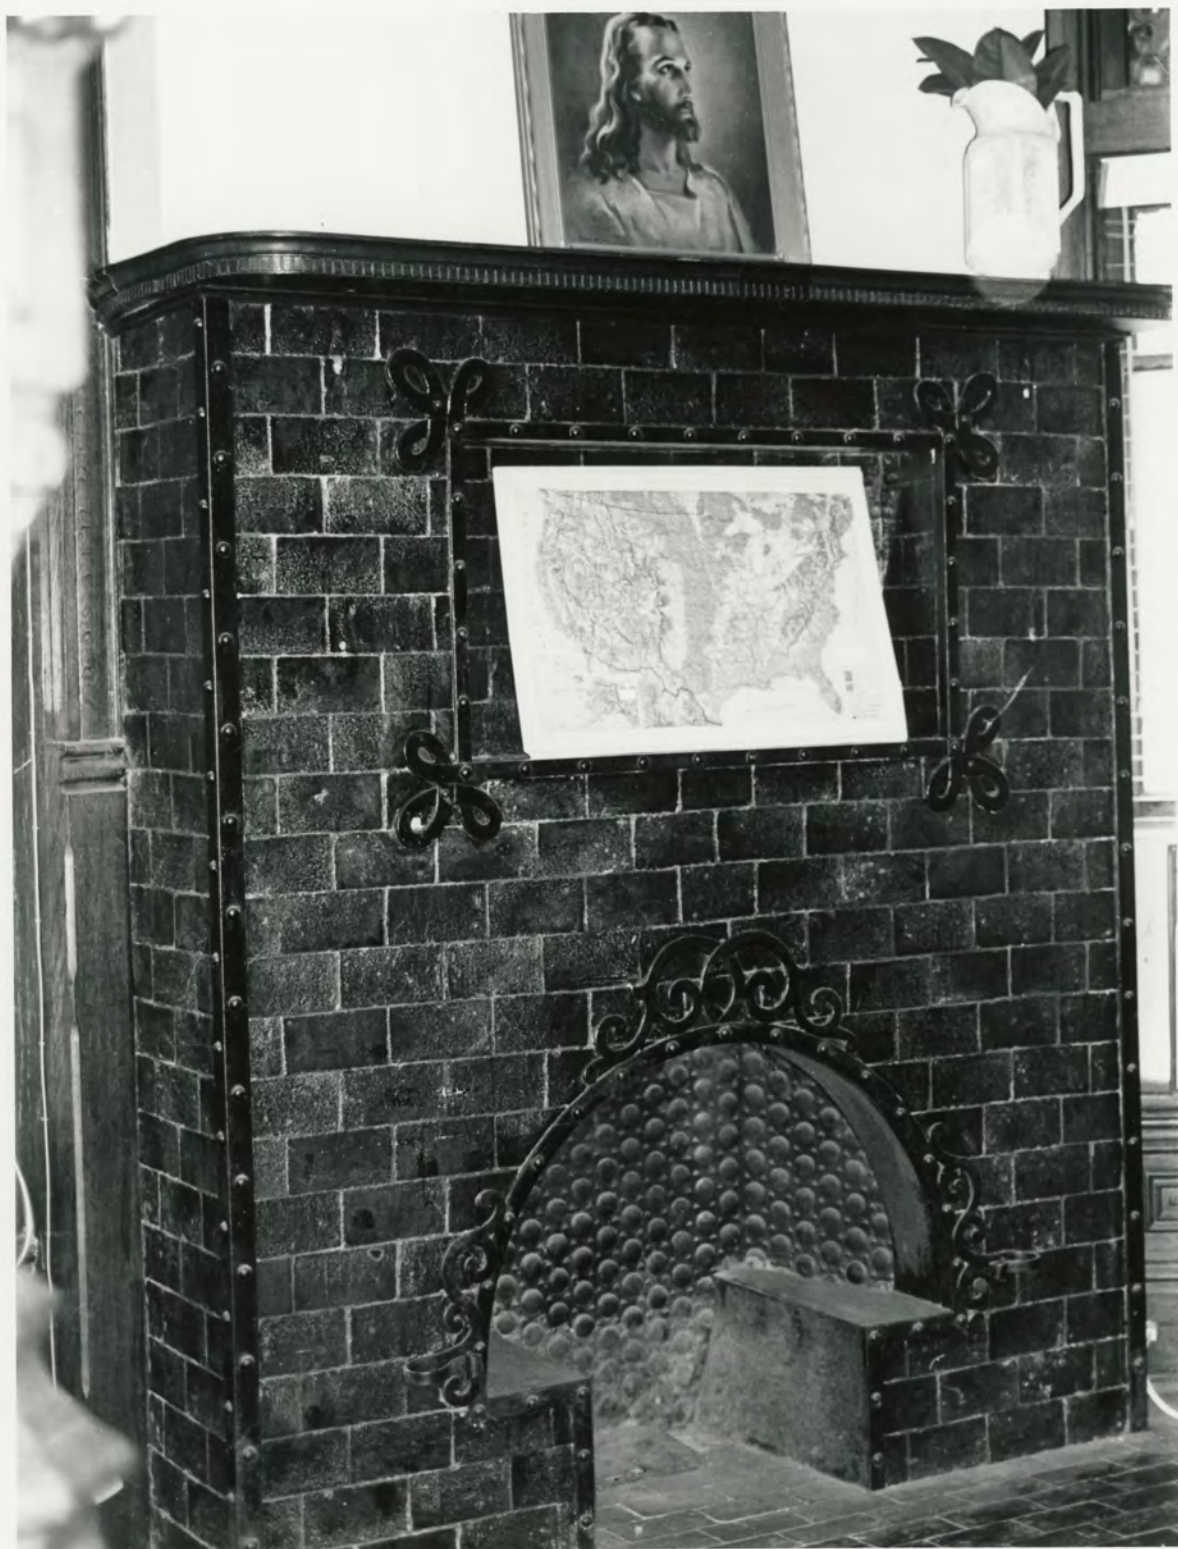
Solomon Gans House  
Little Rock, Pulaski County  
Photographed by Alice Jones  
September, 1983  
Negative on file at AHPP  
Fireplace with Glazed Brick

Though the house was converted into offices nearly forty years ago, much of its original interior fabric remains intact, most notably in the entry hall. Dominated by a round-arched fireplace which is faced with dark green glazed tile and has a six inch mantel trimmed with wrought iron strips and holders for fireplace tools. Much of the oak woodwork in the entry hall, especially the twelve inch cornice and door and window trim, is classically derived. The moulding on either side of the doors and windows was designed to suggest columns which support an entablature across the top of each door and window. The twin newel posts of the oak staircase are small Corinthian columns. The entry hall's lavish oak woodwork, which includes paneled wainscoting, is one of the interior's most distinguishing features. In its adaptation to office use, the interior underwent several changes. Woodwork remains throughout, but some original features have been covered or removed. The original floorplan of the house is still apparent, though some partition walls have been added or moved. The most notable alteration is the c. 1950 two-story concrete block addition at the northeast corner of the house.

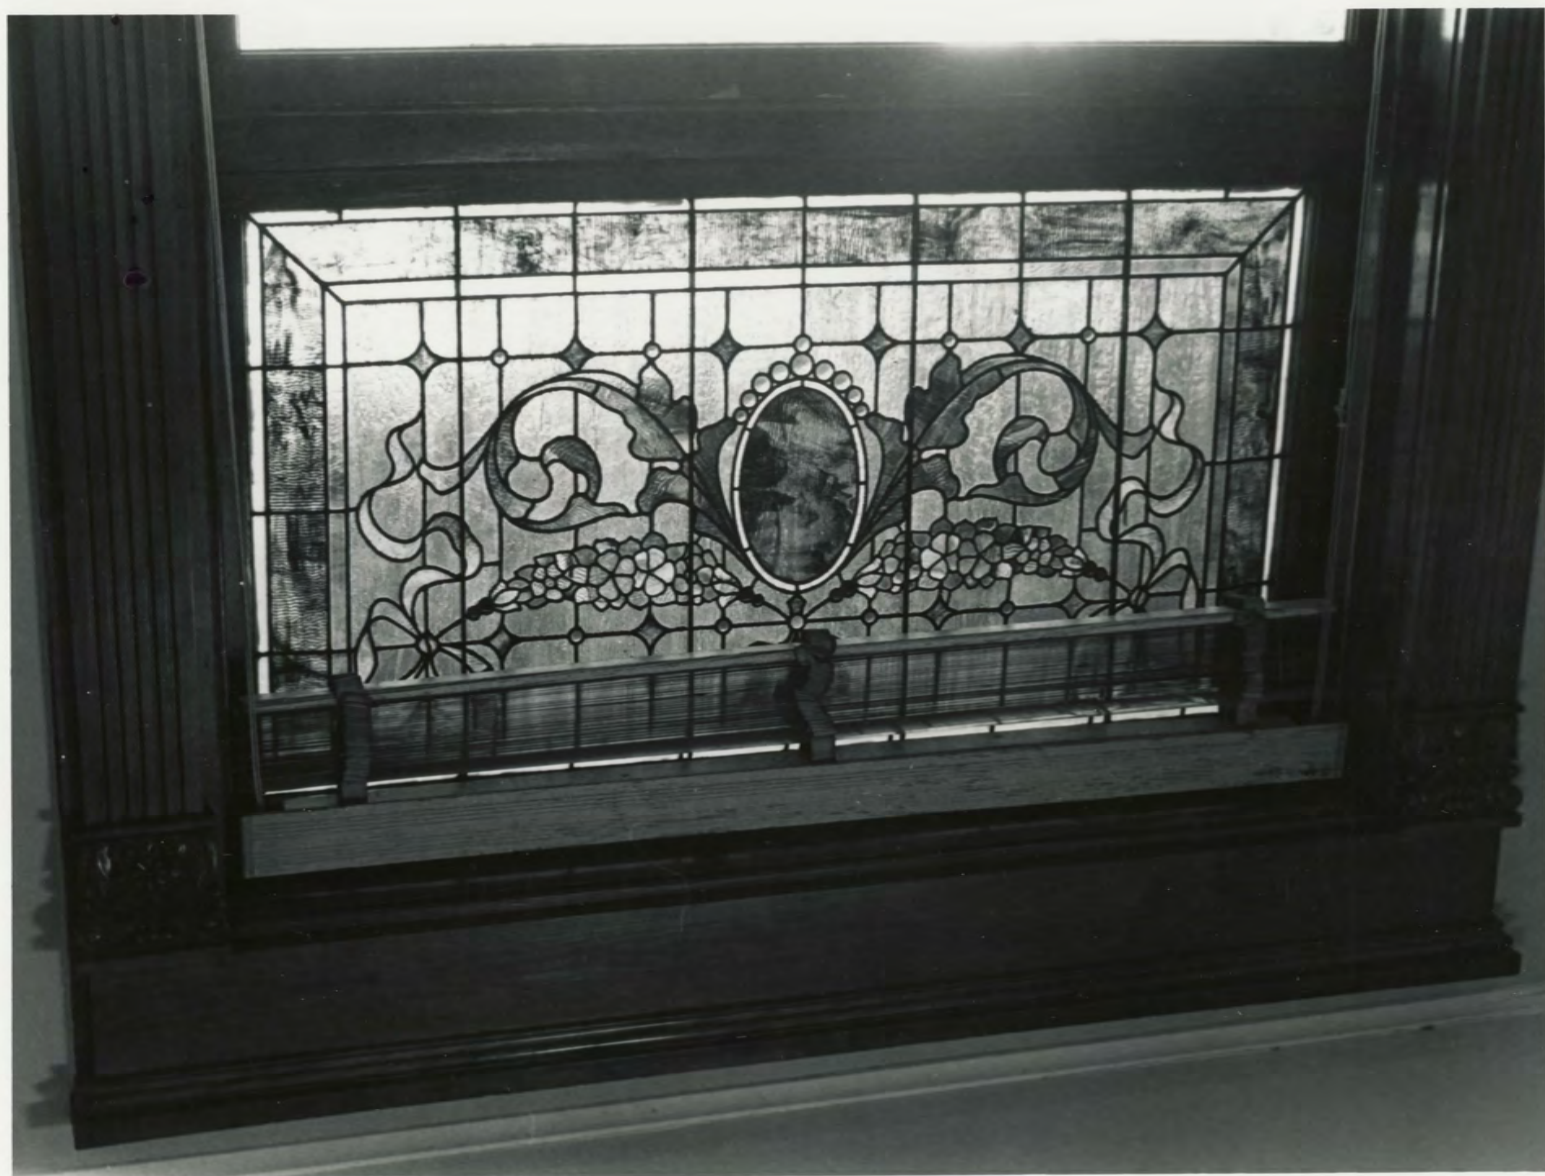
Solomon Gans House  
Little Rock, Pulaski County  
Photographed by Alice Jones  
September, 1983  
Negative on file at AHPP  
Stained Glass Transom
