National Register of Historic Places Registration Form

Historic name: Security State Bank of Dante

Street & number: 320 Main Street

City or town: Dante State: SD County: Charles Mix

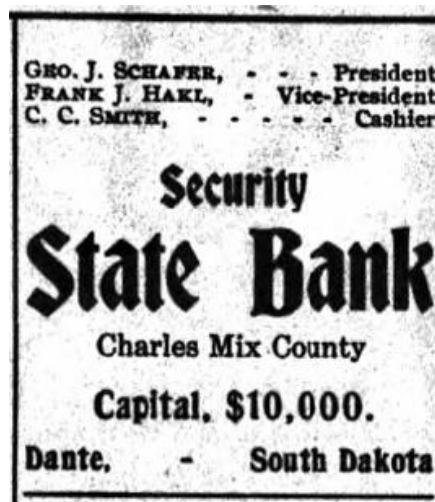
Figures 1 and 2: *Standard Atlas of Charles Mix County, South Dakota* (Chicago: Geo. A. Ogle Co., 1912), 35, 102.

In 1920, the Security State Bank built the existing structure to better serve the growing community and provide a sense of security for the community's finances. A 1912 atlas (see Figure 1) shows a bank on the same lot as the current building on the plat map of the town, and in June 1920, the bank moved that false-front wood frame building to a lot across the street (Block 6, Lot 6) in order to erect the existing two-story brick building.¹⁰ The original building is
