Damascus School
14711 SE Anderson Road
Damascus, Clackamas Co, Oreg.

1 of 14 - Historic view, c.
1900

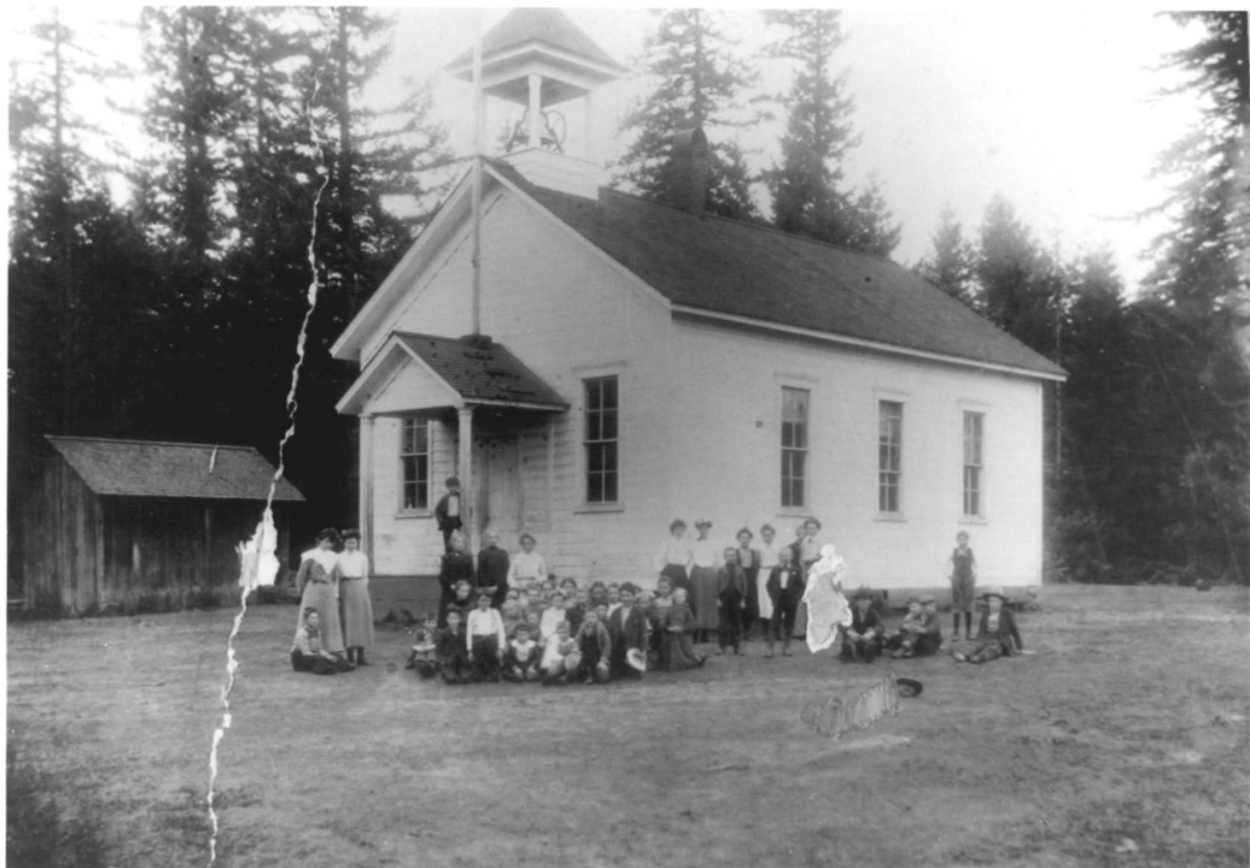
South (front) and east eleva-
tions of school in original
state as built in 1876, show-
ing aedicula-like porch and
symmetry in placement of open-
ings. three bays in side walls.

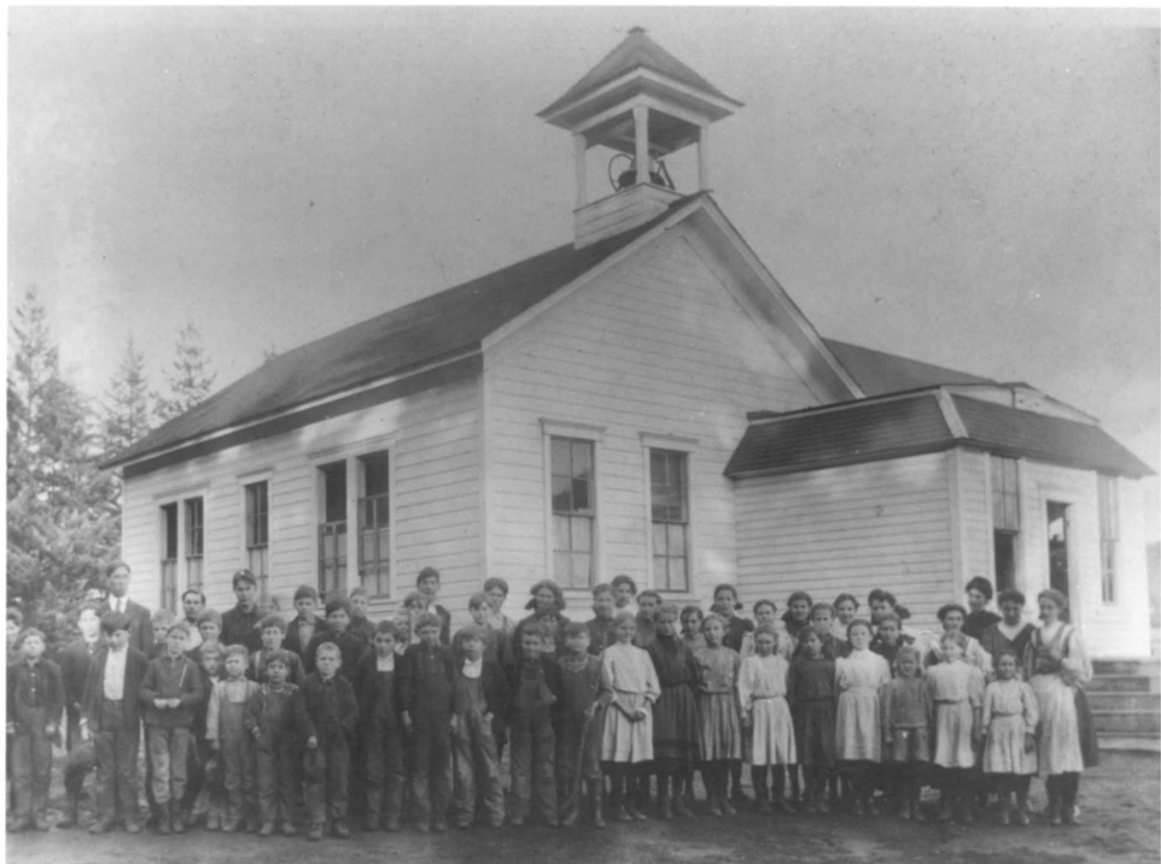
2 of 14 - Historic view, c.
1911

West and south (front) elevations of school as remodeled between 1902 and 1911. Belfry remains open. Original central porch has been replaced by an offset vestibule. Outer bays in west wall have been made compound openings. Perpendicular classroom wing has been added on east side of school.

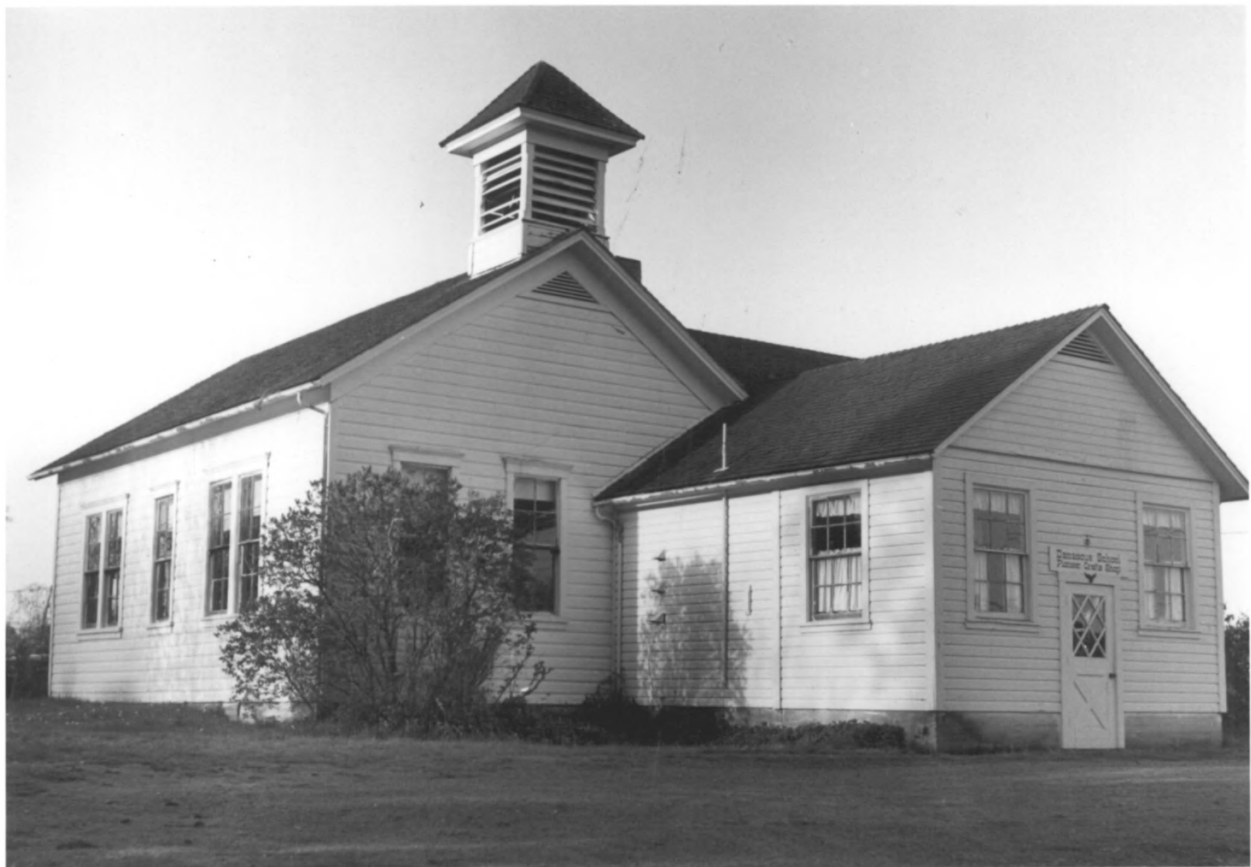
Damascus School
14711 SE Anderson Rd.
Damascus, Clackamas Co, Oregon
3 of 14 - West and south eleva-
tions, showing louvers added to
belfry and enlargement of south
vestibule post-dating 1922.
Damascus Pioneer Craft School
photo, 1980
14711 SE Anderson Rd.
Clackamas, OR 97015

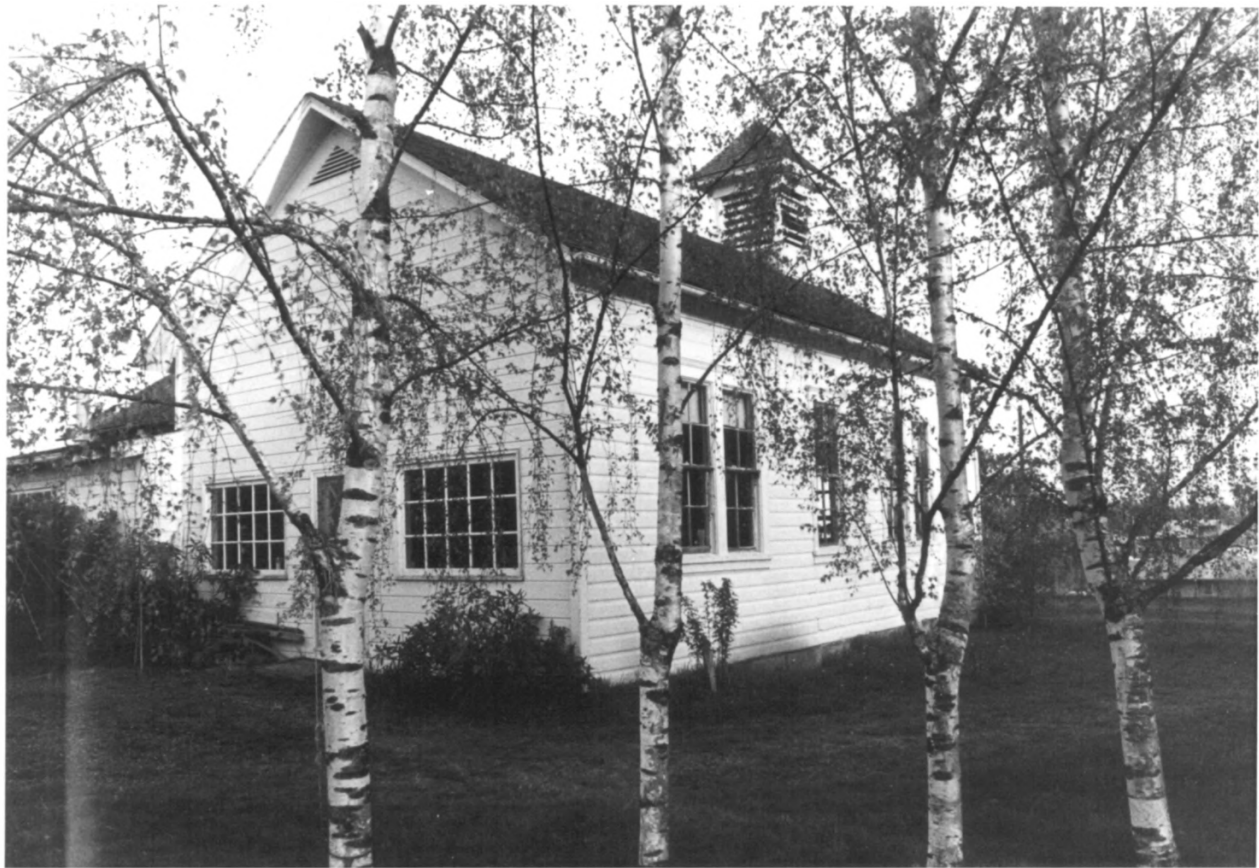
Damascus School
14711 SE Anderson Rd.
Damascus, Clackamas Co, Oregon
4 of 14 - North and west eleva-
tions of original volume of
1876. Openings in west wall
revised 1902-1911. Openings in
north end were made 1967.

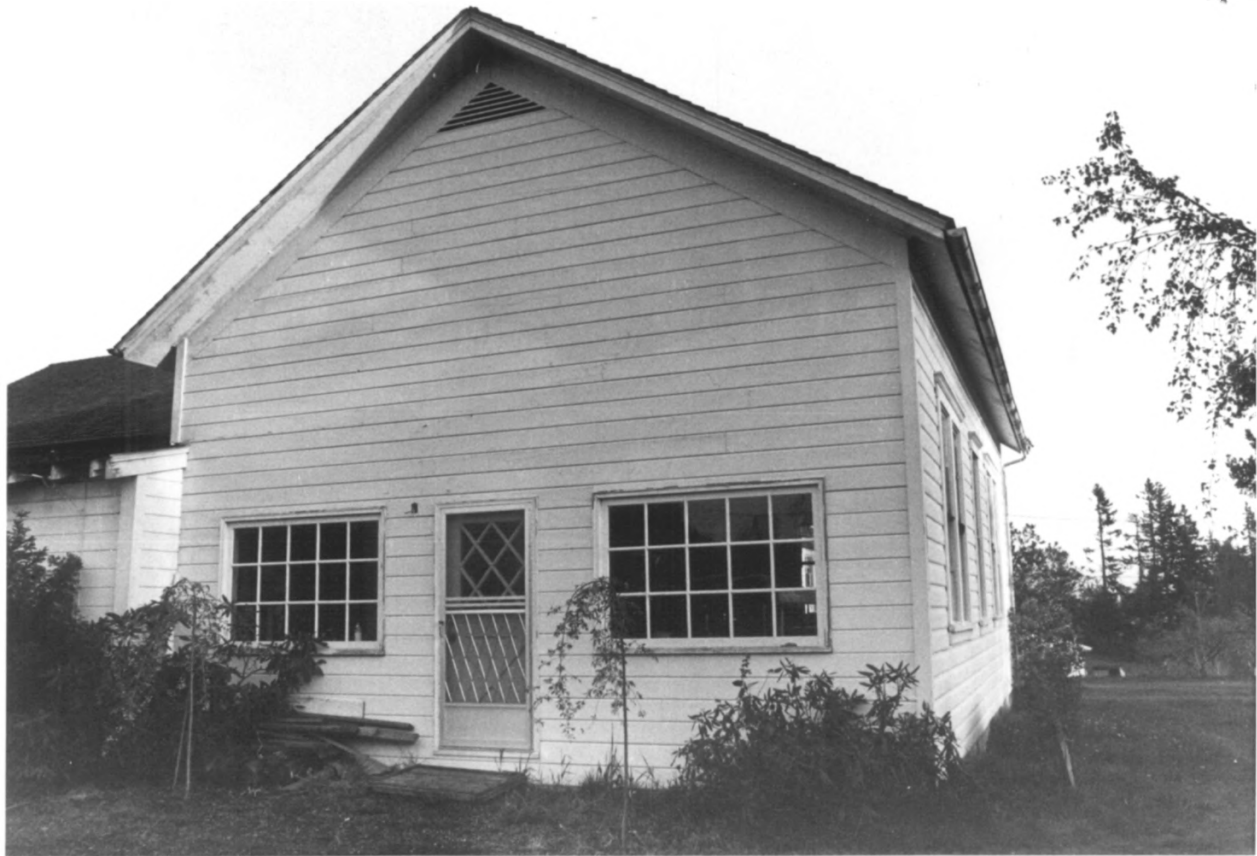
5 of 14 - Detail view of north
end of original volume of

1876, showing openings of 1967.

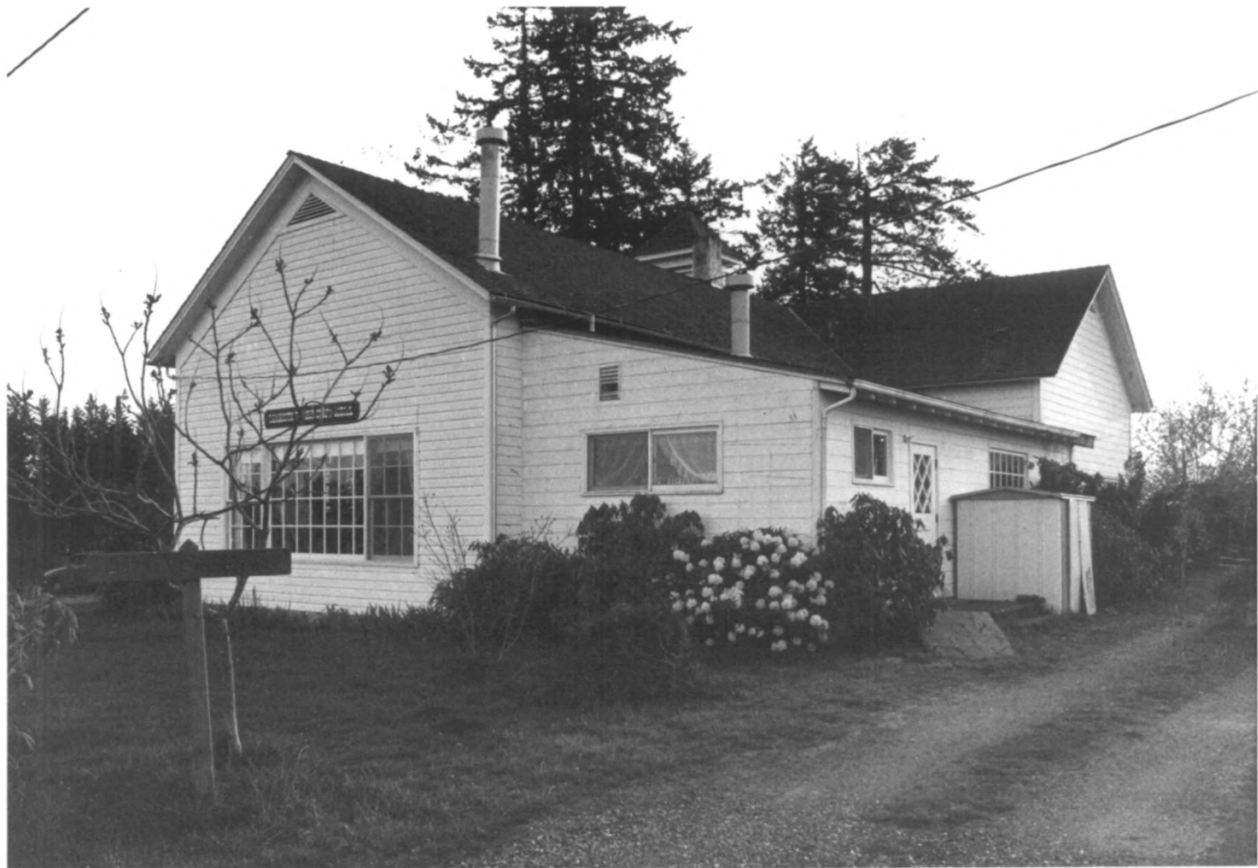
Damascus School
14711 SE Anderson Rd.
Damascus, Clackamas Co, Oregon
6 of 14 - East and north elevations, showing lean-to kitchen

addition of 1935 as enlarged in 1956 and classroom wing of 1902-1911. Multi-paned bay window in east end of classroom addition and other openings shown date from 1967.

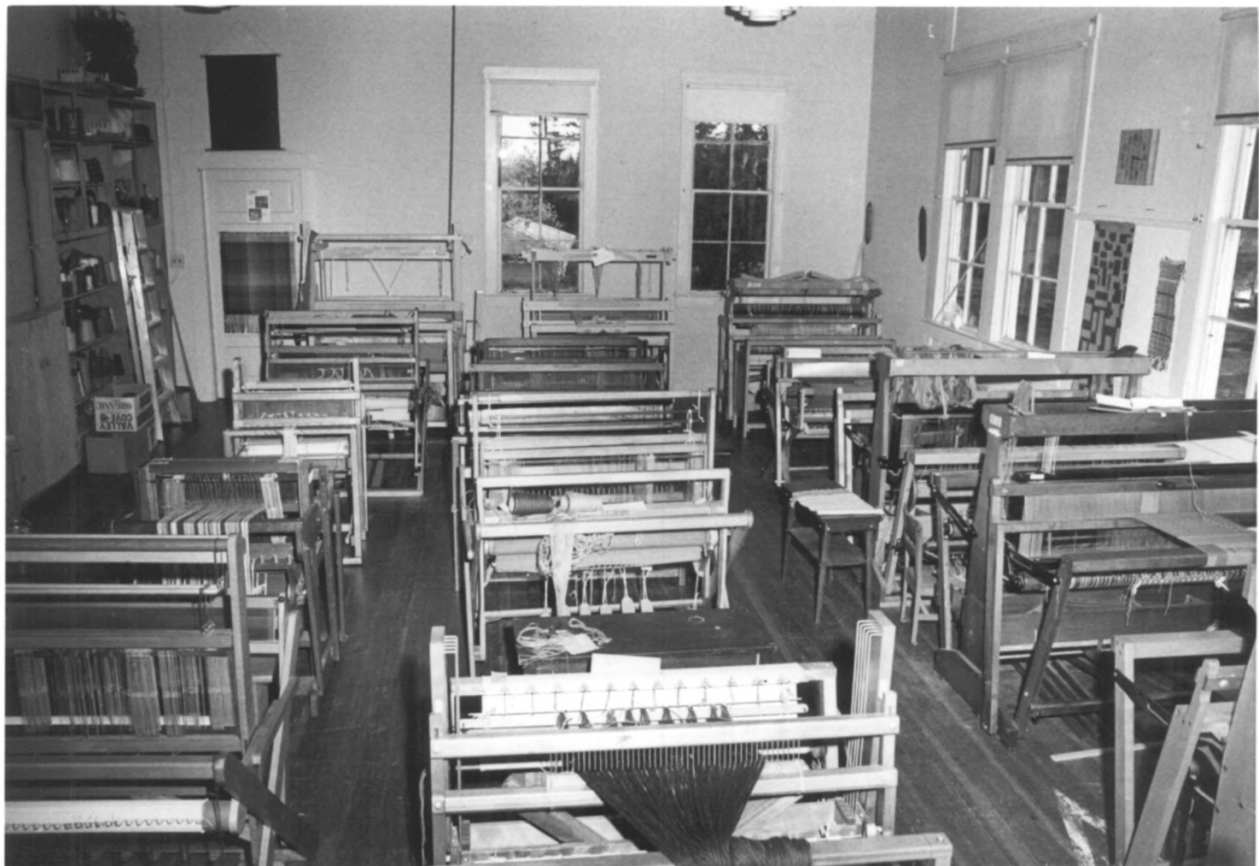
7 of 14 - Interior view, looking south, original volume of

1876, showing window trim and flooring intact. **OCT 6 1980**

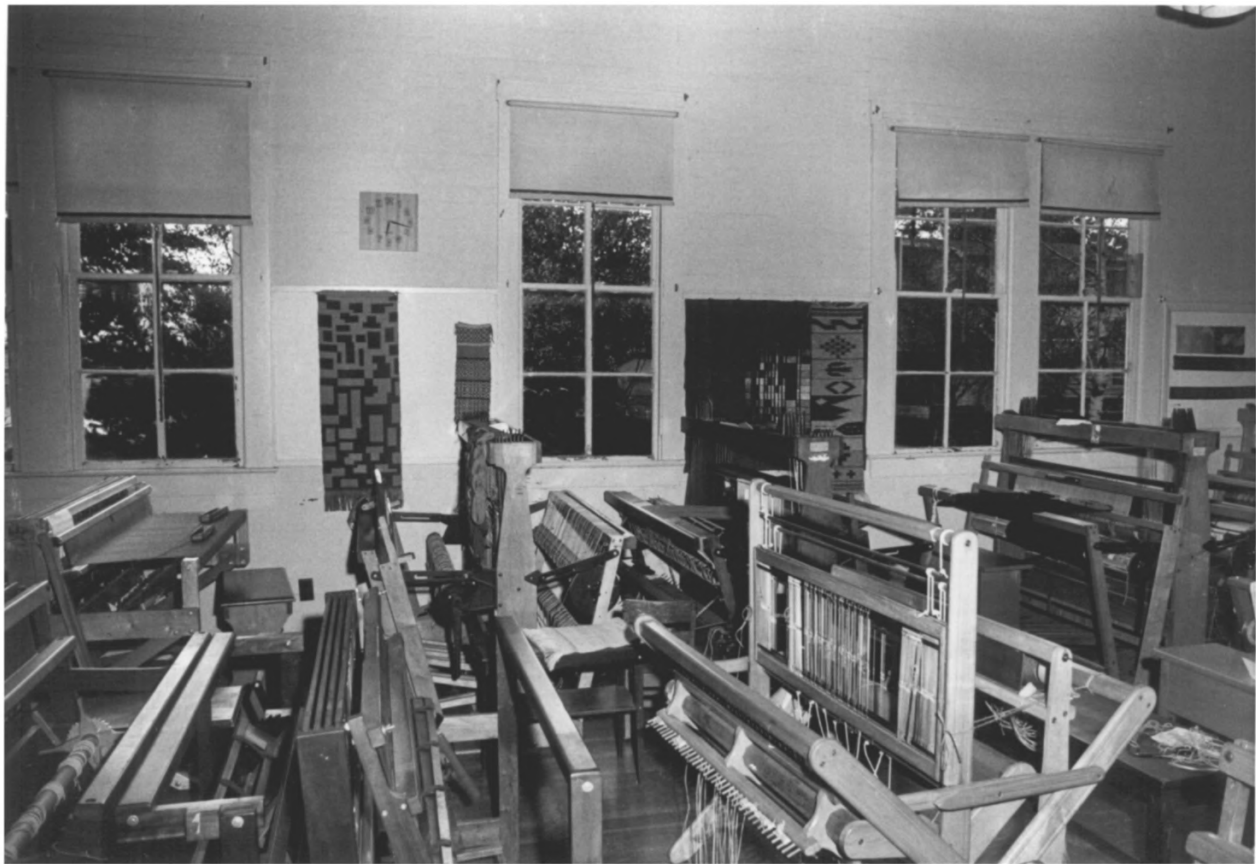
Damascus School
14711 SE Anderson Rd.
Damascus, Clackamas Co, Oregon
8 of 14 - Interior view, looking west, original volume of 1876. Paired window openings in outer bays date from enlargement of 1902-1911.

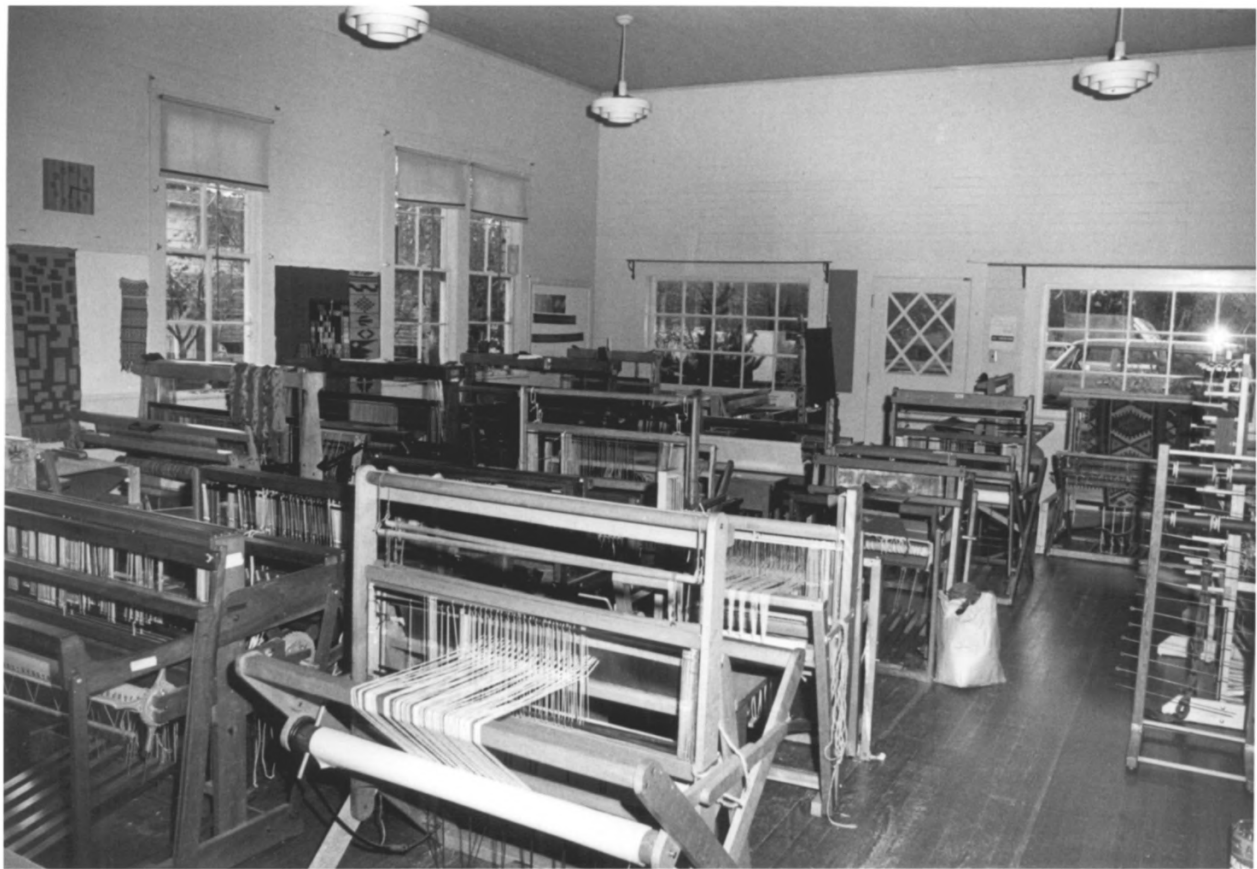
9 of 14 - Interior view, look-
ing north, original volume of

1876. Openings in end wall were
added 1967.

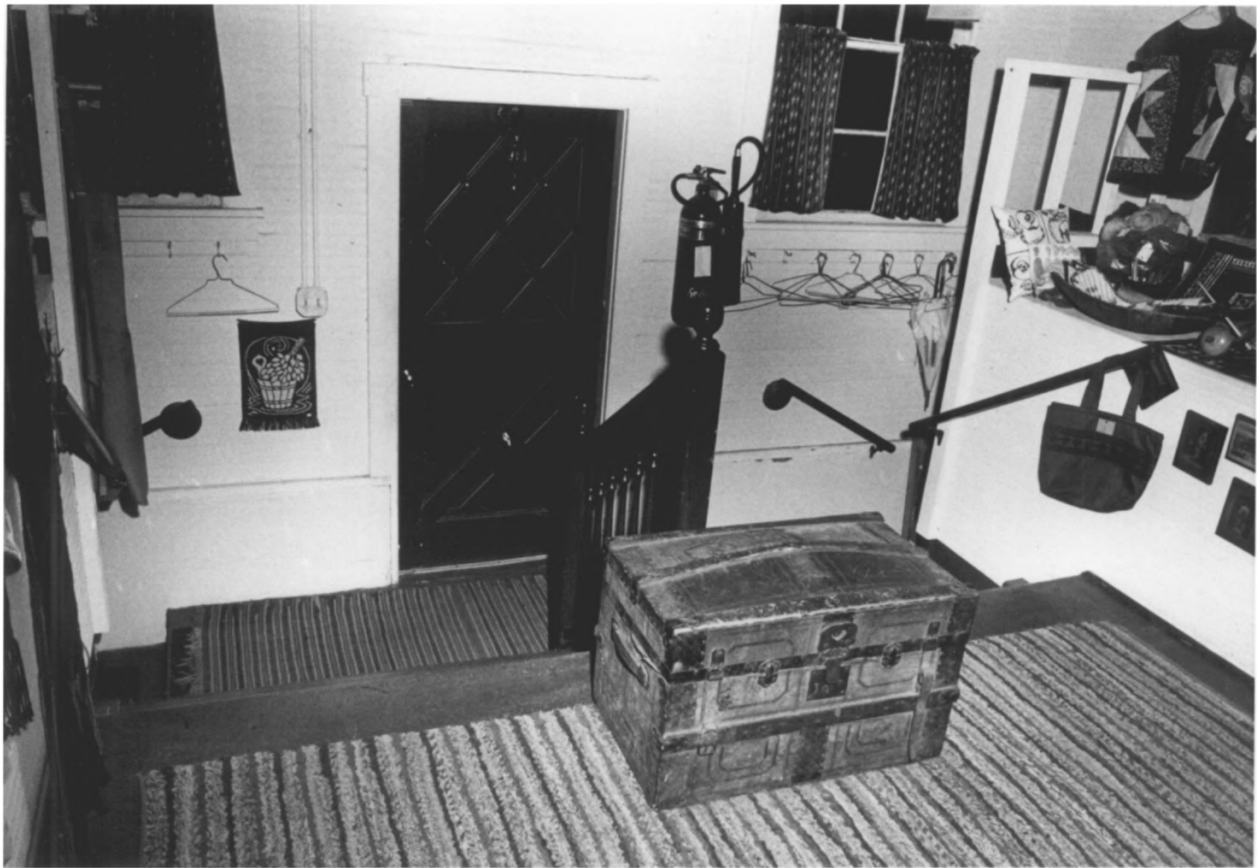
Damascus School
14711 SE Anderson Rd.
Damascus, Clackamas Co, Oregon
10 of 14 - Interior view, looking south, of vestibule as

enlarged after 1922. Door is addition of 1967.

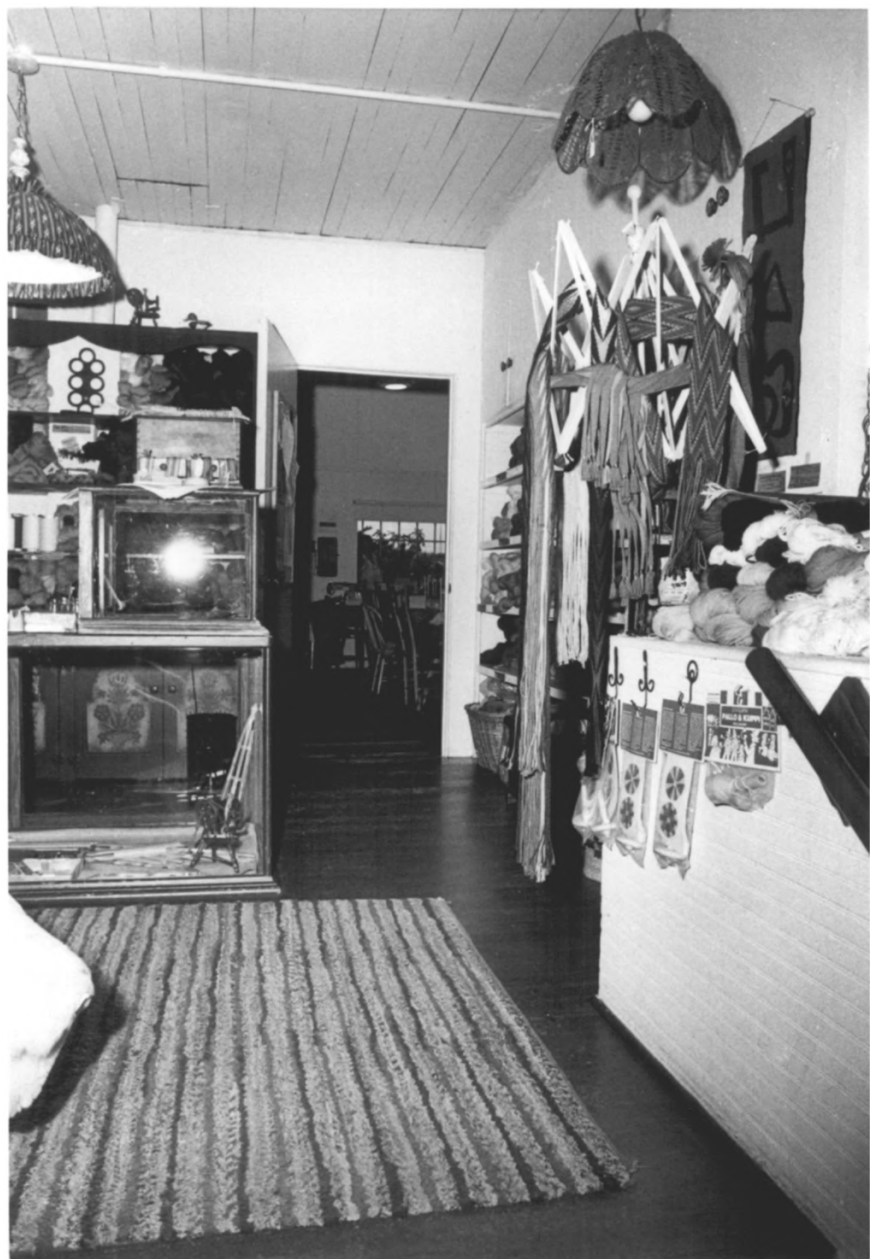
11 of 14 - Interior view,
looking east, into east class-

room wing of 1902 - 1911.

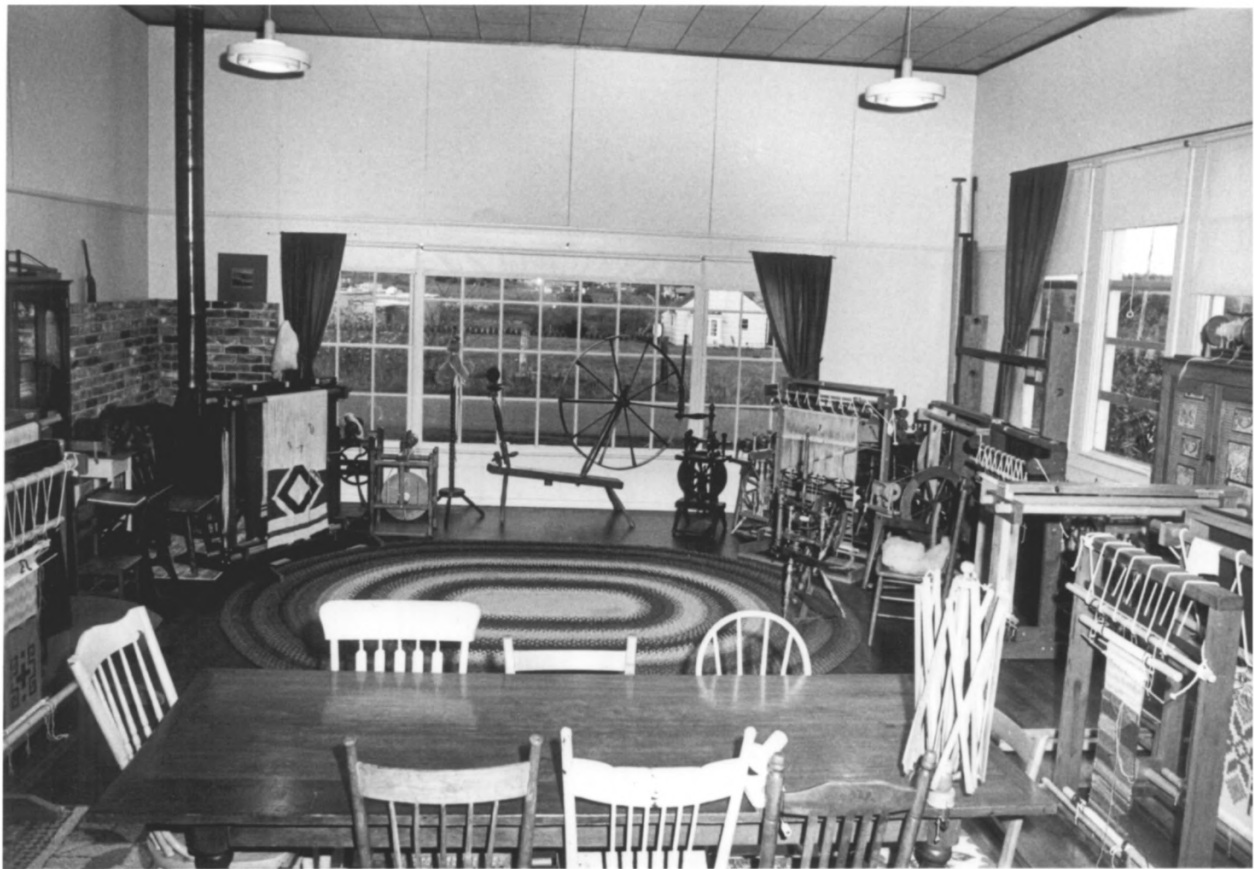
Damascus School
14711 SE Anderson Rd.
Damascus, Clackamas Co, Oregon
12 of 14 - Interior view, look-
ing east, east classroom wing
of 1902-1911. ~~OCT 6 1980~~

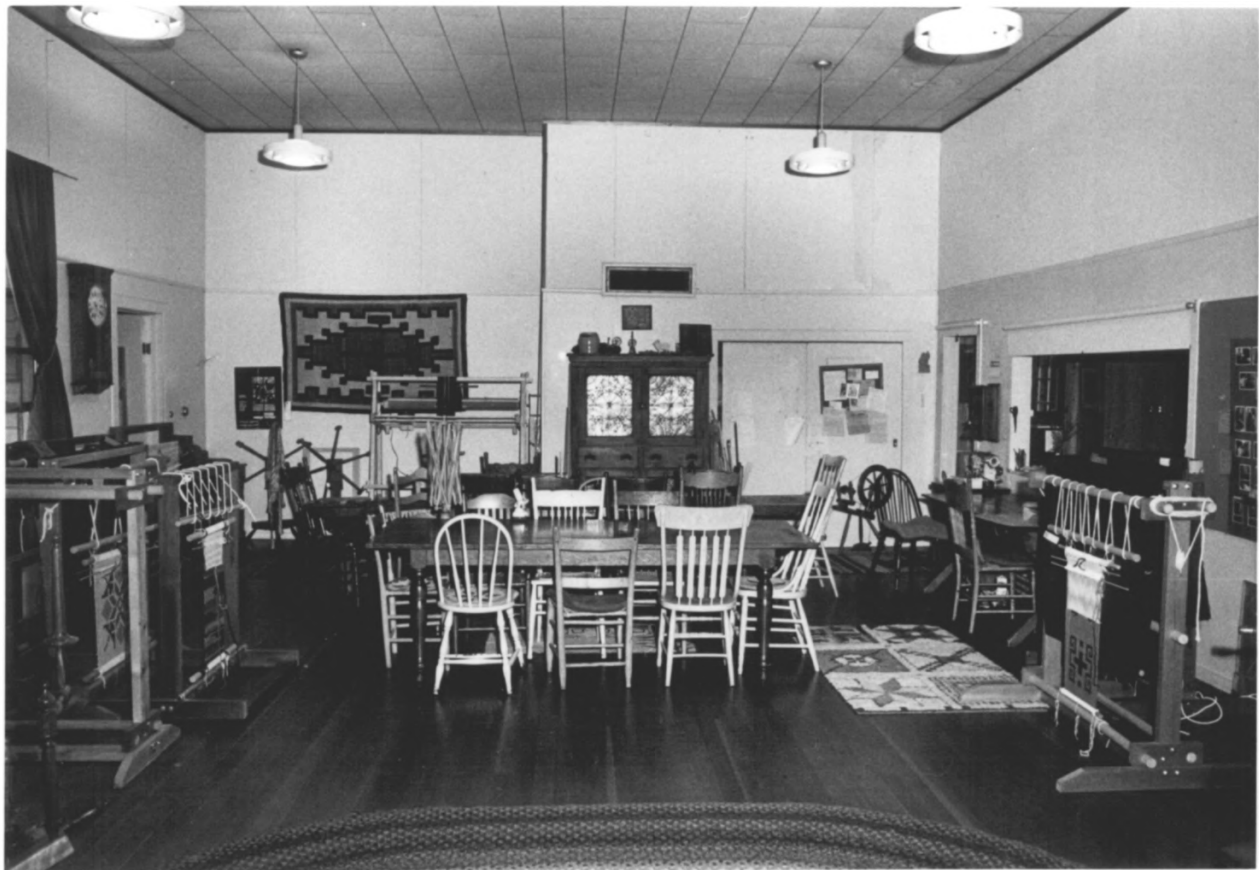
13 of 14 - Interior view, look-
ing north, east classroom wing

of 1902-1911. OCT 6 1980

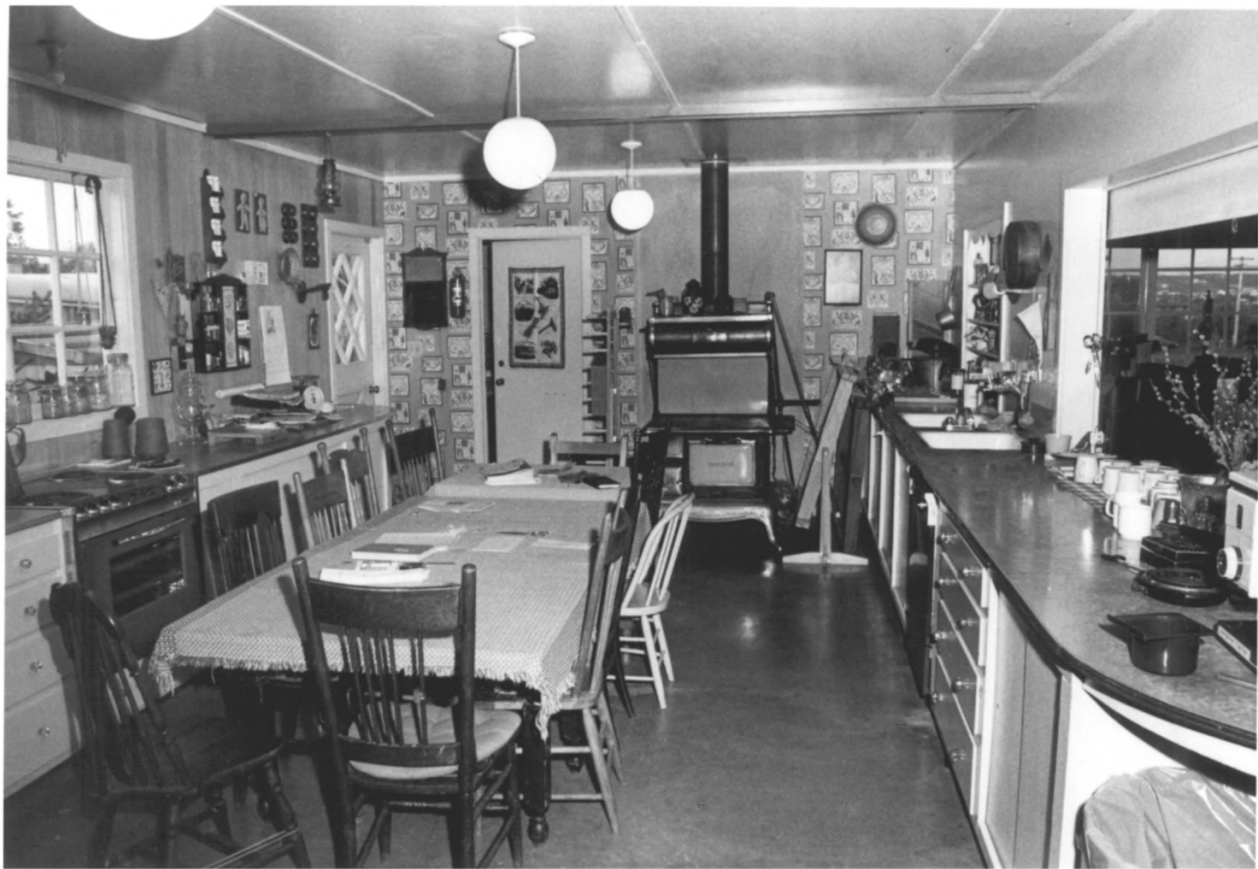
14 of 14 - Interior view, looking east, kitchen/utility addition of 1935 as enlarged in 1956 and given new window openings in 1967.
