National Register of Historic Places Inventory—Nomination Form

<u> 1. Name</u>	•			
historic	Des Moine	es Saddlery Company	Building	
and or common	Saddlery	Building		
2. Locat				
street & number	307-09-11	Court Avenue		not for publication
city, town	Des Moine	es vicinity of		
state	Iowa code	e 019 county	Polk	code 153

7. Description

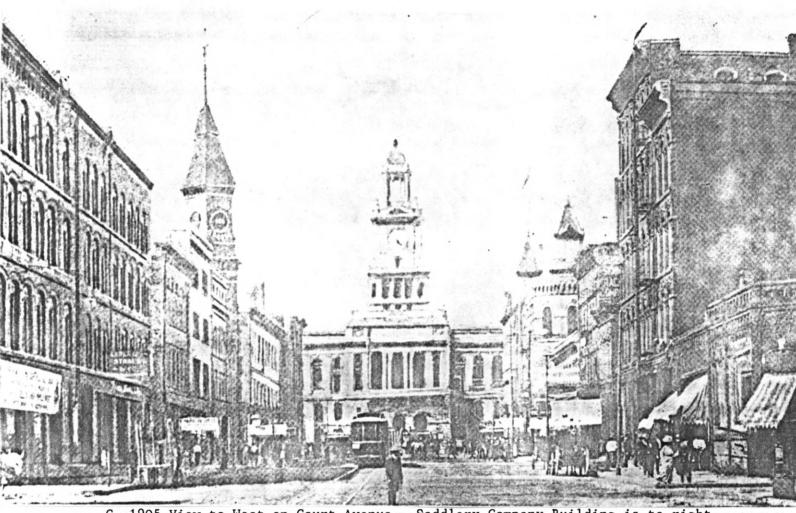
C. 1905 View to West on Court Avenue. Saddlery Company Building is to right hand side. Note lack of fifth floor onneastern mostybayed lack of fifth

The final phase of growth post dated 1905 and pre-dated 1920 and involved the addition of a final fifth floor component to the easternmost bay. The east side wall had been totally devoid of fenestration up to this point, a remarkable fact considering the fact that single story adjoining structures on that side had been the rule since the construction of the first phase of the Saddlery building. The final construction provided for four windows (again with segmental brick arch caps) amidships on the fifth floor. An elevator housing projected to the rear of that short band of windows. By 1920 an alley catwalk connected the building to another building to the immediate north. Sometime after the cessation of building, some window alterations took place on the west and rear walls. These are identified by their
