1. Name of Property	
historic name Hotchkiss Methodist Episcopal Church	
other names/site number Hotchkiss United Methodist Church; Hotchkiss Comm 5DT.1769	nunity United Methodist Church;

2. Location	
street & number 285 N. 2 nd Street	[N/A] not for publication
city or town Hotchkiss	[N/A] vicinity
state <u>Colorado</u> code <u>CO</u> county <u>Delta</u> code <u>029</u>	zip code <u>81419</u>

Hotchkiss Methodist Episcopal Church Delta County/ Colorado

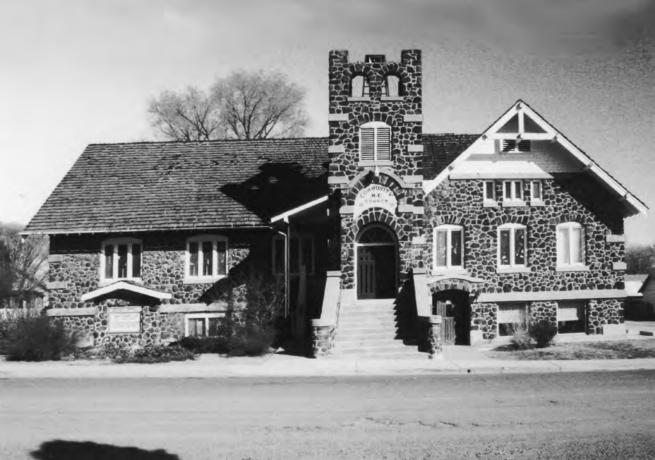
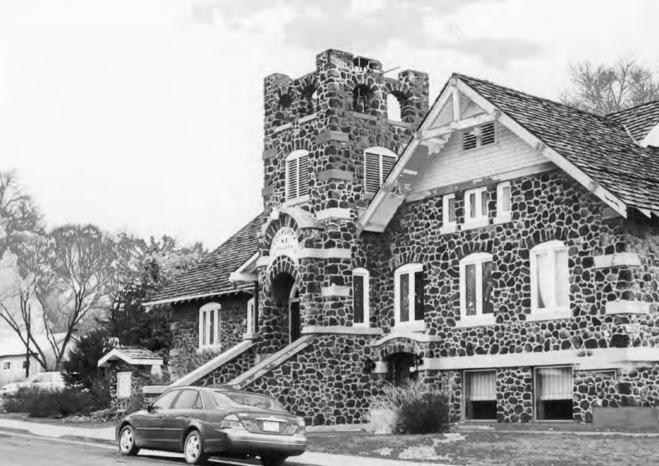
5DT. 1769 #1 Hotzhkiss United Methodist Church Delta County Colorado

A side-gabled roof with overhanging eaves and sculptured exposed rafters covers the section to the north of and behind the bell tower. The section to the south of the bell tower is front-gabled with a gable face that exhibits wood shingles, stick truss work, decoratively carved bargeboards, and exposed purlins. The truss at the apex of the gable protects a wood louvered vent. (See photos 1, 2.)
