Harland Sanders Cafe, Corbin, KY

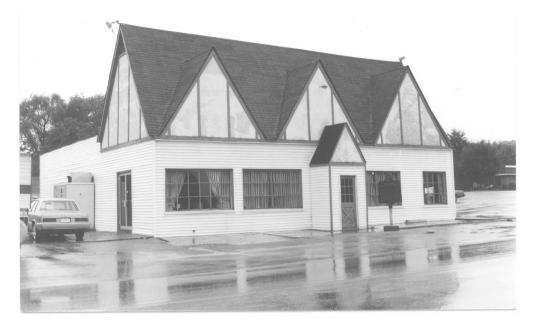
Photo circa 1987 showing the cafe prior to restoration. Note the "new" vestibule and vinyl siding. The Manager's Office door is covered over and the gable ends are covered with stucco.

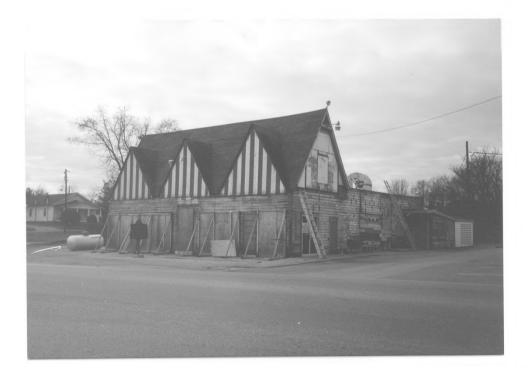
Harland Sanders Cafe, Corbin, KY Photo in December, 1989, during exterior restoration. Vinyl siding and covering on gable ends removed and original window and door openings revealed. Note that the original finish materials survive on the north gable end.
