KENTUCKY HISTORIC RESOURCES INVENTORY

Site No. Me-181

| 1. Historic Name(s) <u>Stone quarters on Burgin Rd.</u> | | 22. ADD/County <u>Bluegrass Mercer</u> | |

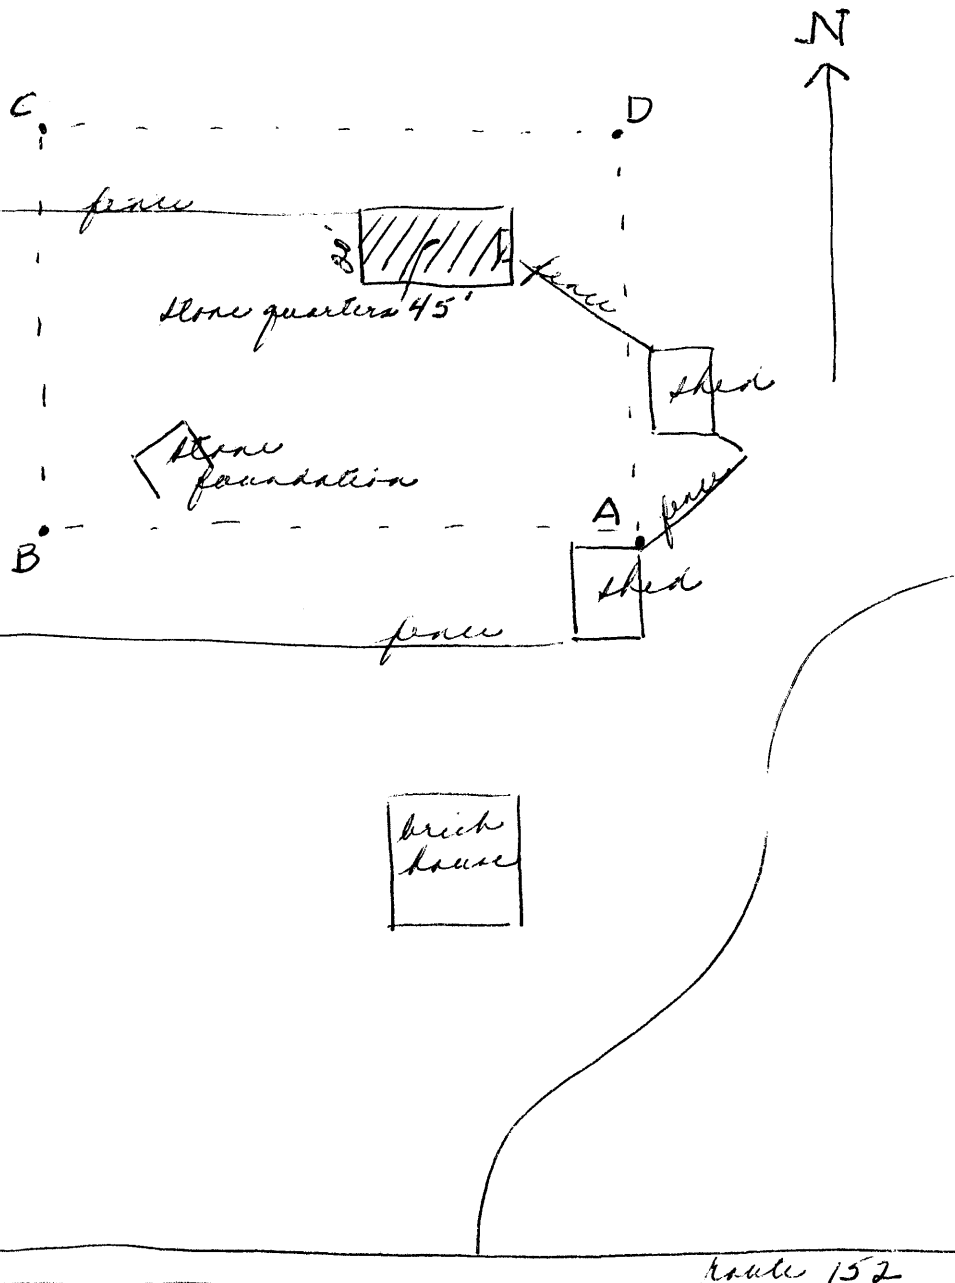
SKETCH MAP OF SITE SHOWING BOUNDARIES AND KEY BUILDINGS AND FEATURES WITH NORTH ARROW.

Beginning at A, at the N.E. corner of a shed behind the brick house, thence W. parallel to front of quarters, W. 140 ft to B, thence at right angles N. 100 ft to C, E 140 ft to D, and S. 100 ft to the beginning, containing the stone quarters and stone foundation, about 1/3 acre.
