National Register of Historic Places
Registration Form

1. Name of Property Munson Valley Historic District (Boundary Decrease)
historic name Park Headquarters
other names/site number _____

CULTURAL LANDSCAPE RECOMMENDATIONS

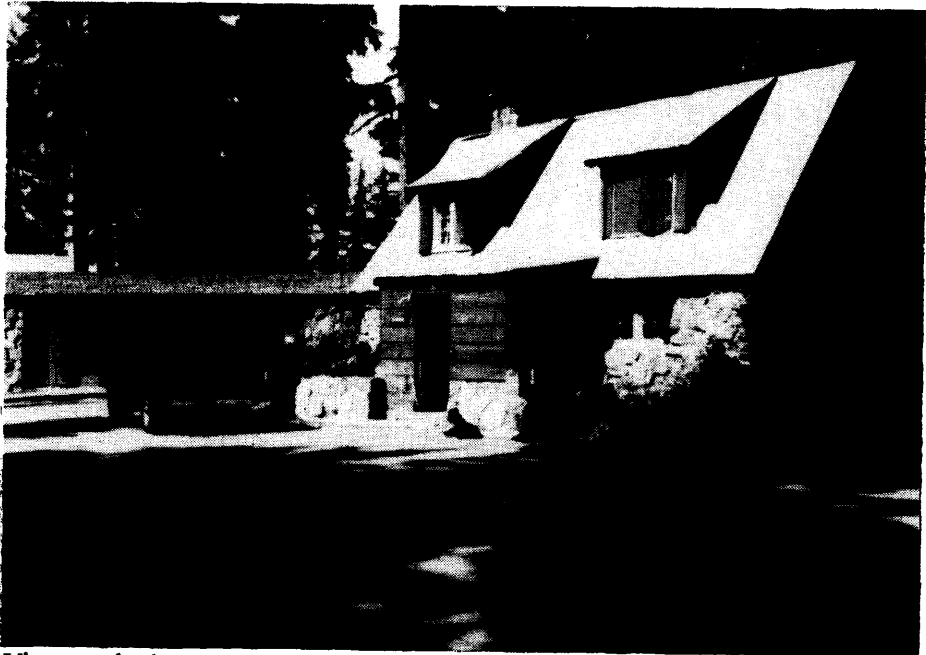
View south along spur road showing typical post WW II snow tunnel addition and widened road bed, 1990

Materials: With the exceptions of snow tunnel additions to the Administration Building and the Ranger Dormitory, and replacement in-kind of building materials during a recent rehabilitation project, structures in Munson Valley remain intact. Existing plant materials are compatible with the historic site although the original plantings are in remnant condition at best.

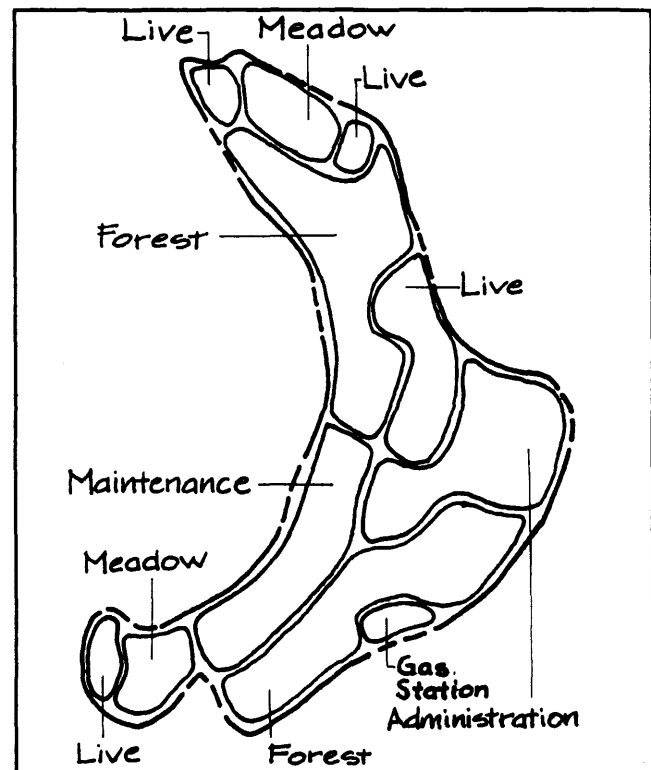
Park Headquarters, 1941-1990

This original land use pattern generally continues in the same configuration today. Housing for permanent employees is located at Steel Circle south of the maintenance area, while seasonal employee housing remains at Munson Valley. Although there have been several physical changes to the site over the years (roads widened and visitor and administration services expanded), the primary historic land use patterns have remained intact.

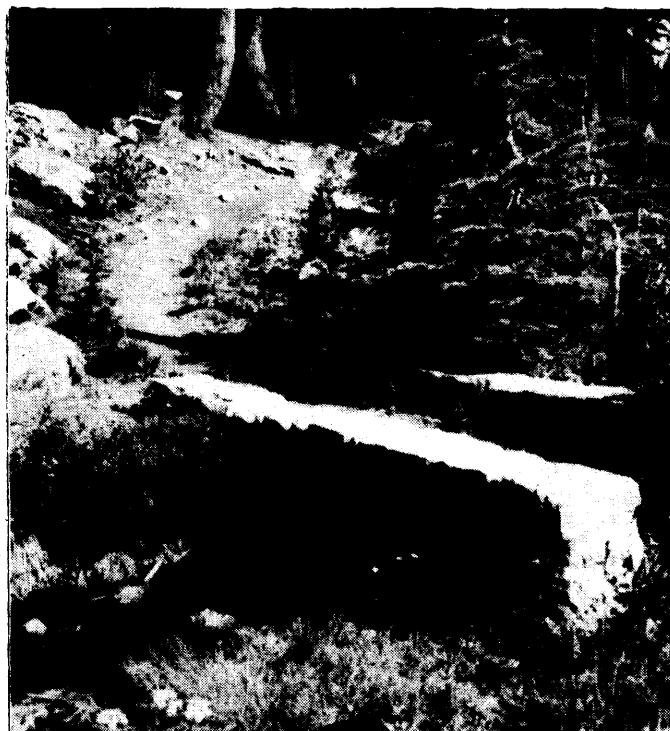
Trail to the middle group of residences and stone bridge crossing Munson Creek west of the Ranger Dormitory.

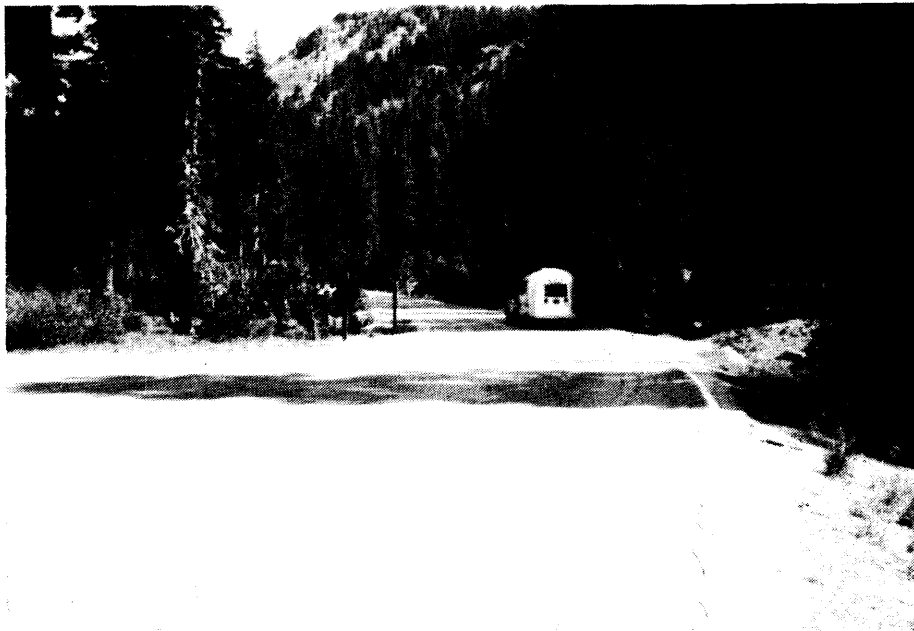
Routed wood entrance sign at the main entrance to Park Headquarters from Munson Road.

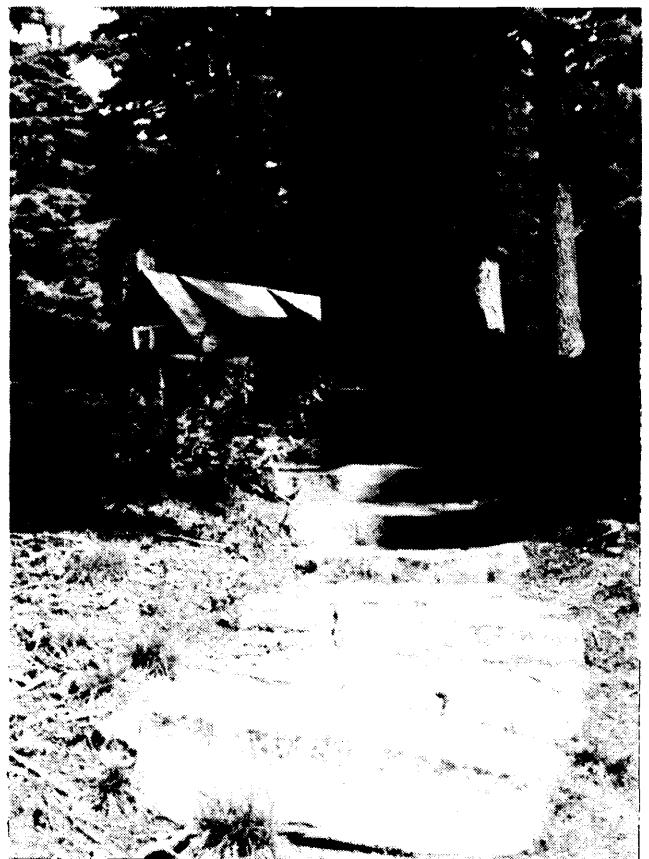
Stone steps to the lower group of employee residences.

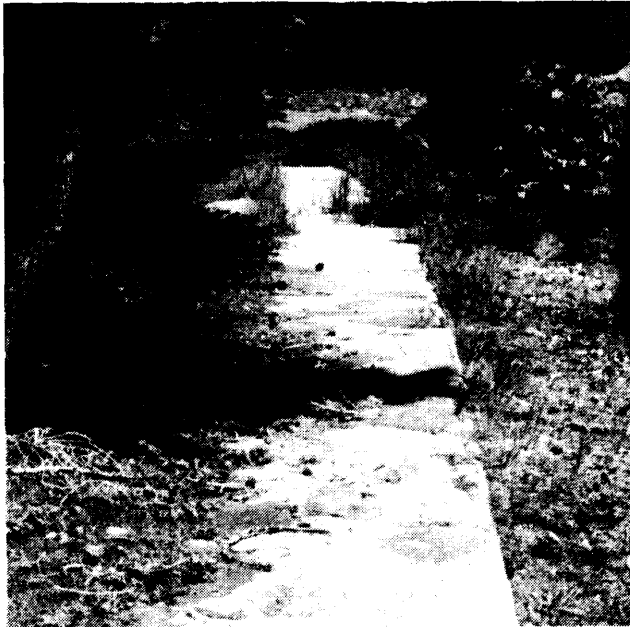
West flagstone walkway at the Superintendent's Residence.

1. Retain original circulation patterns.
2. The condition of all flagstone walkways, stone steps and the Munson Creek bridge should be assessed and an appropriate maintenance strategy for stabilization and preservation determined as noted under the maintenance and management recommendations..

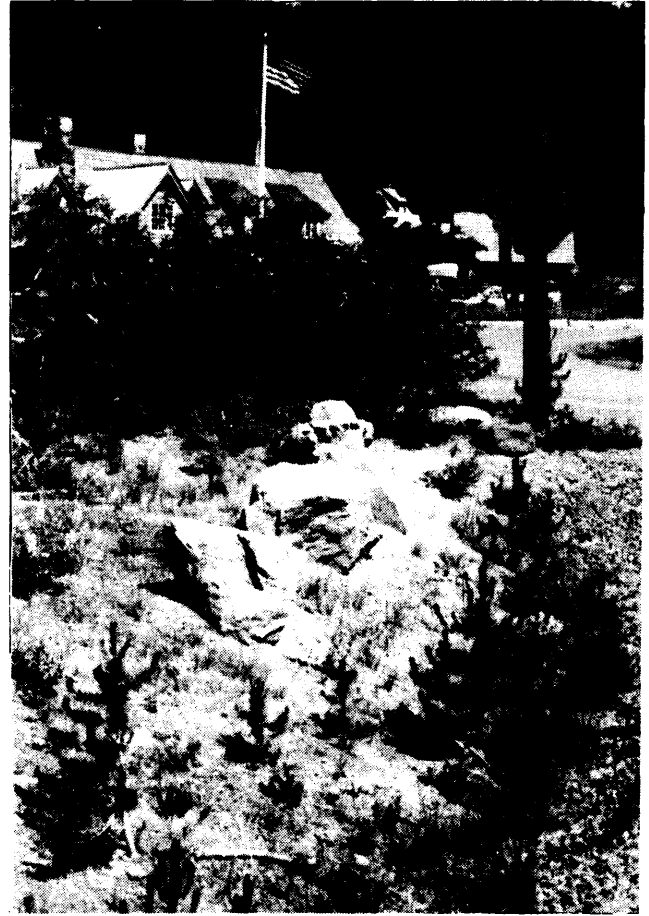
Extant boulders once used as a traffic control device for the old entrance to the plaza.
