Location: Vicinity of Little Creek, DE

Location of Negative: Hall of Records, Dover, DE

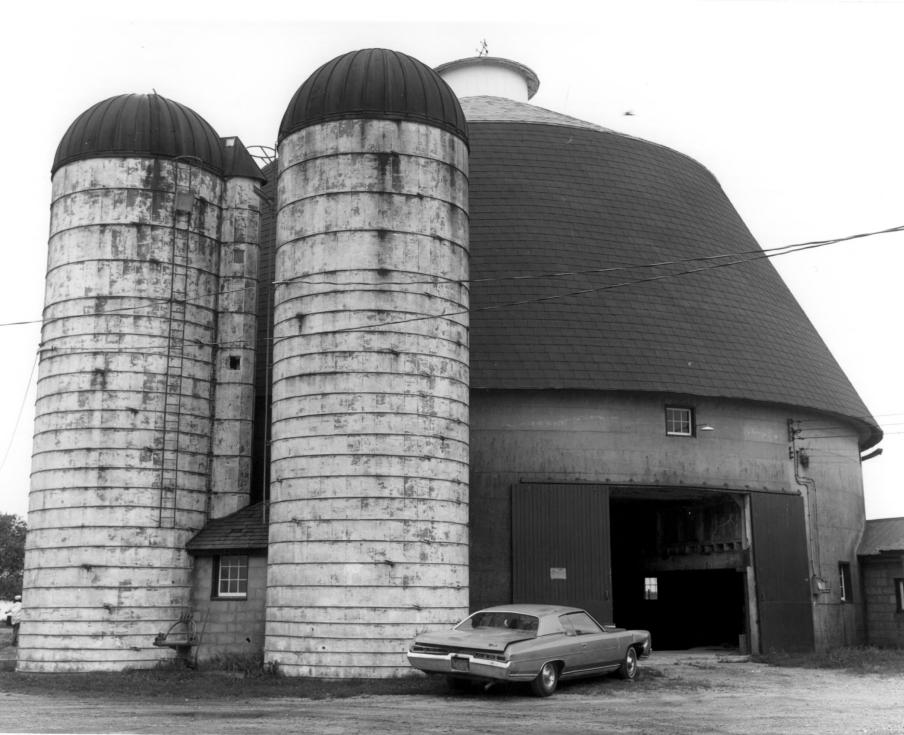
Photograph Number: #1

Description: Looking to the south

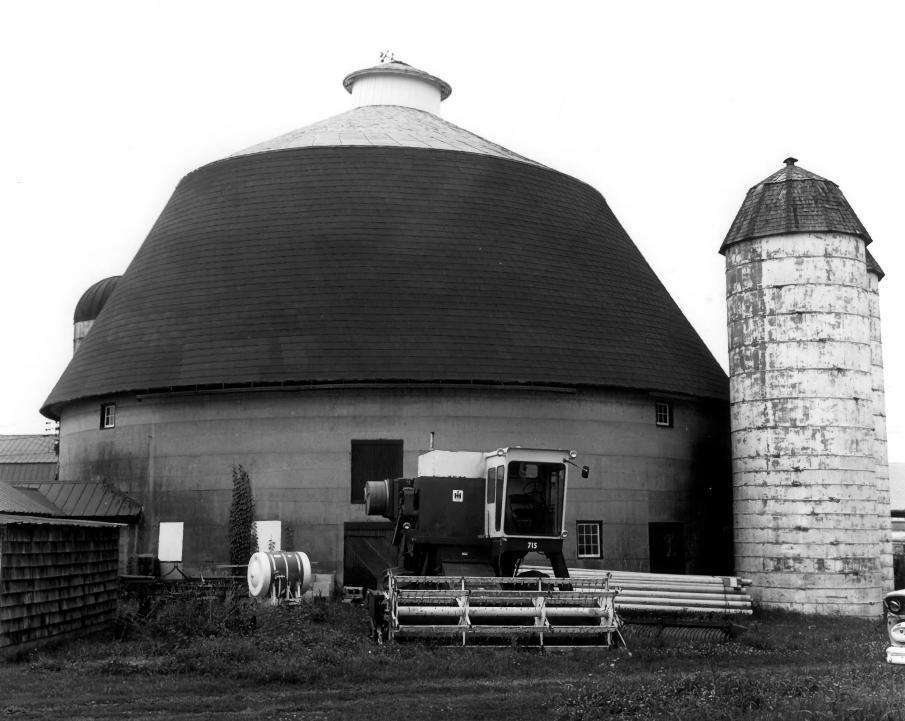
Photograph Number: #2

Description: Looking to the east; the silos to the right retain their original wooden shingles; note portions of the original sheet iron gutter at the eaves.

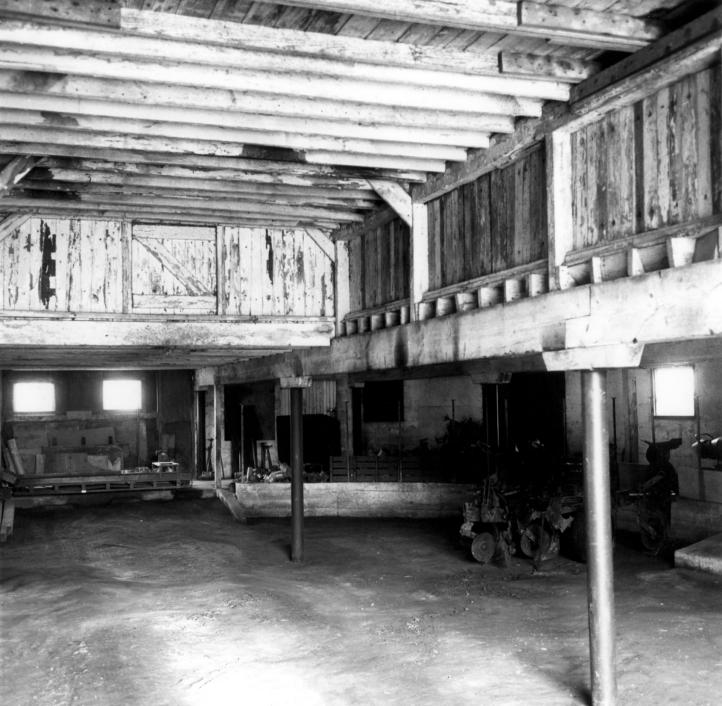
Photograph Number: #3

Description: A view of the interior ground floor, taken from the main entrance.

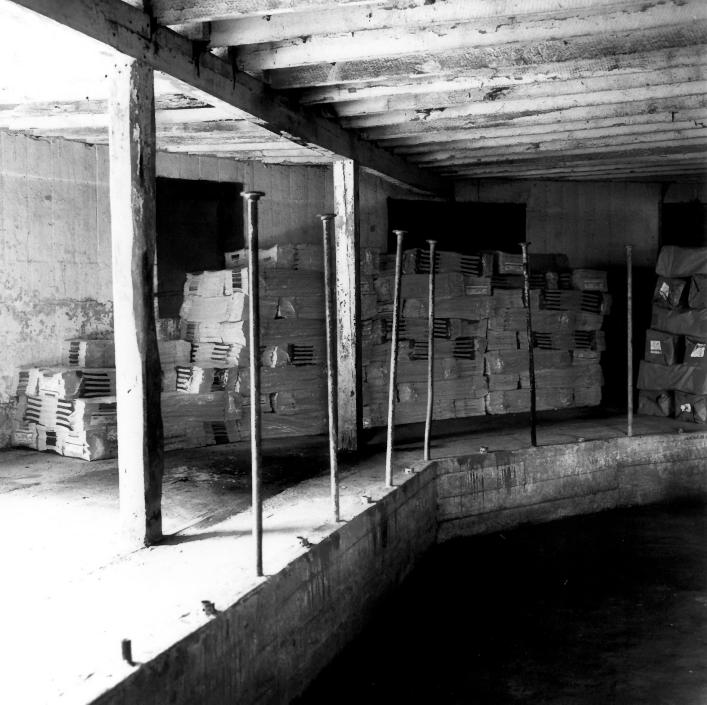
Photograph Number: #4

Description: First floor, showing concrete platform which encircles the sunken earthen floor; the iron pipes formed feeding positions above a trough which is now filled with concrete.

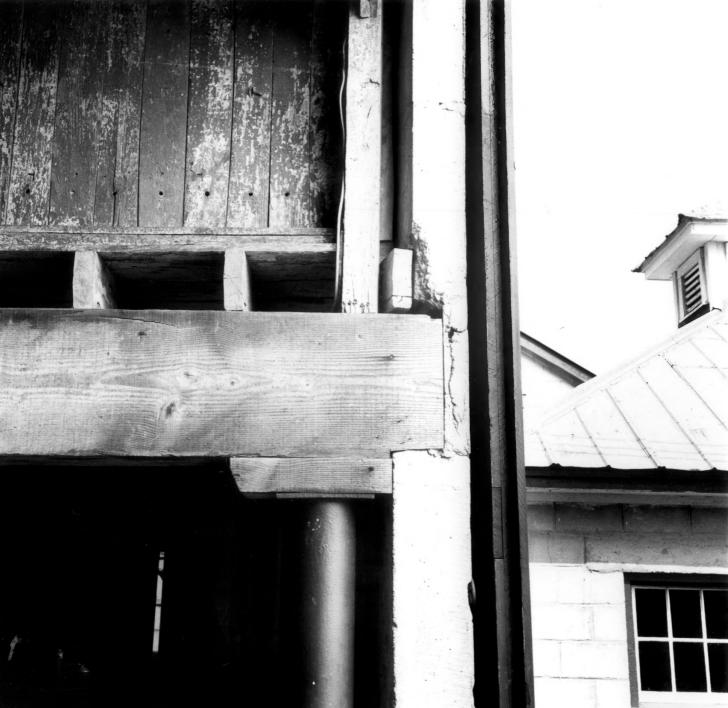
Photograph Number: #5

Description: Detail of junction of girder with cast concrete wall. Weight is supported principally by cast iron columns.

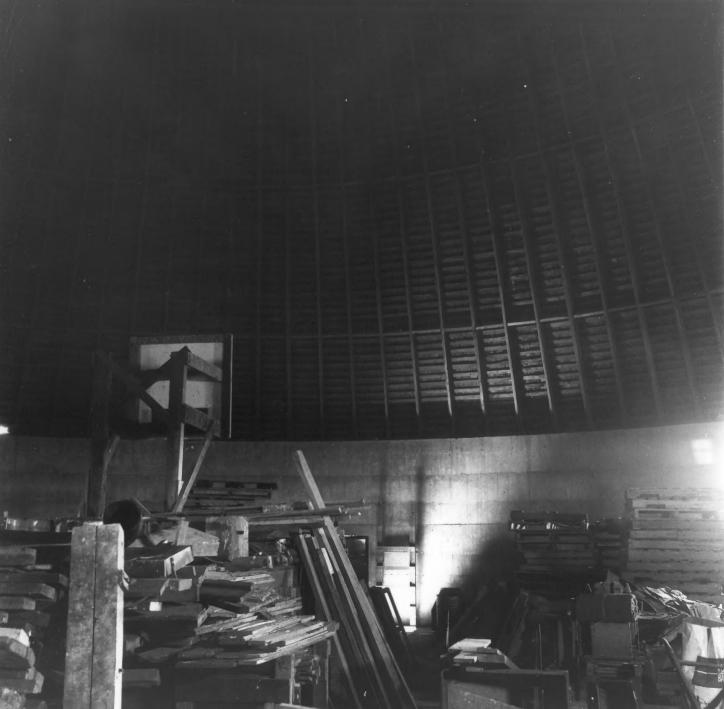
Photograph Number: #6

Description: Loft on 2nd story; illustrating manner in which the rafter system rests upon cast concrete walls.

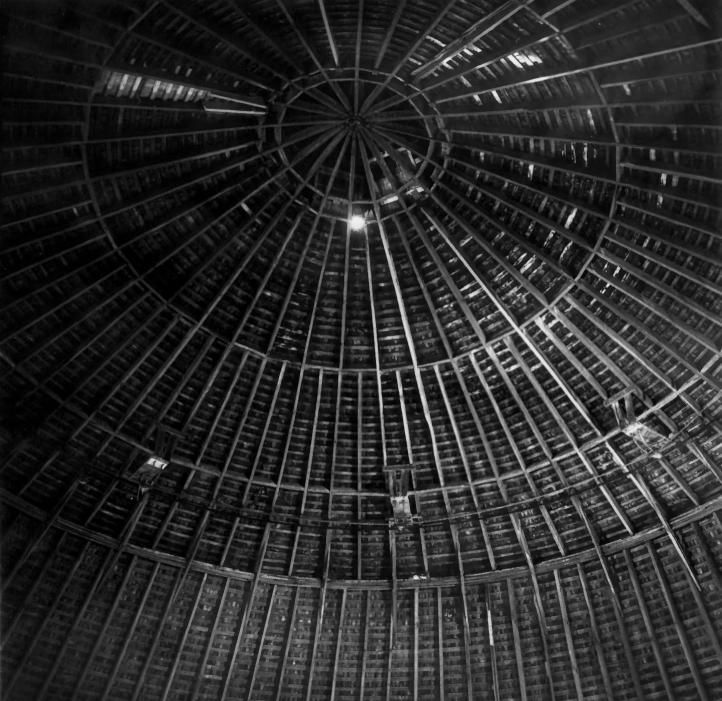
Photograph Number: #7

Description: The rafter system as viewed from the loft floor; the plate for the second roof pitch appears as the lowest arc.
