National Register of Historic Places
Registration Form

Historic name Soderman Building
Other names / site number Delvan's Drawing Room

Soderman Building
Gila County, Arizona

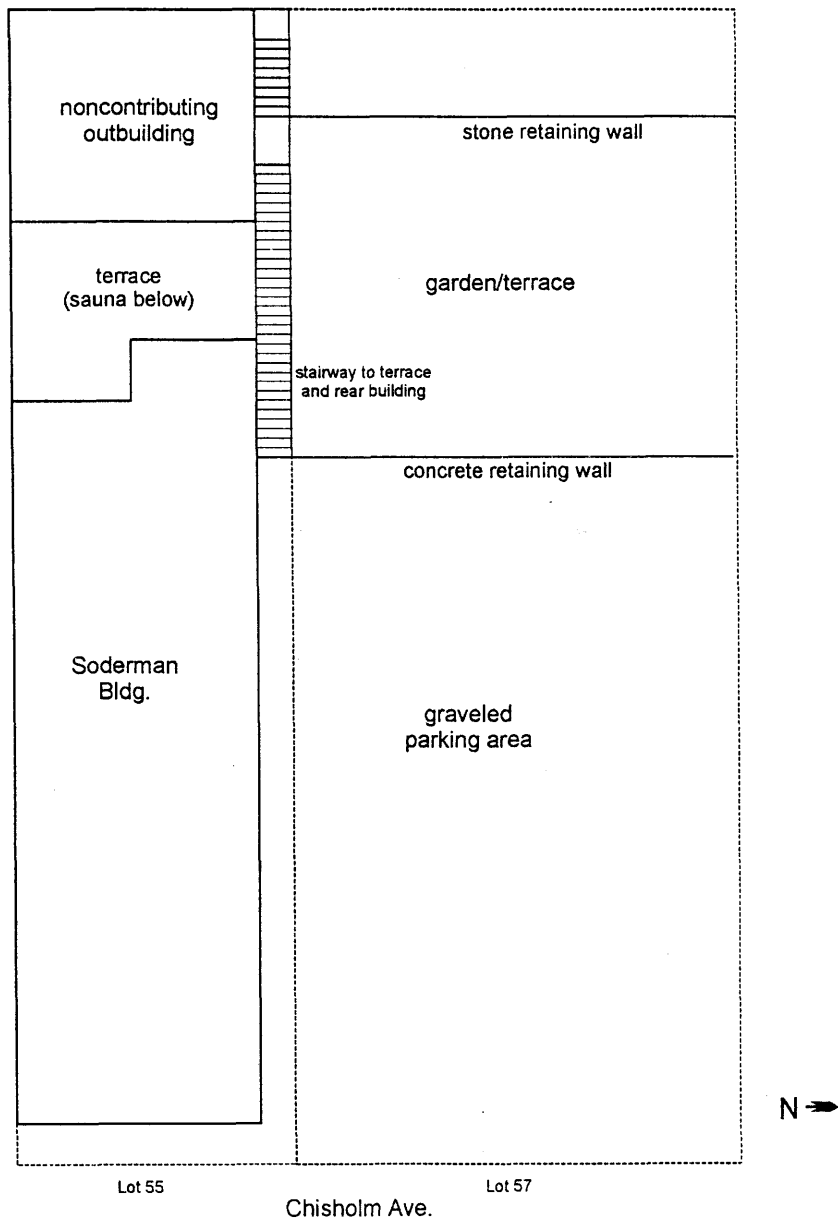
Site Plan, April 1999

The building, which is 25 feet wide and 75 feet long, fills most of its long, narrow lot. Like most commercial buildings from this era, it has no setback, so that the display windows and front entries abut the sidewalk. The rear of the lot is occupied by a two-story, reinforced concrete building erected several years before the Soderman Building. This outbuilding, which originally contained two apartments, has been remodeled and is considered a noncontributing building. To the left (south) of the Soderman Building is a one-story residence, with no sideyard between the two properties; on the right (north) is a vacant lot used by the Soderman Building's owner for off-street parking and as a garden and terrace.

The single rear entry is found at the second floor level and is reached by a concrete stairway adjacent to the north wall of the building. This stair leads to a concrete terrace connecting the rear of the Soderman Building with the front of the outbuilding. In fact, this terrace is the roof of a ground-level sauna and shower, access to which is possible only through an iron trap door set in the terrace floor. The terrace also provides access to the rear outbuilding, either through a ground-floor door that faces the Soderman Building, or a side door on the second floor that is reached by an extension of the exterior concrete stairway.

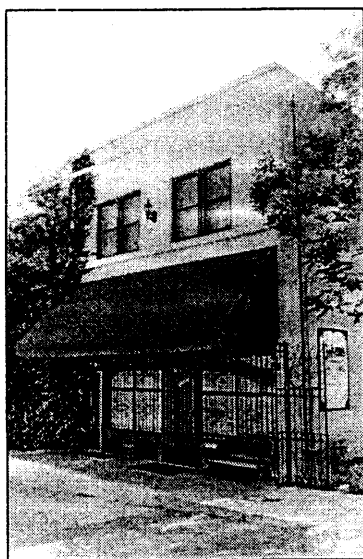
No. 2 : Front of house: east facade, looking southwest from
Chisholm

The facade of the Soderman Building, like all two-part commercial blocks, consists of a storefront with display windows on the first floor and standard-size windows on the second floor. The display windows, which have wood sash, flank a single entry door (panel-and-frame with two glass windows, plus an operable transom). Below the display windows are wood kickplates (panel-and-frame); above them is a row of fixed transom windows with wood sash. To the left of the display windows is a second entry door (also panel-and-frame with two glass windows and a fixed transom) that opens to a stairway leading to the upper floor. Above this entry, on a line with the fixed transom windows, is a two-light metal casement window. On the second floor there are two pairs of 1/1 wood double-hung windows, symmetrically arranged on the facade.

There is no permanent ornamentation on the facade of the Soderman Building except for two concrete copings, one on the parapet and one between the two stories. The current owner has added light fixtures (one between the second-floor windows, and one on each side of the display windows); a canvas awning that covers all of the ground-floor doors and windows, including the transoms; wrought-iron bars over the display windows; and metal security screens on the doors.

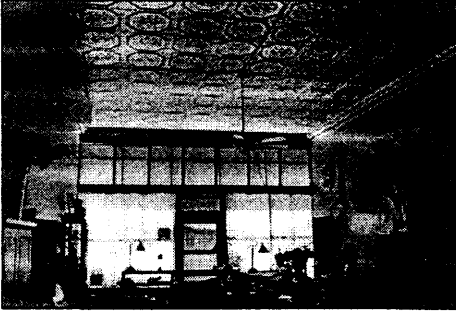
No. 3 : Interior view: from rear of first floor toward front windows, looking east

The main floor of the Soderman Building consists of a single room originally intended for use as a store. Whether it ever had a rear mezzanine (a common feature of similar commercial buildings in Miami) is unknown; none was in place when the current owner acquired the building. The distinguishing feature of this room, which has a concrete floor and no ornamental trim or woodwork, is the pressed tin ceiling, which is in excellent condition after restoration (including repairs using sections from a ceiling scavenged from another building) and refinishing with copper paint.

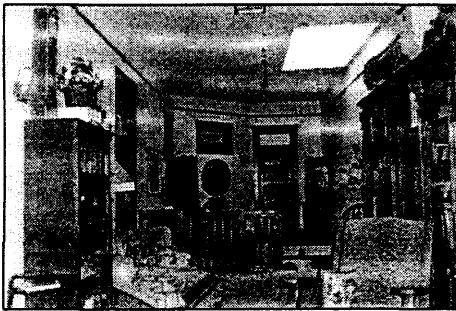
No. 5 : Interior view: from rear of second-floor hallway toward front, looking east (apartment visible at end of hallway)

Upstairs, most of the original woodwork (doors, baseboards, chair-rail molding, and stair balustrade) remains, as does an original skylight located over the stairway. As described below, several changes have been made to the upper floor's layout by the current owner. Originally the second floor contained nine rooms: six along the north wall, one in the southeast corner, and two in the southwest corner. Now it features three guest rooms and a bathroom along the north wall; a kitchen in the southwest corner; and a two-room apartment (with its own bathroom and kitchen facilities) on the front (east) end of the floor.

The most substantial changes have been made to the second floor. A front apartment was created out of three of the original rooms; it now includes a bedroom, bathroom and, as part of the living area, a compact kitchen. The rear room on the north wall was converted into a bathroom, and the rear room on the south wall was converted into a kitchen with a breakfast nook. Finally, one room on the south wall (adjacent to what is now the kitchen) was removed to expand the parlor area.

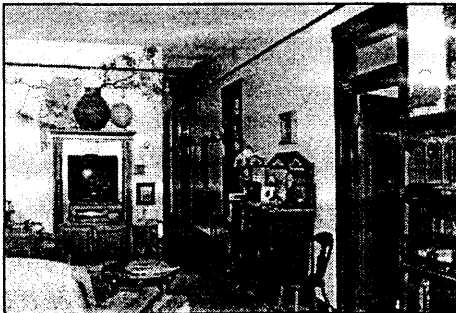
No. 6 : Interior view: from front of second-floor hallway toward rear, looking west

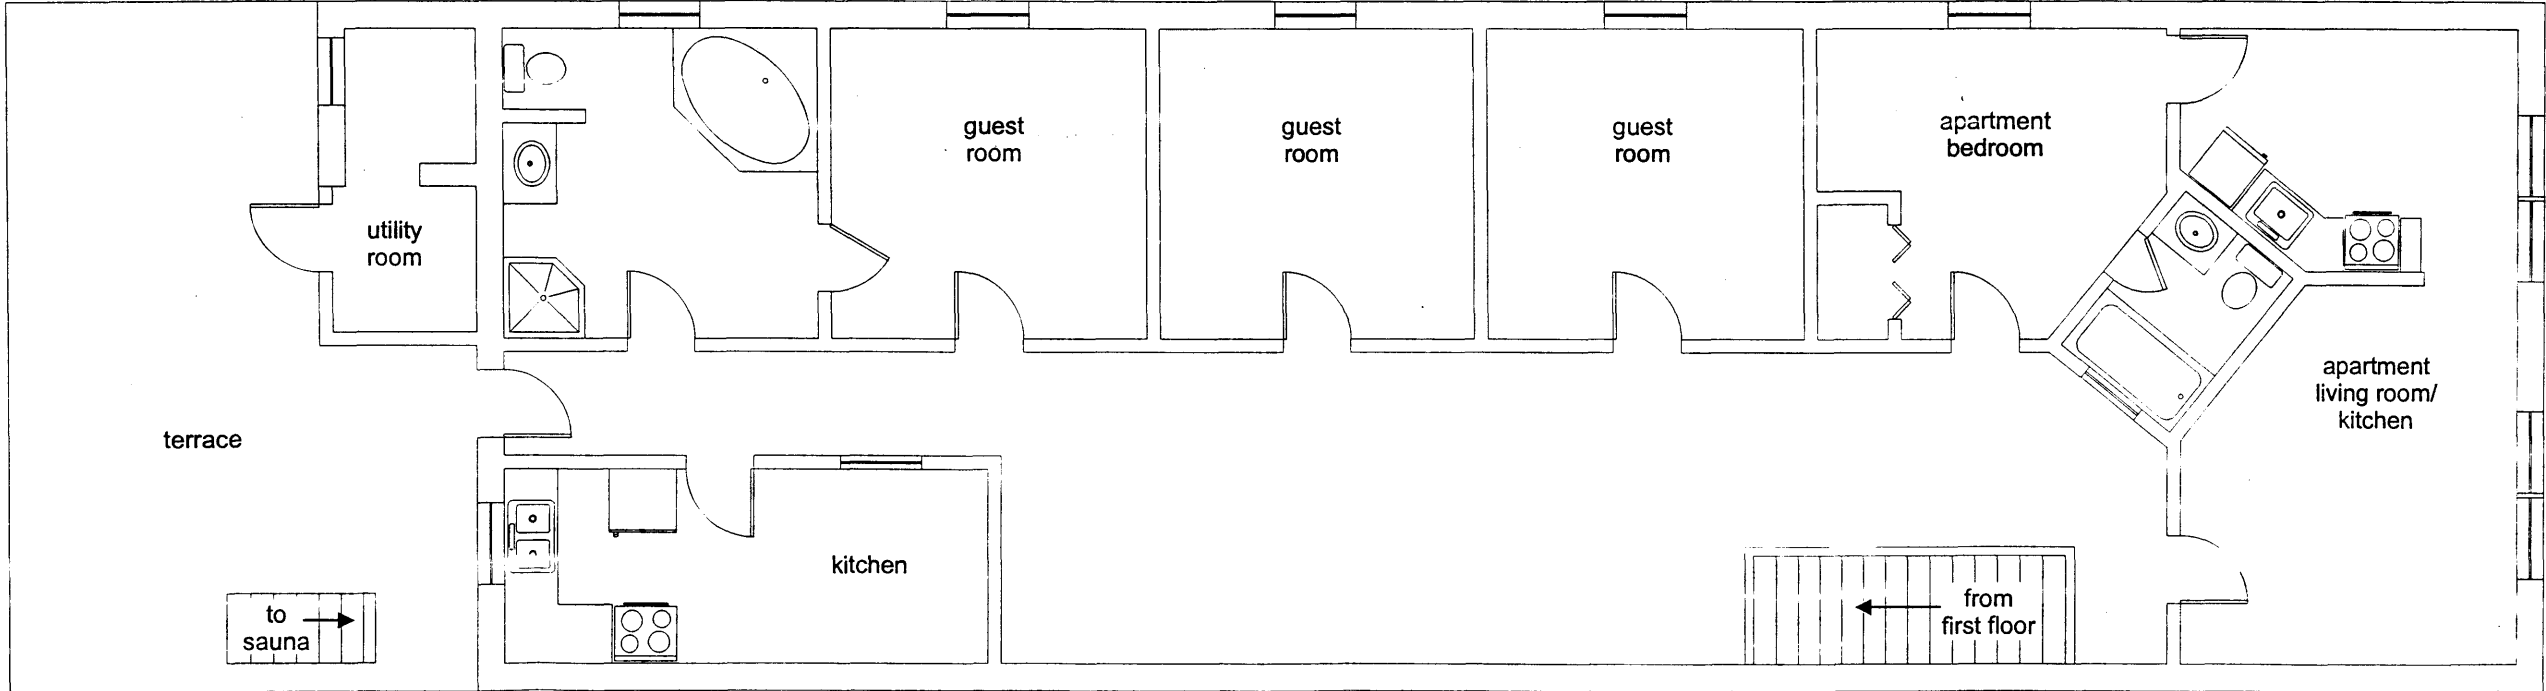
Soderman Building

2d floor
