KENTUCKY HISTORIC RESOURCES
Individual Inventory Form

Resource # 61
Shelby County

1. Name of Resource:
Thomas House

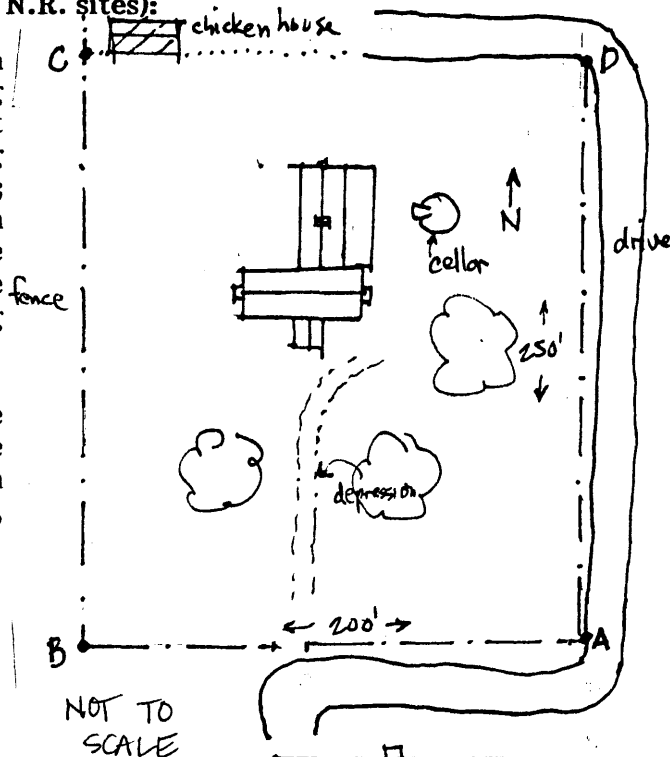
44. Site Plan (and boundary description and justification for N.R. sites):

Beginning at A, a point on the fence along the western edge of the drive at its intersection with a fence defining the southern extent of the yard (point A is 110 ft. east of the eastern edge of the walk), 200 ft. westward along said fence to its intersection with another fence (B); 250 ft. northward along fence to a point of intersection with a line extending from the southern edge of the drive (C); 200 ft. eastward along said line and edge of drive to the point of curve in drive (D); 250 ft. southward along fenceline at western edge of drive to point of origin.

The boundaries were chosen to encompass the house and domestic-related space as defined by fences on the south, east and west, and by a drive on the north. Within the area is a contributing cellar. Several sheds, a barn, and a tenant house are located outside the boundaries.

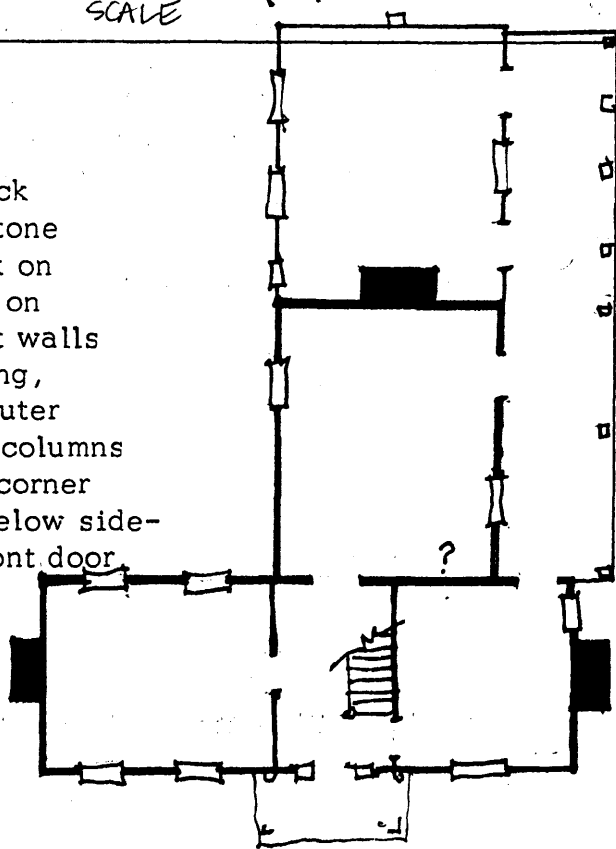
45. Description and House Plan:

2-story, 4-bay frame center-passage plan with brick nogging, exterior brick end chimneys, handsome stone foundation laid to resemble Flemish bond brickwork on the front, weatherboards covered with vinyl siding on front, east and west end walls, and north and west walls of original 1-story ell, box cornice with bed molding, original 1-story pedimented Greek Revival porch: outer columns replaced and railing missing, inner Doric columns are original, reeded door surround with bull's eye corner blocks and rectangular transom, panelled aprons below side-lights, original horizontal and vertical panelled front door, 6/6 sash original, original blinds, brick nogging exposed on rear wall, stone chimney with brick extension in ell, foundation of south room in ell is coursed rubble, that of north room is concrete, shed-roofed porch on east side of ell, cellar immediately to east of ell.
