Property Name: Case-Dvoor Farmstead

National Register of Historic Places
Registration Form

historic name Case-Dvoor Farmstead

street & number 111 Mine Street

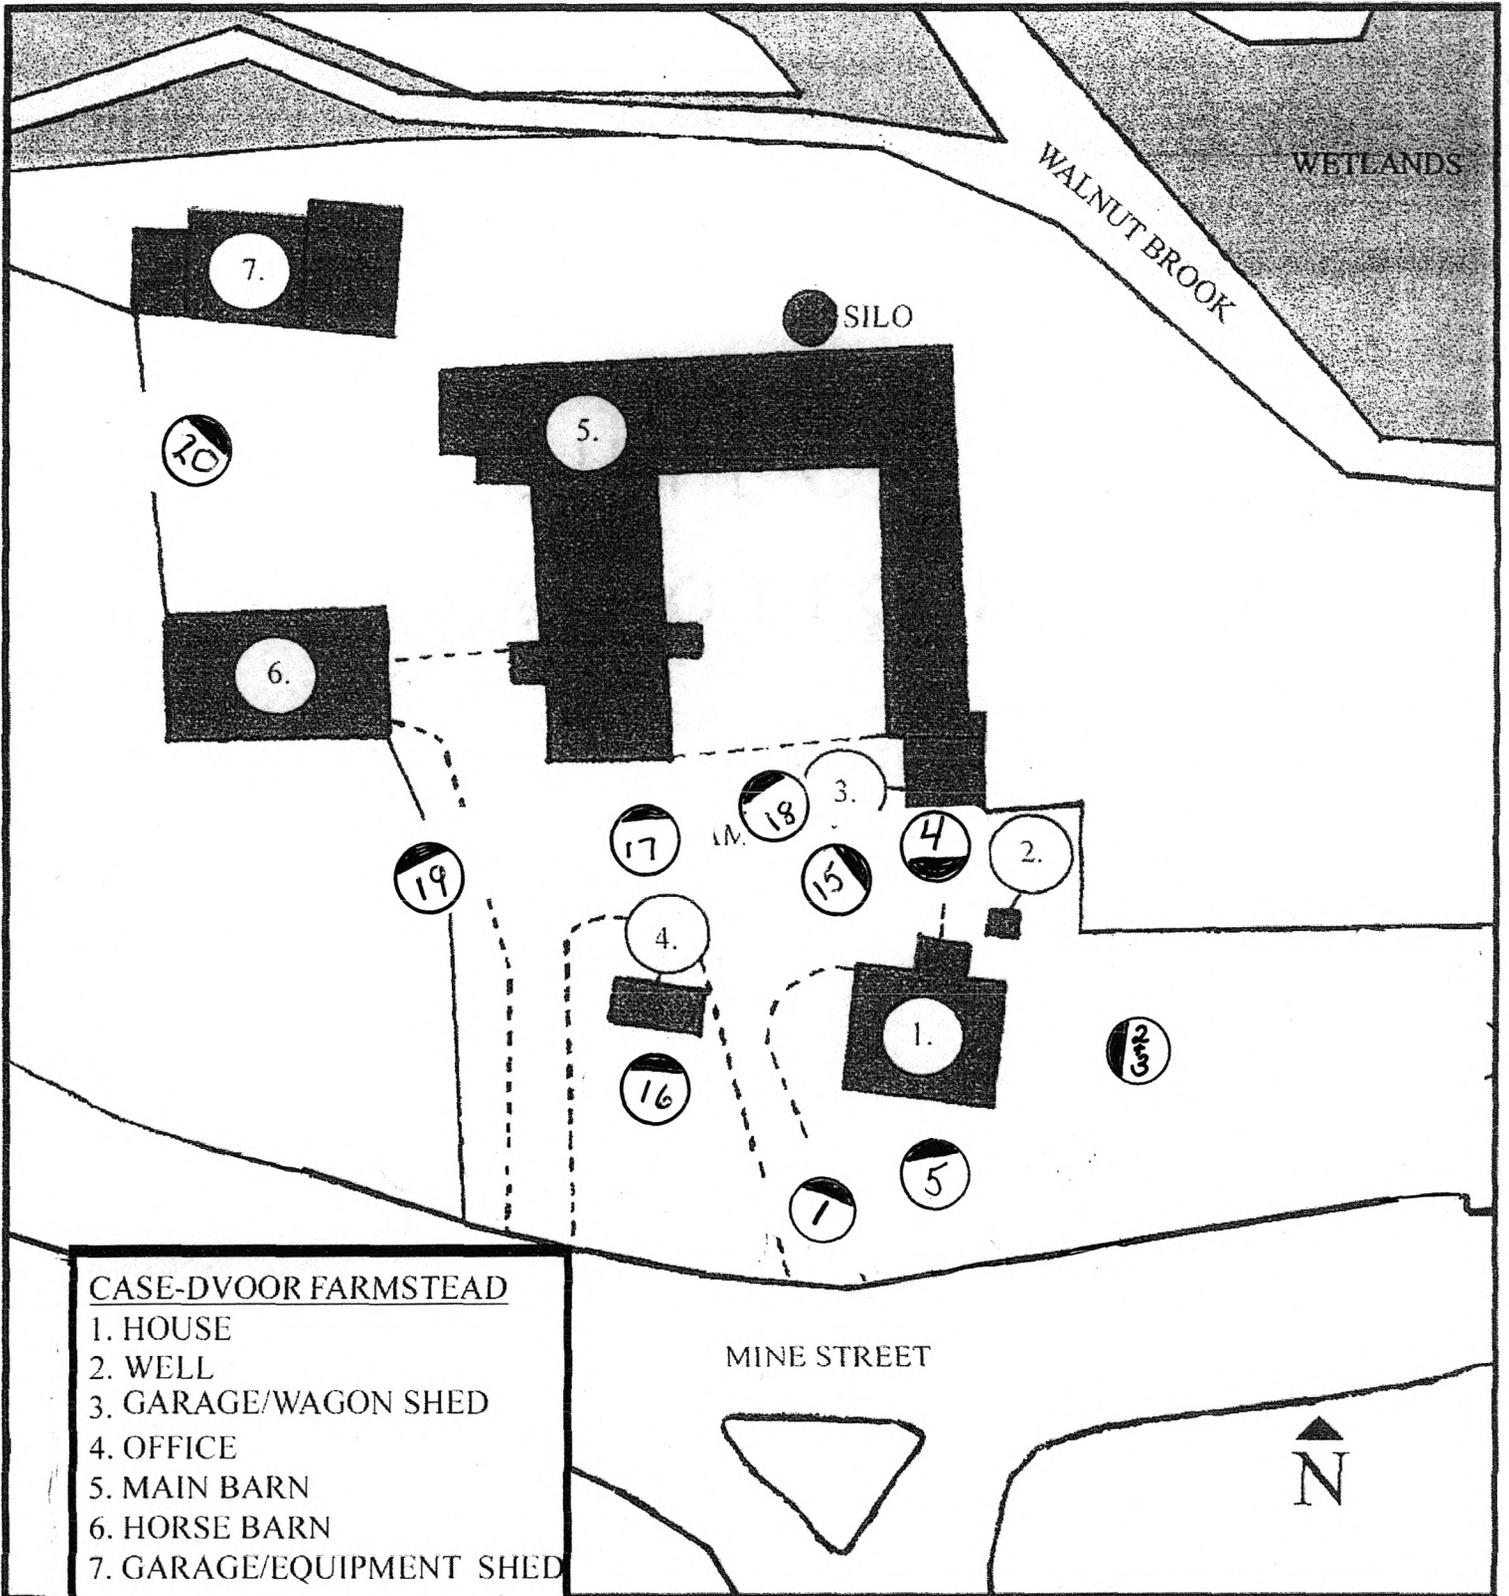
CASE-DVOOR FARMSTEAD

- 1. HOUSE
- 2. WELL
- 3. GARAGE/WAGON SHED
- 4. OFFICE
- 5. MAIN BARN
- 6. HORSE BARN
- 7. GARAGE/EQUIPMENT SHED

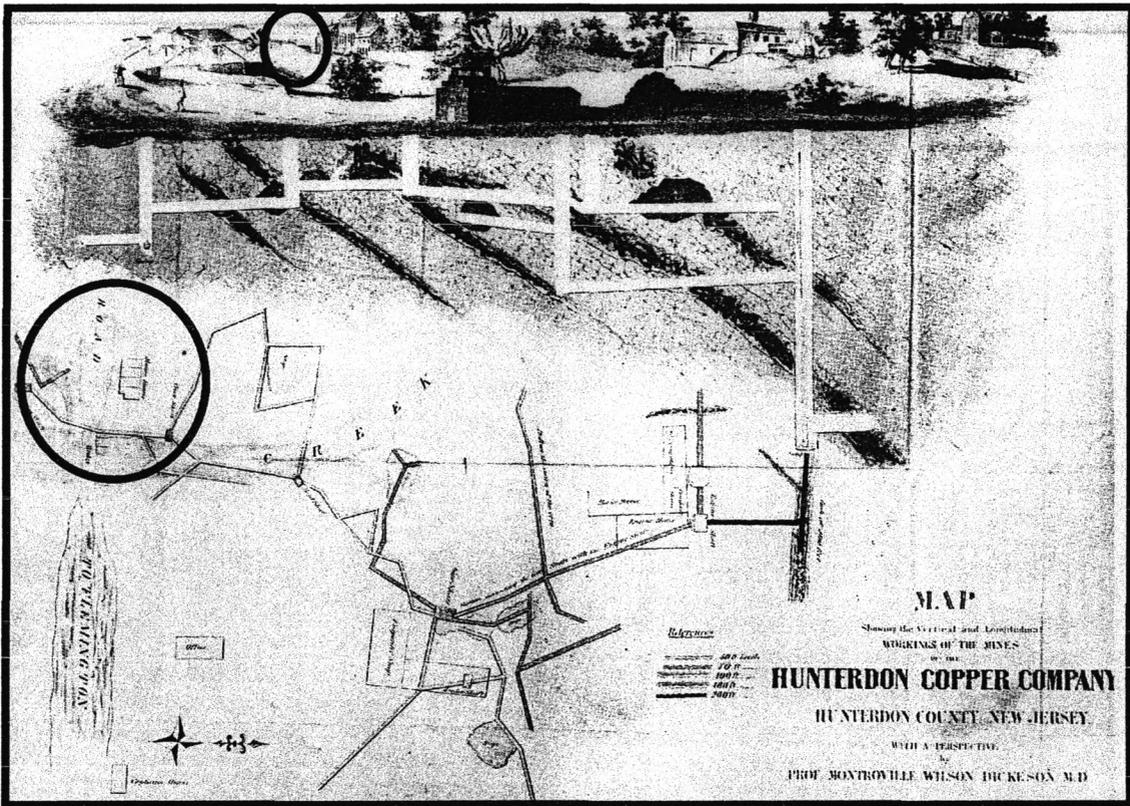
Figure 2. An 1859 map showing the vertical and longitudinal workings of the mines of the Hunterdon Copper Co.. The Case-Dvoor Farmstead is circled. (Original at the Hunterdon County Historical Society)

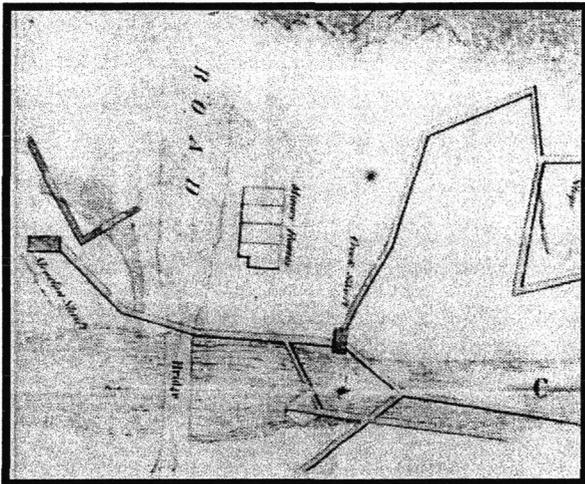
Figure 3. Details of 1859 map showing the Case-Dvoor Farmstead. Note front porch which has been removed. (Original at the Hunterdon County Historical Society)

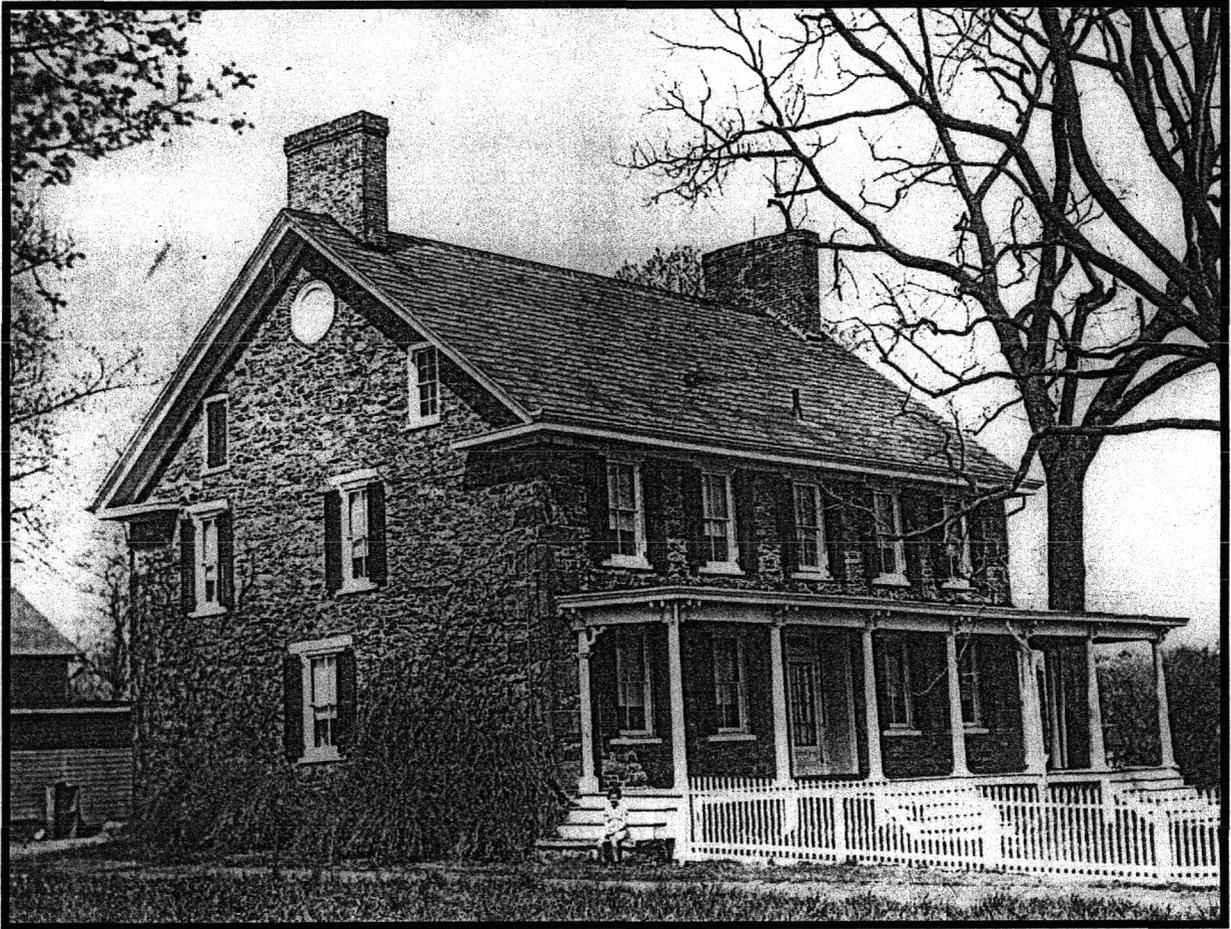
Figure 6. Case-Dvoor Farmstead, northeast view, c. 1930. The 19th century porch retains its original bracketed box cornice and attached rear post. The Tuscan columns are early 20th century replacements. Collection of Herbert Dvoor.

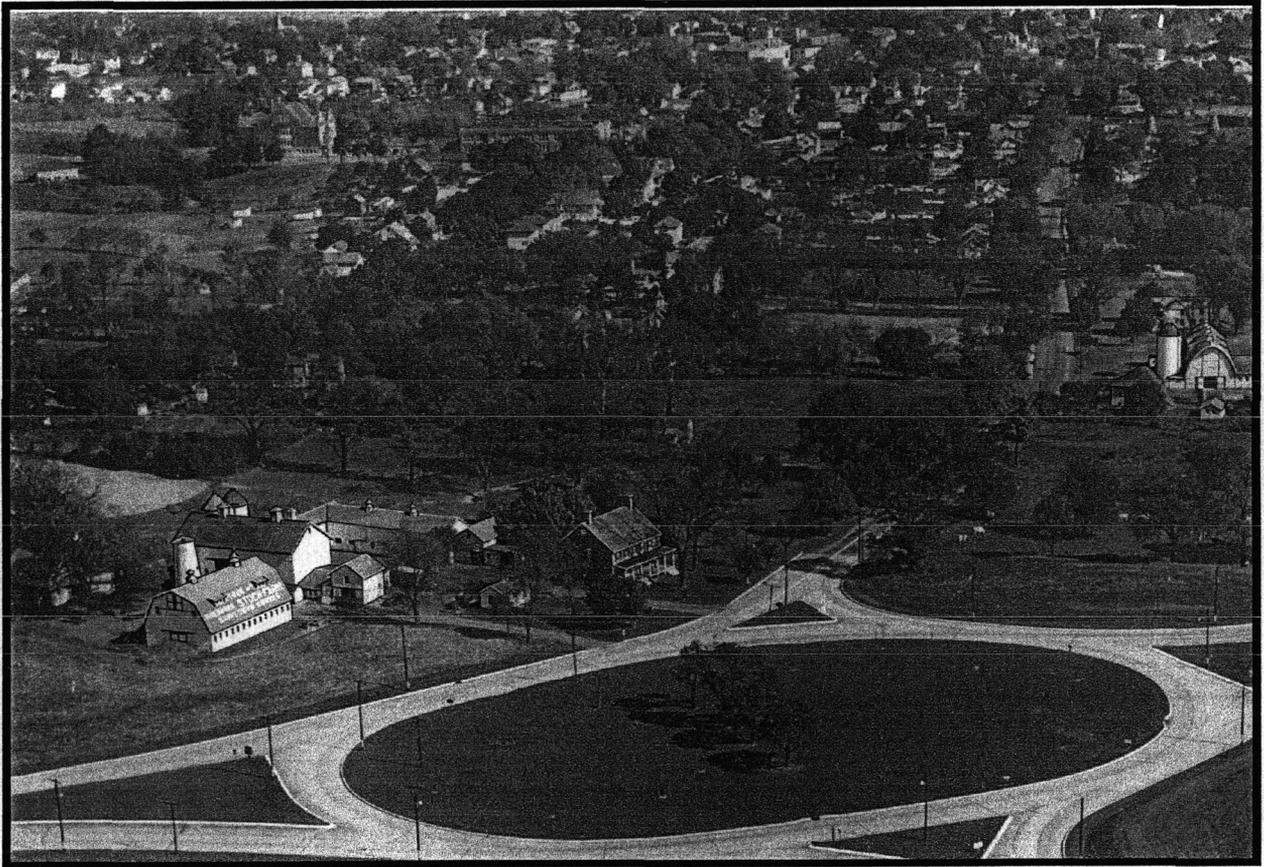
Figure 7. Case-Dvoor Farmstead, late 1930's, northeast view. The wooden silo, visible in Figure 5 between the barn and behind the gambrel-roofed horse barn has not survived. The wagon house, now forming the east end of the equipment shed, is hidden by the trees to the left of the barn. The wagon house behind the main house now serving as a garage, has gable end entries and shed appendage, The picket fence has been removed from the front of the house possibly in conjunction with the construction of the circle. Collection of Herbert Dvoor

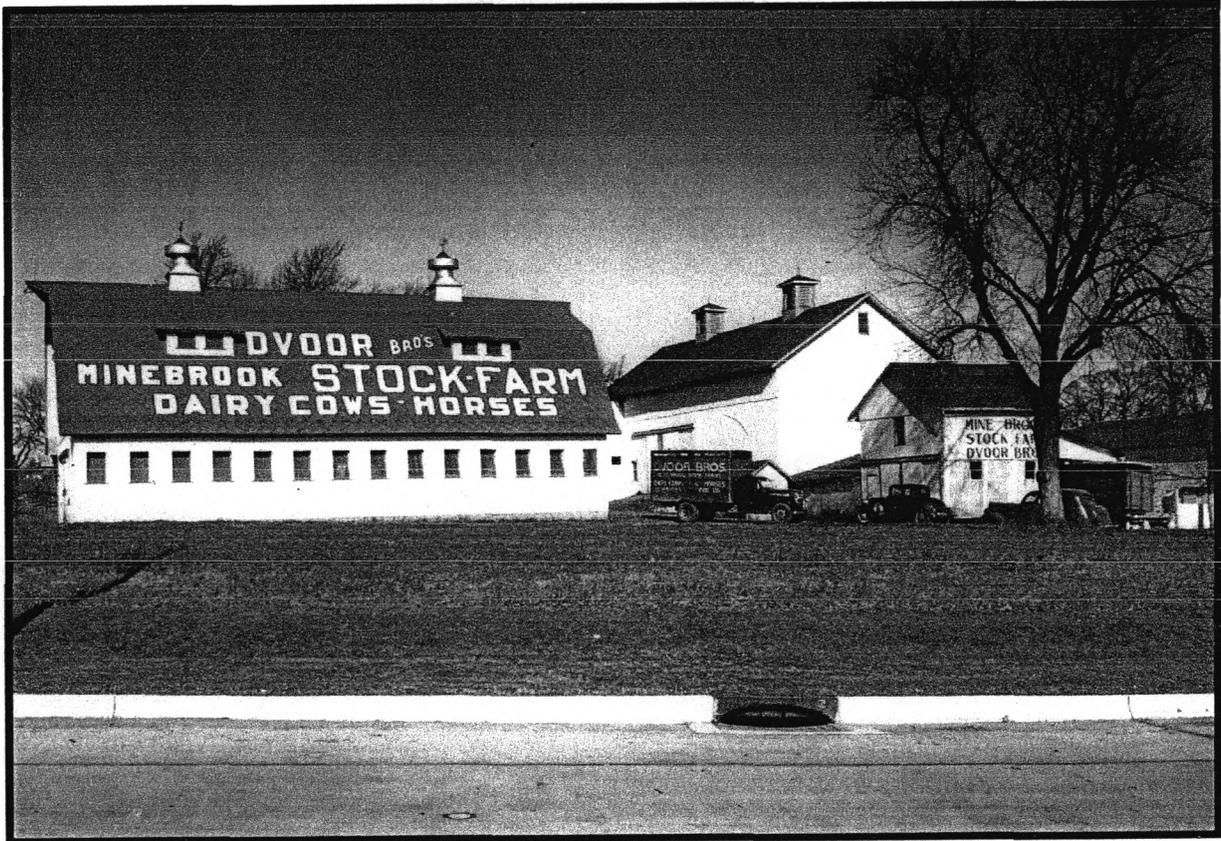
Figure 8. Case-Dvoor Barns, northeast view, c. 1930's, The wagon house adjoining the bank barn, now forms the west end of the equipment shed behind the horse barn on the left. Collection of Herbert Dvoor.

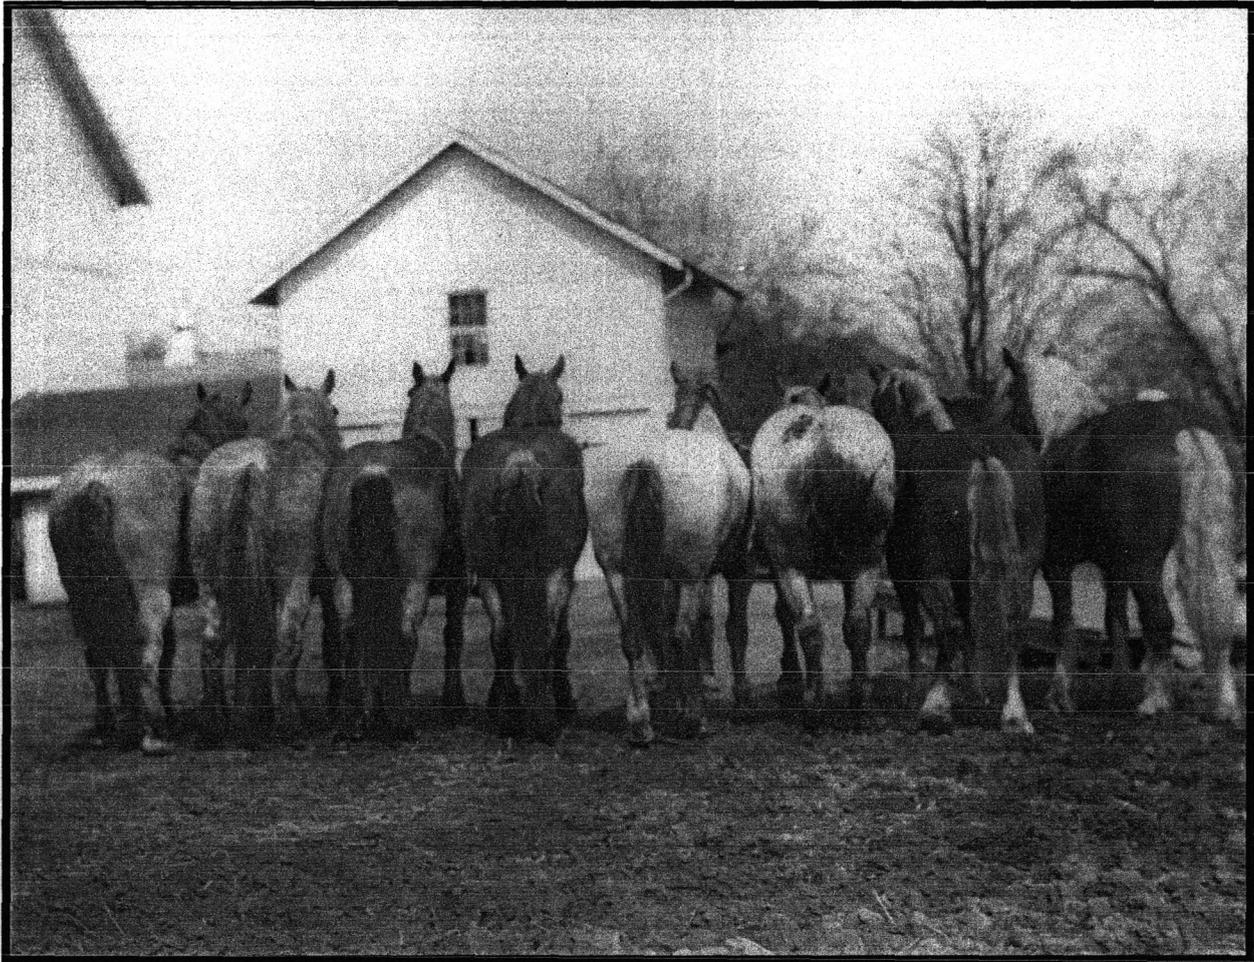
Figure 9. Case-Dvoor Farmstead, c. 1930's, northeast view, towards wagon house formerly at the south end of the bank bam. Draft horses formed a major part of the Dvoor's business until about World War II when tractors came into widespread use on area farms. Collection of Herbert Dvoor.

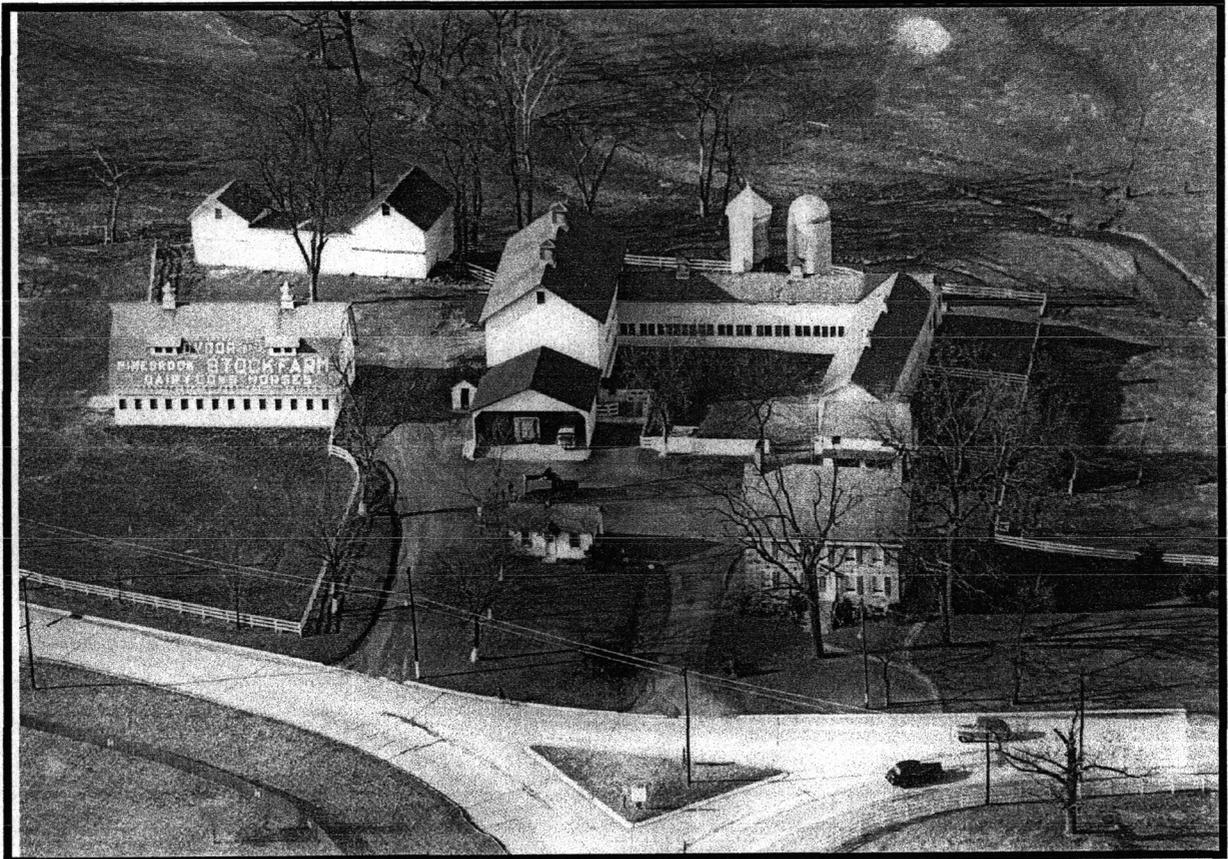
Figure 10. Case-Dvoor Farmstead, c. 1950's, north view. By this time the dwelling's front porch has been removed.

times after the traffic circle was built, but before the 1950s photographs were taken (figures 10 & 11), and judging from double glass and panel door of the paired garage entries, probably before World War II. It has a stone foundation, overhanging eaves with exposed rafter ends, clapboard siding, multi-pane sash windows, and a batten second-story door on the west gable end, as well as a small pent roof above the garage doors that is probably contemporary with them and a small rear shed appendage. The roof treatment with exposed rafter ends may well be contemporary with the garage conversion. The first-story interior is sheathed with tongue-and-groove boards. The asphalt shingle roofing is modern. Photo #15.

Historic photographs suggest that wire fencing enclosed the pastures and fields before the construction of the traffic circle and that white horizontal-board fencing was installed after World War II (figures 5 & 10). Several types of fencing are now present. The horizontal board fencing enclosing the south side of the barnyard may survive from the post-World War II work. The split-rail fence along the property's road frontage presumably is a more recent replacement, as is the wood-post and wiring fencing enclosing the pastures east and west of the farmstead. The metal gates are recent replacements.

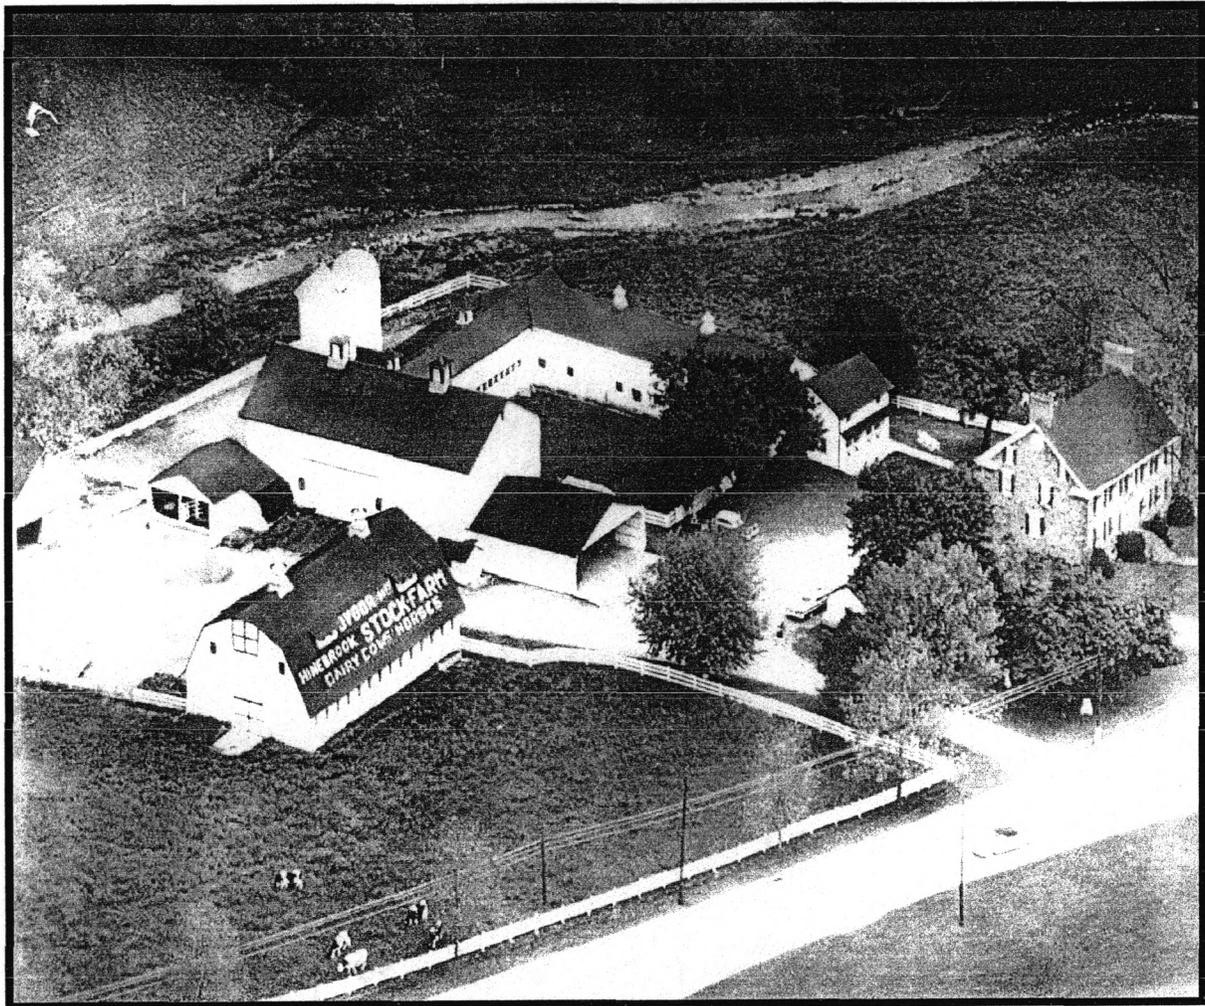
Figure 11. Case-Dvoor Farmstead, c. 1950's, northeast view. Post World War II changes included remodeling the wagon house, moving two wagon houses back to form the equipment shed behind the horse barn, the addition of the cattle chute to the bank barn, as well as the installation of the white board fencing. Collection of Herbert Dvoor.

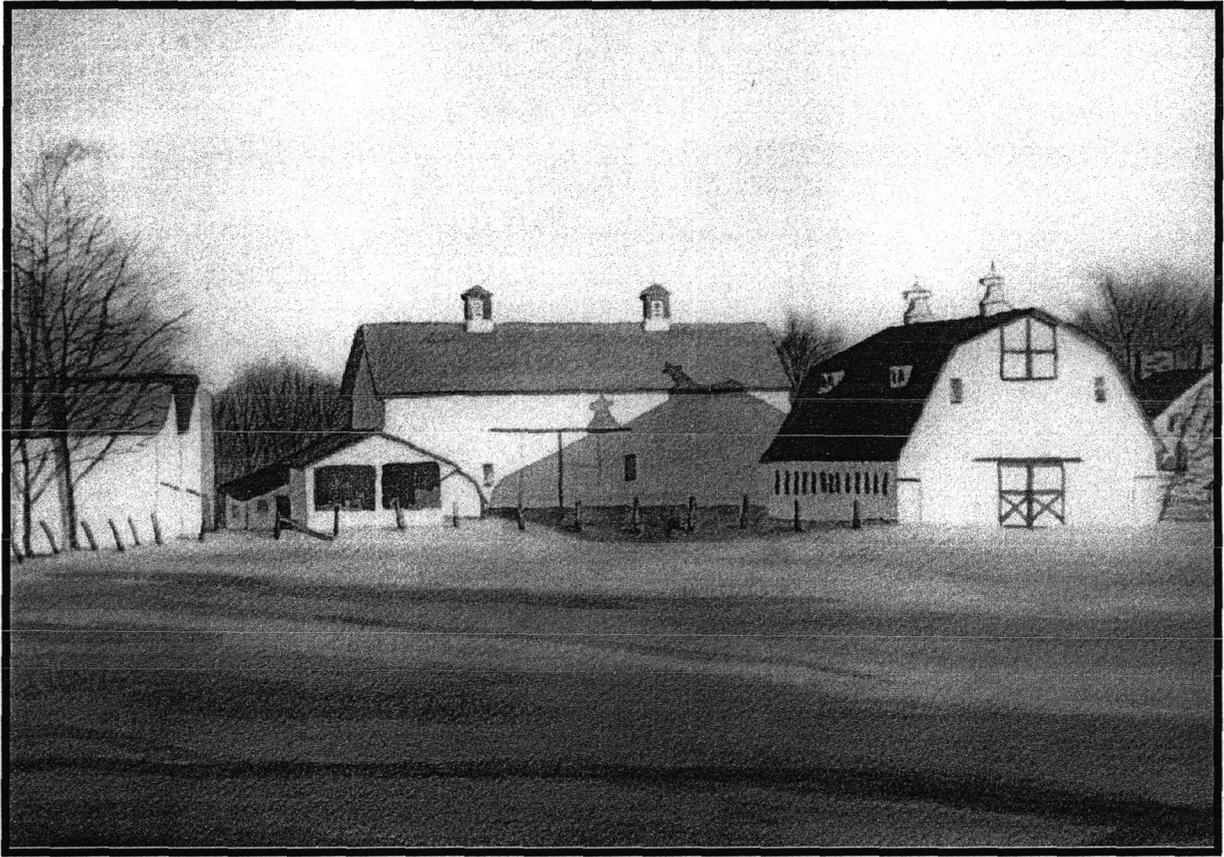
Figure 14. A view of the barns on the Case-Dvoor Farmstead. Watercolor by Bill Anderson, late 1990's. Collection of Herbert Dvoor.
