NATIONAL REGISTER OF HISTORIC PLACES
CONTINUATION SHEET

historic name Ostrander Lake Ski Hut

other names/site number Ostrander Ski Hut, Ostrander Hut, Yosemite National Park Building No. 5110

OTHER: National Park Service Rustic style

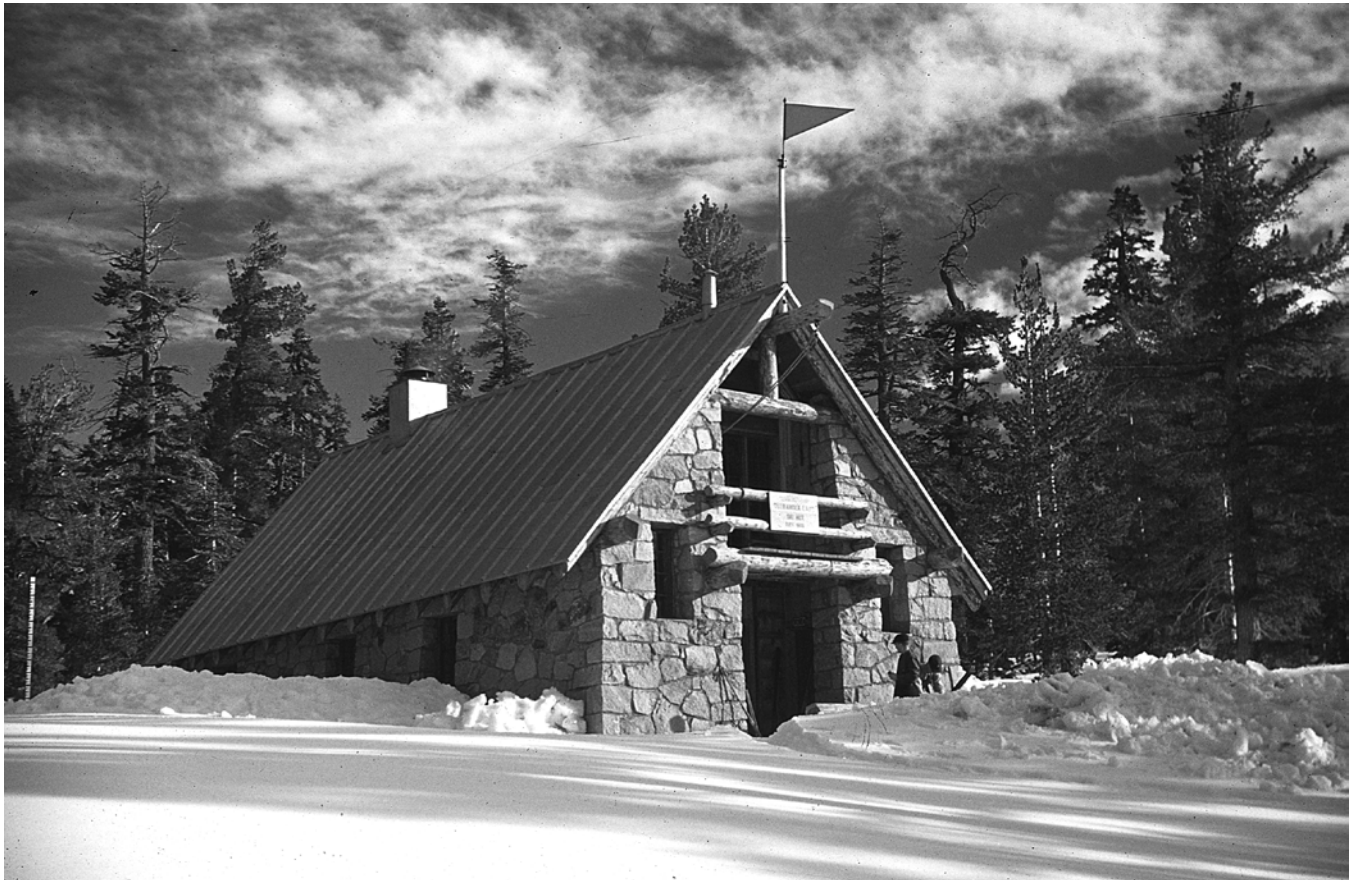
Historic Photo #1. Ostrander Lake Ski Hut, 1941. Photographer unknown.

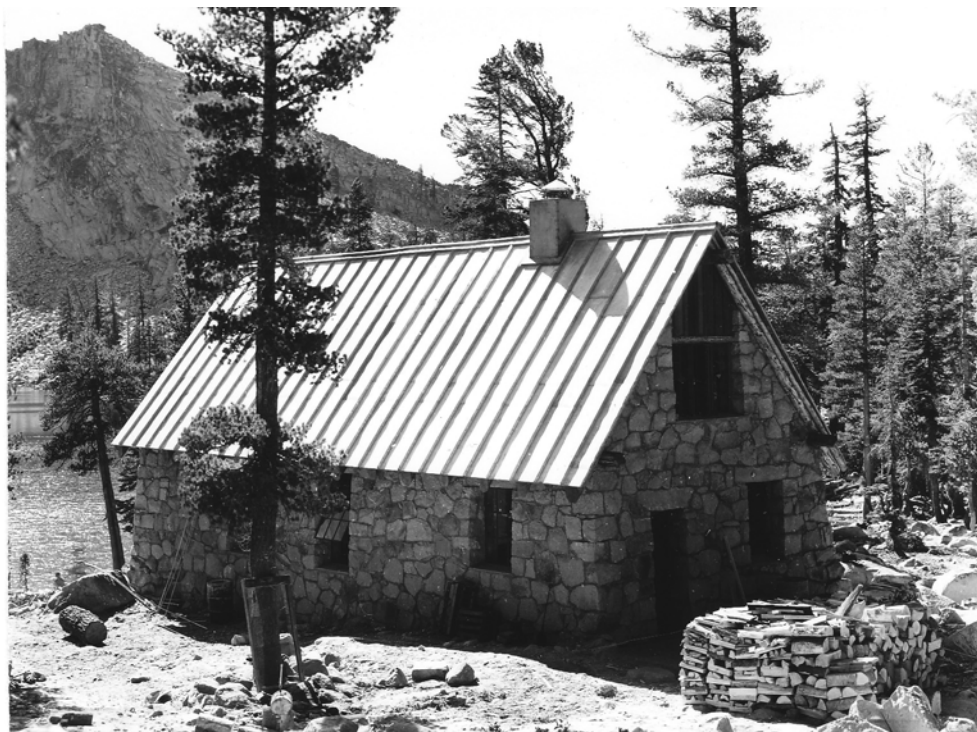
Historic Photo #2. Ostrander Lake Ski Hut under construction, 1940. Camera facing southwest. Horse Ridge is visible in the background. Photographer unknown. Location of original photo: Yosemite National Park, Division of Facilities Management Building File. El Portal, CA
