KENTUCKY HISTORIC RESOURCES
Individual Inventory Form

Resource # 100
Shelby County

1. Name of Resource: Wise House		16. Date: Original Building 1861-65 [6] Addition ca. 1900 [4]	
2. Original Owner: John Wise		17. Style: Vernacular [3V] []

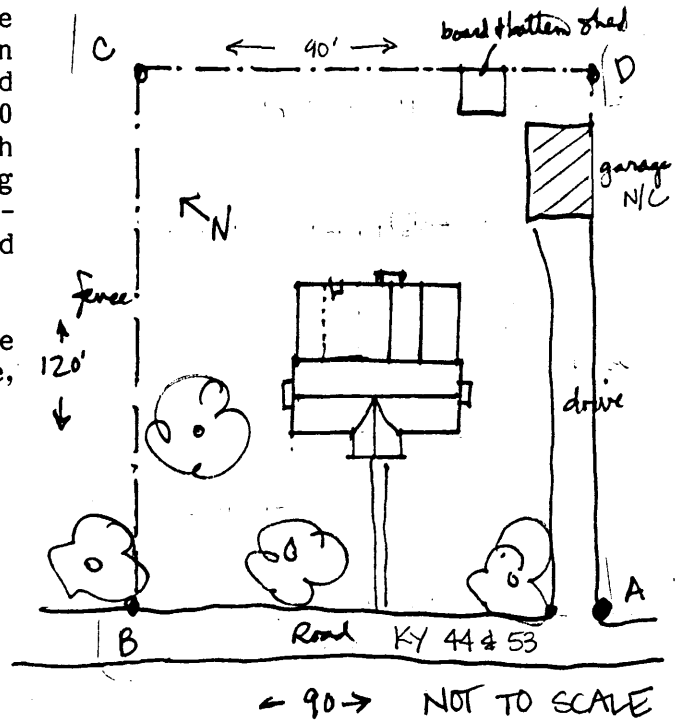
44. Site Plan (and boundary description and justification for N.R. sites):

Beginning at Point A, which is the intersection of the southeastern edge of the drive with the northeastern edge of KY 44 and 53, northwestward 90 feet along said edge of road to intersection with a fence (B); then 120 feet northeastward along fence to its intersection with another fence (C); then 90 feet southeastward along fence to its intersection with a line extended from southeastern edge of drive (D); then 120 feet southwestward along said line and edge of drive to point of origin.

The boundaries were chosen to encompass the house and its domestic space as defined by fences, the drive, and the road.

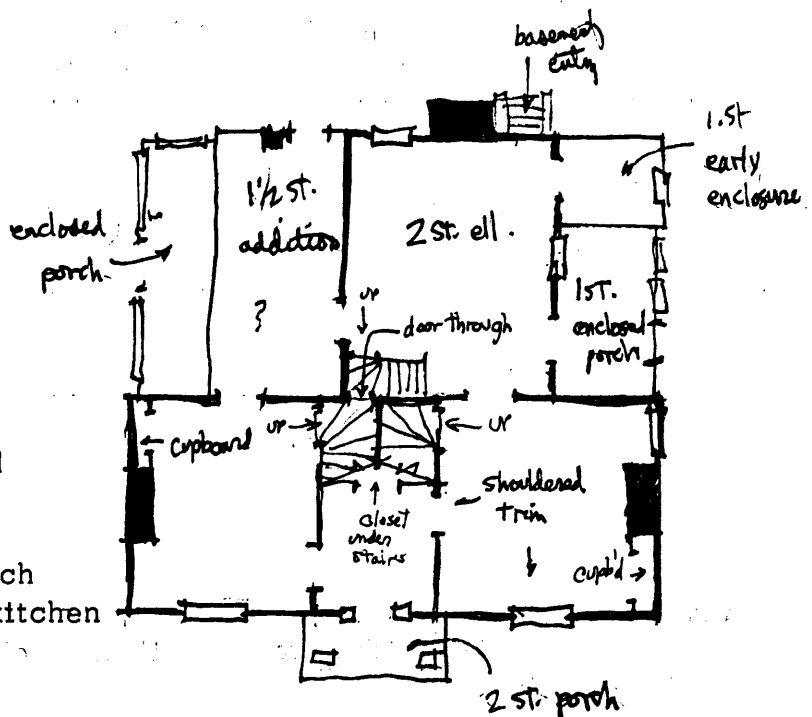
45. Description and House Plan:

2-story, 3-bay, frame, center-passage, single-pile plan, plain weatherboards, gabled, standing seam metal roof, partially exterior brick end chimneys, 1 1/2-story, frame offset ell, original, 2-story, pedimented Greek Revival portico, balcony at second floor, door flanked by engaged square posts and sidelights with panelled aprons, transom, shallow eared surround frames entire opening, same treatment on second floor, deep frieze board at cornice, corner pilasters, cornices over first floor windows, 6/6 sash, deep cornice returns on gable ends, enclosed 1-story porch and room on south side of ell, 1 1/2-story kitchen addition on north side of ell, exterior brick

chimney on east end of ell.

Greek Revival trim and mantels, cornices over windows and panelled aprons beneath, Greek Revival pilaster and shelf mantels, cupboards built into end walls, medium low molded baseboards, 4-panel Greek Revival doors, enclosed corner stairs back to back (no connection) at east end of passage open into north and south rooms rather than an open stair to second floor in passage, enclosed stair in northwest corner of ell opens onto stair form north room.

unusual for the county in that rather than an open flight of stairs to the second floor in the passage, enclosed corner stairs from both the north and south rooms rise at the rear of the passage. This is the only known example of this plan variation in the county. Changes and additions do not affect integrity of the significant elements of the site.
