**NATIONAL REGISTER OF HISTORIC PLACES
REGISTRATION FORM**

historic name Darlington Schoolhouse
other names/site number Havemeyer Hall

Darlington Schoolhouse
Bergen County, New Jersey
Description

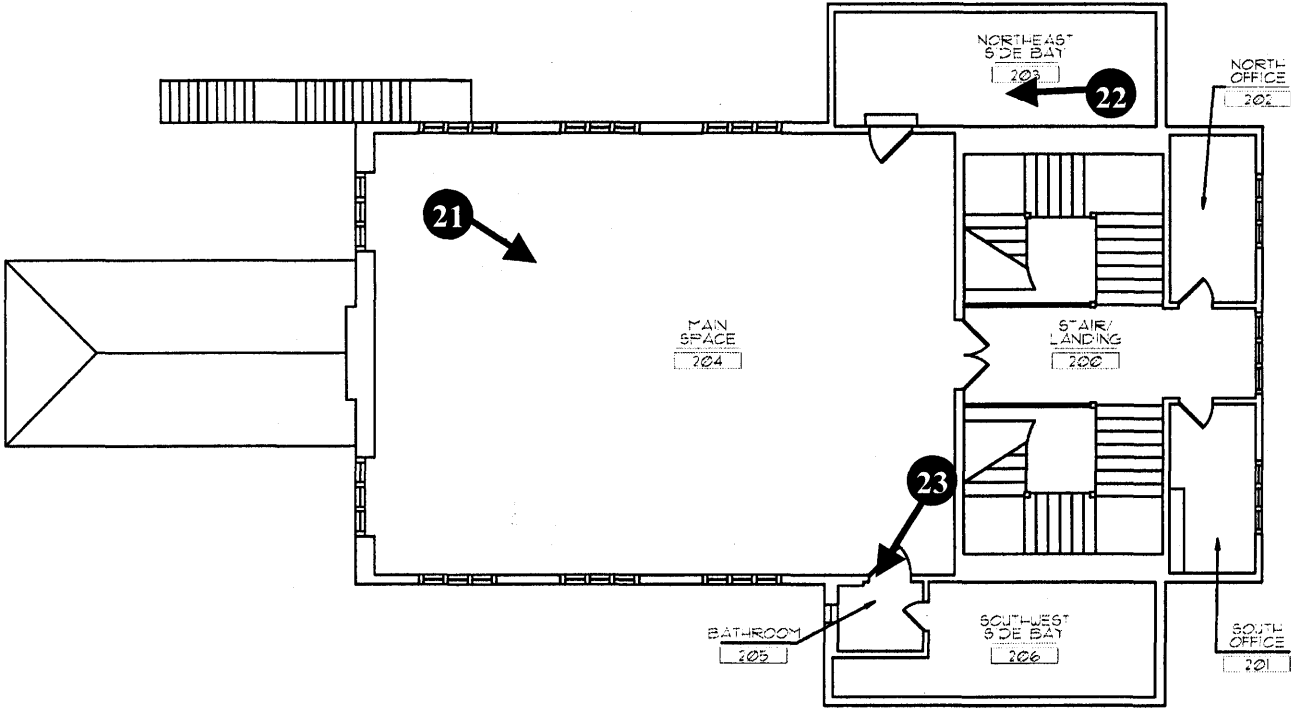
A1 SECOND FLOOR PLAN

Key to 2nd Floor Photographs

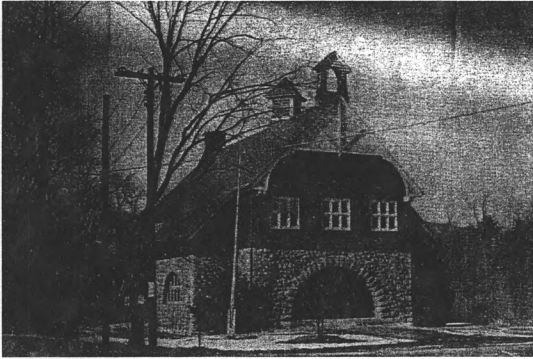
Photo of Darlington Schoolhouse in Bischoff's *From Pioneer Settlement to Suburb*, 146 (book published in 1979).

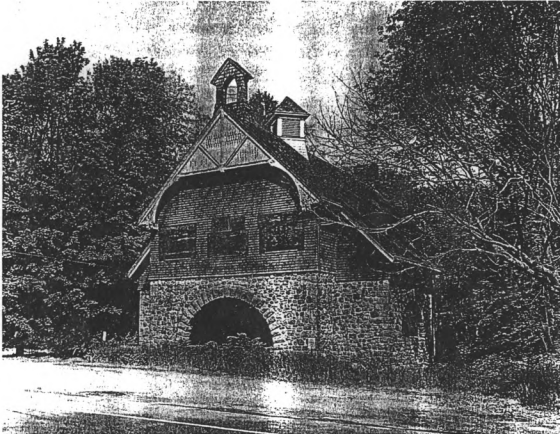
Photo of Darlington Schoolhouse in *The Architecture of Bergen County, New Jersey*, by Brown and Warmflash, 153 (book published in 2001).

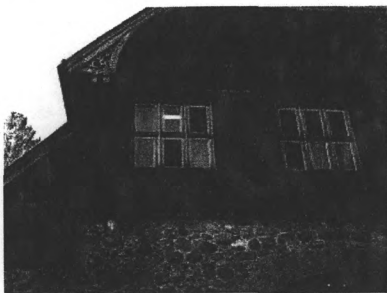
Detail, southeast elevation. Undated photo from www.abandonedbutnotforgotten.com, illustrating windows prior to being covered with plywood.

The façade of the building presents three bays in the main section of the building and an additional bay on each side recessed behind the entry porch. **(Photo 2)** The entry porch is marked by a rounded Syrian arch, with large red sandstone rusticated voussoirs of alternating heights. **(Photo 3)** The building's entry (currently covered in plywood) has double wood, glazed doors with wood, glazed sidelights and a wood threshold. Both doors and sidelights are cased within a rounded-arch wood surround that mirrors the porch's stone arch. There are decorative wood panels below the sidelight windows. The entry porch has a red clay tile floor with granite front steps and edging block at tile. The walls are painted wood shingles, and the ceiling is tongue and groove board to fit the curve of the arch. There are built-in, painted wood benches at either side of the porch. Each bench has a pierced wood element in its base. **(Photo 4)** Windows and gable have painted wood trim, and the gable features a decorative Stick-style truss with a chamfered king post bisecting the base of the truss, diagonal struts, and pierced wood inserts. **(Photo 5)** Additional decorative wood elements attached to the base of the truss include two half arches with pierced wood inserts and two pairs of corbelled brackets. There are three windows on the second story, but they are covered in plywood and details are not visible from the exterior. There is one metal louver at both of the side bays at the upper part of the first level.
