NATIONAL REGISTER OF HISTORIC PLACES
INVENTORY -- NOMINATION FORMSEE INSTRUCTIONS IN HOW TO COMPLETE NATIONAL REGISTER FORMS
TYPE ALL ENTRIES -- COMPLETE APPLICABLE SECTIONS

Ragland House

1617 Center

Little Rock,

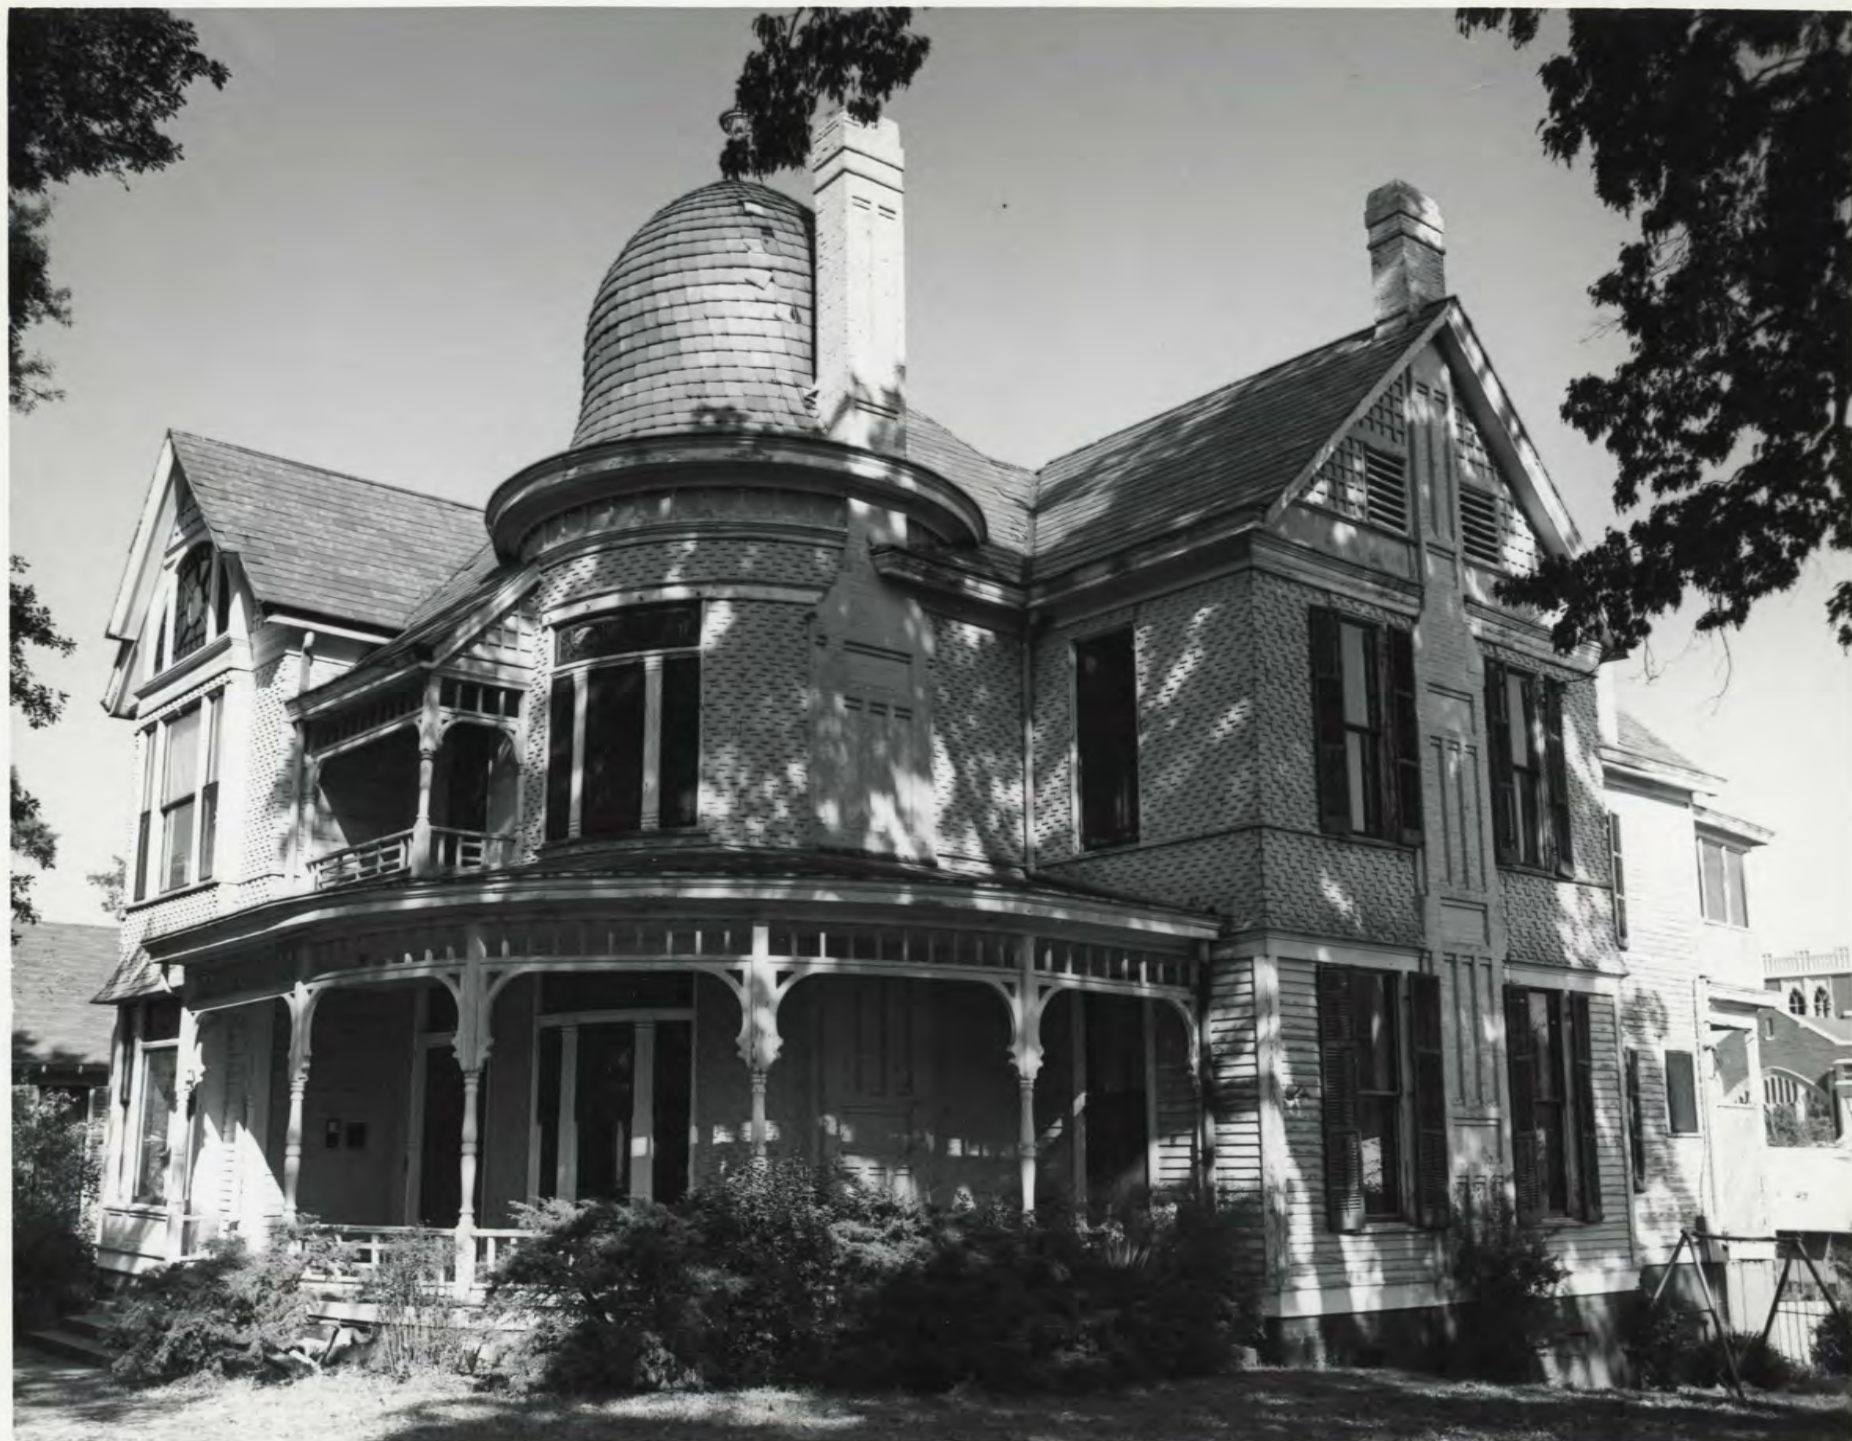
1. RAGLAND HOUSE
PULASKI COUNTY, ARKANSAS
FACADE, VIEWED FROM THE SOUTHWEST
DOE 6-17-77

Facade, viewed from the southwest

The facade (west elevation) of the Ragland House features a gable end on the north end covered in waffle patterned stickwork surrounding a large semi-circular window of leaded stained glass in geometric patterns. A wide double-hung window flanked on either side by narrow double-hung windows are found at the second story level under the gable end. At the first floor level is a wide single light window topped by a stained glass horizontal transom. Narrow double-hung windows flank either side of this window. Below these windows is a narrow horizontal center section of vertical flushboard flanked by small sections of diagonal flushboard. The gable and the first and second story windows are found in a slightly projected bay.

A one-story portico beginning in the center of the facade circles around the southwest corner to the south elevation. This portico is supported by delicately turned posts with decorative brackets. Beneath the cornice of the portico runs a band of small square balluster-like posts. A railing with square vertical and horizontal balusters runs around the porch.

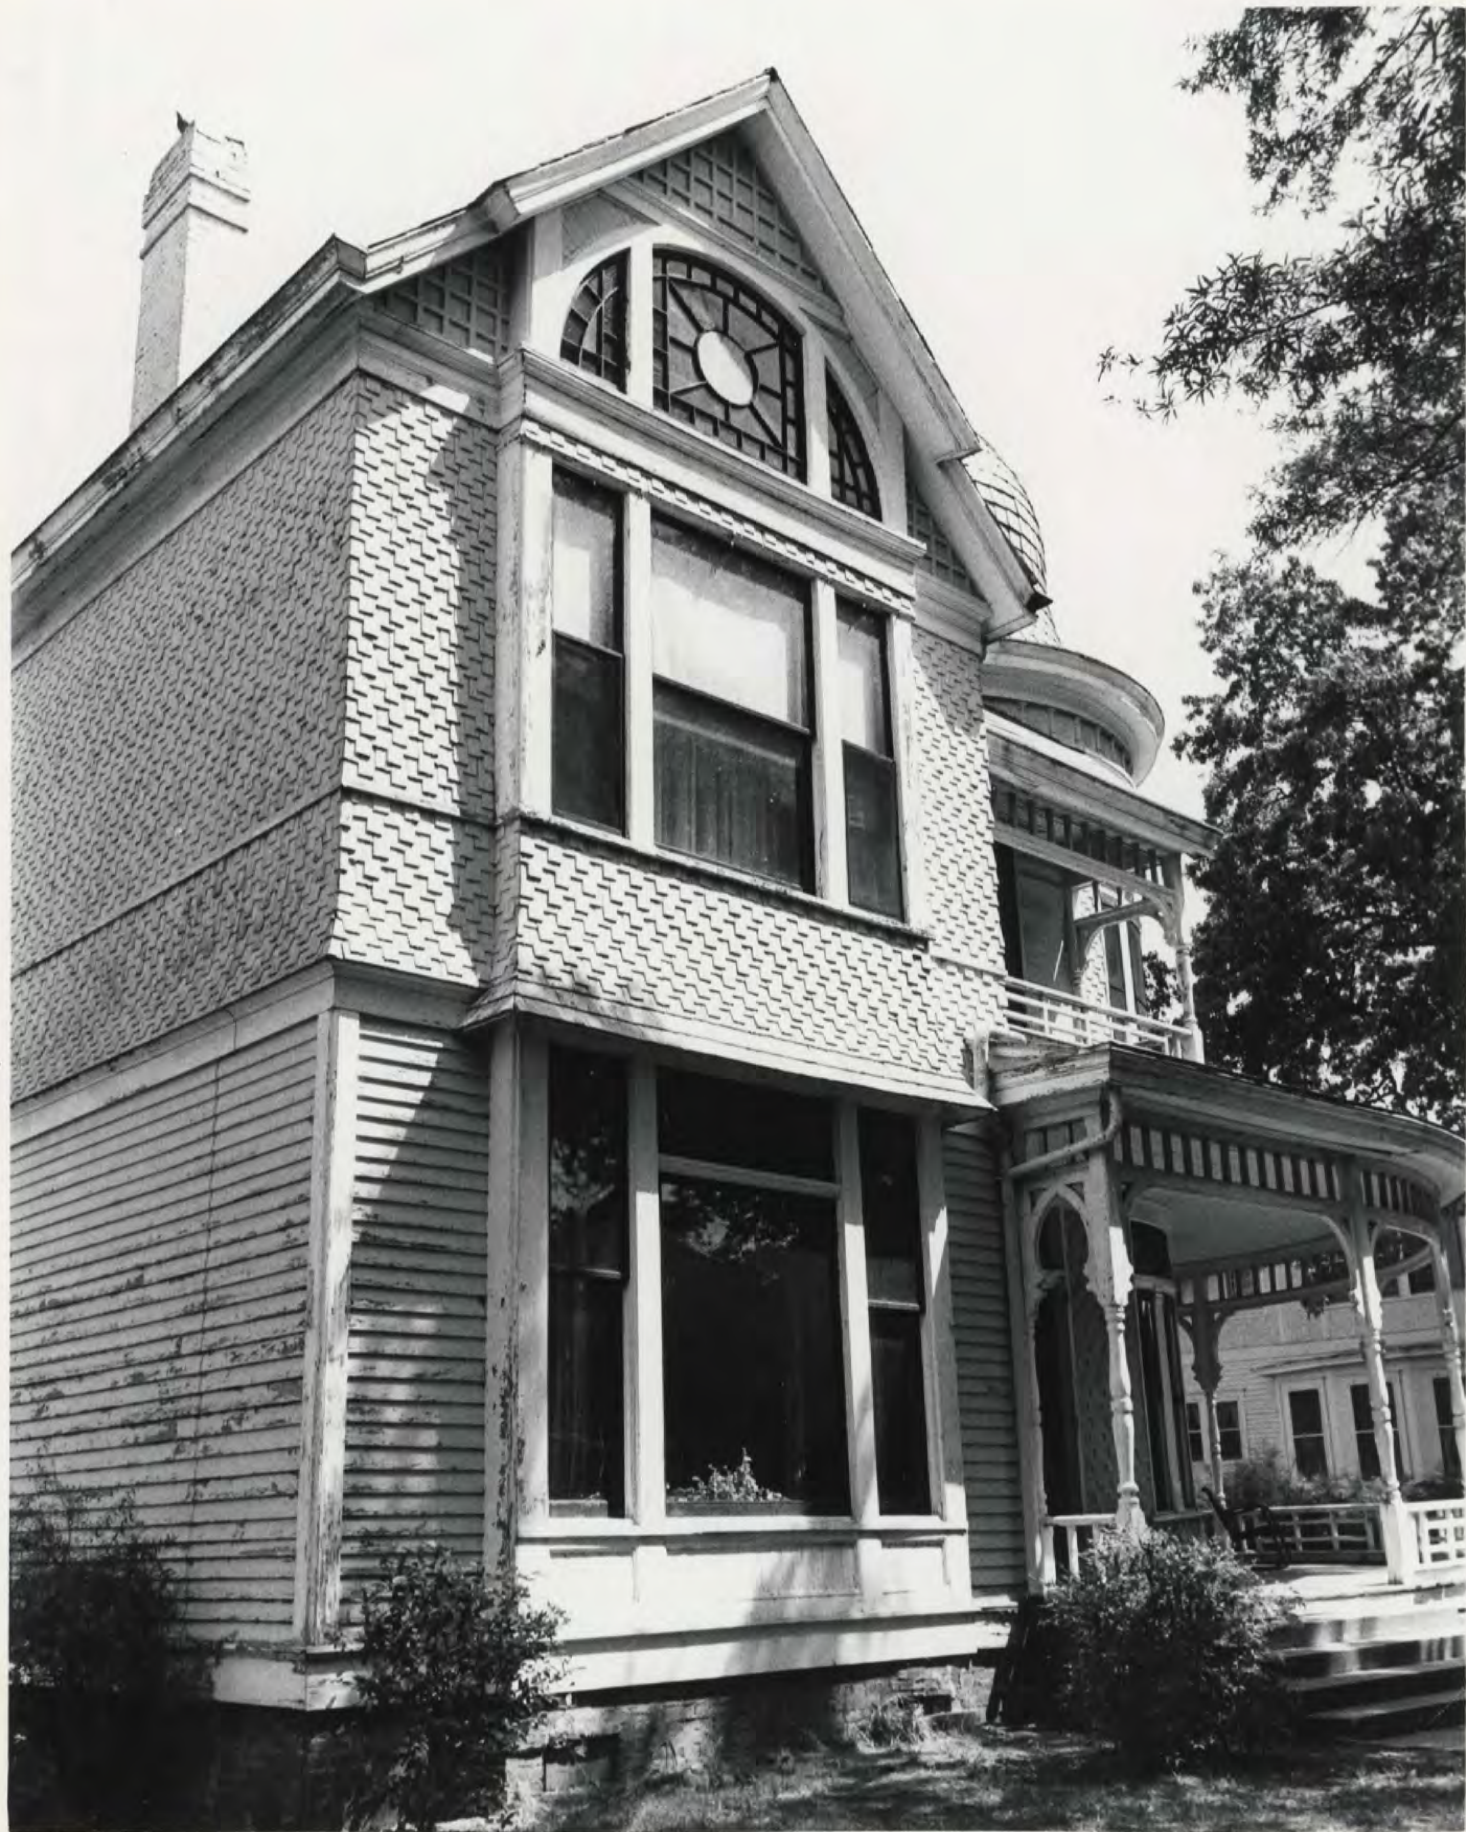
2. RAGLAND HOUSE
PULASKI COUNTY, ARKANSAS
GABLED BAY ON FACADE, VIEWED FROM THE NORTHWEST
D.O.P. 6-17-77

Gabled bay on facade, viewed from the northwest

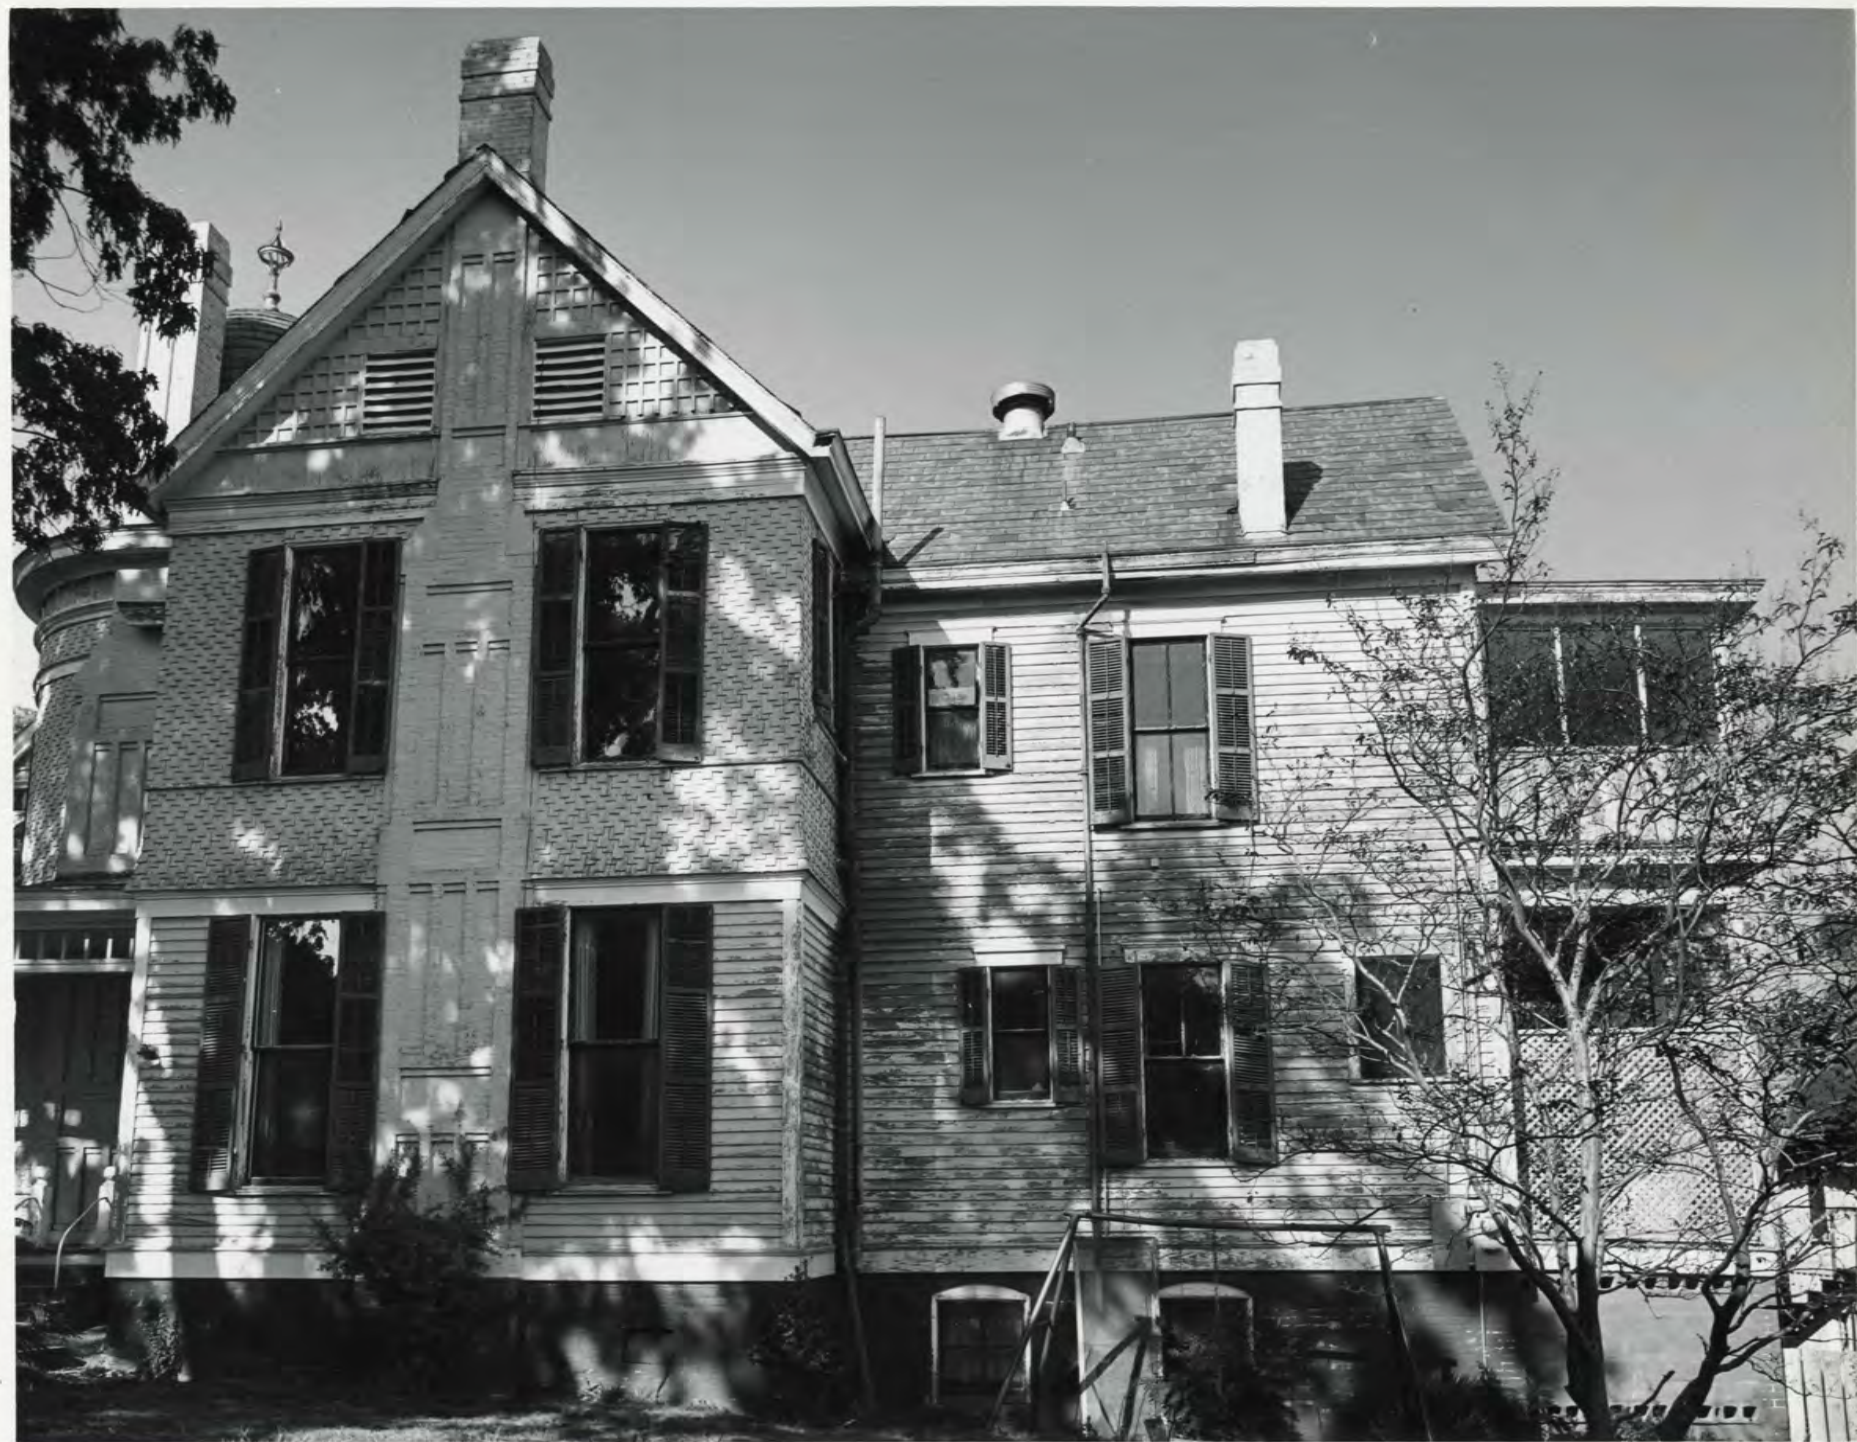
2. RAGLAND HOUSE
PULASKI COUNTY, ARKANSAS
SOUTH ELEVATION, VIEWED FROM THE SOUTH
D.O.C. 6-17-77

South elevation, viewed from the south

The dominant feature of the south elevation is a two story projection. A brick chimney with geometric designs runs up the center of the projection. The gable end is covered in waffle-patterned stick work. Double-hung single-light shuttered windows flank either side of the chimney on both first and second story levels. The east end of the south elevation is covered in clapboard siding and features a two-over-two-light double-hung shuttered window at both first and second story levels. Three small double-hung windows are found irregularly spaced on this section of the house. Two four-light windows with arched wooden heads are found at the basement level.

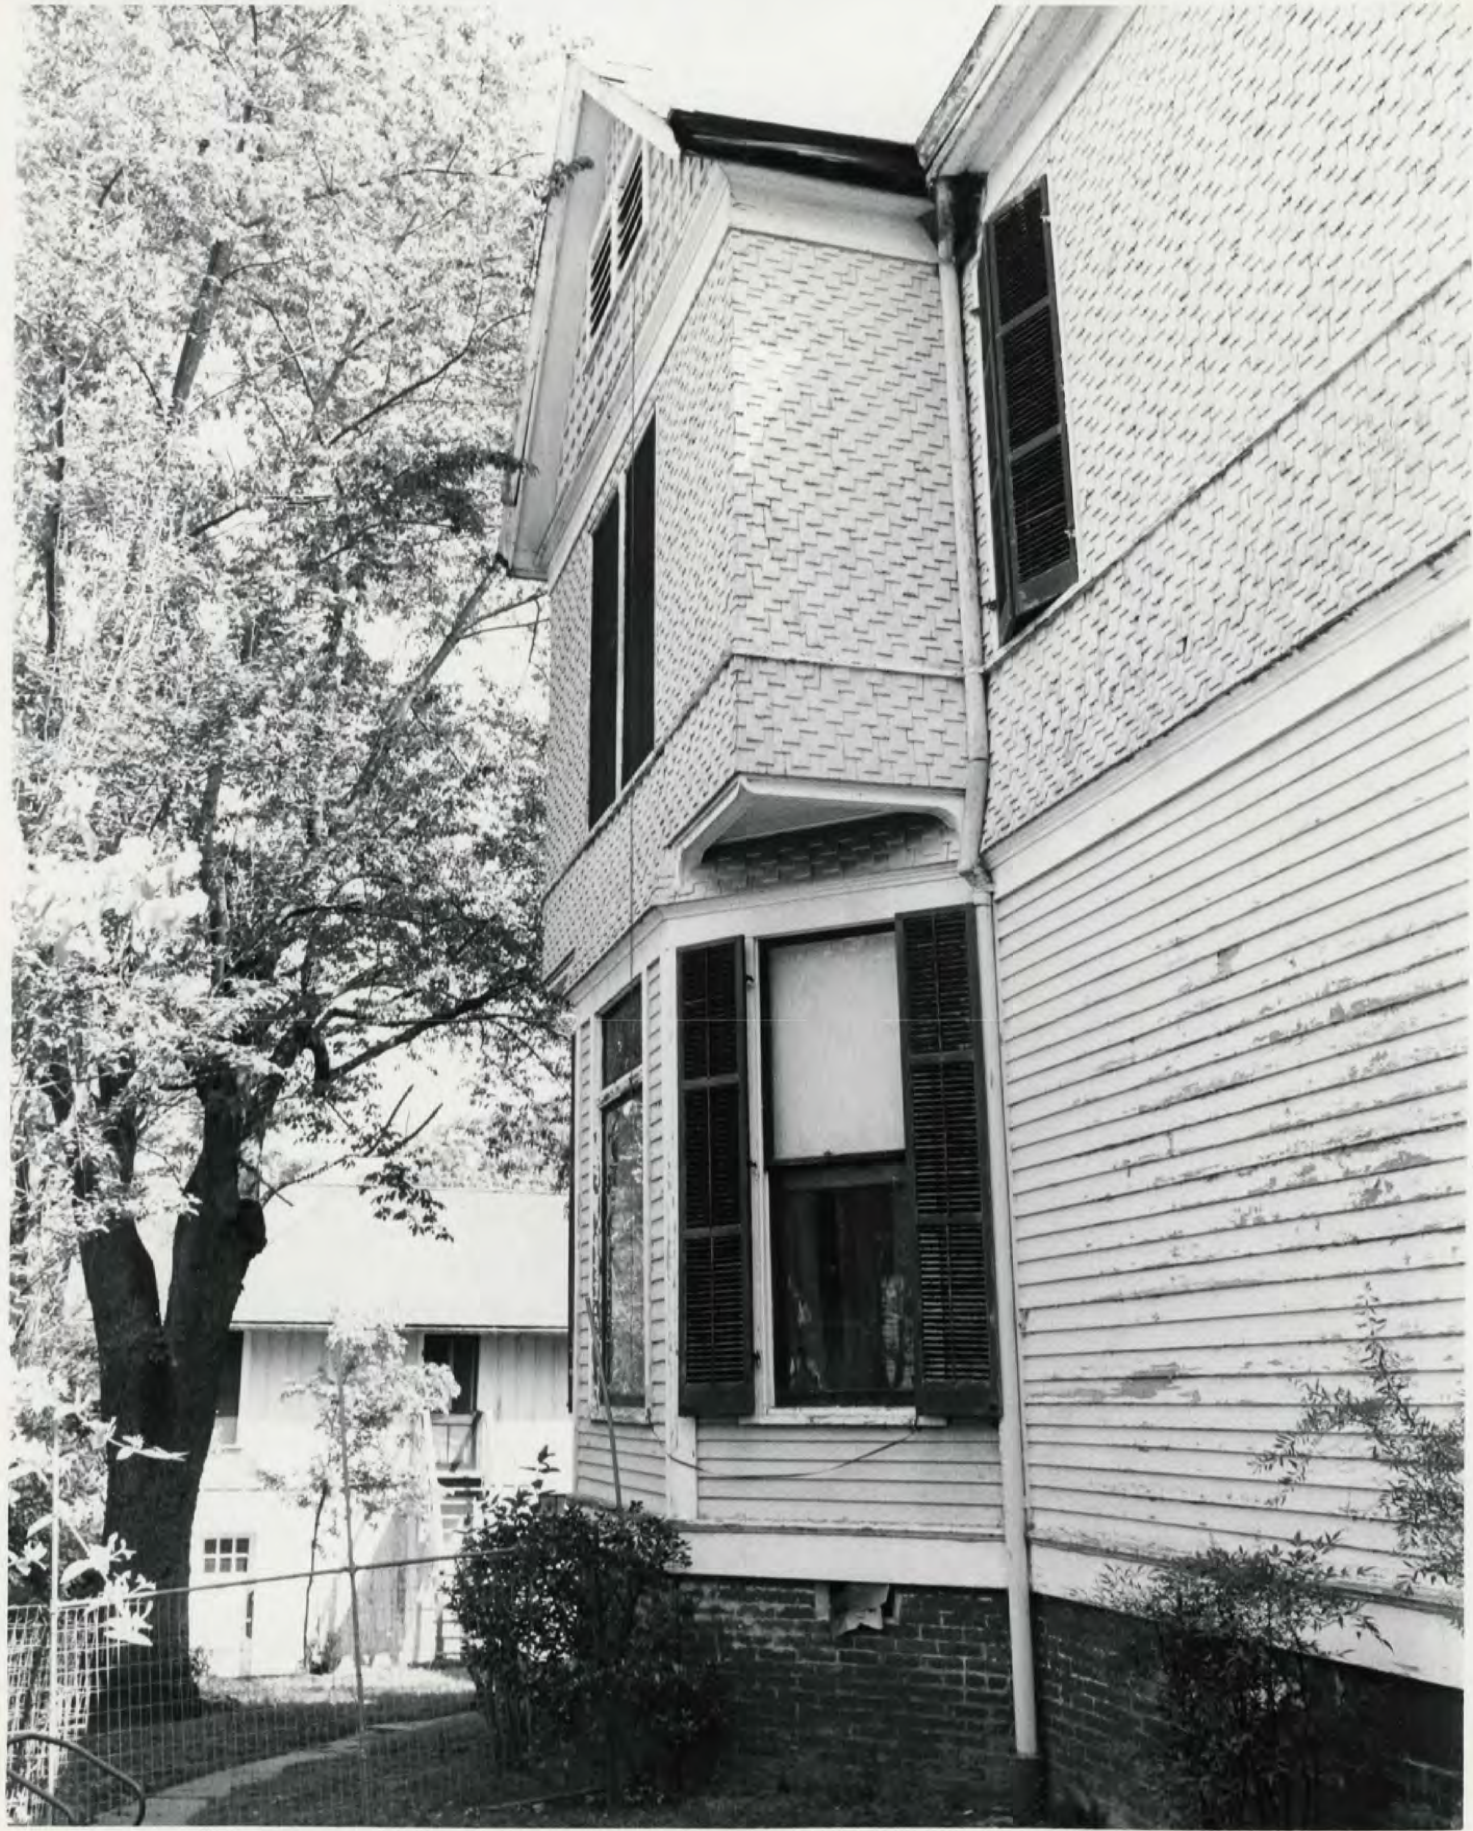
4. RAGLAND HOUSE
PULASKI COUNTY, ARKANSAS
Gabled bay on north elevation, viewed from the northwest
D.O.C. 6-17-77
4 of 9

Gabled bay on north elevation, viewed from the northwest

The south elevation of the Ragland House is dominated by a two-story gable bay. Waffle-patterned stick work covers the gable end. A pair of double-hung windows is found at the second story level. The first floor of the bay is three sided featuring a double-hung shuttered window on each side.

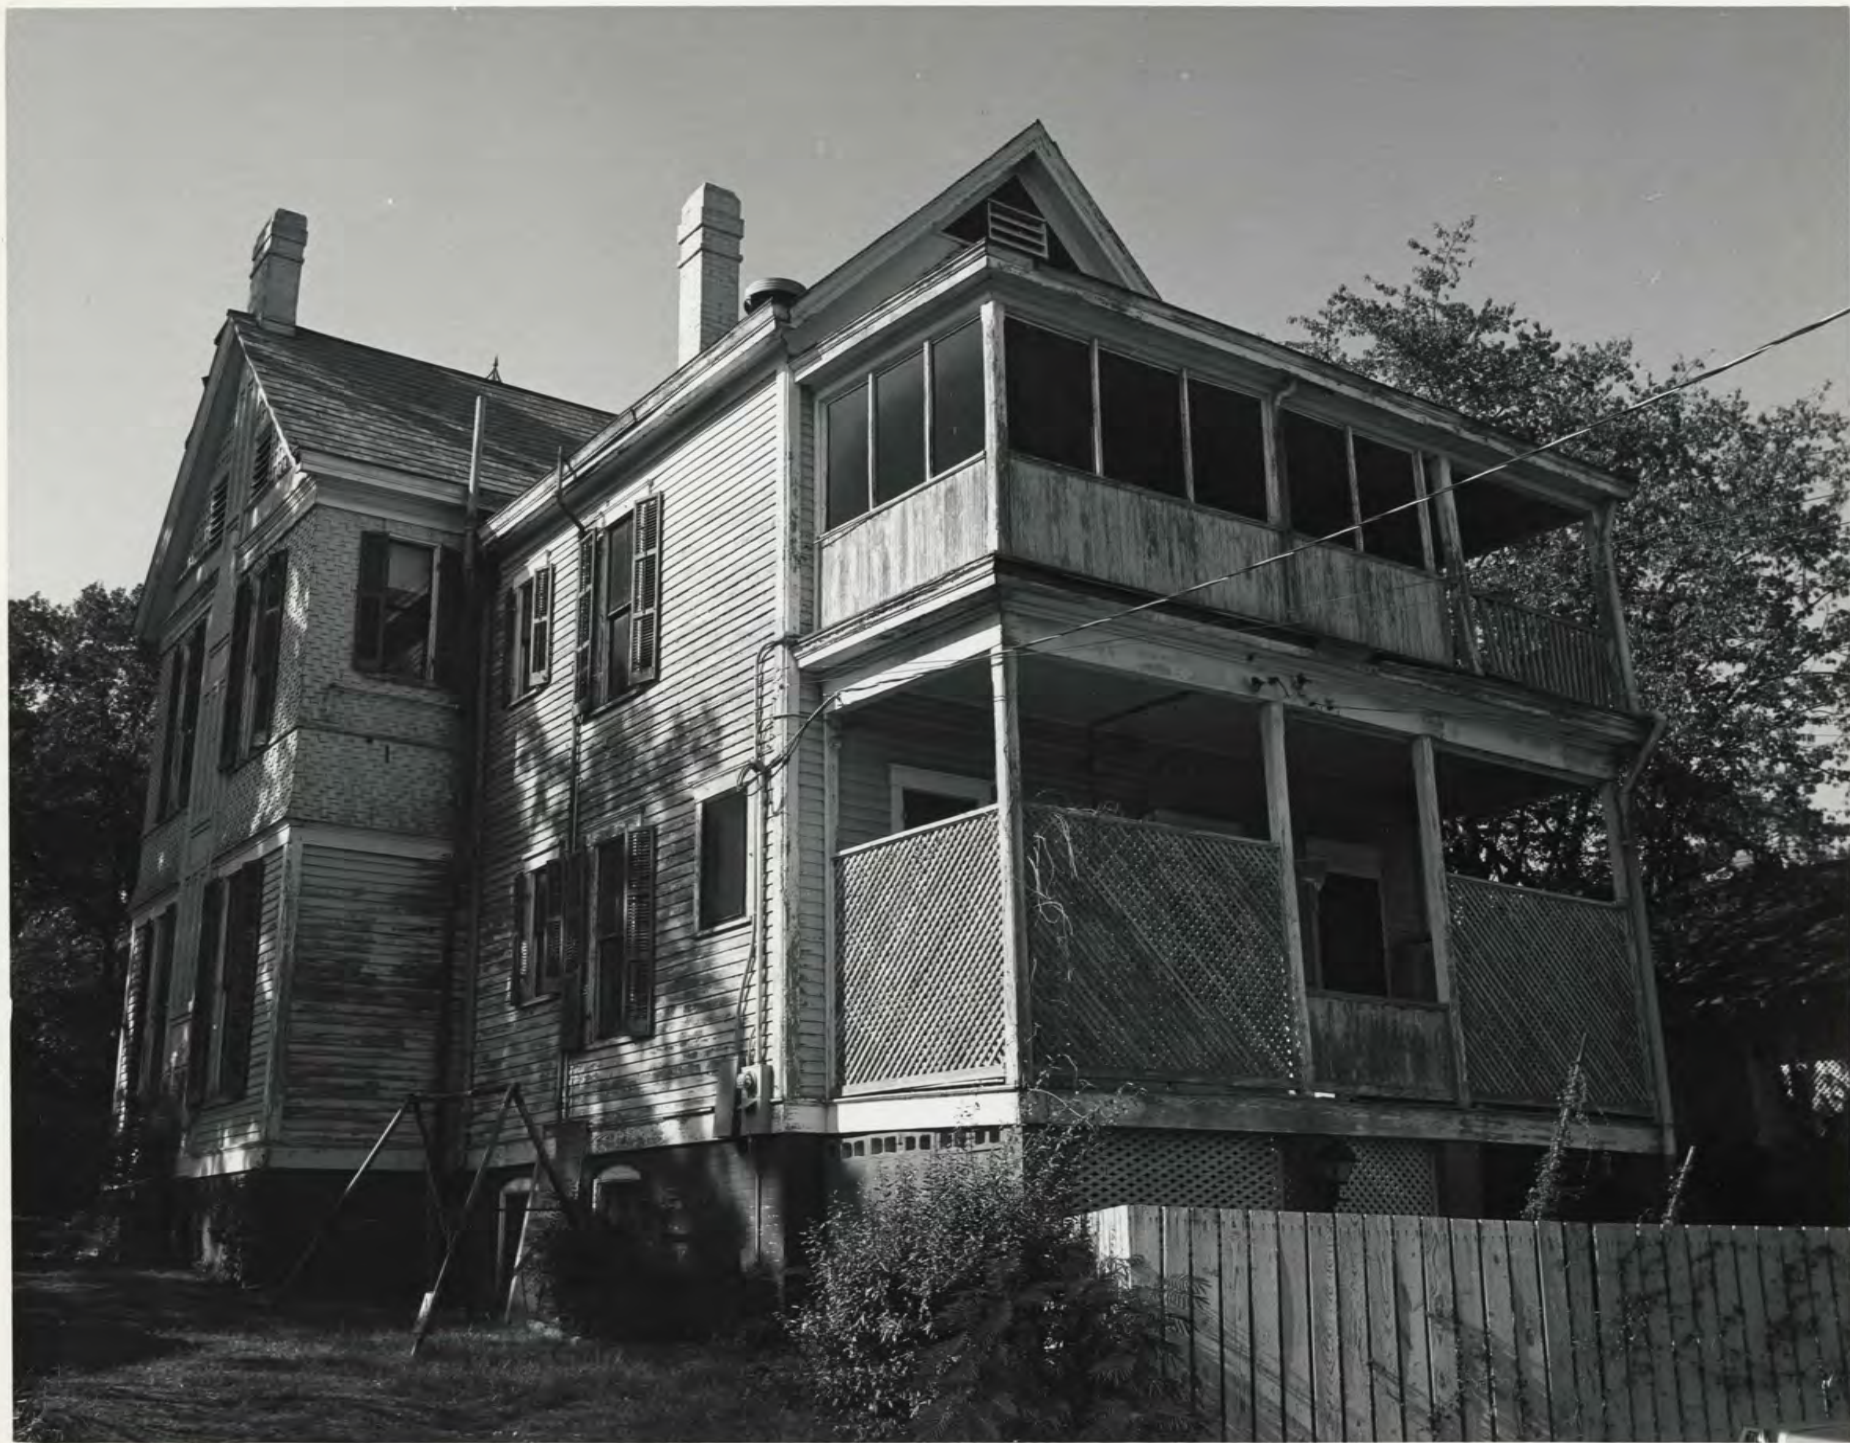
5. RAGLAND HOUSE
PULASKI COUNTY, ARKANSAS
EAST ELEVATION, VIEWED FROM THE SOUTHEAST

East elevation, viewed from the southeast

The east elevation features a two-story portico with a basement. The original lattice remains around the first floor portico while a portion of the second story portico has been enclosed.

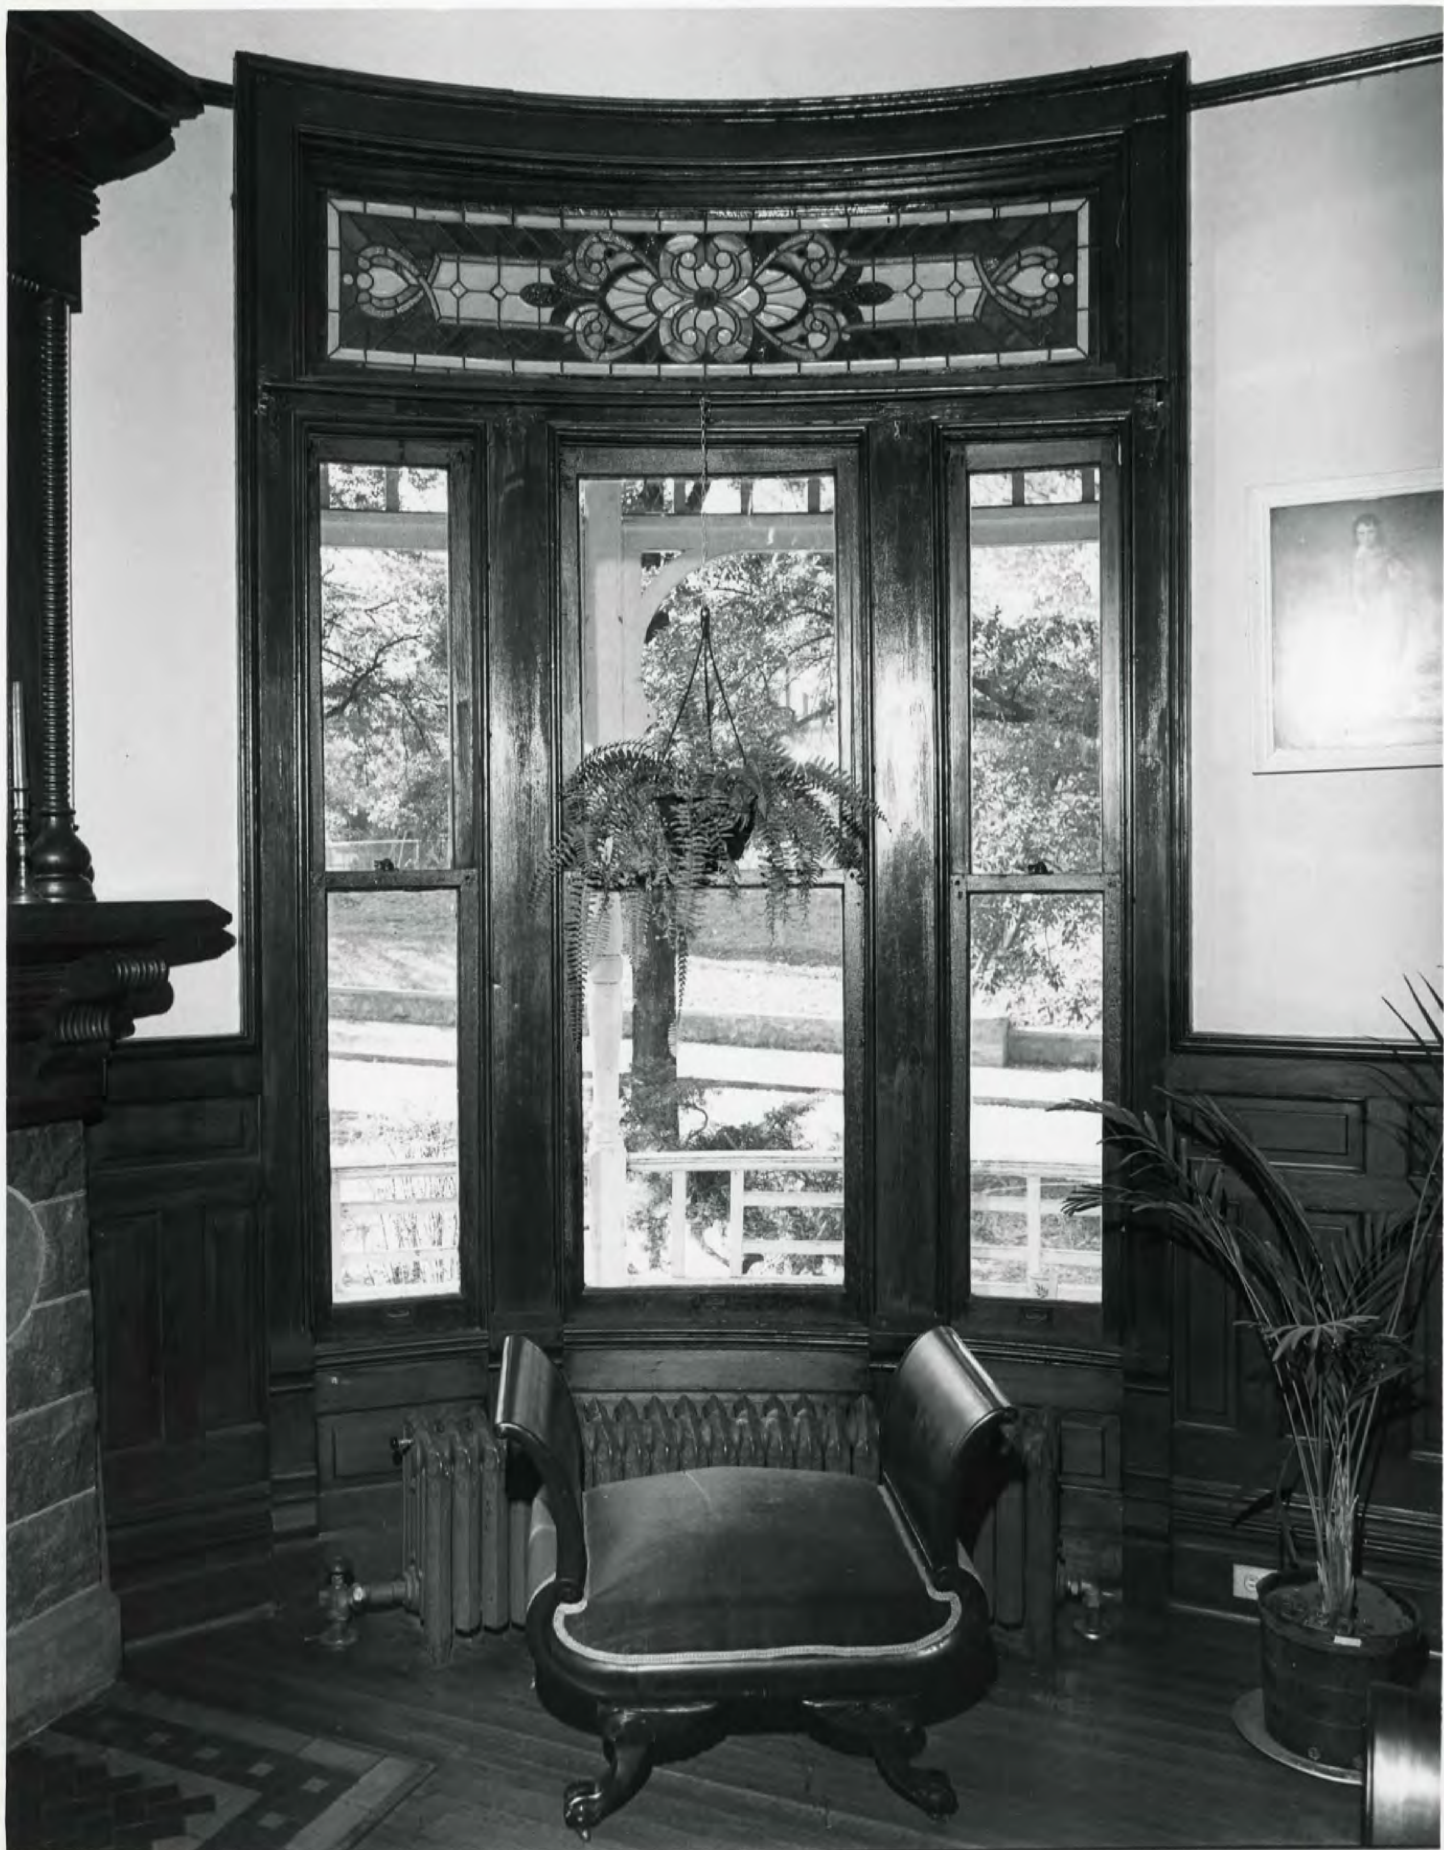
6. RAGLAND HOUSE
PULASKI COUNTY, ARKANSAS
interior of curved window in bay
D.O.E. 6-17-77

Interior of curved window in bay.

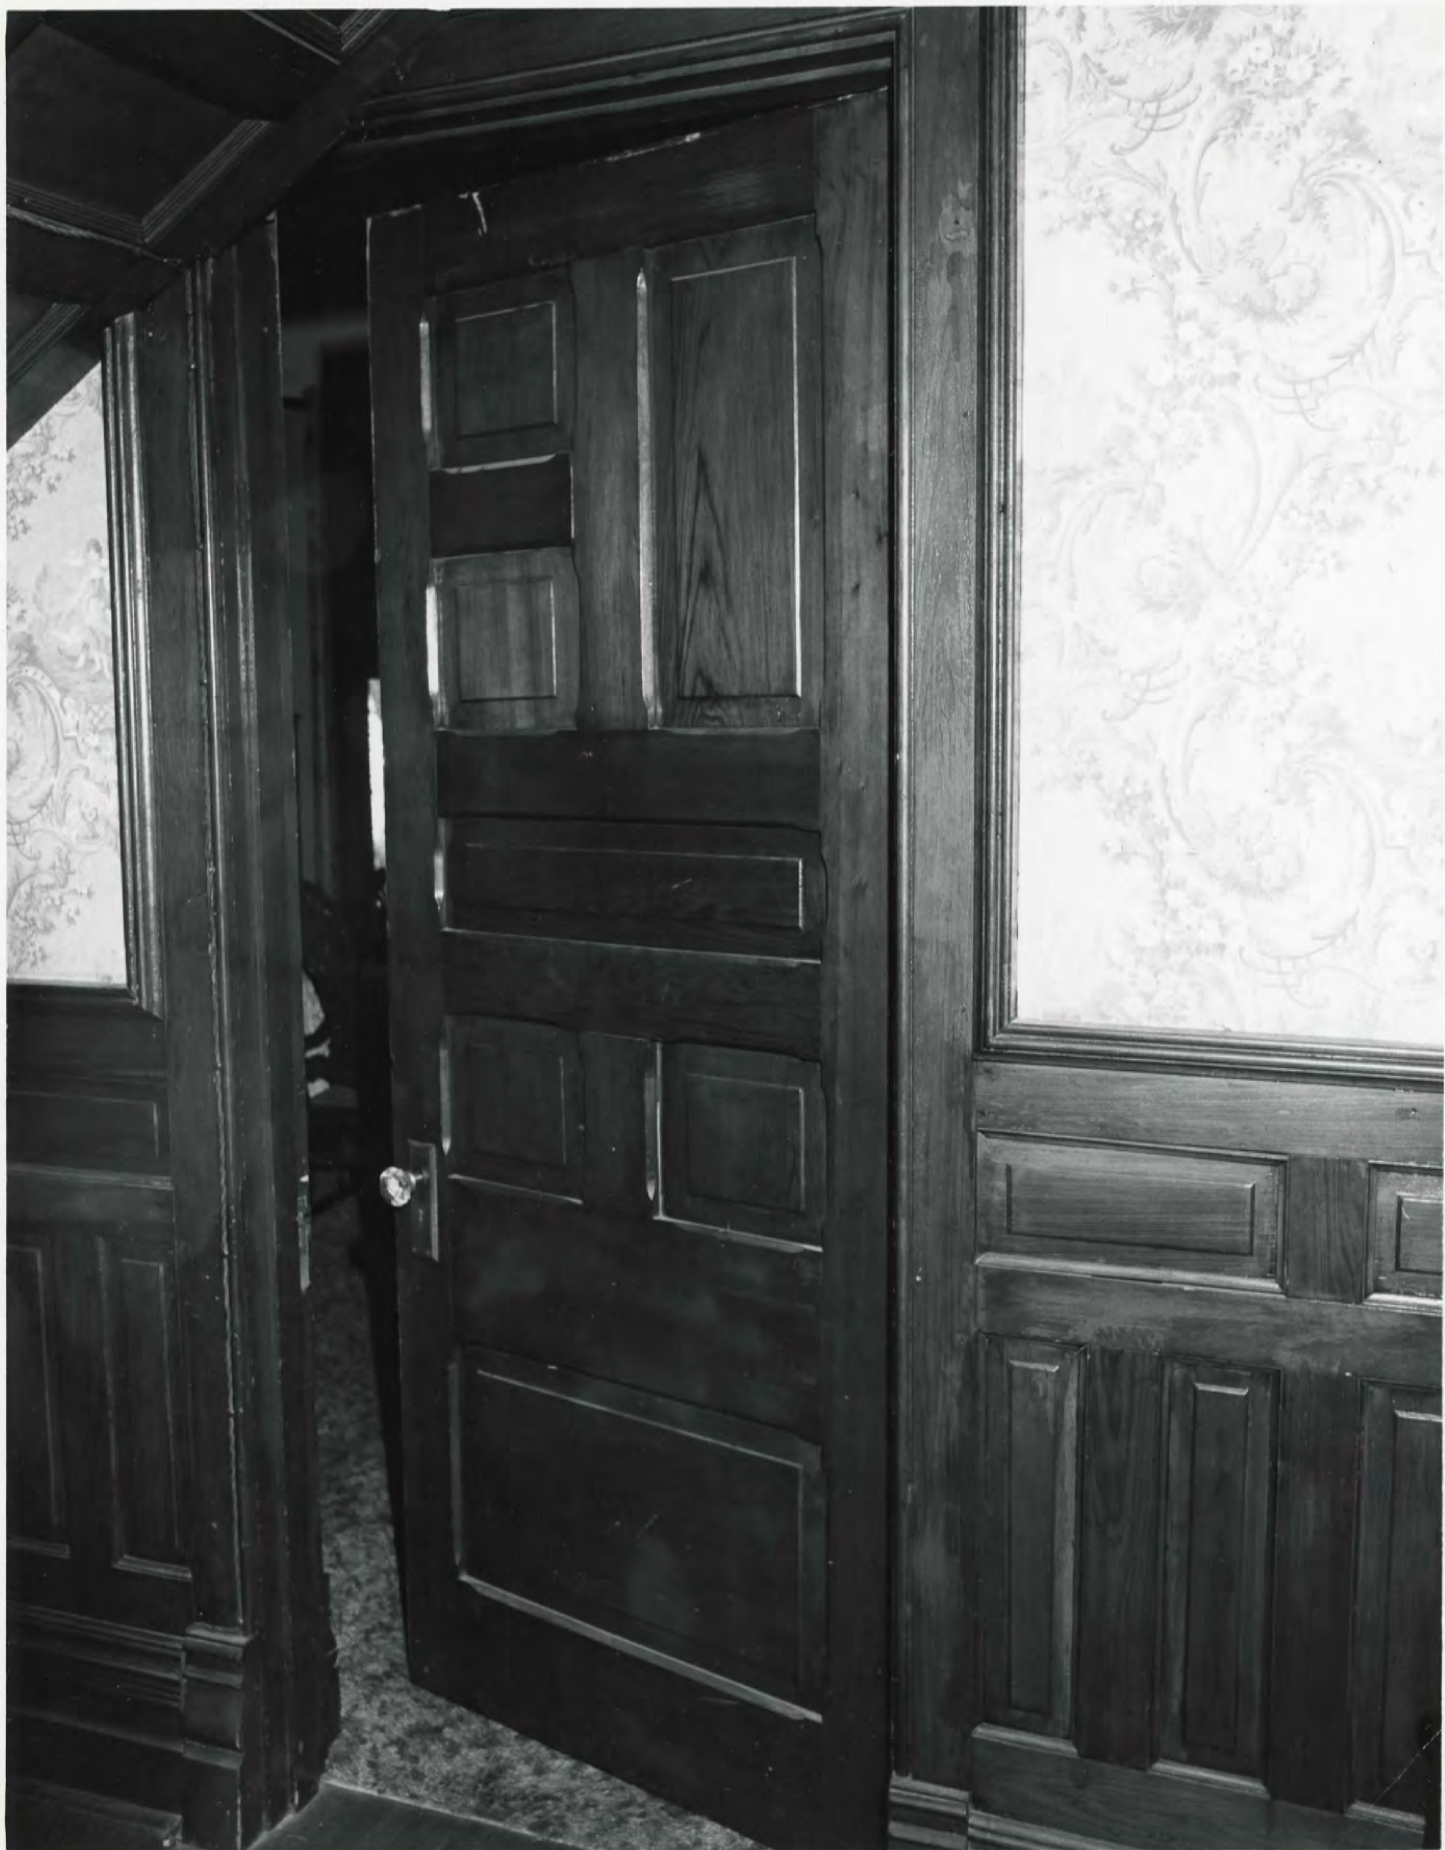
7. RAGLAND HOUSE
Pulaski County, ARKANSAS
UNUSUAL PANEL DESIGN IN DOORS
D.O.E. 6-17-77
7 of 9

Unusual panel design in doors.

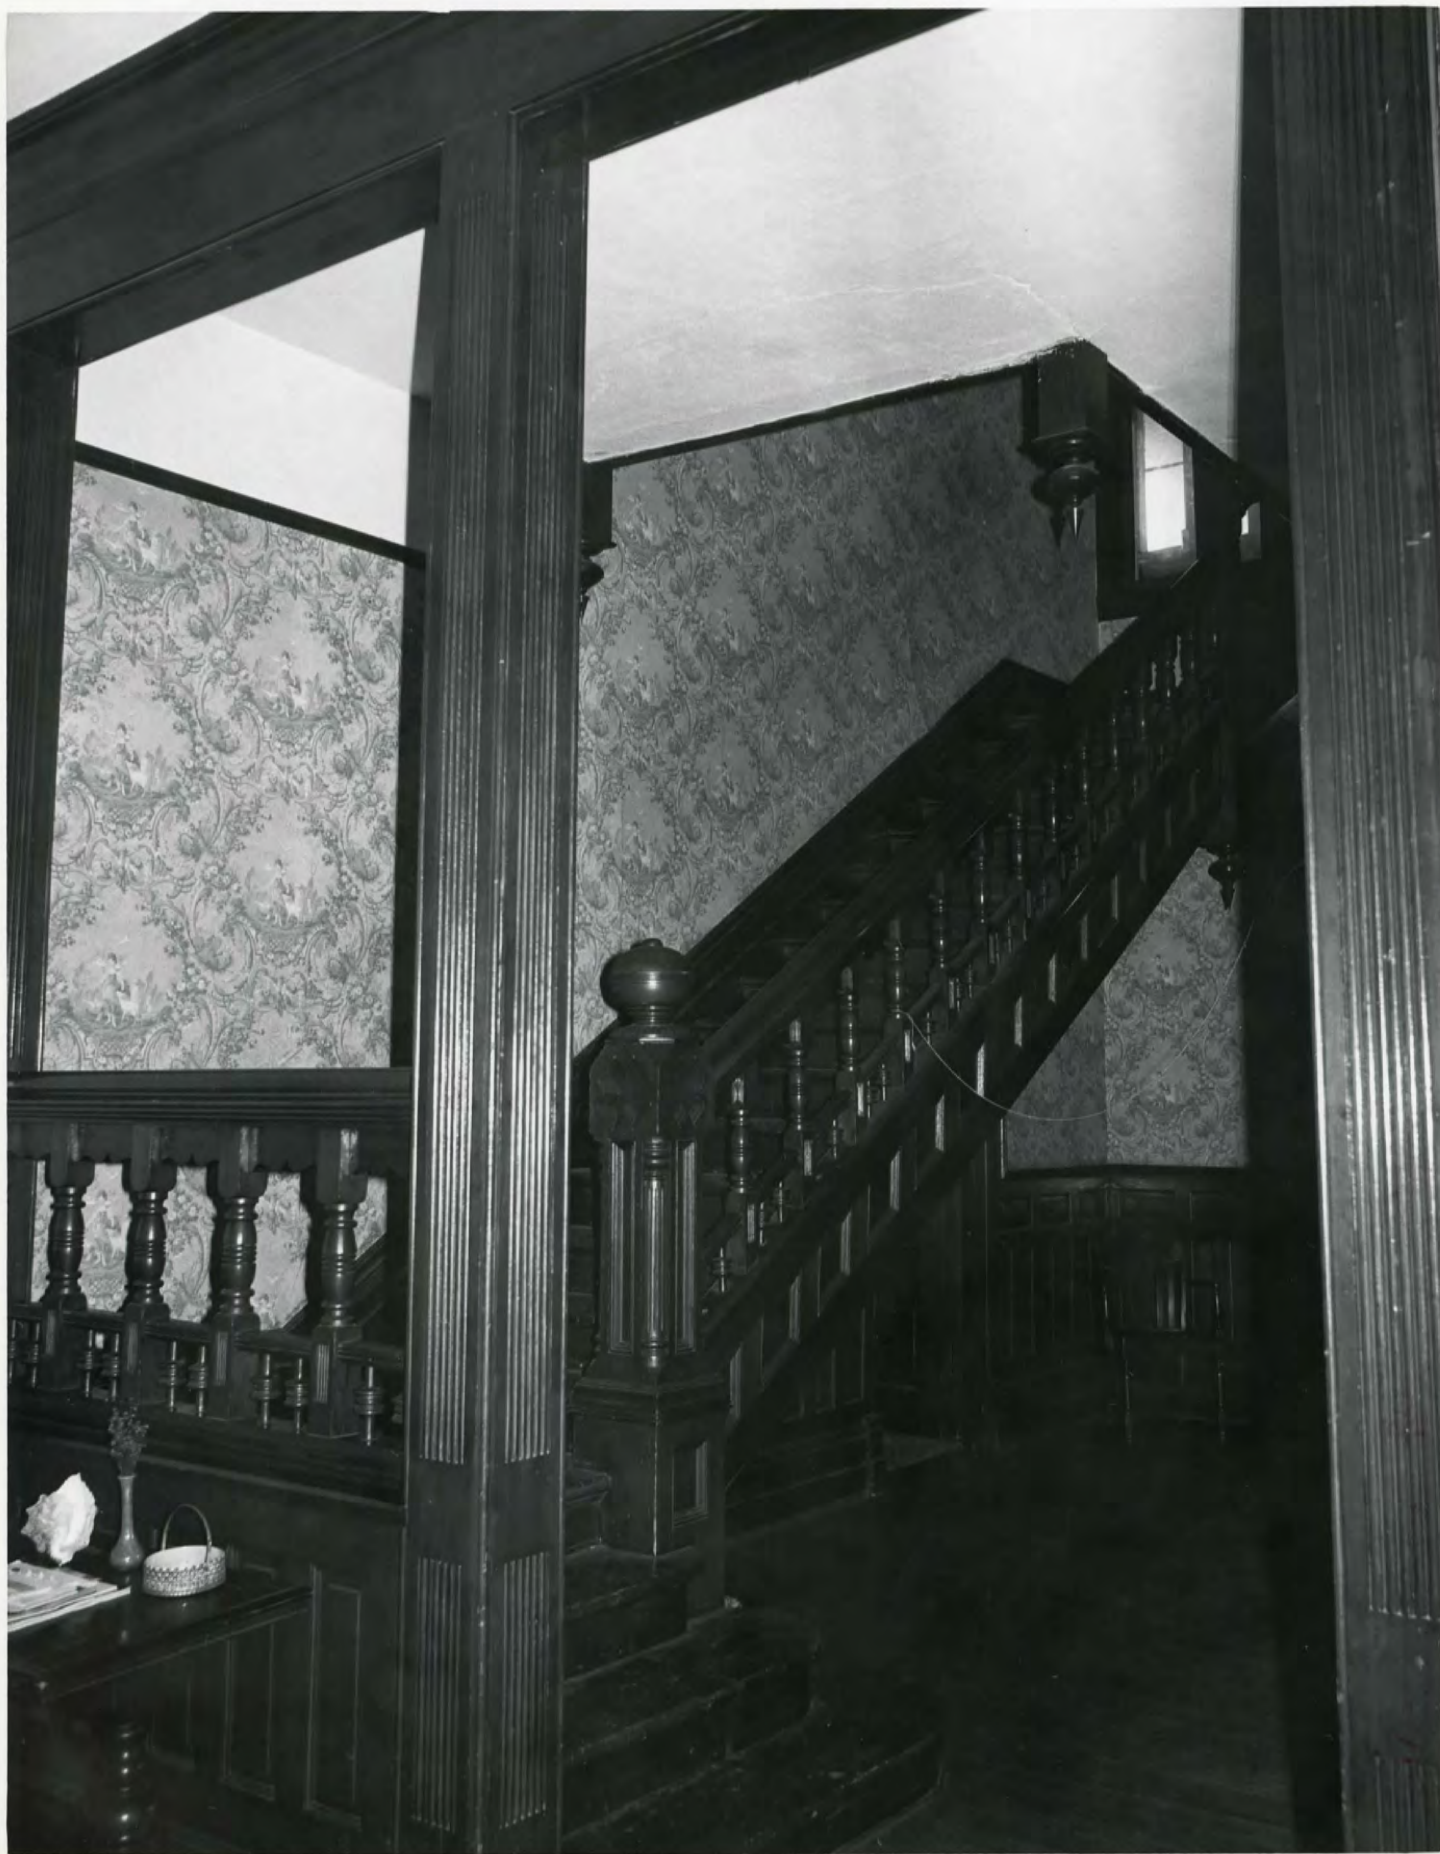
8. RAGLAND HOUSE
PULASKI COUNTY, ARKANSAS
STAIRWAY IN CENTRAL HALL
D.O.E. 6-17-77
8 of 9

Stairway in central hall.

Although complex in exterior shape, the Ragland House is basically a central hall plan. The original hardwood woodwork is found throughout the house in mantels, floors, doors, wainscoting, baseboards and window and door trim. All seven fireplace mantels are unique in design. The mantel in the south parlor is of decoratively designed birds-eye maple. The doors feature an unusual design in their panelling. An open well two-run stairway rises to the second floor from the central hall.

The stairway features an ornamental newel post and turned ballusters. Several of the original light fixtures wired for gas and electricity are found in the house.
