NATIONAL REGISTER OF HISTORIC PLACES
INVENTORY -- NOMINATION FORMSEE INSTRUCTIONS IN HOW TO COMPLETE NATIONAL REGISTER FORMS
TYPE ALL ENTRIES -- COMPLETE APPLICABLE SECTIONS

Ragland House

1617 Center

Little Rock,

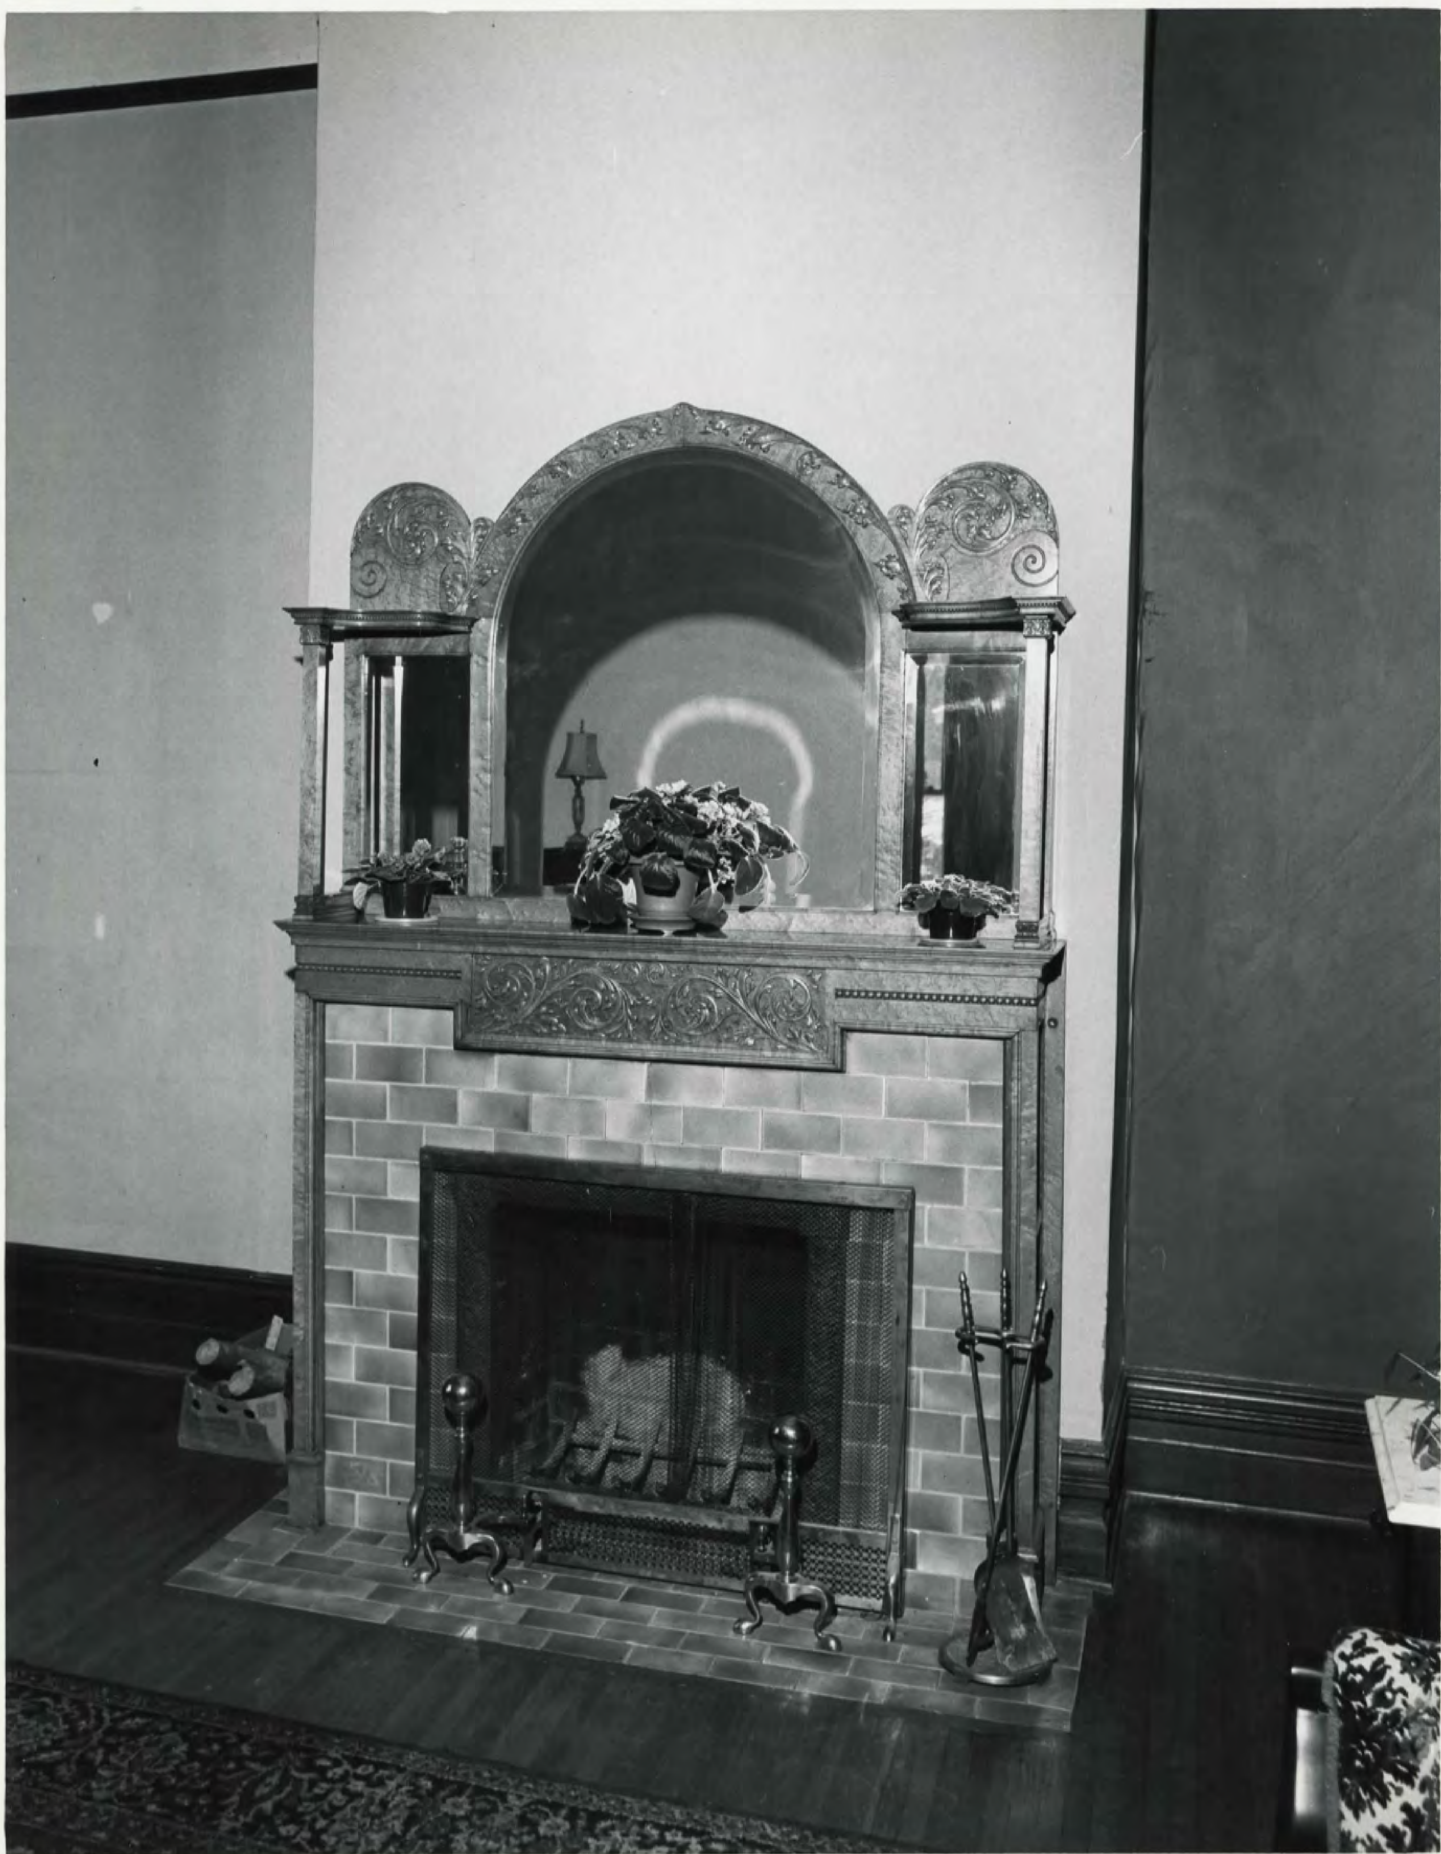
9. RAGLAND HOUSE
PULASKI COUNTY, ARKANSAS
BIRD'S-EYE MAPLE MANTEL
D.O.E. 6-17-77

Bird's-Eye maple mantel.

Although complex in exterior shape, the Ragland House is basically a central hall plan. The original hardwood woodwork is found throughout the house in mantels, floors, doors, wainscoting, baseboards and window and door trim. All seven fireplace mantels are unique in design. The mantel in the south parlor is of decoratively designed birds-eye maple. The doors feature an unusual design in their panelling. An open well two-run stairway rises to the second floor from the central hall.
